LICENSEE: Southern California Edison Company

FACILITY: San Onofre Unit No. 1

SUBJECT: REPORT OF JULY 10, 1980 MEETING TO DISCUSS THE RESULTS OF STEAM GENERATOR INSPECTIONS AND CORRECTIVE ACTIONS FOR SAN ONOFRE UNIT 1

SCE - NRC
MEETING ON STEAM GENERATORS
JULY 10, 1980

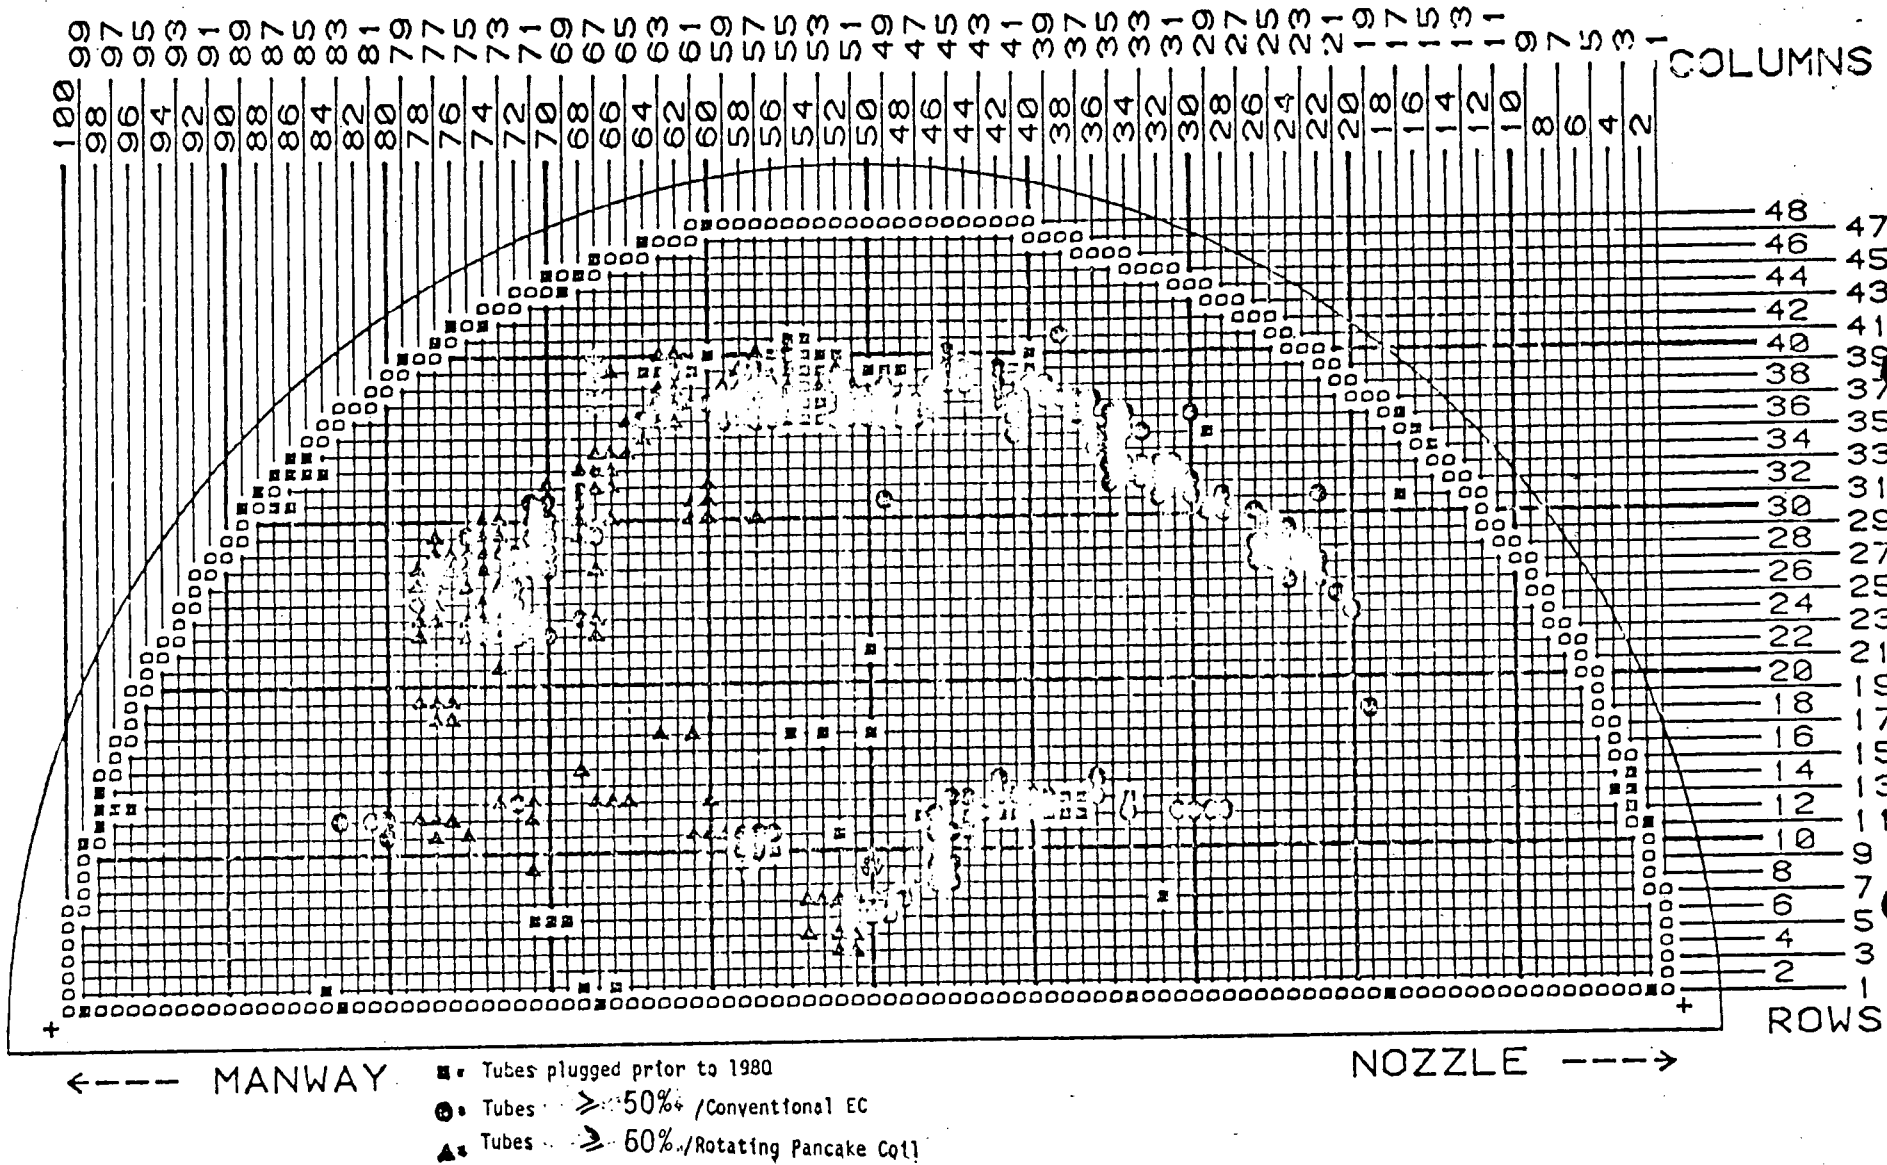
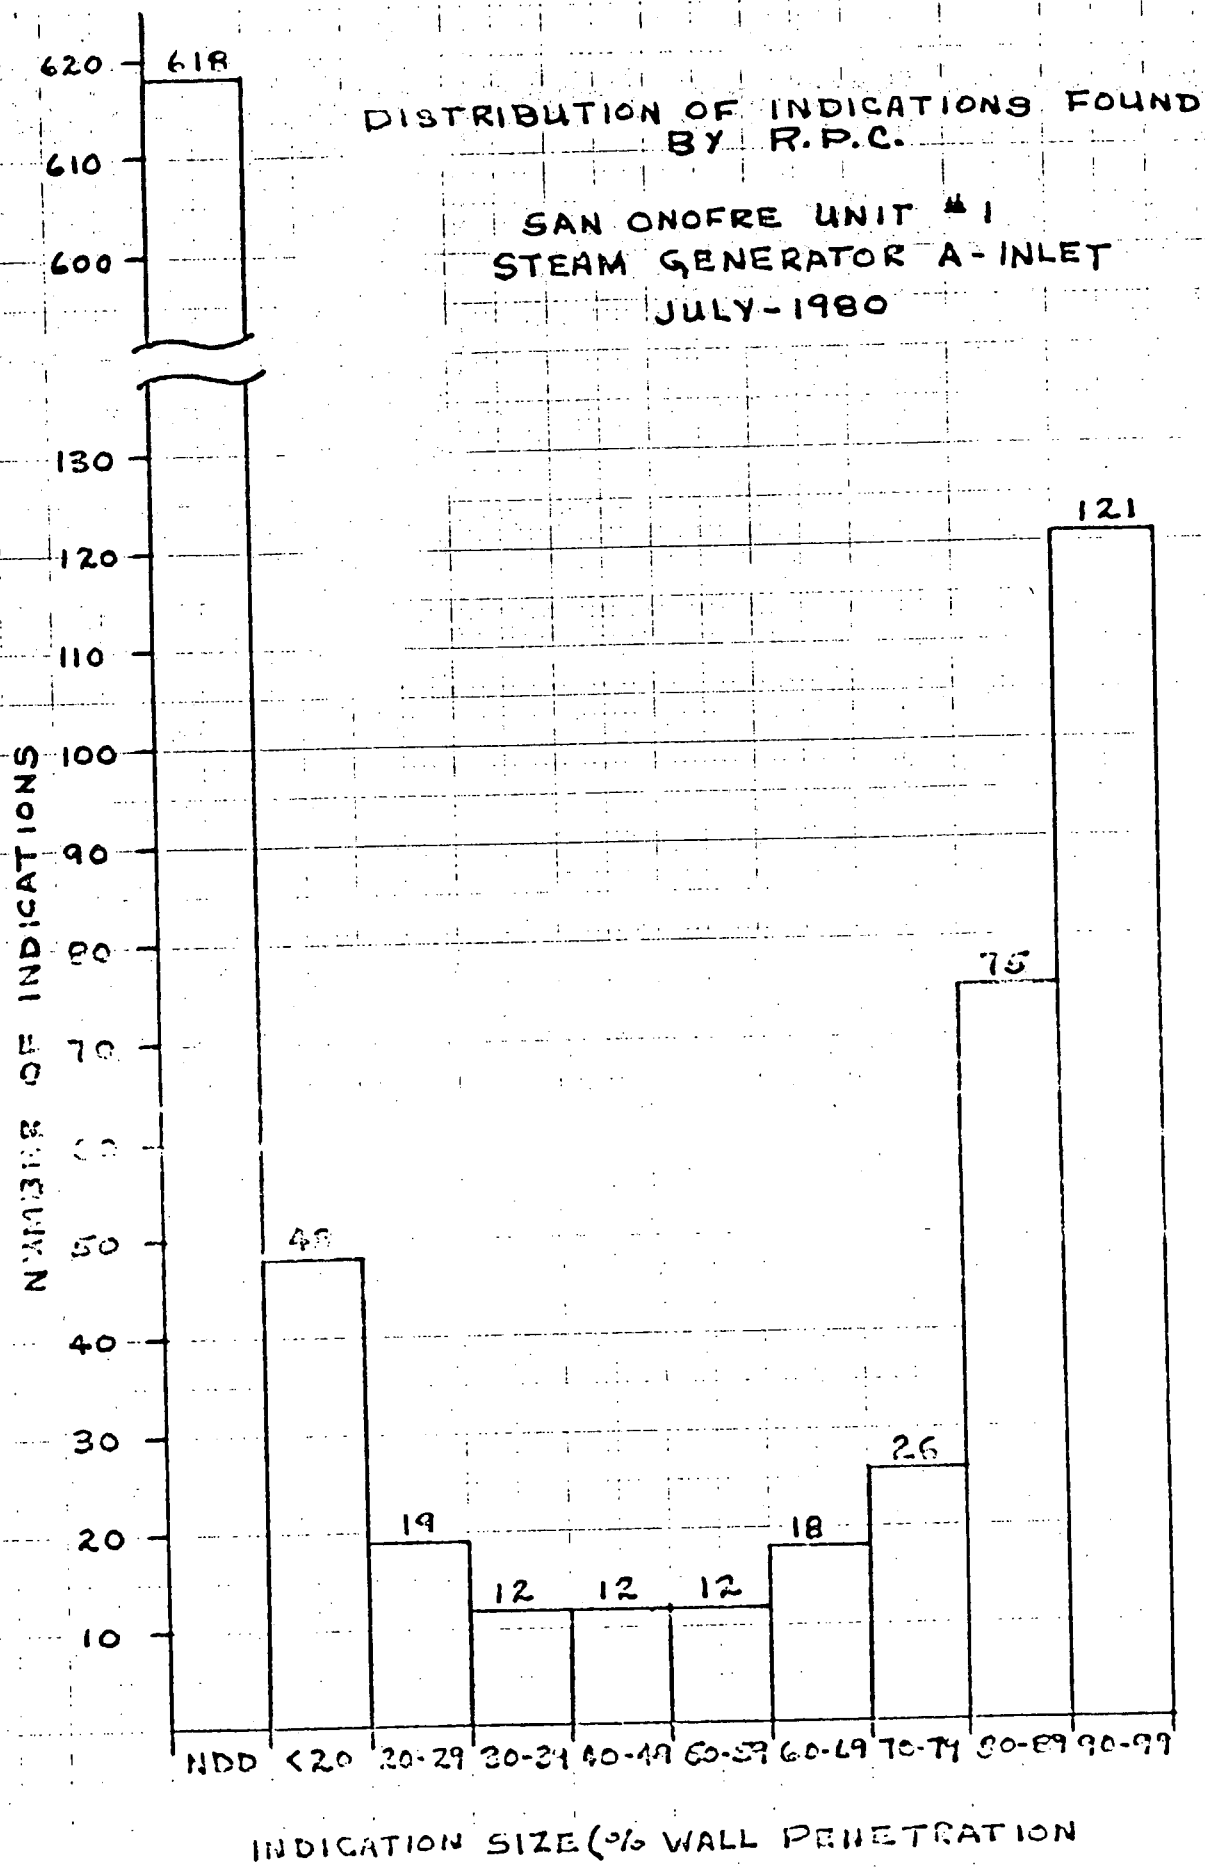
ROTATING PANCAKE COIL INSPECTION RESULTS

JULY, 1980

Tubes evaluated (0800, 7/9/80)	<u>1179</u>
Results	
No detectable Indications	<u>772</u>
< 20% Indications	<u>76</u>
>= 20% < 50% Indications	<u>61</u>
>= 50% Indications	<u>270</u>
Number of New Indications	<u>248</u>
Number of New >= 50% Indications	<u>122</u>
