SAFETY EVALUATION  
OF THE GEOLOGIC FEATURES  
AT THE SITE OF THE SAN ONOFRE NUCLEAR  
GENERATING STATION

Docket Nos. 50-206  
50-361  
50-362

U. S. NUCLEAR REGULATORY COMMISSION  
Office of Nuclear Reactor Regulation

July 8, 1975

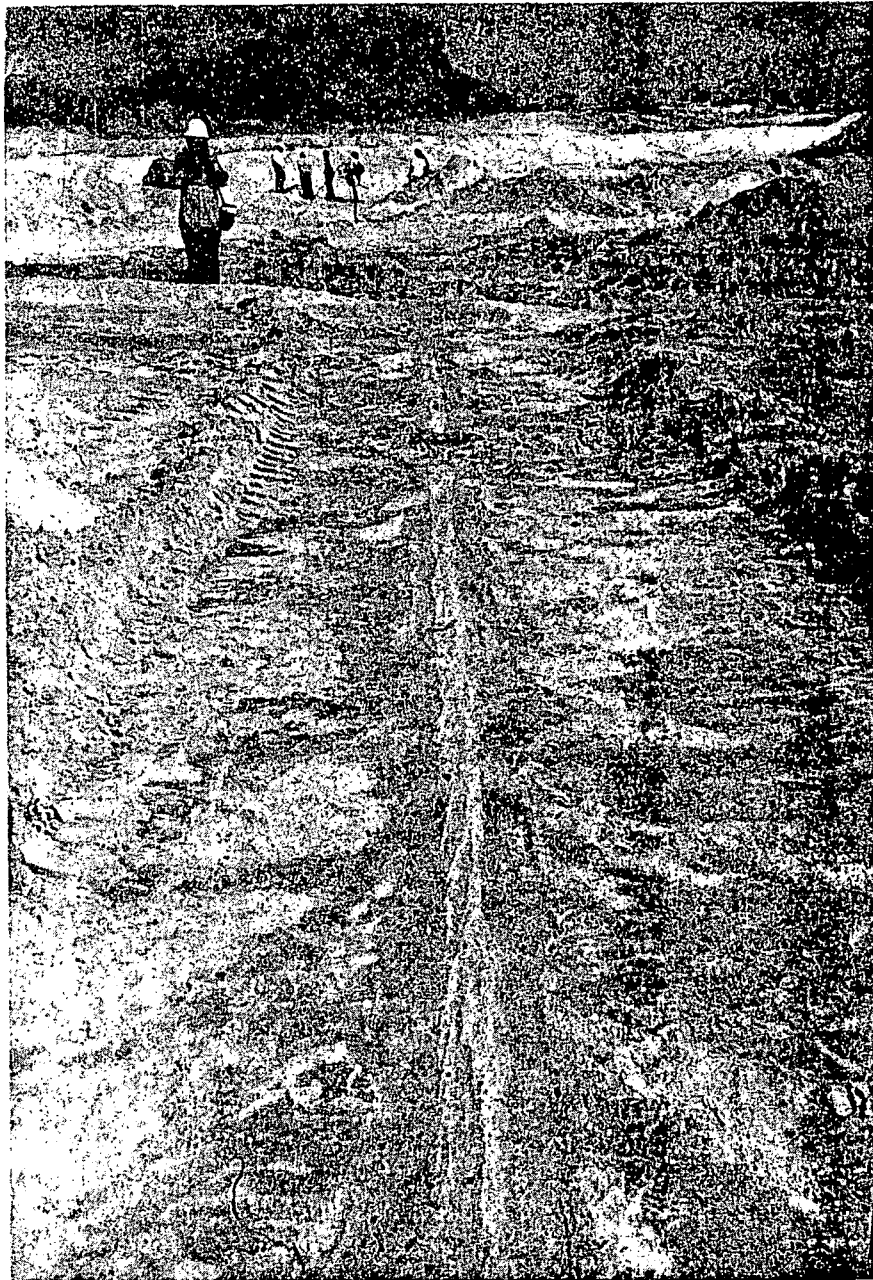
Figure 1

View of one of the Type B shear zones facing southeasterly.

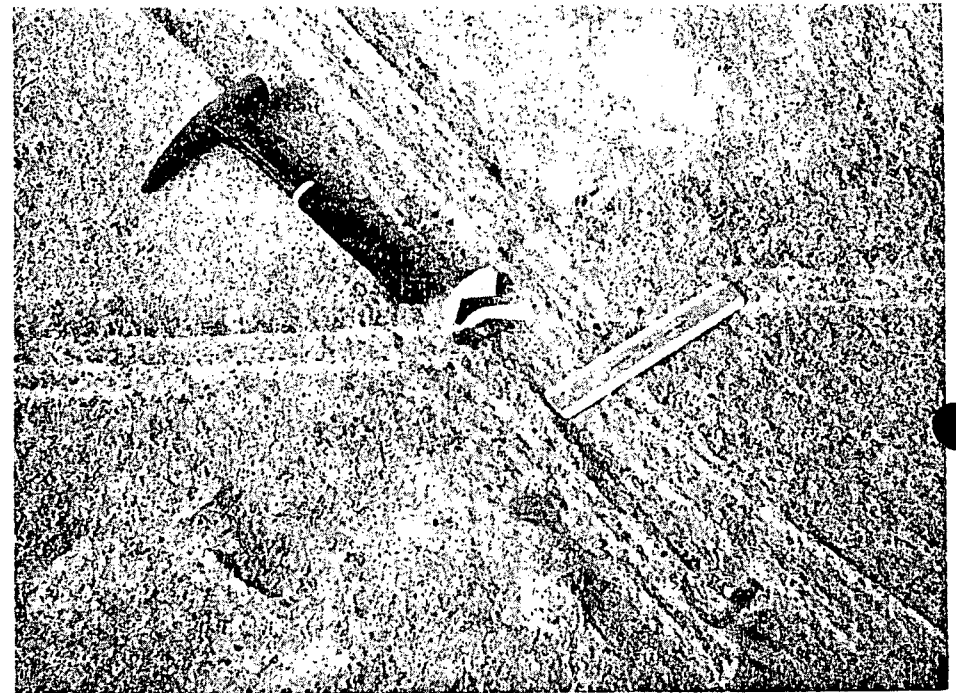
Figure 2

Where the two sets of shear zones intersect, each offsets the other. The maximum total displacement at their intersections and across clay inclusions has been observed not to exceed 4 inches (See Photos 2, 3, and 4). The sense of displacement is consistently left lateral for the Type A shears and right lateral for the Type B shears, indicating the development of a conjugate set of fractures.

Intersection of a Type A and Type B shear zone showing the mutual offset relationship.

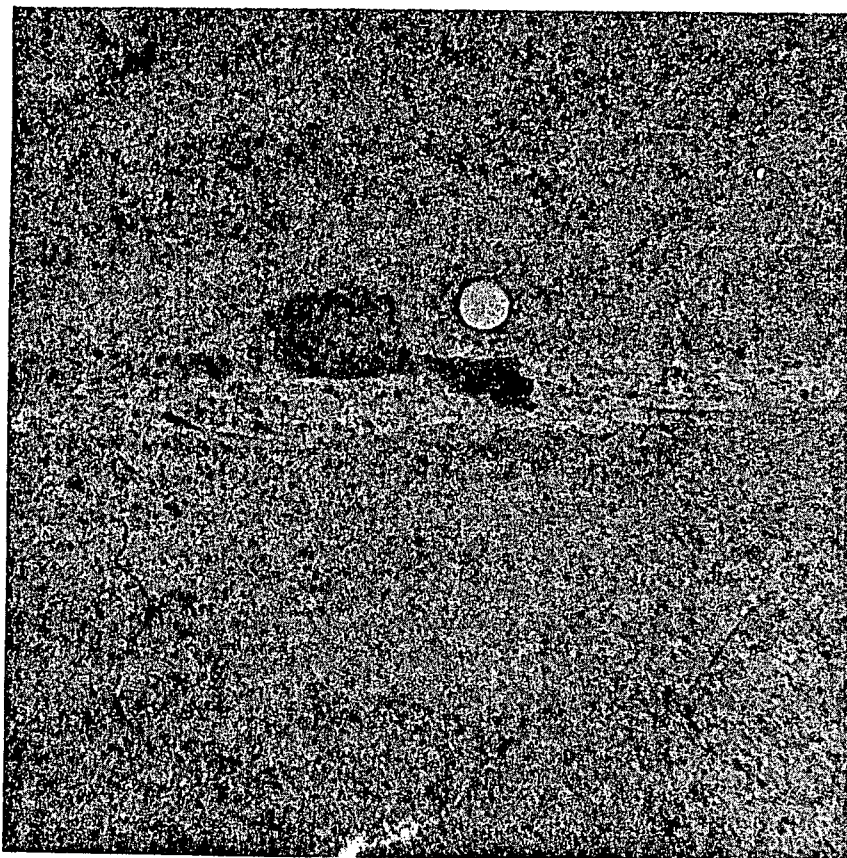
Figure 3  
Clay silt inclusion offset by Type A shear zone. Coin is a quarter.

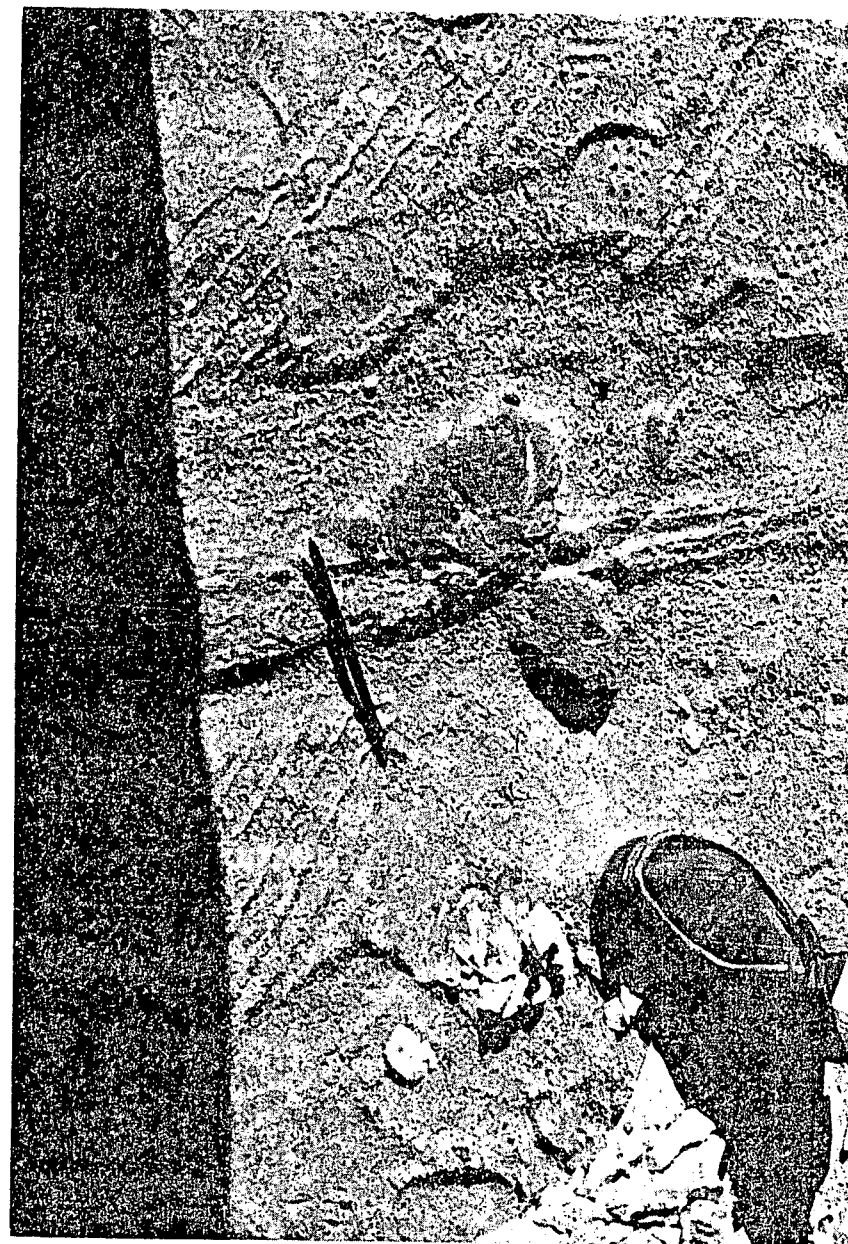
Figure 4  
Clay silt inclusion intersected by Type A shear zone.

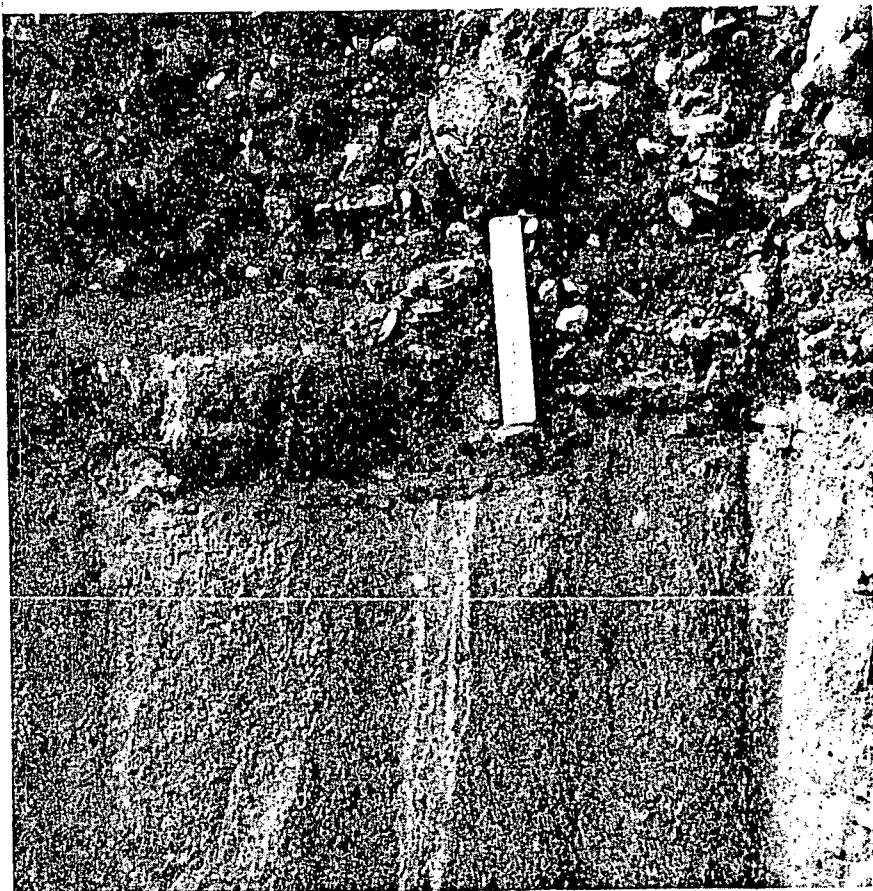
Figure 5  
Type A shear zone in San Mateo Formation  
truncated by terrace deposit. Cast of Unit 2  
excavation. Page 21

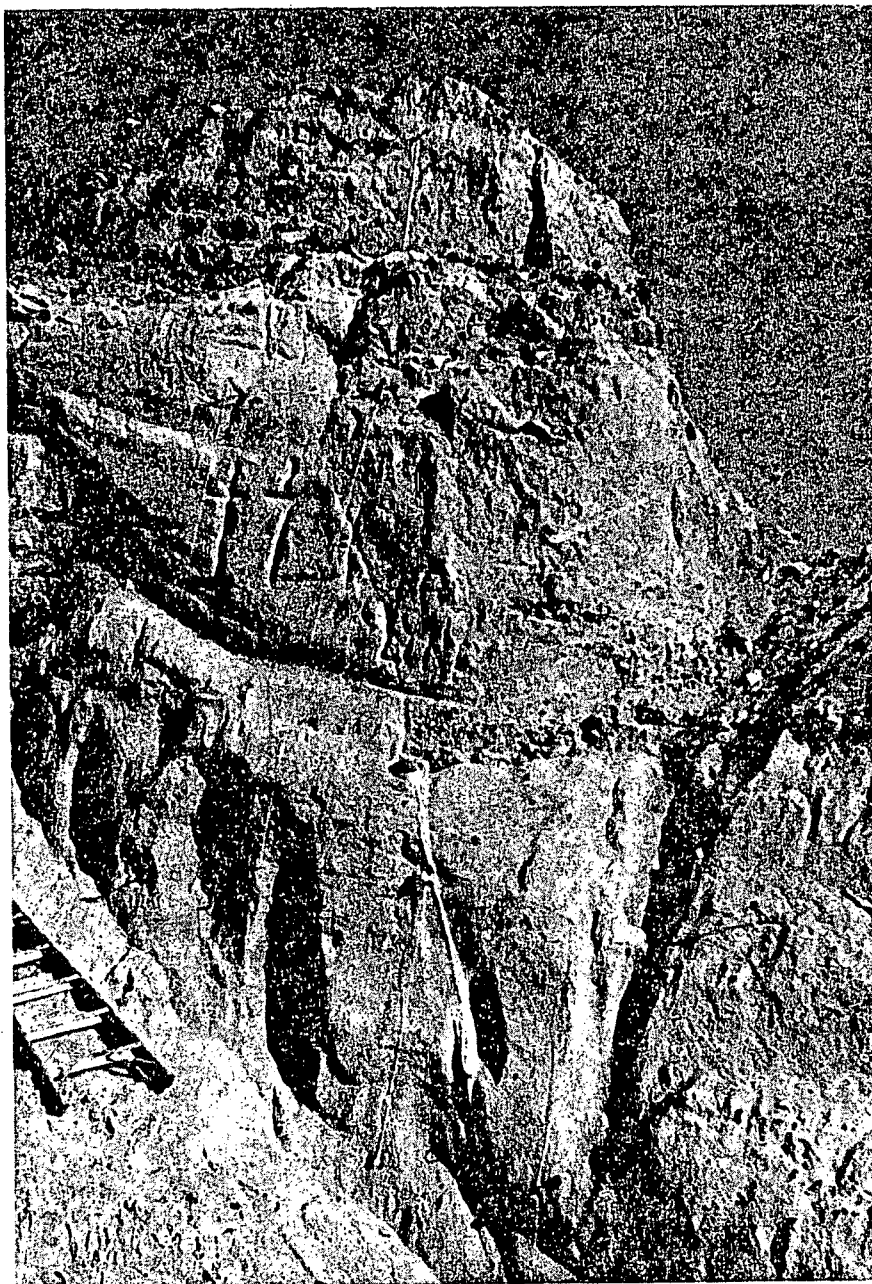
The alignment of the contact between Qm on the San Mateo Formation conveys the initial impression that the terrace deposit (Qt<sub>1</sub>) to the right of the shear alignment, (see upper right of Photo 6), is displaced downward. Photos 7 and 8 are closeup views of the shear zone-terrace contact from the landward and seaward sides, respectively. The photos show the shear zone to be clearly truncated by the marine terrace deposit (Qm). Wherever the shear zones are observed to intersect the terrace deposits - San Mateo Formation contact, no offset of the contact is visible.

Figure 6  
Landward or North Face of the Seacliff  
Exposure showing apparent fault.

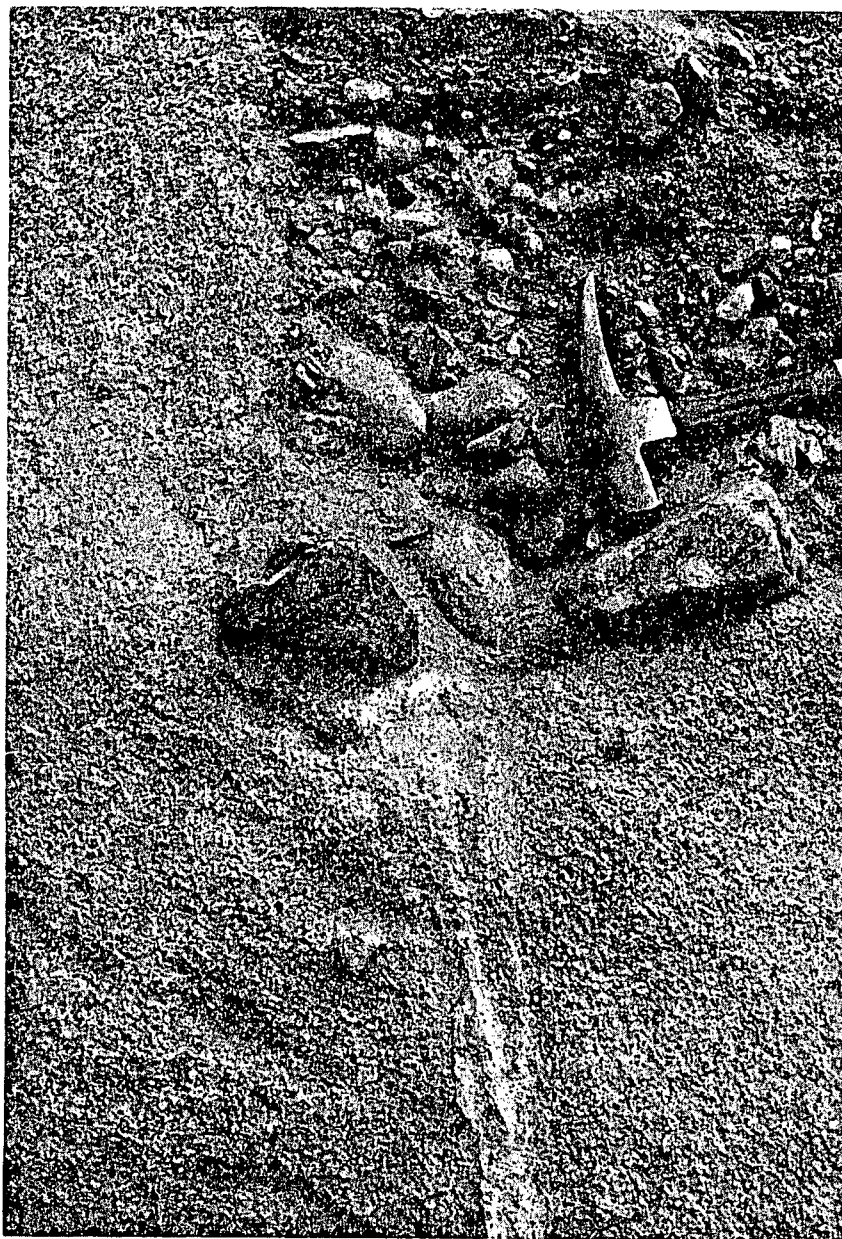
Detailed geologic mapping of the seacliff, where the apparent terrace offset was found, showed that the shear zone was capped by the marine terrace deposit (Qm) (Photos 7 and 8) which is locally present in this area.

Figure 7  
Shear Zone (A3) truncated by marine terrace (Qn).  
Detailed view of Figure 1.

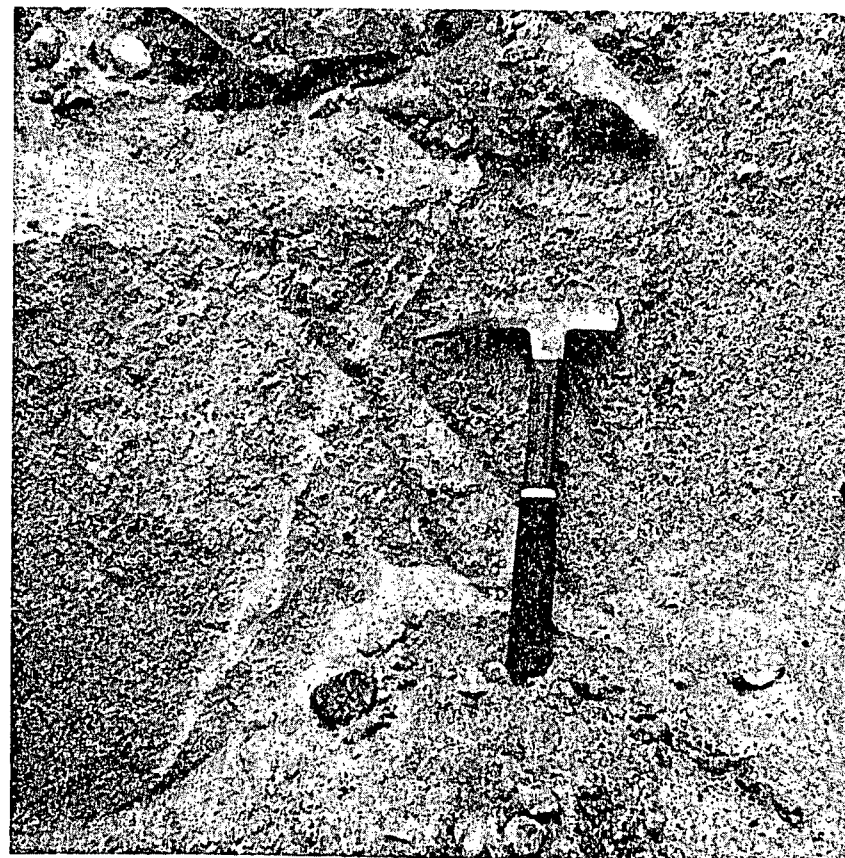
Figure 8  
Shear Zone (A3) truncated by marine terrace.  
South face of seacliff exposure.

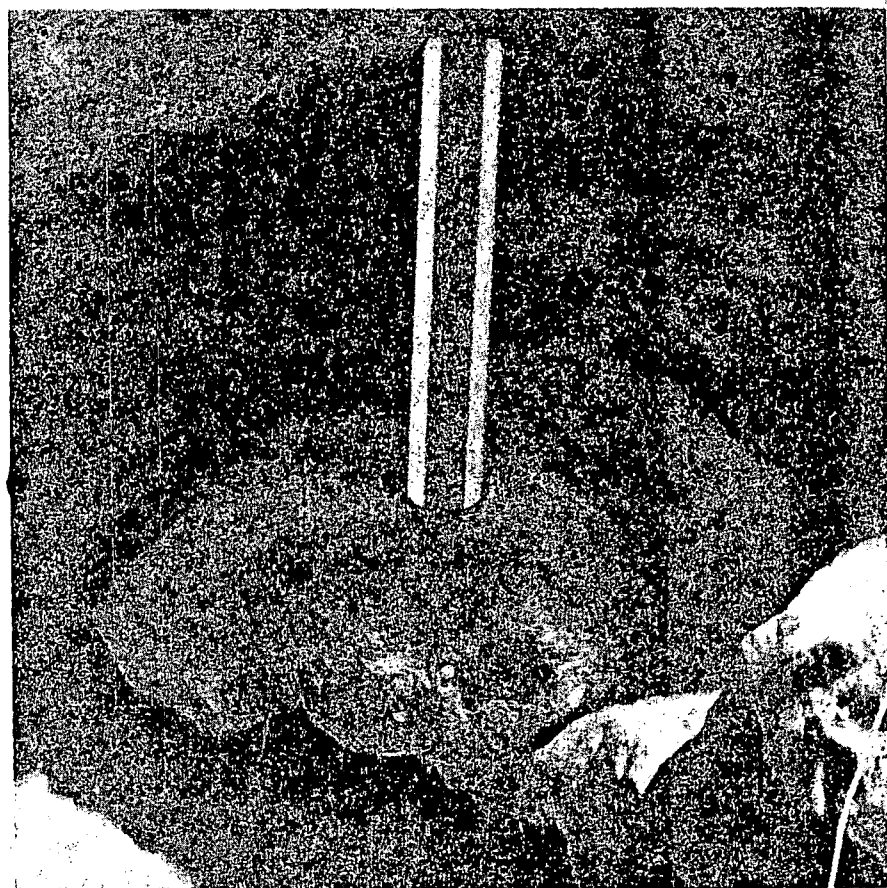
illustrated in Photos 9 and 10. In these photos, a clay boulder in the seacliff below the apparent offset terrace is seen to be intersected by the Type A shear. The plane of the shear is marked by the two nails at the top and bottom of the boulder. The 10 foot apparent vertical displacement seen in the terrace deposit is incompatible with the little or no vertical offset in the boulder.

Figure 9  
Clay silt inclusion in the San Mateo fm intersected by shear zone (A3). Exposure is in the seacliff directly below the exposure shown Figure 8. Nails mark trace of shear zone.

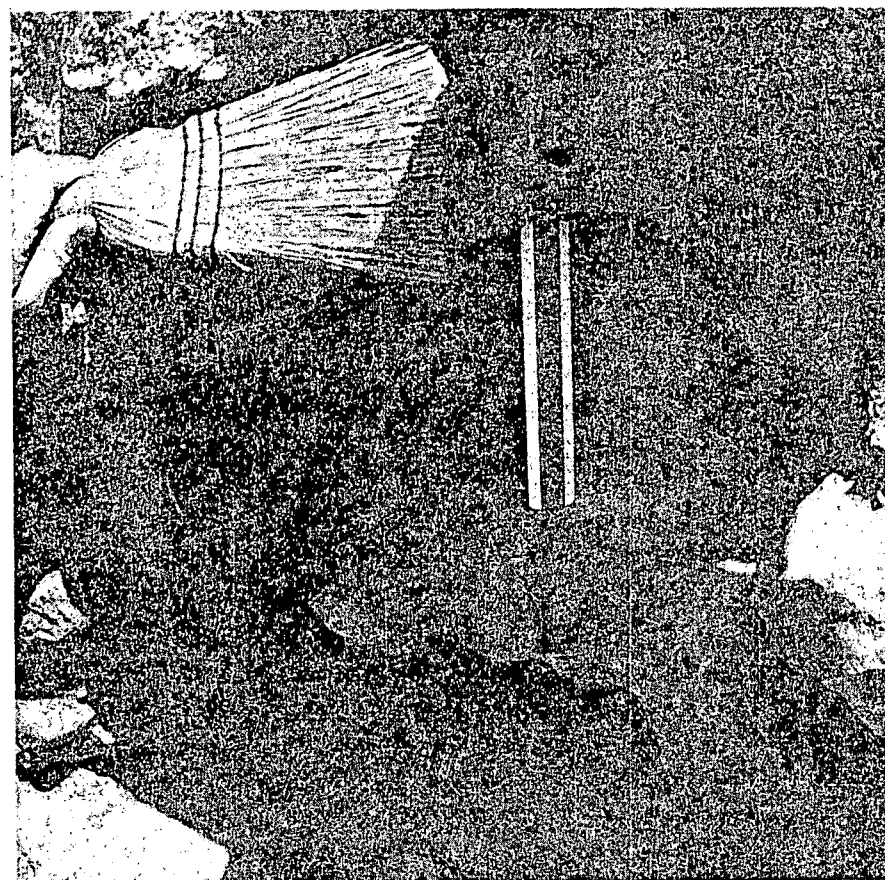
Figure 10  
Clay silt inclusion in the San Mateo fm intersected by shear zone (A3), as in Photo 9. Showing lack of vertical offset.

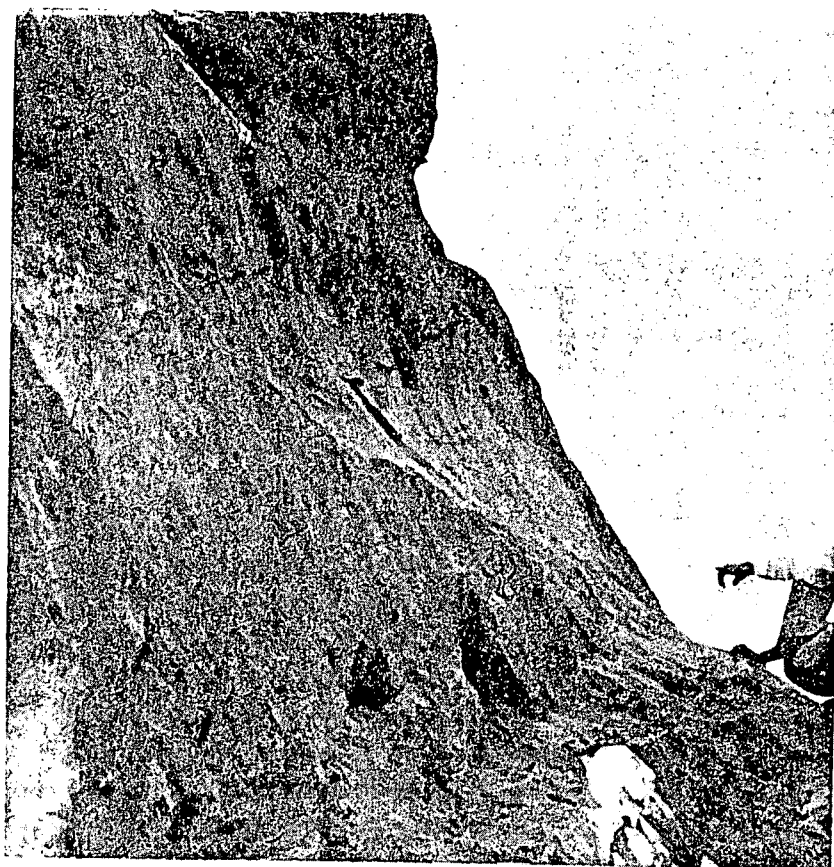
Upon careful removal of the marine terrace deposit, it was found that the plane of contact between the marine terrace deposit and the San Mateo Formation was irregular, as shown in Photos 11 and 12. This confirms that the plane of contact which initially appeared to be a fault plane is an erosional surface (Photo 12). Representatives from the staff and the USGS were present when the marine terrace contact was exposed by excavation and concur with the applicant's interpretation that the contact is of erosional origin. We conclude that the marine terrace deposit (Qm) materials were deposited in an erosional channel developed within the San Mateo Formation.

Figure 11  
Face of erosional contact between the marine terrace and San Mateo Formation after excavation of the marine terrace materials. Page 24

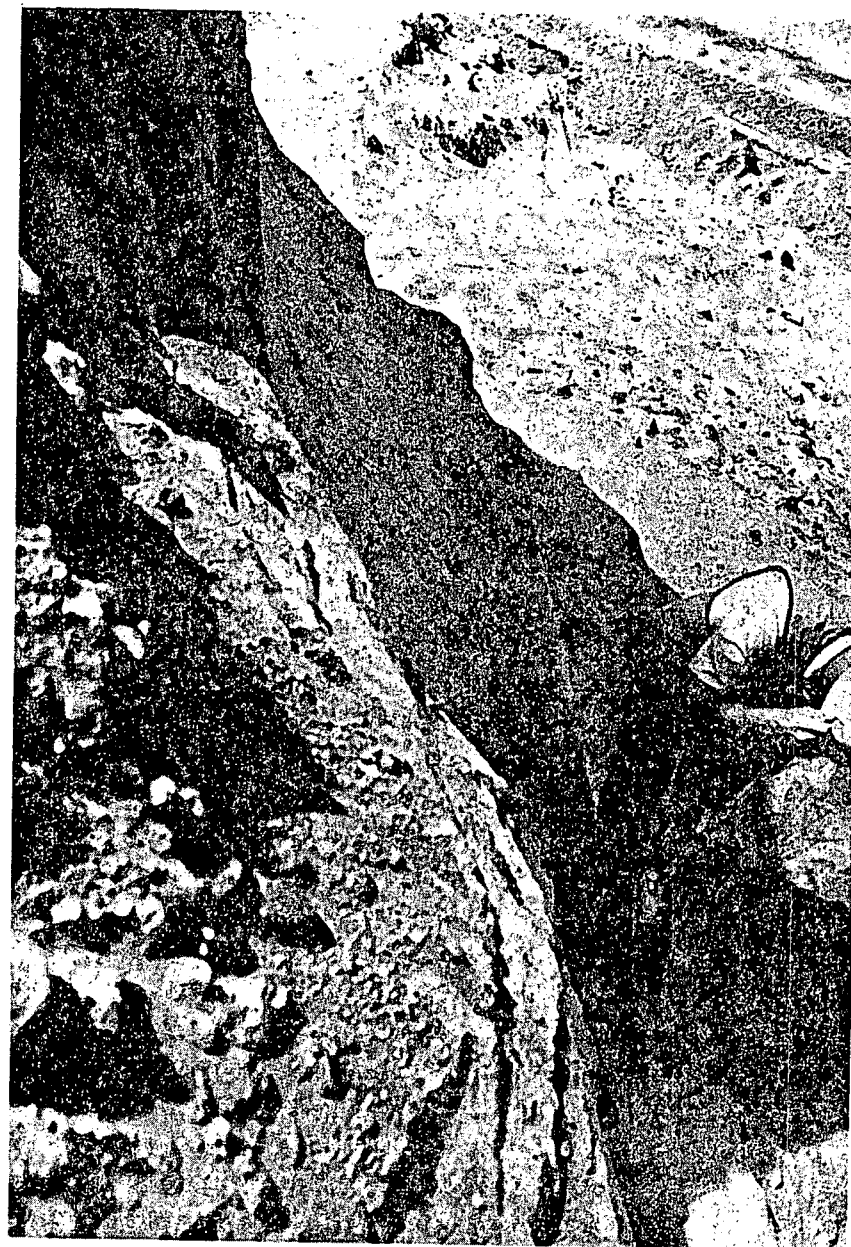
Figure 12  
Trace of shear zone (A3) at the feet of sweeper. The irregular surface to left of sweeper is the erosional contact of the marine terrace and San Mateo Formation.
