SUBJECT: LEAKING PULSATION DAMPENER LEADS TO LOSS OF
CHARGING SYSTEM

AEOD TECHNICAL REVIEW REPORT*

UNITS: Palo Verde Units 1 & 2 TR REPORT NO: AEOD/T
DOCKET NOS.: 528 and 529 DATE:
LICENSEE: Arizona Public Service EVALUATOR/CONTACT: T. C. Cintula

EVENT DATES: February 18, July 12, and July 18, 1986

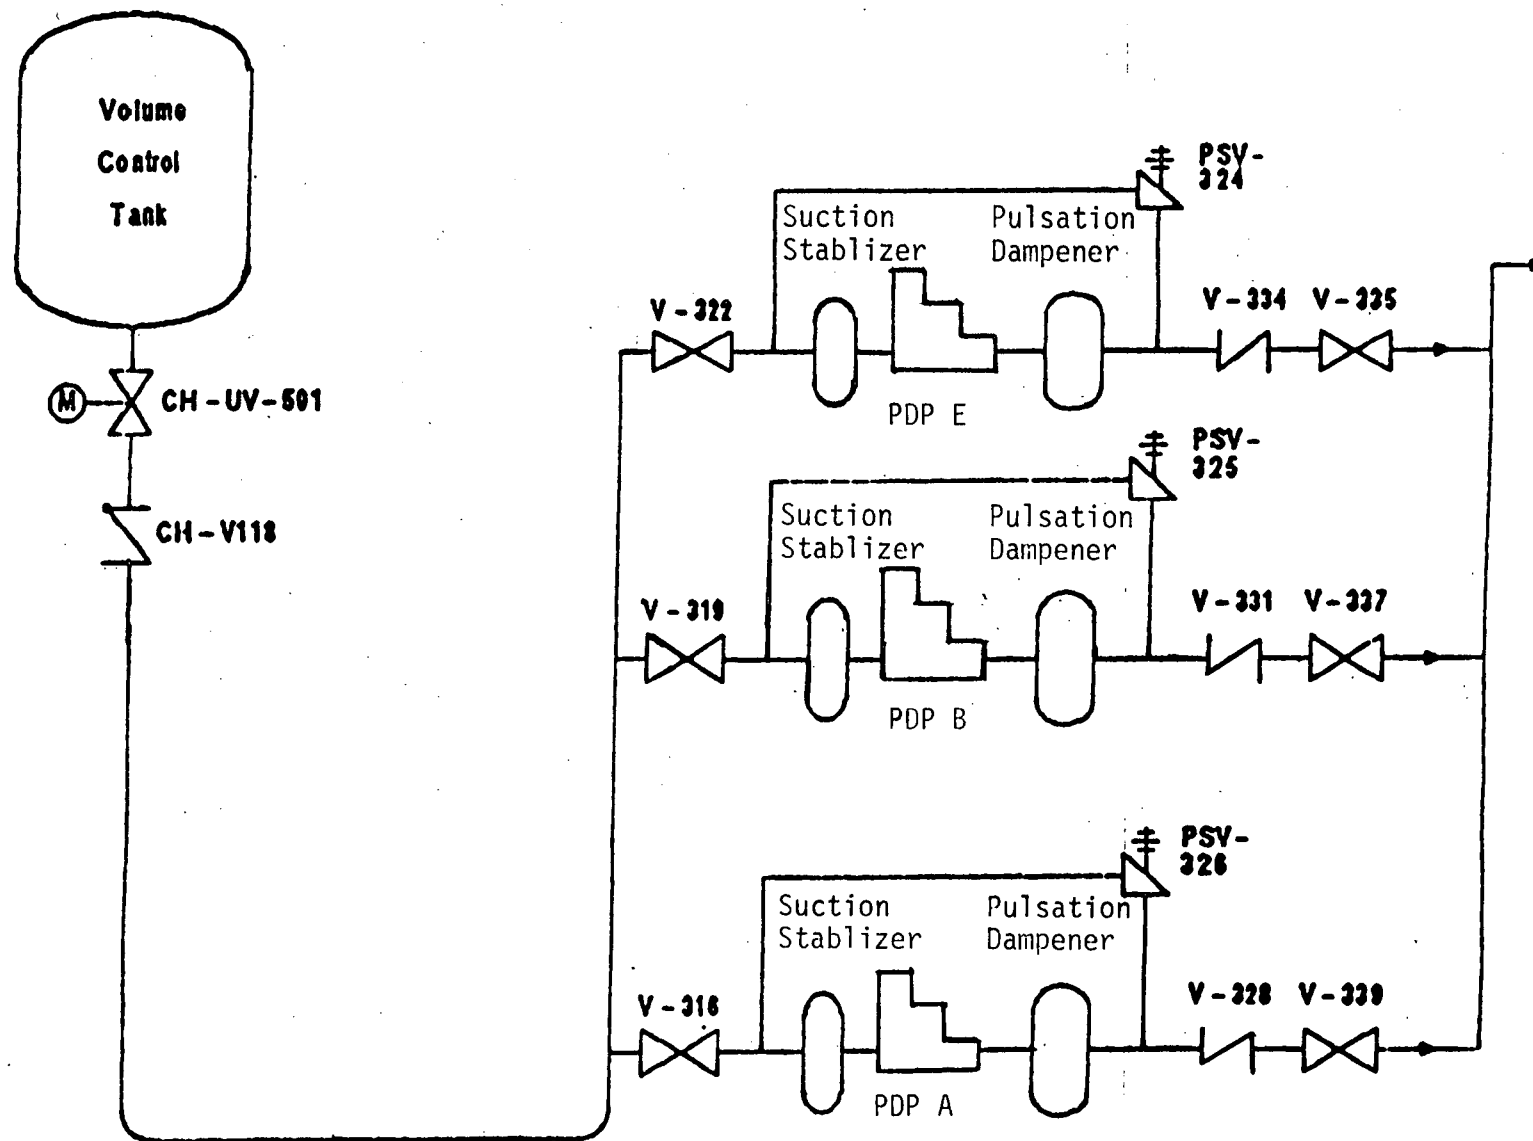
Figure 1. Charging Pumps at Palo Verde Units 1 and 2.

During the troubleshooting of the charging system of the CVCS, a check of records showed that the pulsation dampener of the B charging pump had been repeatedly charged with nitrogen gas over the last several shifts. Subsequent investigation discovered that the pulsation dampener bladder had been leaking.

The licensee concluded that the attempts to pressurize the leaking pulsation dampener over several shifts had resulted in nitrogen gas being introduced into the B pump discharge piping. Subsequent operation of the B pump with a gas-water mixture is believed to have resulted in pressure spikes large enough to lift the relief valve (PSV-325) on the discharge of the pump. This valve relieves directly to the B charging pump suction header. Thus, nitrogen gas was introduced into the B charging pump suction header and collected in the high points of the charging system (i.e., the VCT or the VCT discharge check valve when this valve was in the closed position). The nitrogen gas collected on the discharge side of the check valve during the RCS dilution, and prevented the subsequent reopening of the check valve after the dilution was completed. Mechanical agitation of the check valve allowed the check valve to open and in doing so, restored flow from the VCT. It should be noted that although the licensee believed that the positive displacement charging pumps were capable of pumping a gas-water mixture, there were no indications of gas accumulation in the high points of the RCS.

A post-trip investigation revealed that the bladder in the E pump suction stabilizer had ruptured and in doing so, added gas to the charging pump suction. The A and B pump bladders were checked and found to be intact. The time that the E pump bladder ruptured could not be determined. It was postulated that the most probable cause for the premature rupture of the bladder of the suction stabilizer was not venting the suction stabilizers when the CVCS was filled.

An investigation determined that charging pump A discharge pulsation dampener bladder (Greer Hydraulics Inc., Part No. 720507) had ruptured. When the bladder ruptured, nitrogen gas leaked to the suction side of charging pump A through relief valve PSV-326 on the discharge line.

The licensee presumed with only charging pump E running, there was not sufficient flow in the suction header to impede gas movement from the pulsation dampener of charging pump A to charging pump E. When enough gas had migrated through the common suction header to charging pump E, the pump E became gas bound.

The root cause of the gas binding of charging pump E was the rupture of the charging pump A discharge pulsation dampener bladder. The bladder is believed to have ruptured due to normal inservice wear. The manufacturer's recommended replacement interval (based on shelf life) is three years. As a conservative measure, the dampener bladders will now be replaced during each refueling outage.

Several corrective actions were implemented as a result of this event. The leaking bladder was replaced and the charging pumps were subsequently verified to operate normally. The bladder was believed to have leaked due to normal end-of-life age related degradation of the component. The bladders have a shelf life of three years. A preventative maintenance program was initiated to verify the condition of each pulsation dampener bladder monthly to provide early detection/replacement of a leaking bladder. The Unit 1 and 2 VCT outlet check valves were disassembled and no discrepancies were found.

The immediate corrective action was to replace the charging pump A discharge pulsation dampener bladder. To prevent recurrence, the preventive maintenance procedures for Units 1 and 2 have been revised, to include the following steps:

- (a) The suction valve of the pump being charged will be closed prior to the precharge of the pulsation dampeners and suction stabilizers. This will prevent gas from migrating into the suction of the other pumps should a bladder failure occur during the precharge.
- (b) After completion of each precharge, the pressure in the discharge piping will be reduced below the bladder precharge pressure to ensure the bladder has not failed.

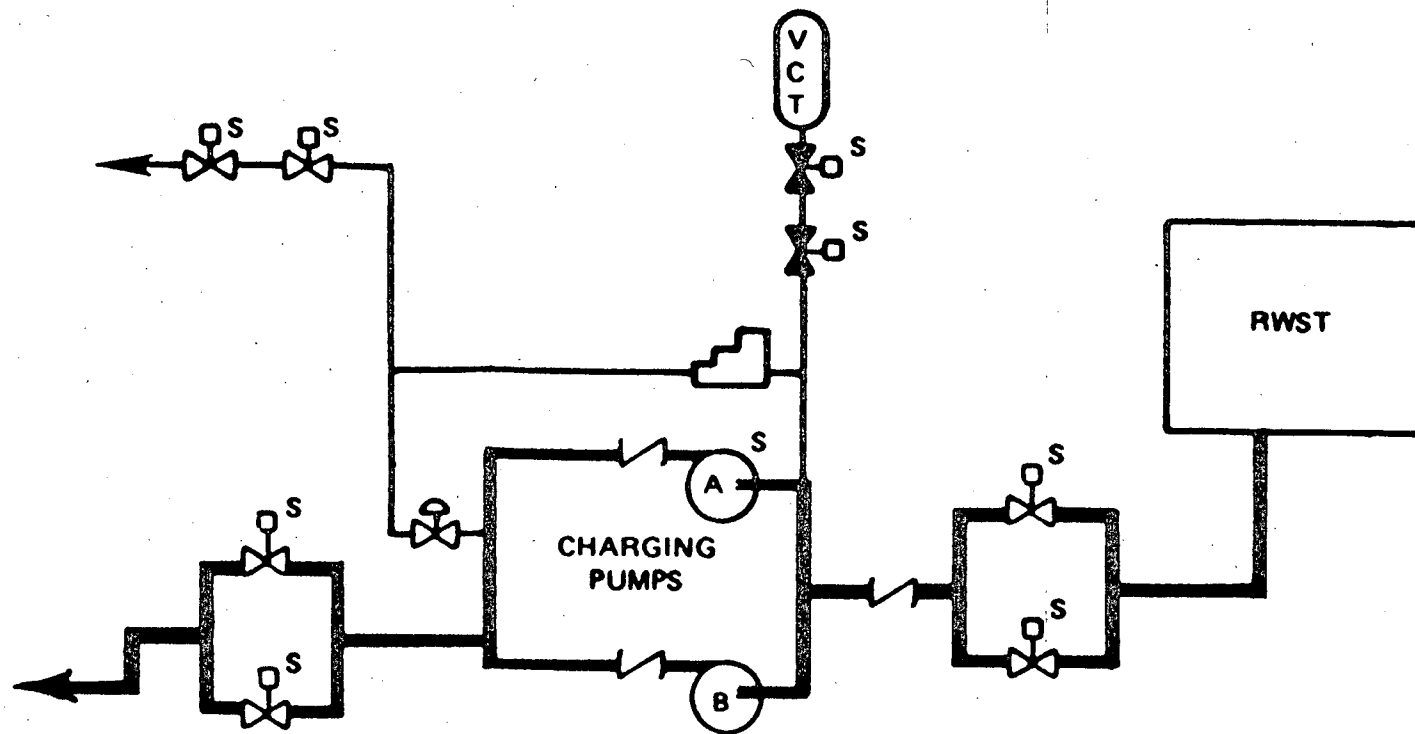
Figure 2. Charging Pump Configuration at Some Westinghouse Plants

Some W designs also have a PDP in their charging system. The other two pumps are centrifugal charging pumps (CCPs), and all pumps have a common suction header (see Figure 2). In this design, the PDP is not safety-related and the two CCPs are the motive force for the high head safety injection system to provide protection for steamline breaks or for small RCS breaks where the pressure remains above the shutoff head of the intermediate head pumps for an extended time period. Therefore, at W plants the two CCPs are safety-related.

It is conceivable that a failure similar to those described at Palo Verde could cause gas binding of the safety-related centrifugal charging pumps through their common suction header by a bladder failure of either the pulsation dampener of the suction stabilizer of the nonsafety-related PDP.

Thus, it would appear that failure of the pulsation dampener of the PDP could not lead to gas binding of the safety-related centrifugal charging pumps at a W plant.
