Subject: Docket No. 50-206
Acceptance Criteria for Thermal Shield Inspection
San Onofre Nuclear Generating Station
Unit 1

THERMAL SHIELD MID-CYCLE INSPECTION PLAN
AND ACCEPTANCE CRITERIA

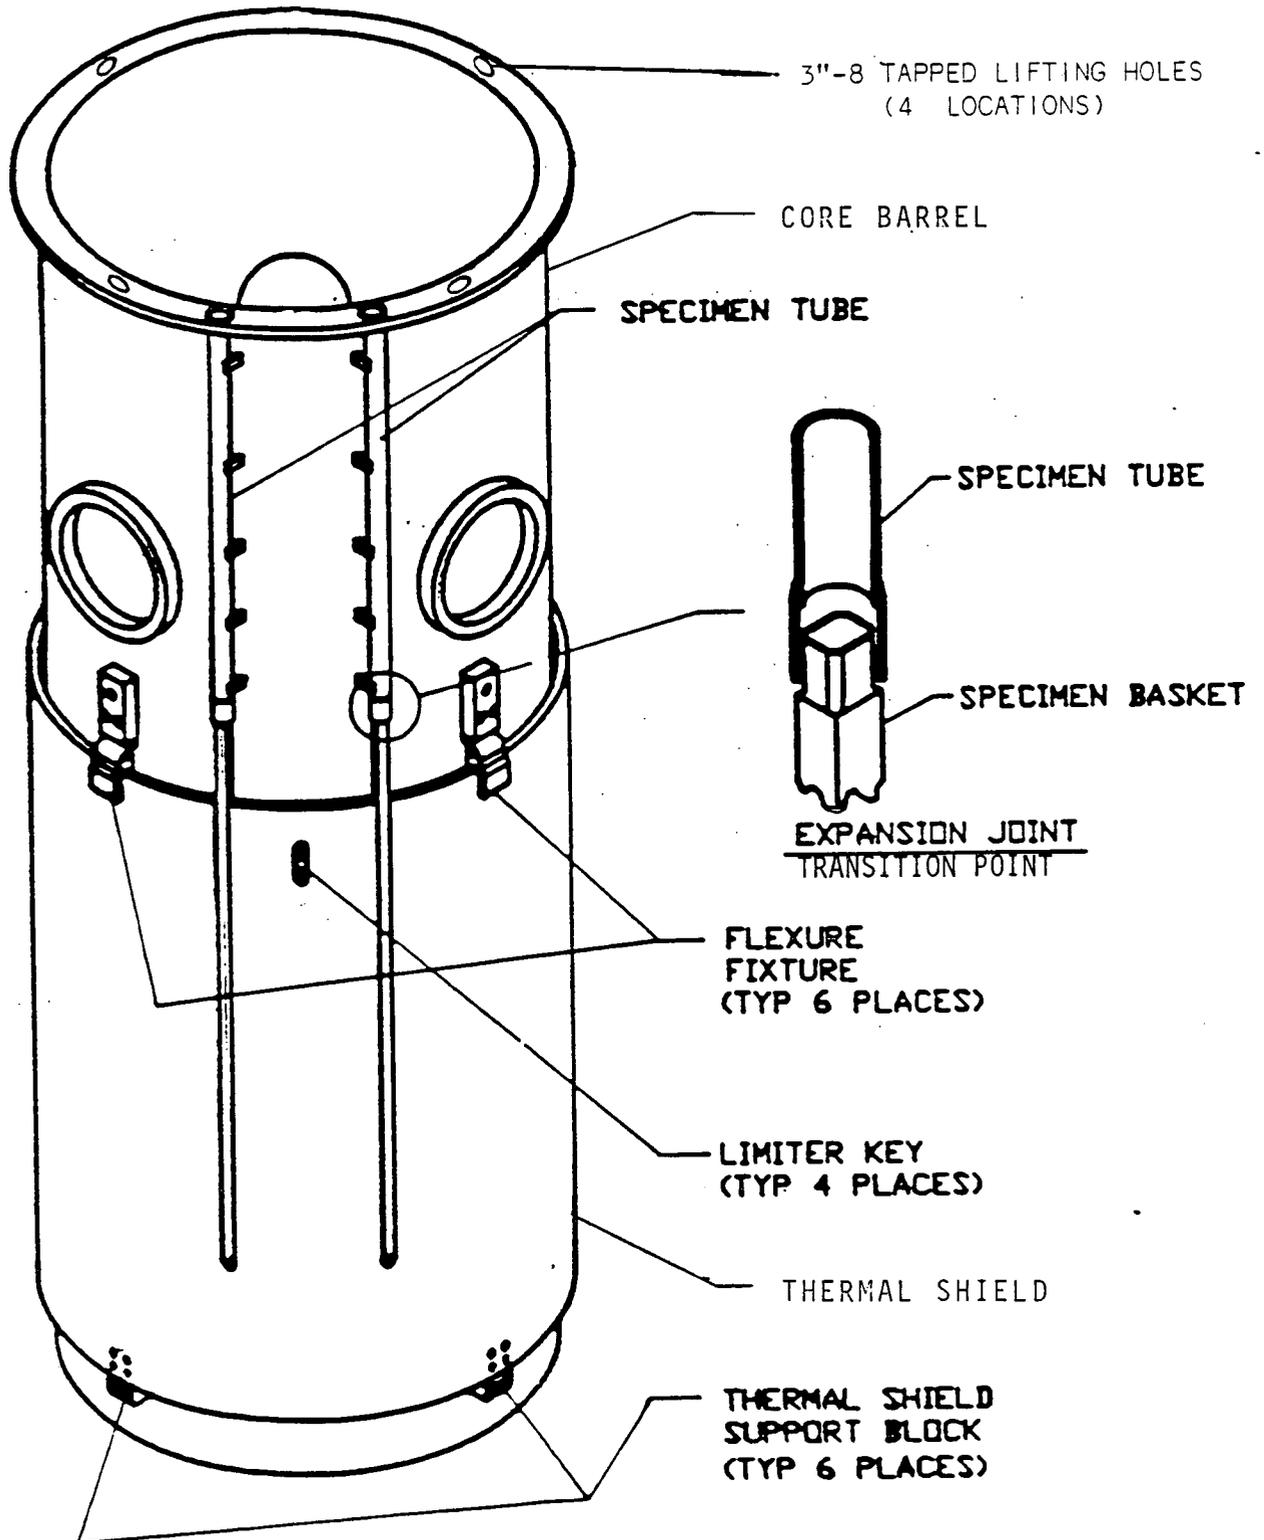
FIGURE 1

Inspection between the thermal shield and reactor vessel will be performed with the core barrel in the vessel. A camera will be lowered through the four 3" diameter core barrel flange lifting holes (Figure 1). Inspection of the outside of the core barrel and the thermal shield is performed as follows:

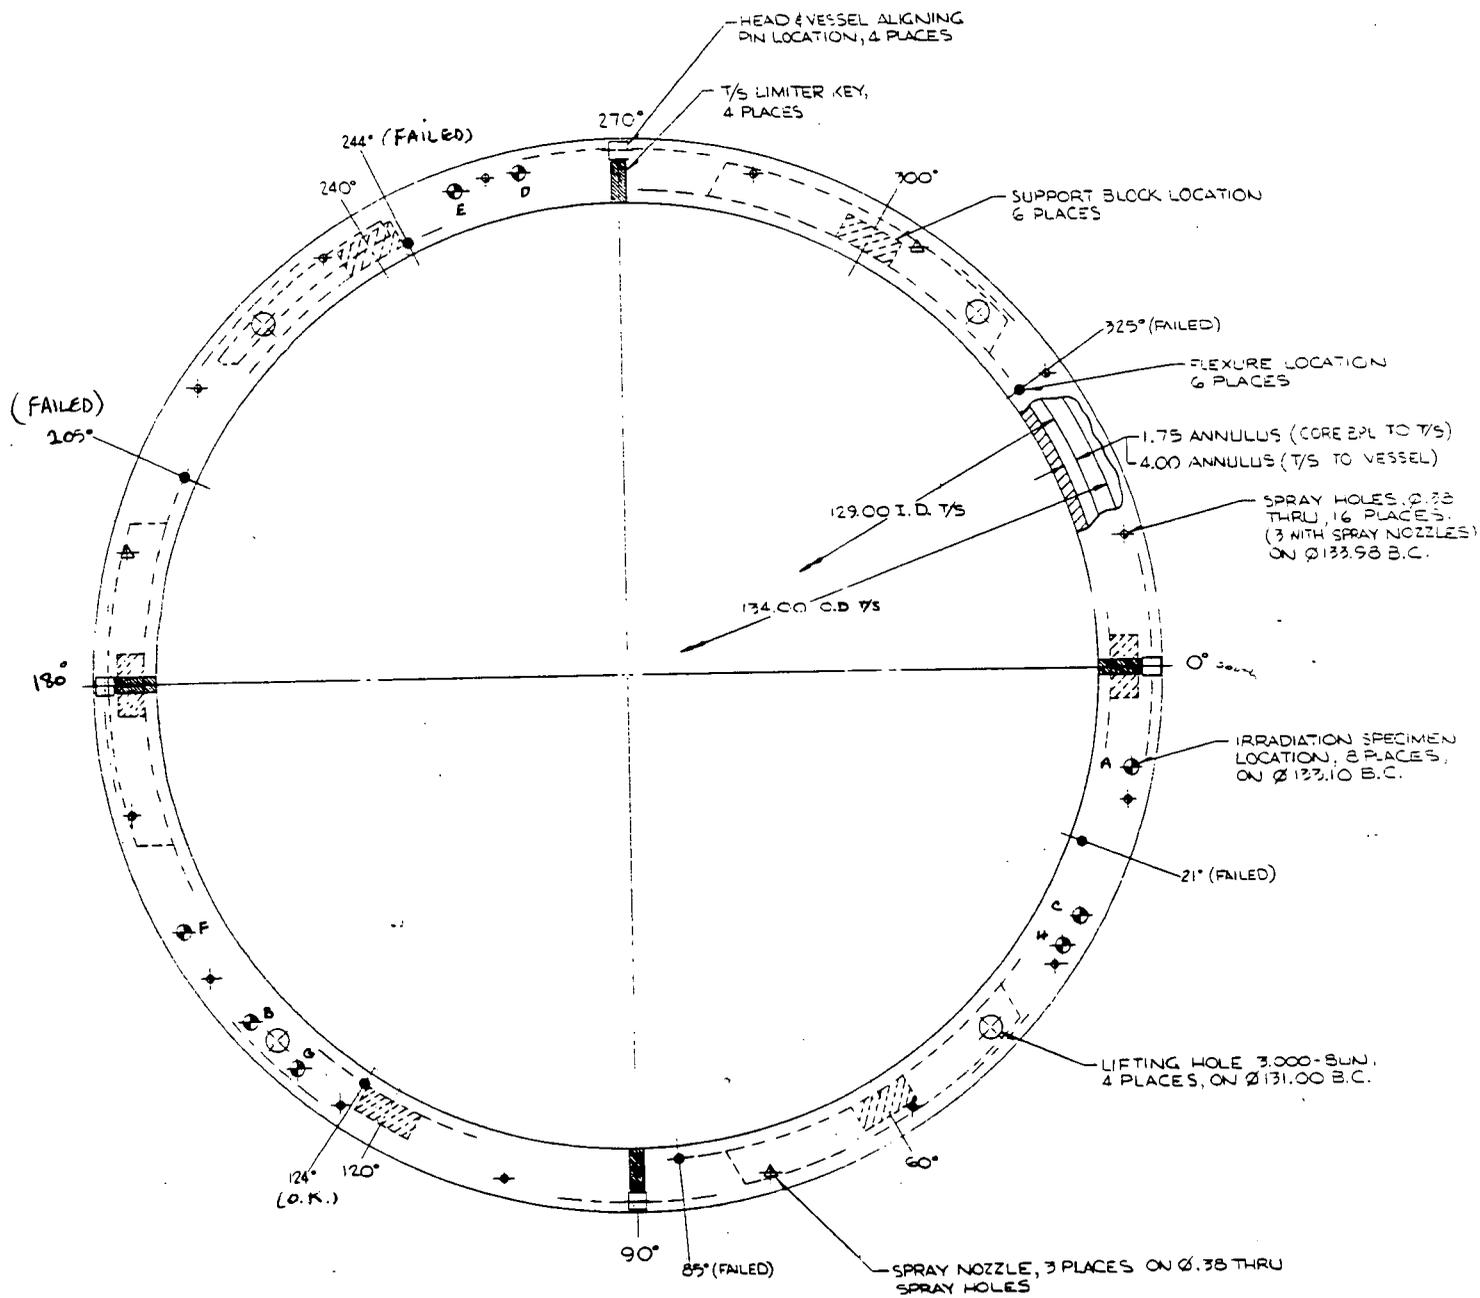
Figure 2 Core Barrel/Thermal Shield Top View

1. Inspect the transition point on the irradiation specimen holders C, H, G, B, and F (see Figure 2). At the transition point we are looking for differential wear at the interface area. This would be an indicator of differential movement.

- a) If signs of differential movement are observed while inspecting the transition point on the irradiation specimen holders, the bounding analysis will be reevaluated. Additional analysis may be required to justify continued operation.
