U. S. NUCLEAR REGULATORY COMMISSION  
OFFICE OF INSPECTION AND ENFORCEMENT

Report No. 50-206/79-16  
Docket No. 50-206 License No. DP-13 Safeguards Group \_\_\_\_\_  
Licensee: Southern California Edison Company  
2244 Walnut Grove Avenue  
Rosemead, California 91770  
Facility Name San Onofre Unit 1  
Inspection at San Onofre and Rosemead, California  
Inspection conducted: November 1-2 and 26, 1979  
Inspectors: L. F. Miller, Reactor Inspector December 19, 1979  
Date Signed  
A. Johnson, Reactor Inspector January 4, 1980  
Date Signed  
B. Pate, Resident Reactor Inspector January 4, 1980  
Date Signed  
B. H. Faulkenberry, Chief, Reactor Projects  
Section #2  
Approved By: B. H. Faulkenberry January 4, 1980  
Date Signed  
B. H. Faulkenberry, Chief, Reactor Projects  
Section #2, Reactor Operations and Nuclear Support Branch

Inspection on November 1-2, 1979 and November 26, 1979 (Report No. 50-206/79-16)  
Areas Inspected: Routine, announced inspection of scope and methods of field inspection for IE Bulletin 79-14; routine, unannounced inspection of repair of shorted electrical buswork from the November 7, 1979 reportable occurrence; discussions of this event, of the proposed

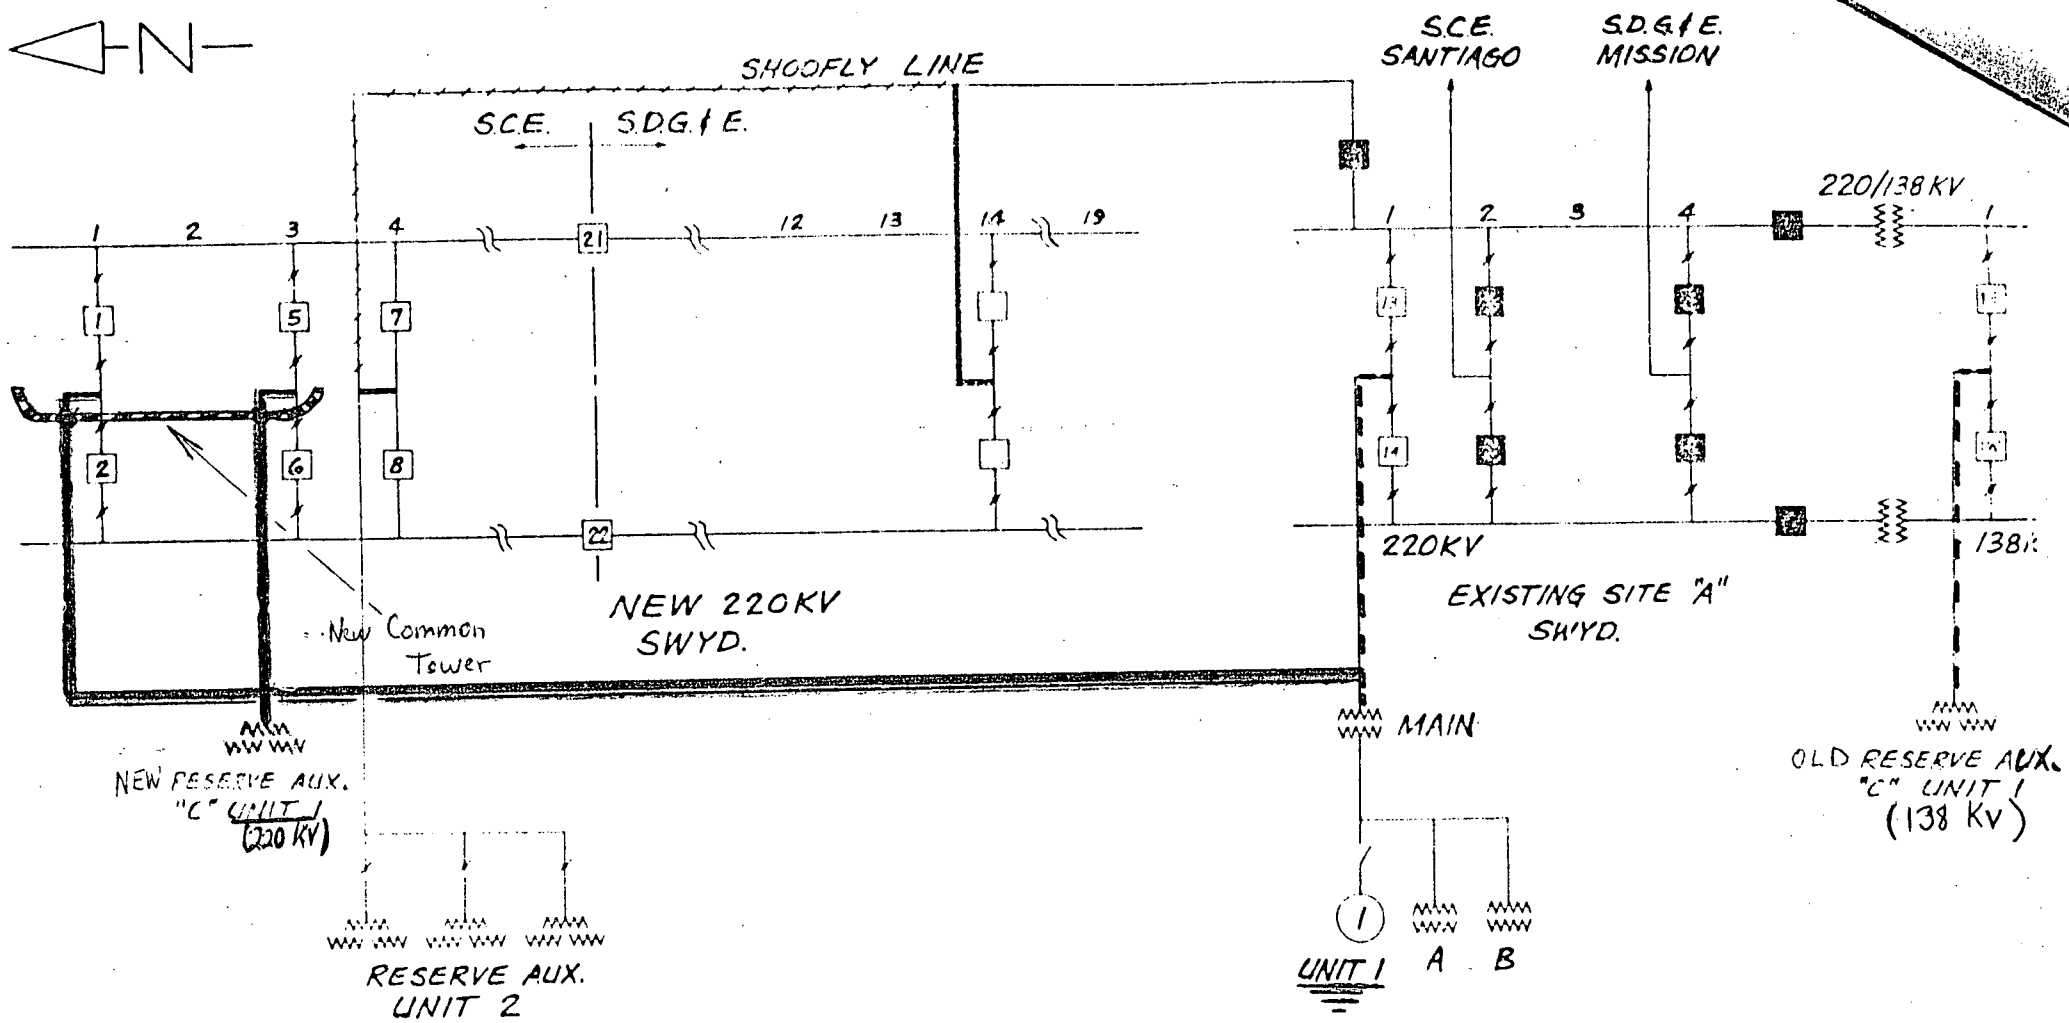
SIMPLIFIED  
ONE-LINE  
FOR SWYD  
CUT-OVER

An exit interview was conducted on November 26, 1979 to discuss the licensee's plan to switch over offsite power to the new station 220 KV switchyard during the next refueling outage. The design change, 79-20, would replace the existing offsite transmission lines from the onsite electrical busses to the existing 220 KV/138 KV Switchyard with new transmission lines, towers, transformers, and a 220 KV-only Switchyard (Figure 1). This change is part of the licensee's plan to integrate San Onofre Units 1, 2 and 3 offsite power distribution into a common site 220 KV Switchyard (Units 2 and 3 are under construction). As planned, the new transmission lines from the Unit 1 onsite power busses to the new switchyard would share one tower of their respective transmission paths to the site switchyard. This would be a significant departure from the present offsite power network described in the FSAR (p. 3-29): "The 220 KV and 138 KV transmission lines between the Switchyards and the station are physically separated (emphasis added) to keep a postulated tower failure on one circuit from affecting the other circuit." After the change, the only two transmission paths from the site to the new switchyard would no longer be physically independent, because they would now pass onto a common tower located inside the perimeter of the switchyard. Failure of the new common tower could simultaneously fault both lines. This possibility for one tower failure faulting both lines does not exist with the present network because there are no common towers for the two independent lines to the existing switchyard. Therefore, the probability of loss of all offsite power would be increased by this change. Since loss of all offsite power is an accident or malfunction of equipment important to safety evaluated in the Safety Analysis Report (Section 9), this design change would appear to be an unreviewed safety question, as defined by 10 CFR 50.59(a)(2).

1. CONNECT SHOOFLY TO POSITION 14. (OCT. '79)
2. CONNECT UNIT 1 MAIN AND RES. AUX. TRANSFORMERS TO NEW SWYD. (MARCH '80)
3. KEEP SITE "A" ENERGIZED UNTIL NOV. 1980, i.e. THE CONTROLS OF SCE. PCB'S SHOWN AS HAVE TO BE OPERABLE.
