U.S. NUCLEAR REGULATORY COMMISSION

Report Nos. 50-206/92-23, 50-361/92-23, 50-362/92-23

Facility Name: San Onofre Nuclear Generating Station
Units 1, 2 and 3

Inspection conducted: July 17, 1992 through August 26, 1992

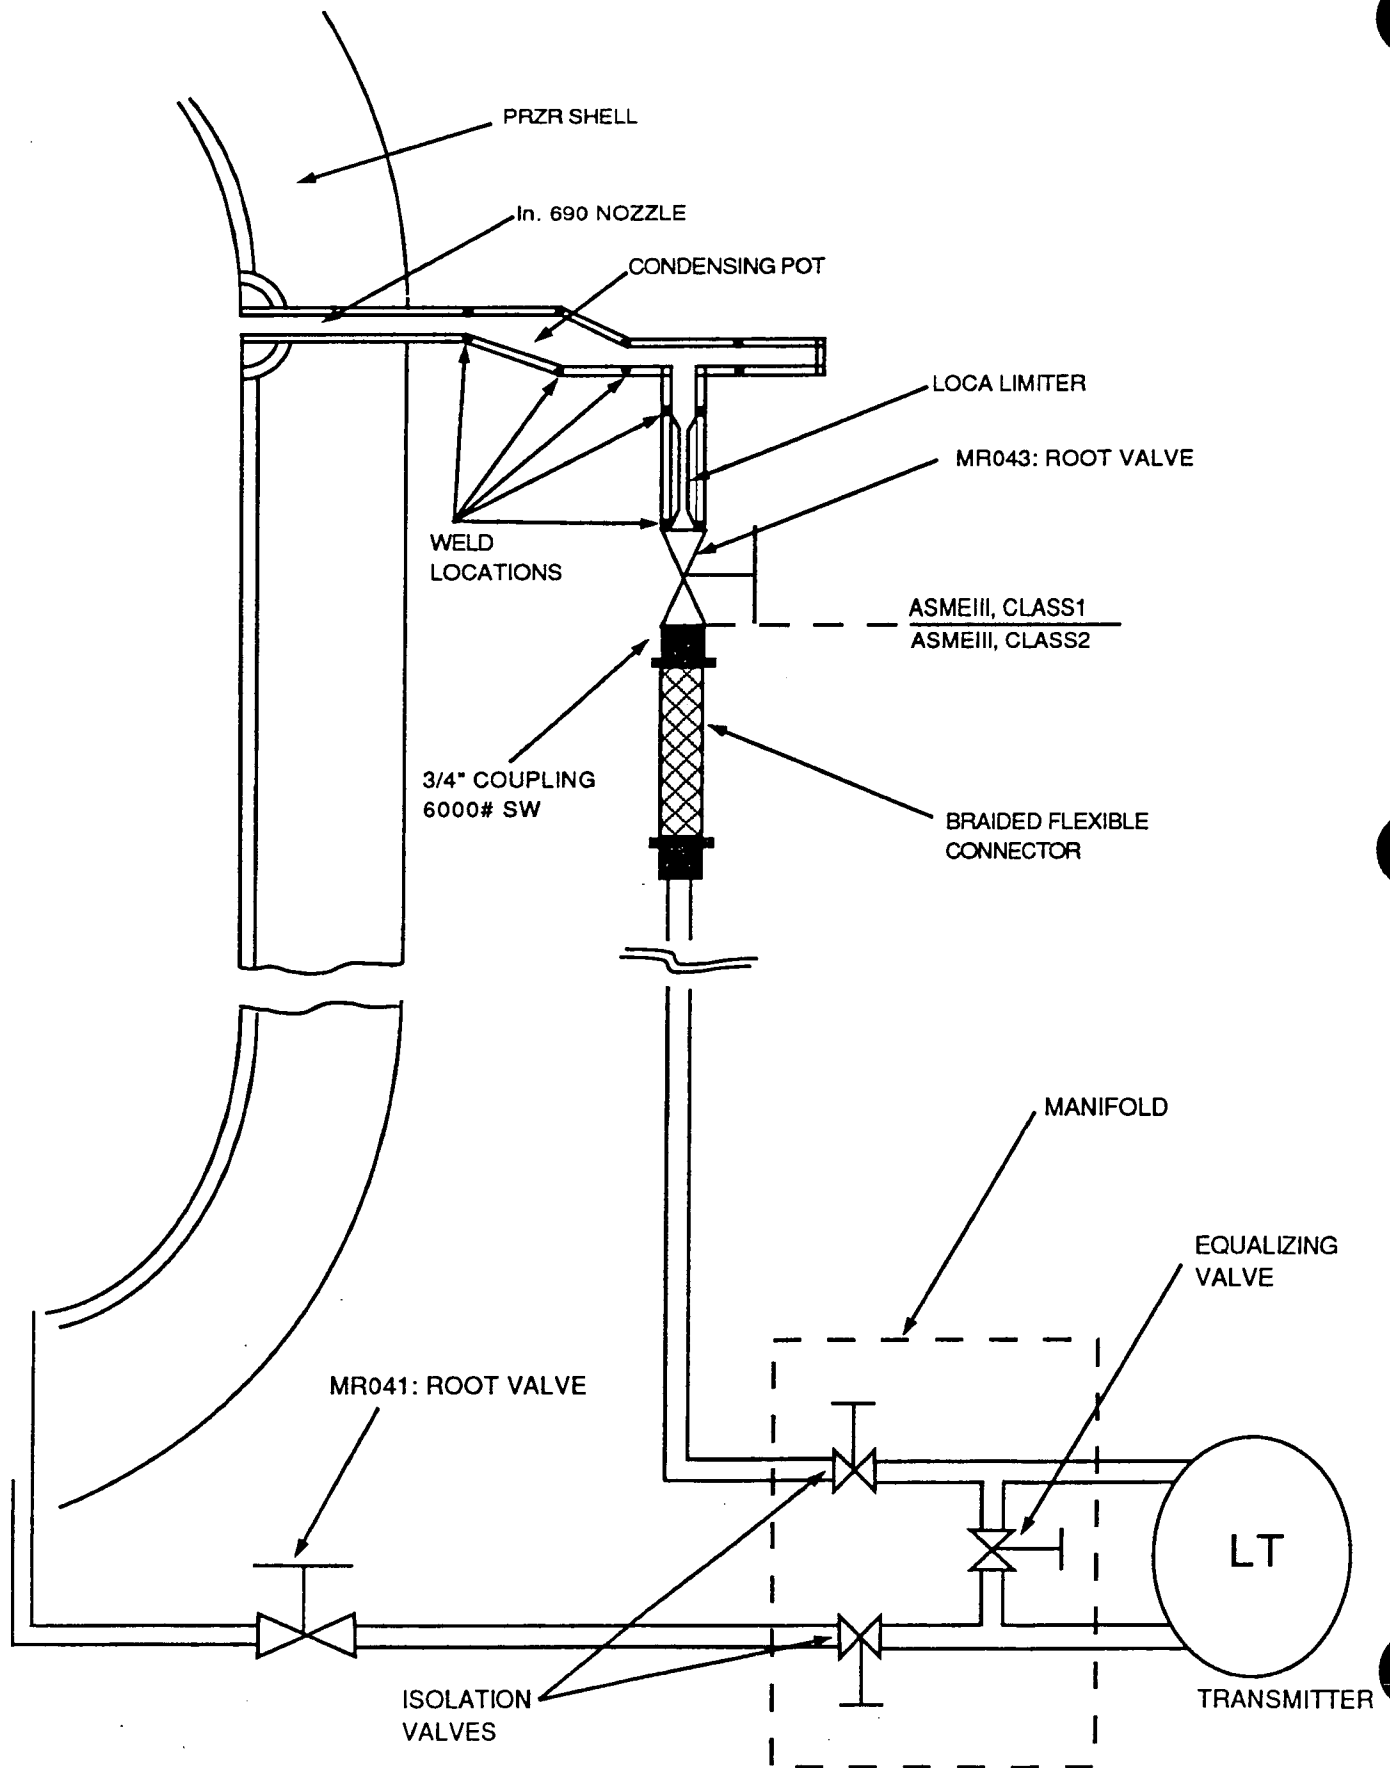
TYPICAL PRZR. INSTR. NOZZLE CONFIGURATION

The small amount of leakage (.076 gpm) was evident by a 5.5% high deviation in level in Channel Y, transmitter 3LT01102, in comparison to the redundant channel. It was believed that such a deviation could be caused by a leak in the reference leg of the transmitter. As a result, the licensee initiated non-conformance report (NCR) 92070079 to assess the implications of the leak on the operation of the Unit.

During discussions with the licensee, they were not able to exclude the possibility that the leak was from the reactor coolant system pressure boundary. However, they believed that the leak was most likely from the reference leg isolation valve (e.g., body to bonnet canopy weld), the flexible hose connecting the transmitter tubing to the isolation valve, or the connections between the tubing and the flexible hose. The licensee also believed that the leakage source was downstream of a loss-of-coolant-accident (LOCA) limiting orifice. Thus, a break would be limited to within analyzed values.

- o On 6/14/92, Pressurizer Level Anomaly in Y Channel
- o Transmitter Replaced and Channel Returned to Service
- o On 7/20/92, Pressurizer Level Control Anomaly in Y Channel
- o Performed:
 - Loop Check/Calibration - No Problems Identified
 - ECAD - No Relevant Problems Identified
- o Attempts to Re-Calibrate Transmitter In Containment Identified Feedback Coil Misaligned
- o Replaced Transmitter
- o 5.5% Deviation Still Present
- o Suspected Deviation Due to Leak In Reference Leg

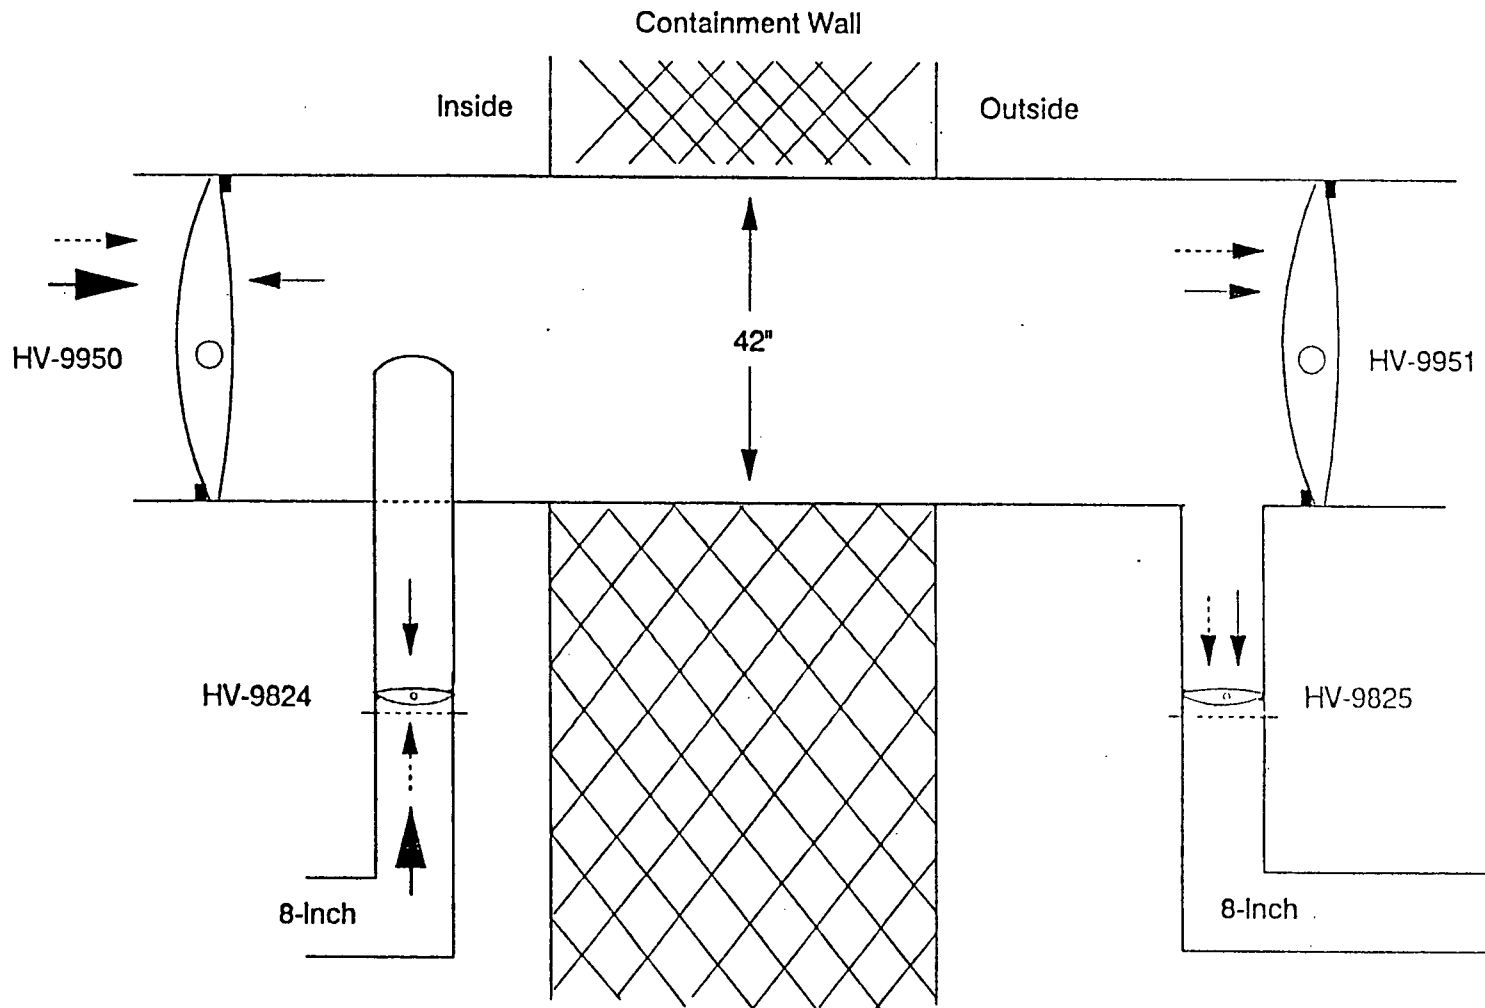
Containment Purge Exhaust Penetration

- ←--- Pressure Assisted Shutoff Side of Valve
- ← Side Pressurized For Quarterly LLRT
- ← Special LLRT with Blank Flange Installed Performed Each Refueling Outage

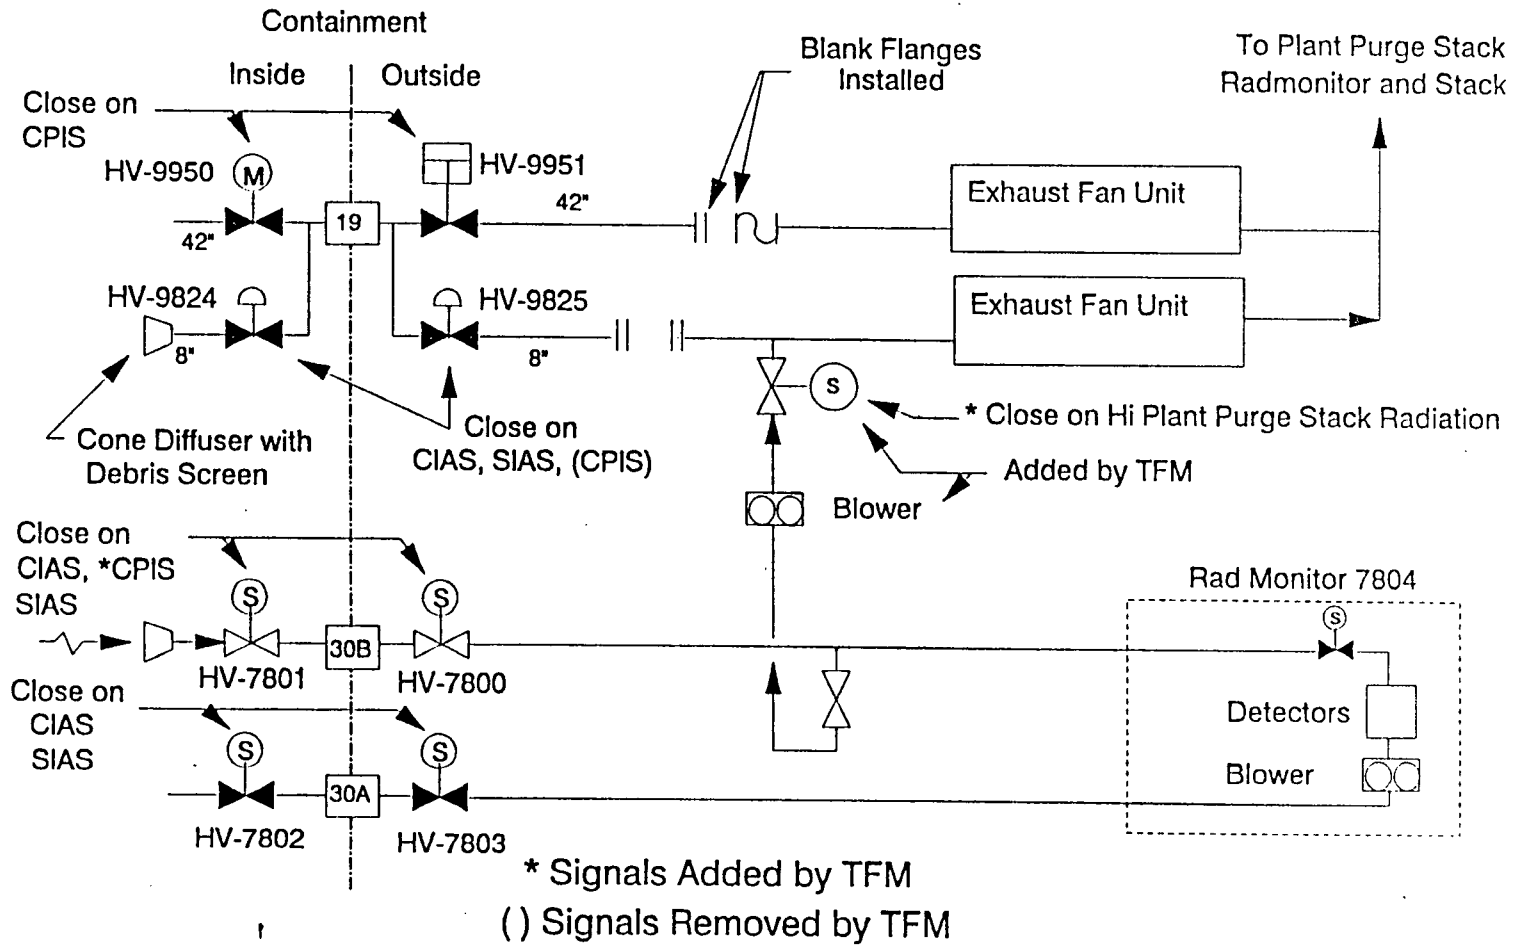
Containment Venting After TFM Implementation

The inspector reviewed a temporary facility modification (TFM) to the Unit 2 containment purge system. The TFM was implemented because the outboard containment mini-purge valve leaked after the completion of containment venting on four occasions in June and July 1992. The leakage was determined to be due to buildup of small pieces of debris under the seat of mini-purge valve 2HV9825.

In general, the TFM appeared to be well designed, implemented and within program requirements. However, the inspector was concerned that there were no corrective actions other than to blow the debris away from the seat of HV9825 when the valve was found leaking. This had been done four times between June 9 and July 2, 1992. Thus, during that period, when the valve was opened, it could not perform its leak tight function. However, the inspector considered that this was of minor safety significance; the licensee assured that the valve was leak tight before they left it, leakage through the penetration was less than TS allowable, and the inboard valve appeared to be relatively leak tight.

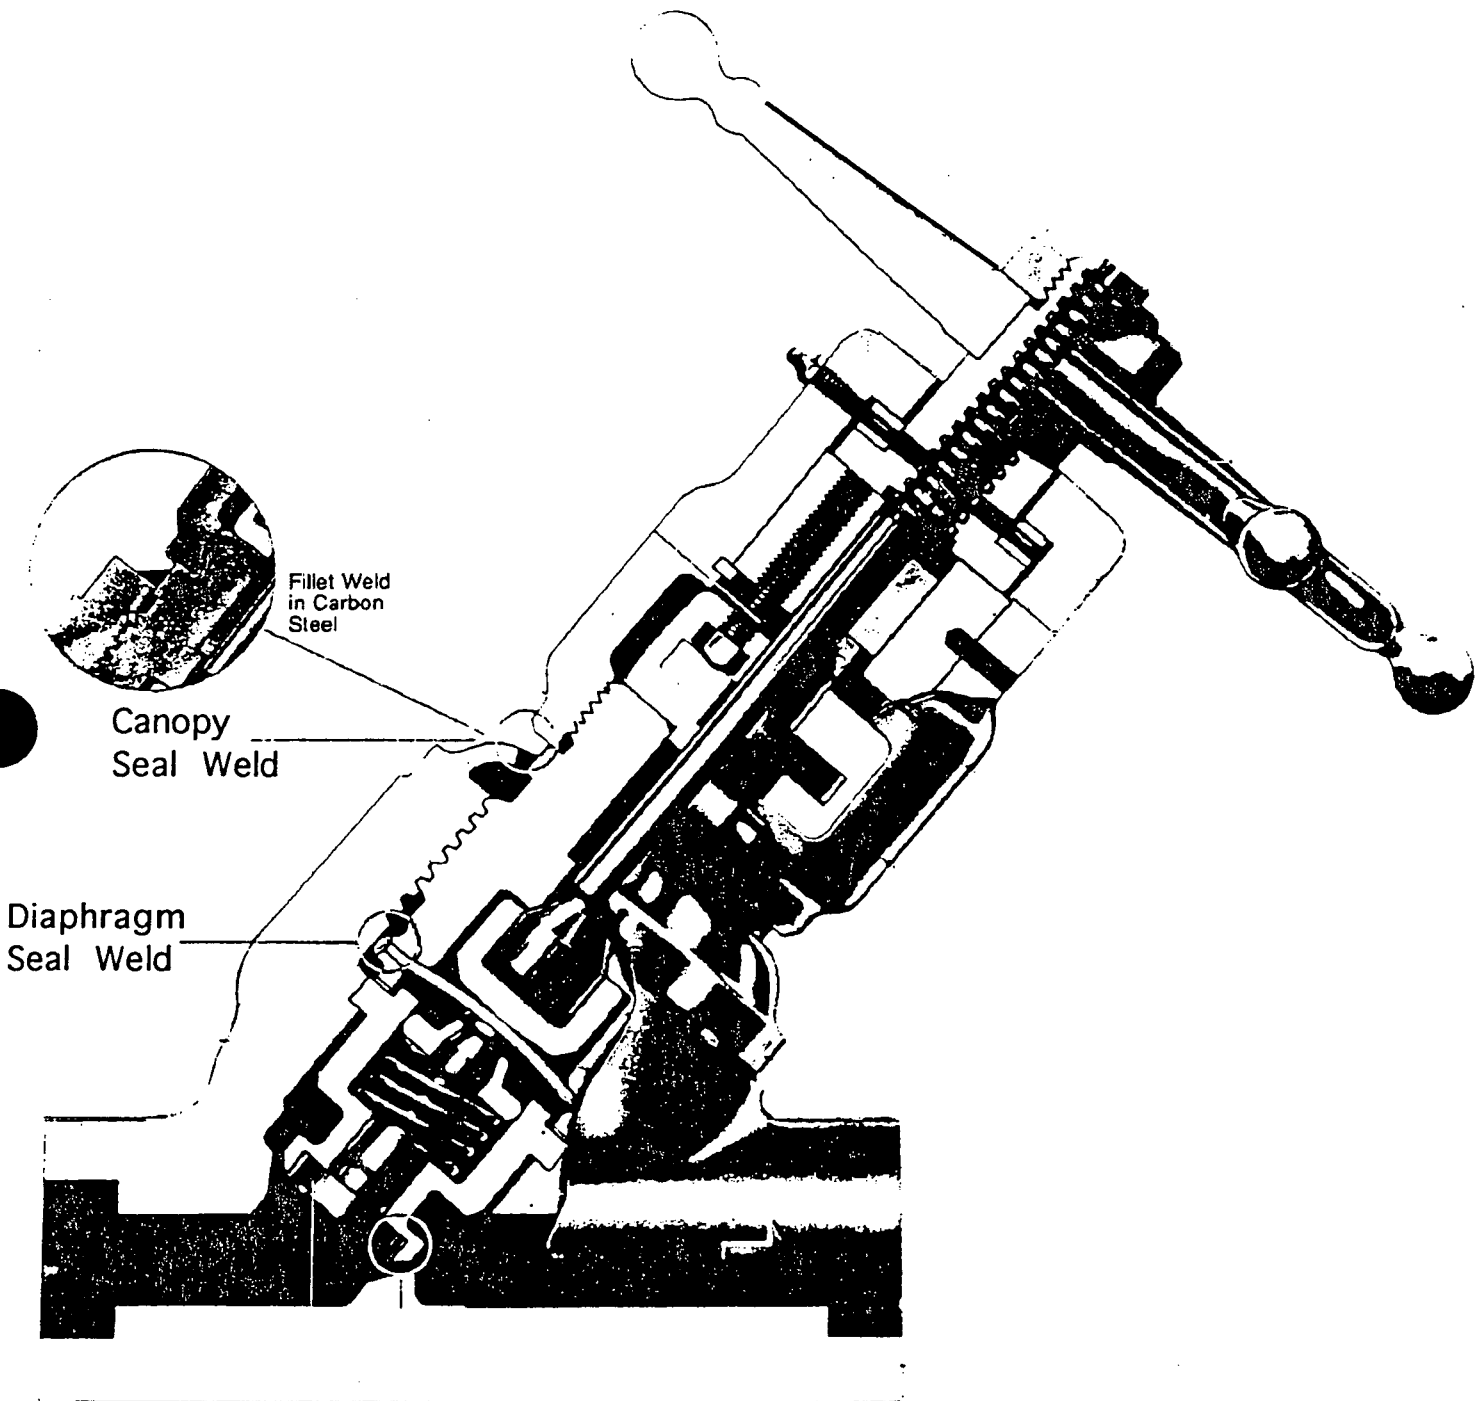
ROOT VALVE MR043

Class: 1500
Design Pressure:
2485 psig @ 700 deg F
