Shearon Harris Nuclear Power Plant, Unit No. 1
Docket No. 50-400

Subject: Relief Request I3R-13, Reactor Vessel Closure Head Nozzle 37,
Inservice Inspection Program – Third Ten-Year Interval

Relief Request I3R-13
Reactor Vessel Closure Head Nozzle 37
Inservice Inspection Program – Third Ten-Year Interval

Proposed Alternative
in Accordance with 10 CFR 50.55a(a)(3)(i)
Alternative Provides Acceptable Level of Quality and Safety

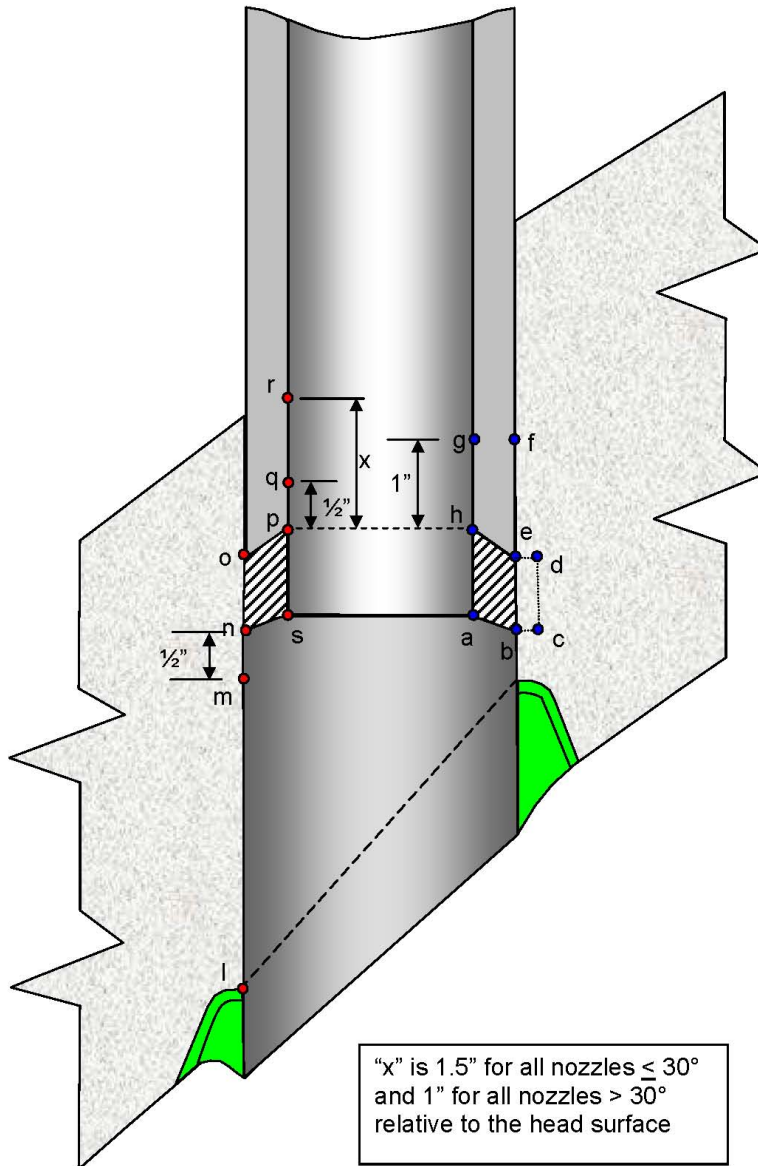
Figure 3. Examination Areas

Examination of the area depicted in Figure 3 will assure that all unacceptable flaws associated with the weld repair area have been removed.

Pre-Weld PT	l-m-n-o-p-q
Post-Weld PT	m-n-s-p-q-r
Post-Weld UT (Weld)	a-b-c-d-e-h
Post Weld UT (Nozzle Material)	e-f-g-h

4. Liquid penetrant (PT) examination of the machined area (Refer to Figure 3).
5. Welding the remaining portion of the nozzle to the RVCH using primary water stress corrosion cracking (PWSCC) resistant Alloy 52M weld material (Refer to Figure 2). Alloy 82 weld material may be used at the interface between the Alloy 182 existing weld and the Alloy 52M new weld if necessary.
6. Machining the weld and nozzle to provide a surface suitable for nondestructive examination (NDE).
7. PT and UT examination of the weld and adjacent area (Refer to Figure 3).
8. Abrasive water jet machining (AWJM) remediation on the portion of the remaining nozzle most susceptible to PWSCC. The AWJM process removes a small amount of material thickness while imposing compressive residual stress on the nozzle surface.
9. PT examination of the weld and adjacent area.
10. Welding of new Lower Thermal Sleeve Assembly.

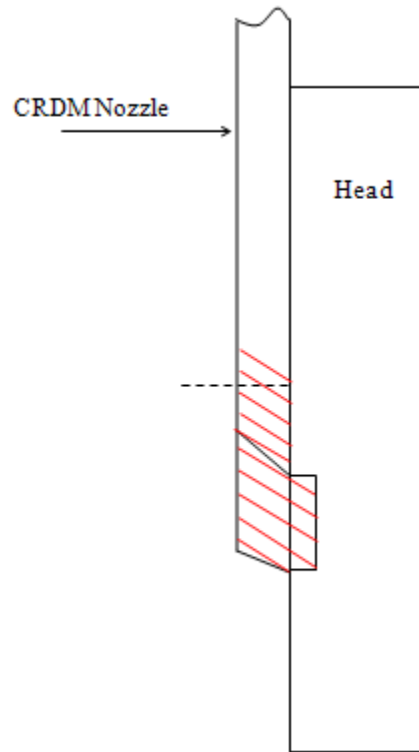
Figure 5. UT 45° L-wave Beam Coverage Looking Down

PT examination will be performed on the entire surface area. In addition, the volume in question will be examined to the extent practical using the 70°L and 45°L (see Figures 5 and 7) axial UT examination scans (looking down). There is no portion of the repair that does not receive surface liquid penetrant examination and at least single-direction UT coverage of the volume.

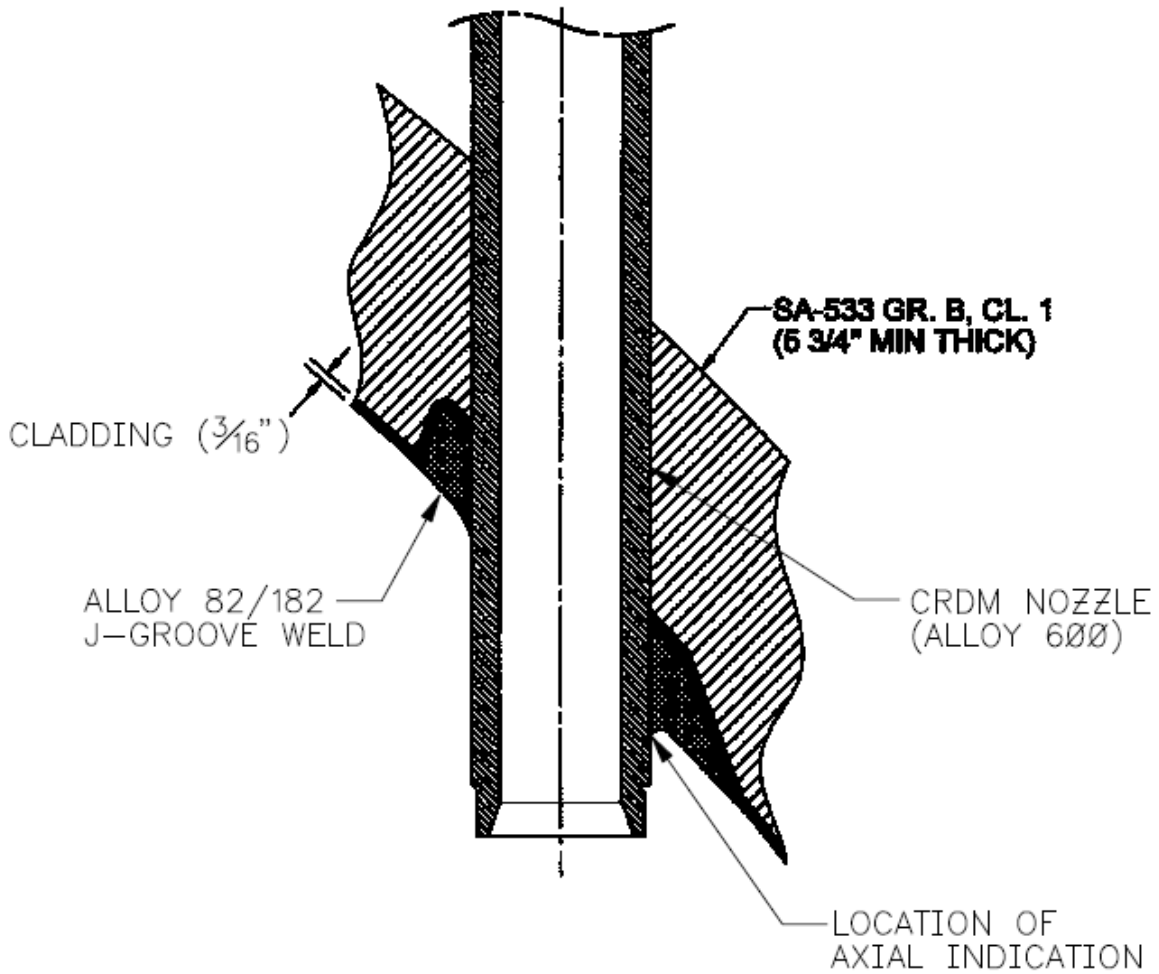
Figure 10. Location of Axial Indication

An indication requiring repair was detected during an Inservice Inspection Program ultrasonic (UT) examination of the HNP Reactor Vessel Closure Head (RVCH) nozzle penetrations. Nozzle 37 will be repaired under this request. Figure 10 shows the location of the axial indication and Figure 11 shows the relative location of the nozzle on the RVCH. Table 1 provides sizing and characterization information on the flaw leading to the repair activity. The flaw is in the tube outside diameter (OD) surface extending inward toward the tube inside diameter (ID) and is axially oriented at the lower toe side of the weld.

Because of the risk of damage to the RVCH material properties or dimensions, it is not feasible to apply the post welding heat treatment requirements of the original Construction Code. As an alternative to the requirements of RVCH Code of Construction, ASME Section III, 1971 including Addenda through Winter 1971, HNP proposes to perform the repair of the RVCH nozzle penetration utilizing the Inside Diameter Temper Bead (IDTB) welding method to restore the pressure boundary of the degraded nozzle penetration. The IDTB welding method is performed with a remotely operated weld tool, utilizing the machine GTAW process and the ambient temperature temper bead method with 50° F minimum preheat temperature and no post weld heat treatment. The repair will be performed in accordance with the 2001 Edition through the 2003 Addenda of ASME Section XI, Code Case N-638-1, Code Case N-729-1, and the alternatives discussed below.
