SOIL BACKFILL CONDITIONS

SAN ONOFRE NUCLEAR GENERATING STATION

UNIT 1

AUGUST 31, 1983

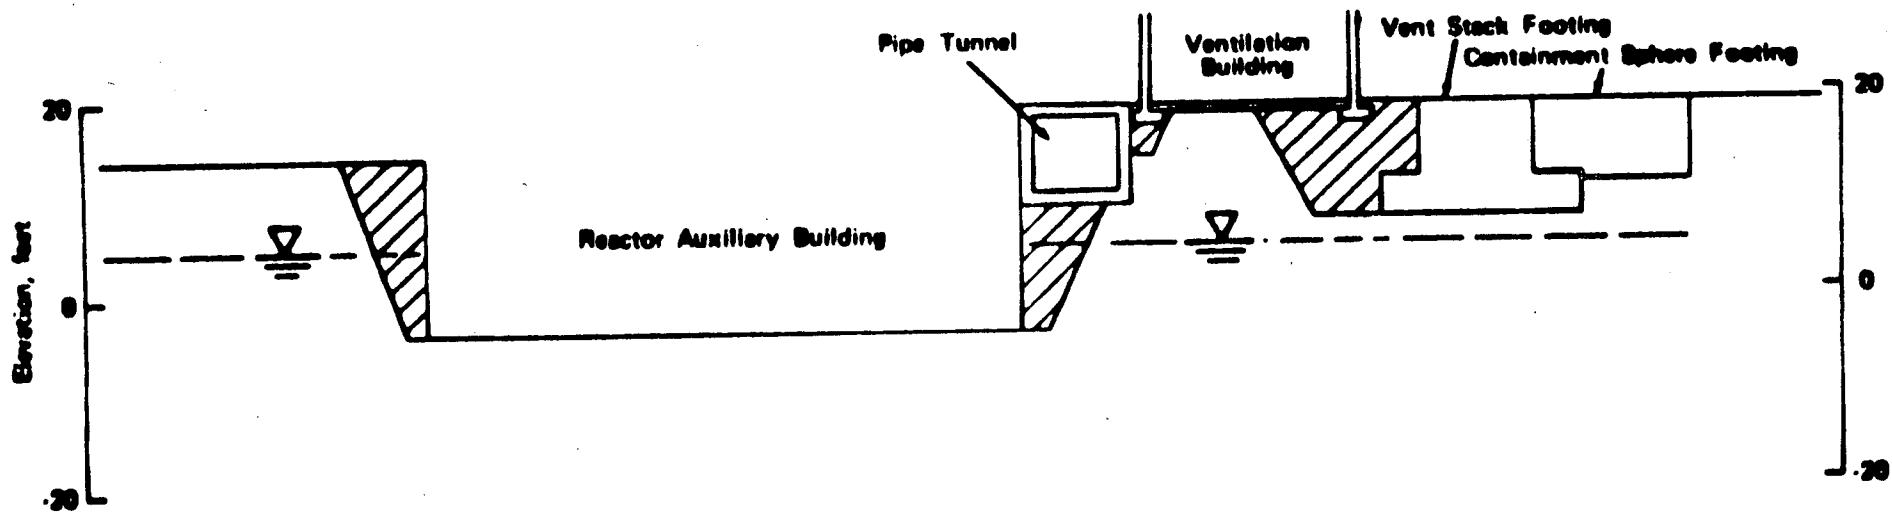
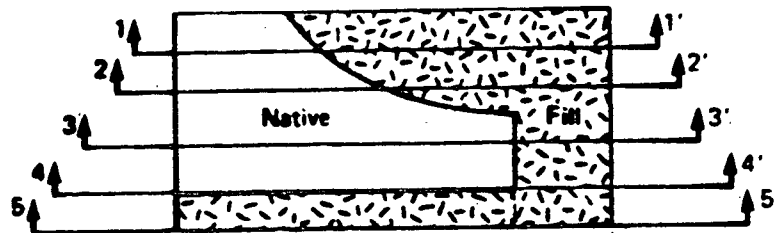
CROSS SECTION
BACKFILL CHARACTERIZATION
FIGURE 4.2a

19 ft of the north wall and about 10 feet in the northern portion of the east wall are founded on native soil. A cross-section of the backfill beneath the Ventilation Equipment Building is shown in Figure 4-2a and discussed below. The cross-section in Figure 4-2a shows less backfill beneath the west wall than was documented in Section 2 of this report. This change was made based on observations which have been located regarding the inspection of foundations for the dog house structure north of the Ventilation Building in December 1980. The western 3 feet of the north wall is founded on about 4 feet of backfill, designated as category D. The center 24 feet of the east wall is founded on up to about 8 feet of category D backfill and the southern 10 feet of the east wall is founded on backfill with depth varying from 8 feet to a maximum of 21 feet near the Fuel Storage Building. The west wall is founded on about 4 feet of category D backfill with the southern 10 feet of this wall founded on from 4 feet to a maximum of 21 feet of category D backfill. The south wall of the structure is founded on category D backfill with a thickness of about 21 feet near the Fuel Storage Building. As indicated in Figure 3-4, the category D backfill on the south side of this structure could develop high pore water pressures when subjected to the 0.67g Housner DBE.

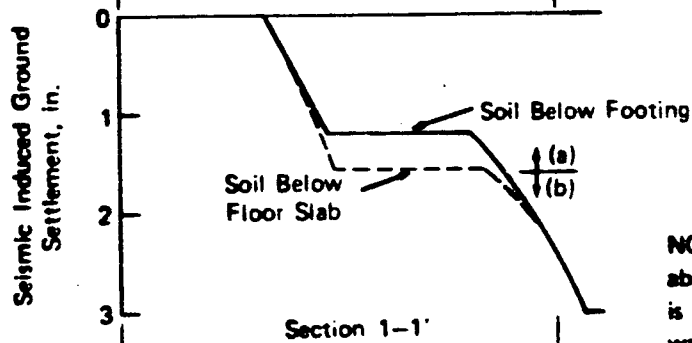
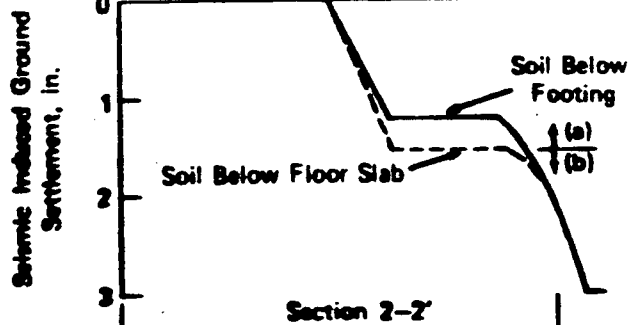
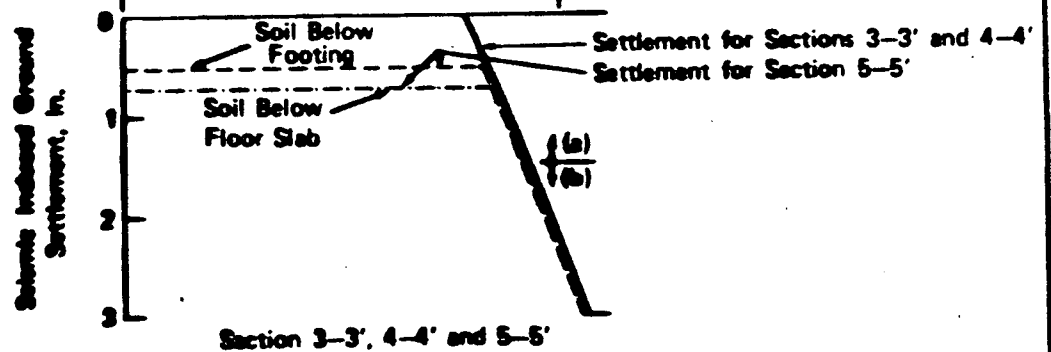
FIGURE 4-2b

The estimated maximum seismically induced settlement of the soil below this structure is summarized in Figure 4-2b. The proportion of settlement above the water table is designated by (a), and the proportion of settlement below the water table is designated by (b). It is expected that the settlement of soil above the water table, shown as a maximum of one and one-half inches of settlement in the settlement profiles in Figure 4-2b, would occur during seismic shaking. The settlement caused by liquefaction of soil below the water table would occur as pore water pressures dissipate after seismic shaking. The total soil settlement beneath the south end of the building is three inches, including post-seismic settlement.

NOTE: Settlement designated above the line designated as (a) is dominated by soil above the water table. Settlement below the line designated as (b) is dominated by the liquefaction effects of the soil below the water table.

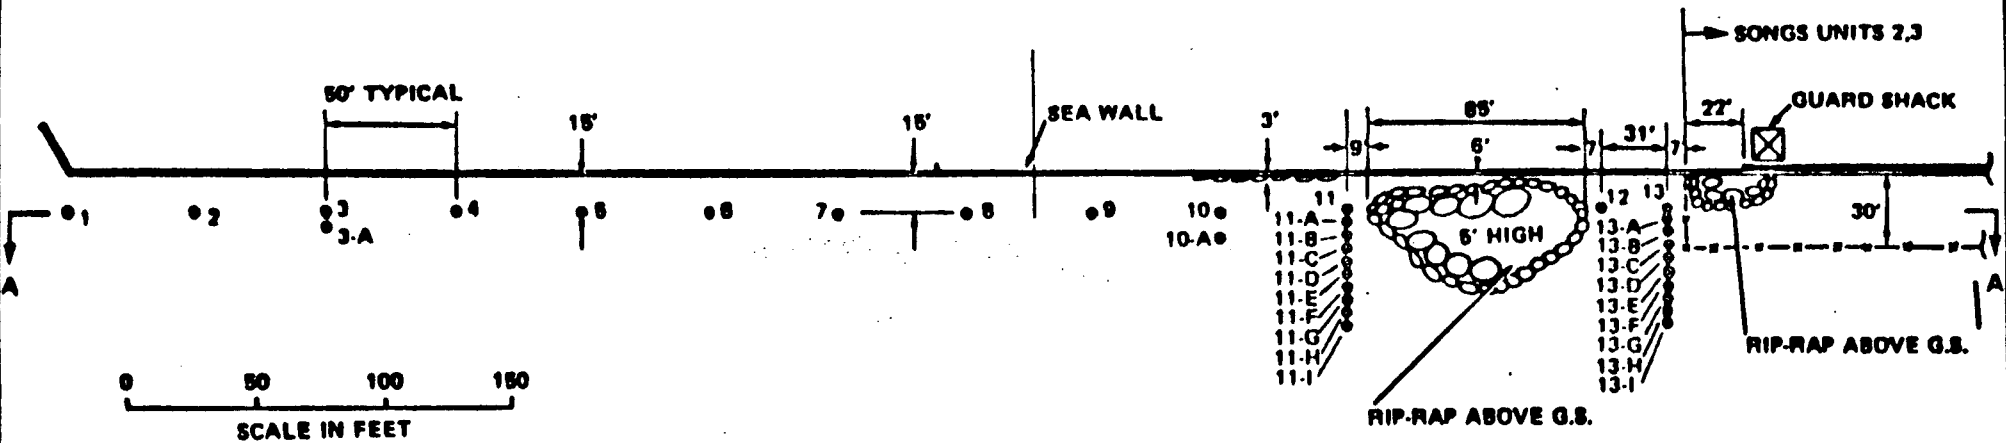
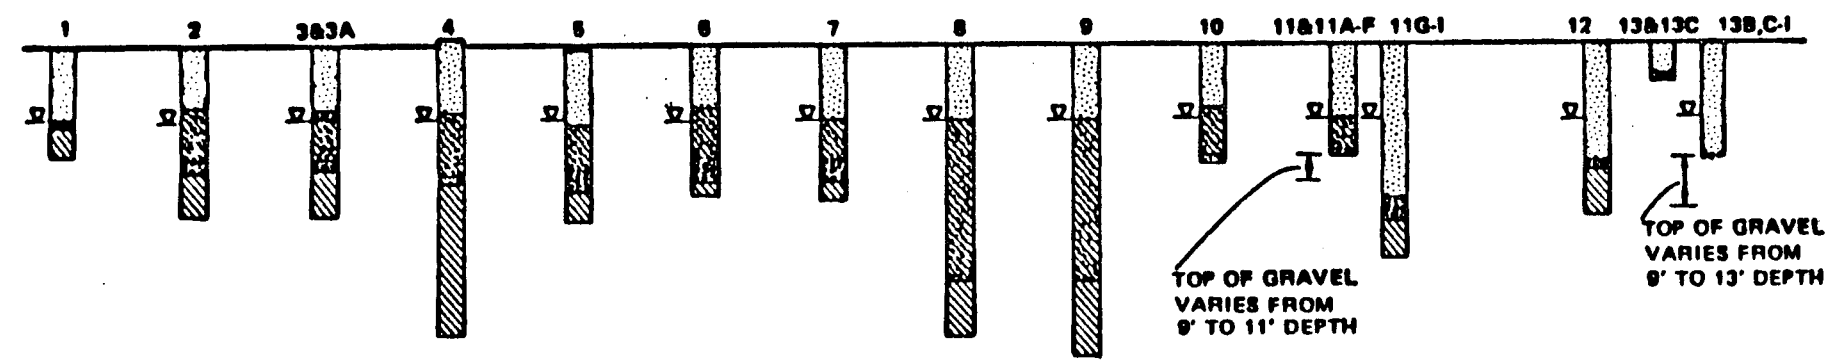
FIGURE 4-3

The Seawall was constructed during the initial plant construction in 1964 and 1965. The wall is constructed of sheet piles driven to elevation - 8.0 ft. For most of its 1,500 foot length, the sheet piles were driven into the native San Mateo sand, which exists at an average elevation of about +2.0 ft. except for about 300 feet in the southern section where the wall was constructed in the backfill placed in the excavation for the intake structure. Soil conditions on the sea side of the wall (outside of the main plant area) were investigated for construction of the beach walkway in April and May of 1980 by drilling 34 borings between 2 and 25 feet in depth within 15 feet of the wall. The location of these borings in plan view and a stick log summary of the materials

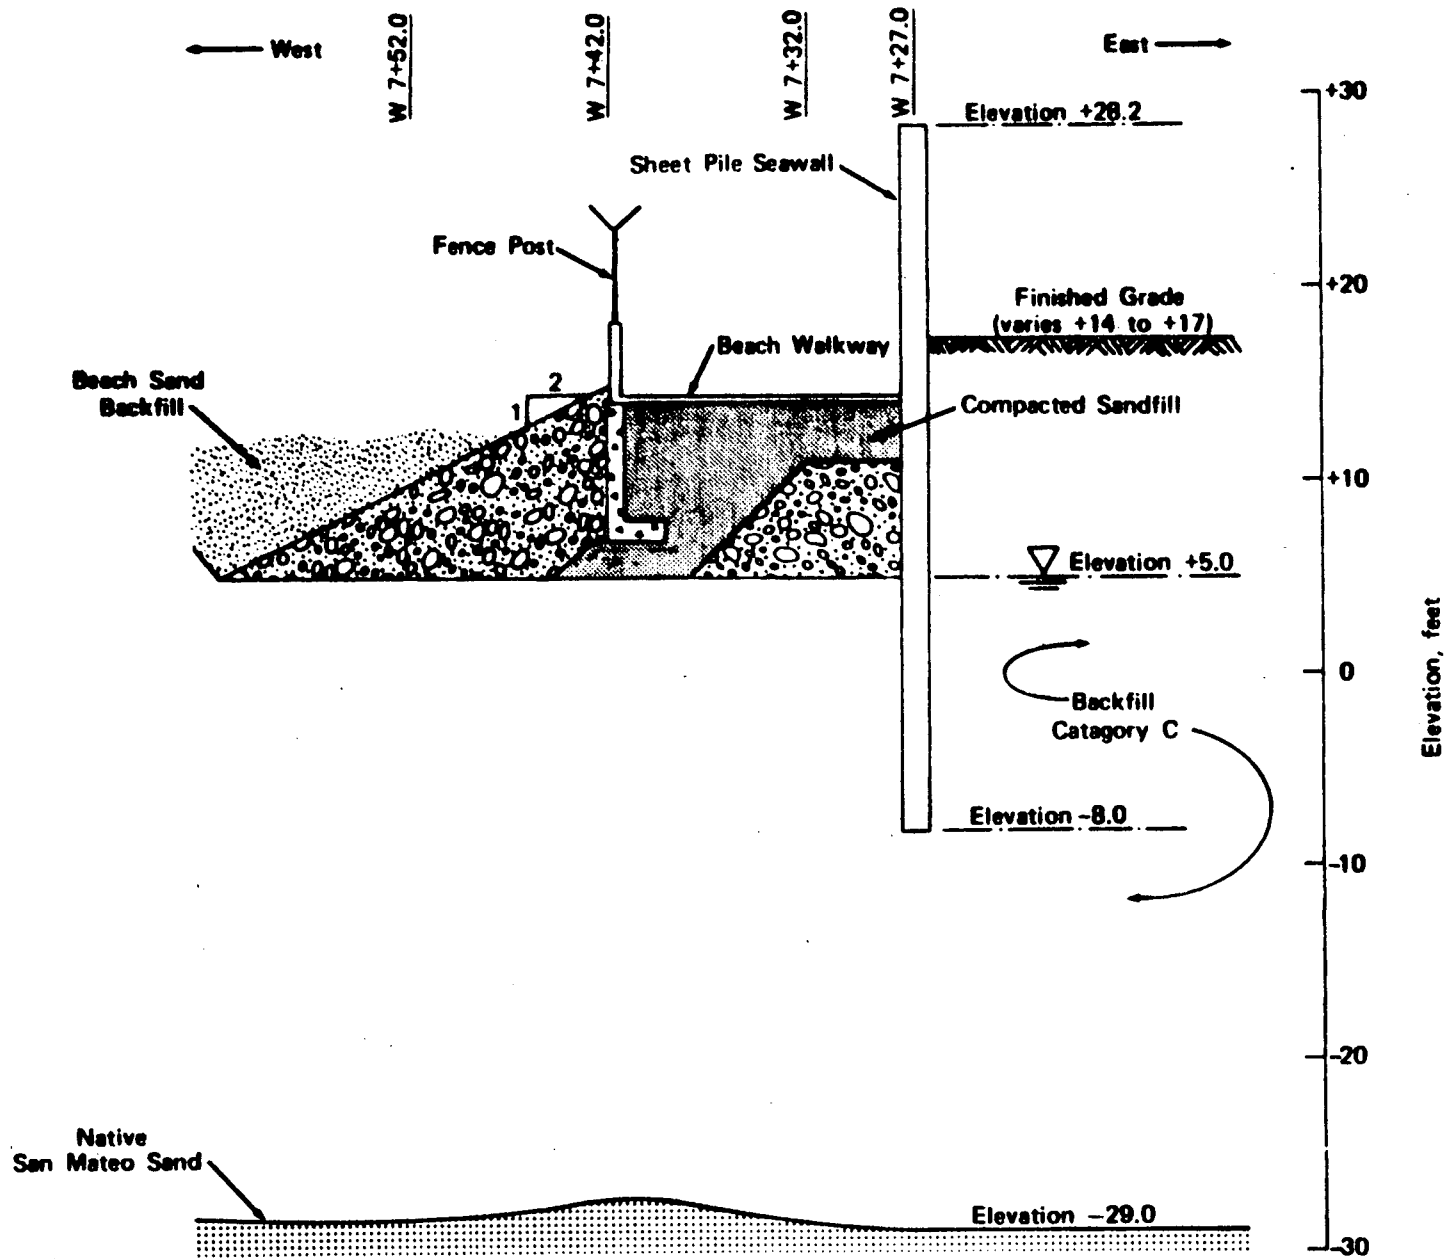
CROSS SECTION SHOWING SOIL CONDITIONS USED
 IN THE EVALUATION OF THE SEAWALL
 FIGURE 4-5

The analyses indicate that the Seawall will be stable and that stresses will be low for all possible loading conditions assuming worst case soil conditions. Therefore, it is concluded that the Seawall meets the seismic reevaluation criteria for both the DBE and the tsunami events.
