**SAFETY ENGINEERING
ROOT CAUSE REPORT**

**SONGS 1 THERMAL SHIELD LOWER
SUPPORT BLOCK FASTENERS
ROOT CAUSE EVALUATION
RCE-91-002
REVISED MARCH 21, 1991**

ROOT CAUSE EVALUATION RCE-91-002

March 21, 1991

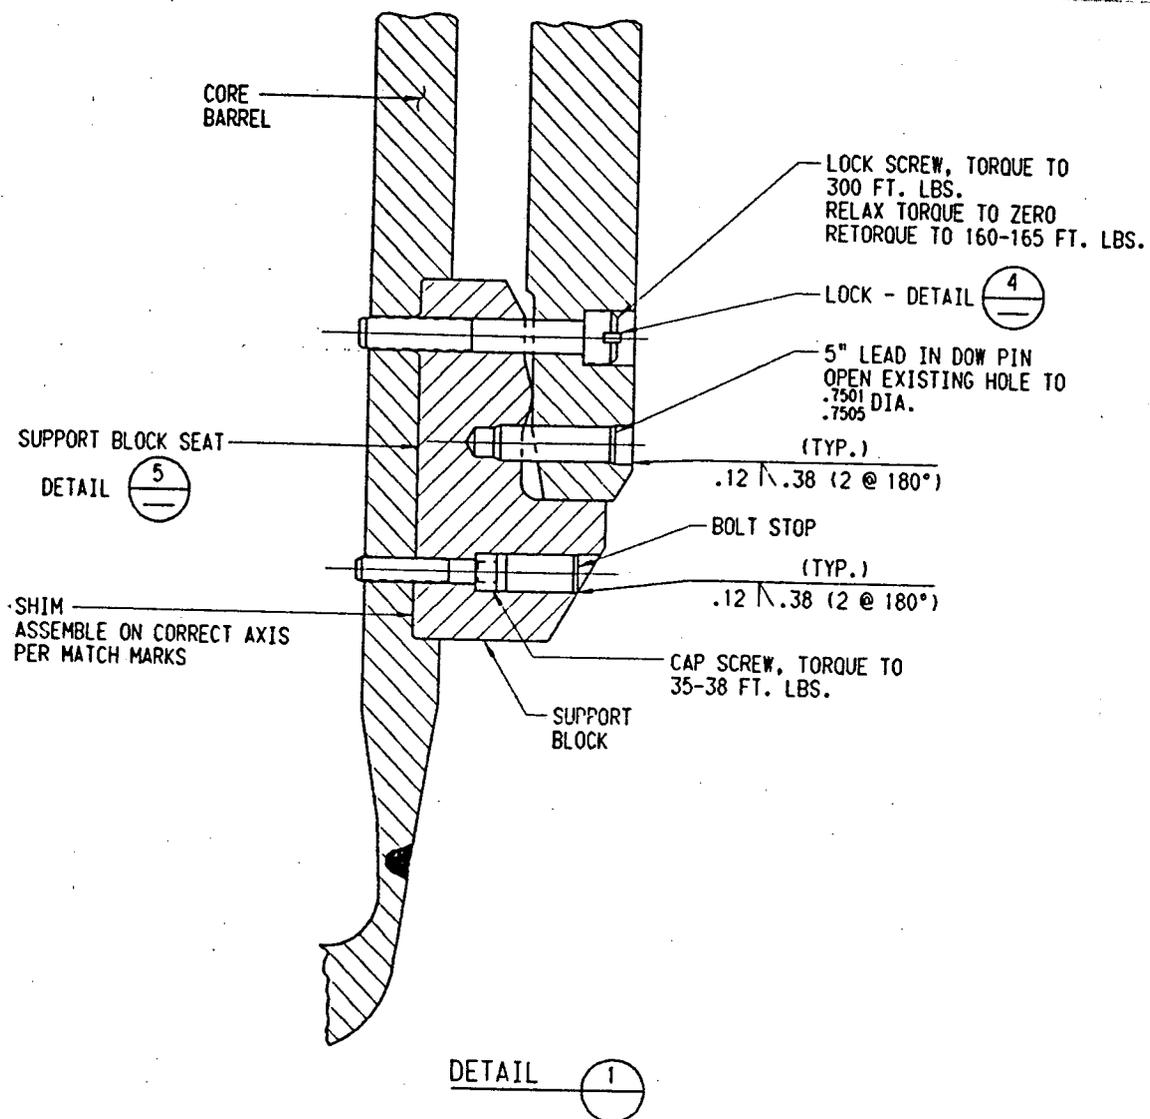
FIGURE 3a. Original Support Block Design

The design of the support block and the type of fasteners enhanced crack initiation and propagation. In particular, the upper portion of the old support block had merely a line of contact with the thermal shield (see Figure 3), this facilitated rocking action between the shield and the block. Also, the old fasteners were threaded all the way to the bolt head. This created a stress riser and generated high stress concentration factors at the base of the head.

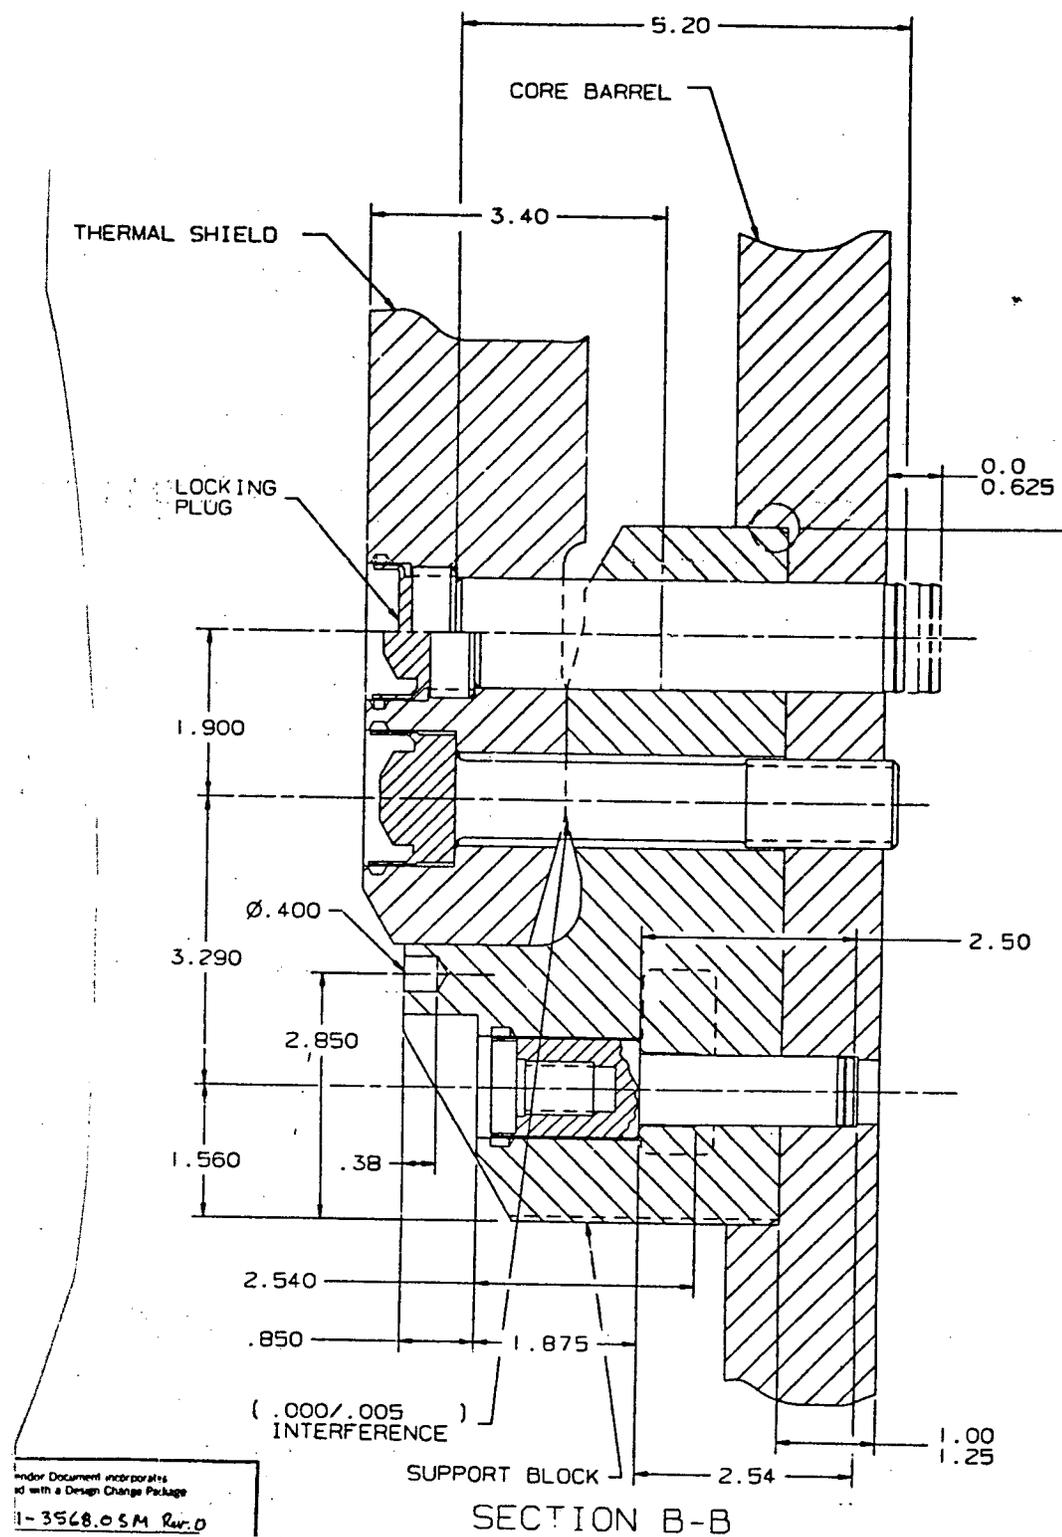
FIGURE 3b. Replacement Support Block Design

The thermal shield repair included a redesign of the upper thermal shield flexures as well as a redesign of the support block and a change in the type of fasteners used. The new support block will provide an area of contact (instead of a very narrow band) between the block and the thermal shield which will minimize the potential rocking action. Bolts with a smooth shank and a large radius of curvature at the head to shank transition and with overall high mechanical properties were used. The upper flexures were redesigned to withstand the calculated stresses.

A design change was made to the support blocks to provide an area contact instead of a line contact between the block and thermal shield. This reduces the potential for rocking action, thereby reducing potential vibration significantly.

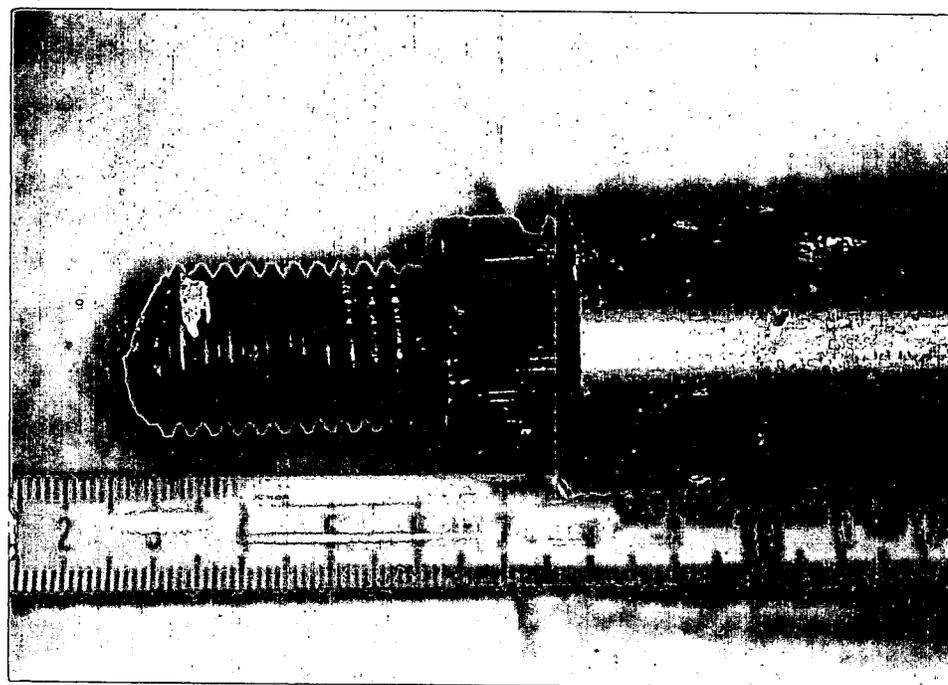
Figures 4 and 5 show two different side views of fractured hidden bolt H1 (0.875" in diameter). Figure 4 illustrates the presence of significant wear on the bolt head at the location marked by the arrow. This indicates that the bolt was in a cocked position in its hole. Figure 6 shows the overall appearance of the fracture face illustrating the presence of multiple fatigue ratchet marks around the perimeter of the fracture which coincides with the thread root. This is further illustrated in Figures 7, 8 and 9. The presence of these ratchet marks is indicative of fatigue fracture under high stress concentration conditions. The macroscopic appearance of the fracture surface indicates a limited fatigue zone estimated to be under 30% of the fracture surface. This in turn is indicative of fracture under relatively high nominal stresses.

FIGURE 4. Appearance of hidden bolt H1 as found. The arrow points to significant uneven wear on the bolt head.

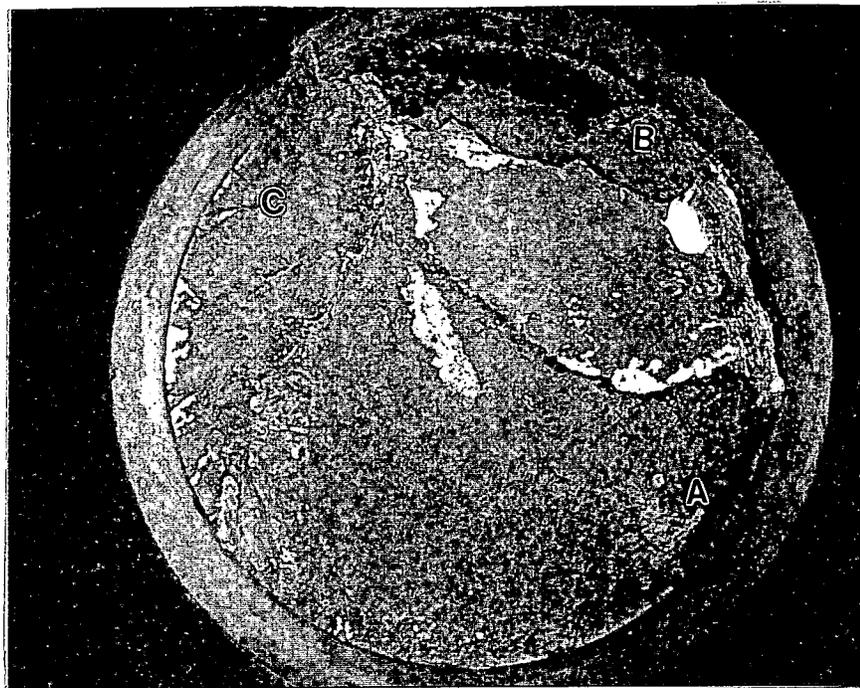
FIGURE 5. Another view of hidden bolt H1.

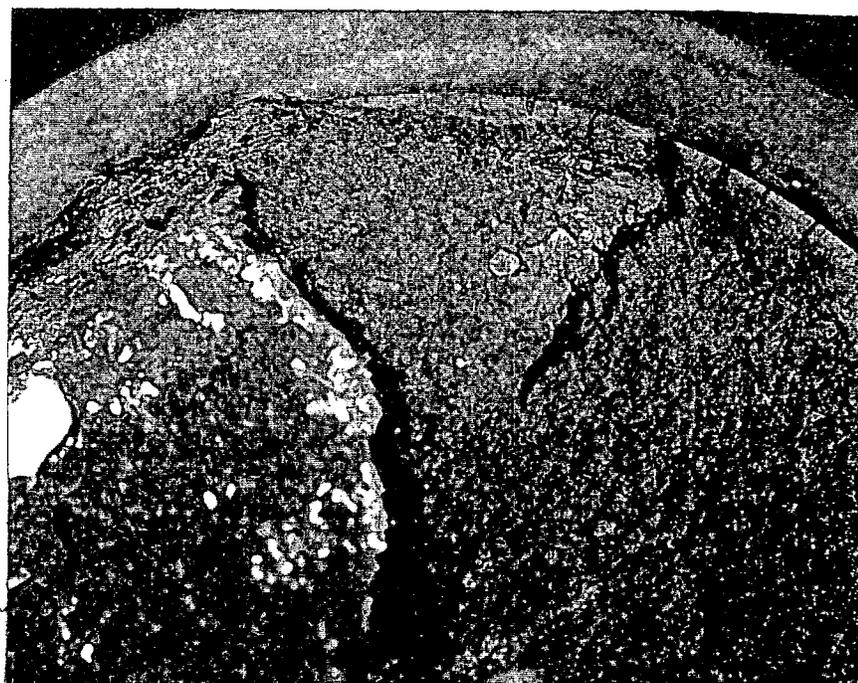
FIGURE 6. Macro photograph of the fracture face of hidden bolt H1 after cleaning. 5x

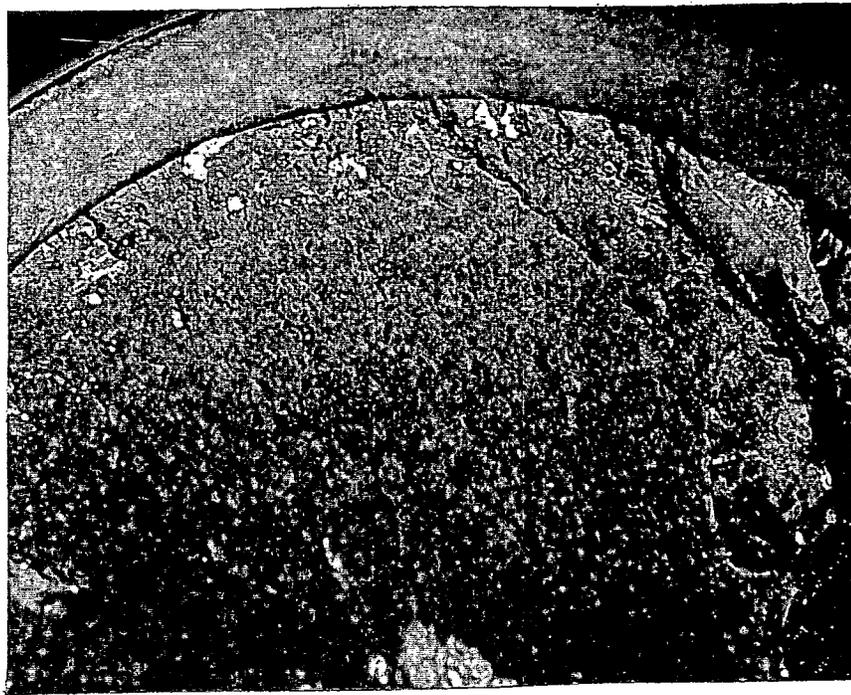
FIGURE 7. Close-up view of Area "A", Figure 6, showing fatigue ratchet marks at the thread root. 10x

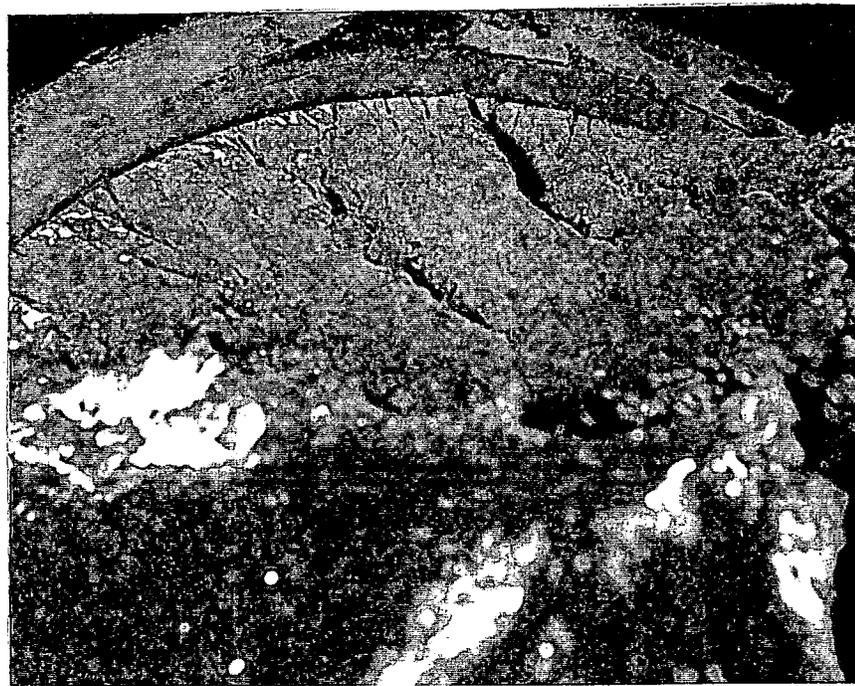
FIGURE 8. Close-up view of Area "B", Figure 6, showing fatigue ratchet marks at the thread root. 10x

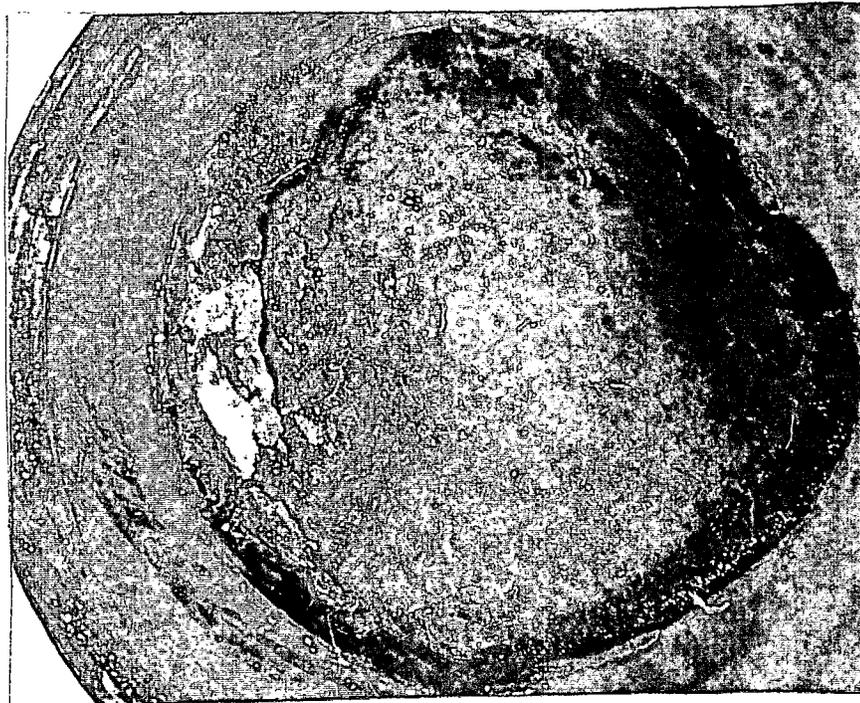
The appearance of fractured hidden bolt H2 is illustrated in Figures 10 and 11 in the as found condition. The fracture surface in Figure 11 is severely oxidized and the plane of fracture coincides with the first thread root at the bolt head. Figure 12 illustrates significant rubbing damage which is indicative of being fractured for a period of time during which the mating fracture surfaces rubbed against each other.

FIGURE 11. Appearance of the fracture face of hidden bolt H2 illustrating severe high temperature oxidation.

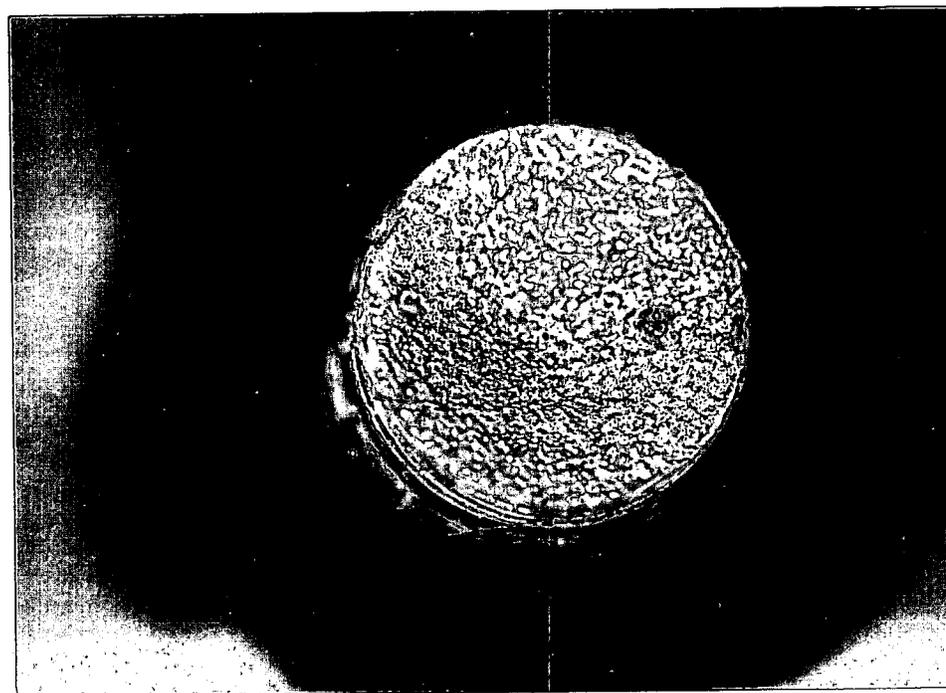
Figure 16 shows extensive wear and flattening of the sides of the bolt in the vicinity of the fracture and present all around the perimeter of the bolt. This may be indicative of rotational movement in place rather than rocking action. Rocking action would create wear only on one side of the bolt which is not the case here.

FIGURE 16. Close-up side view of the fractured end of hidden bolt H3, illustrating the presence of uneven side wear, as found condition.

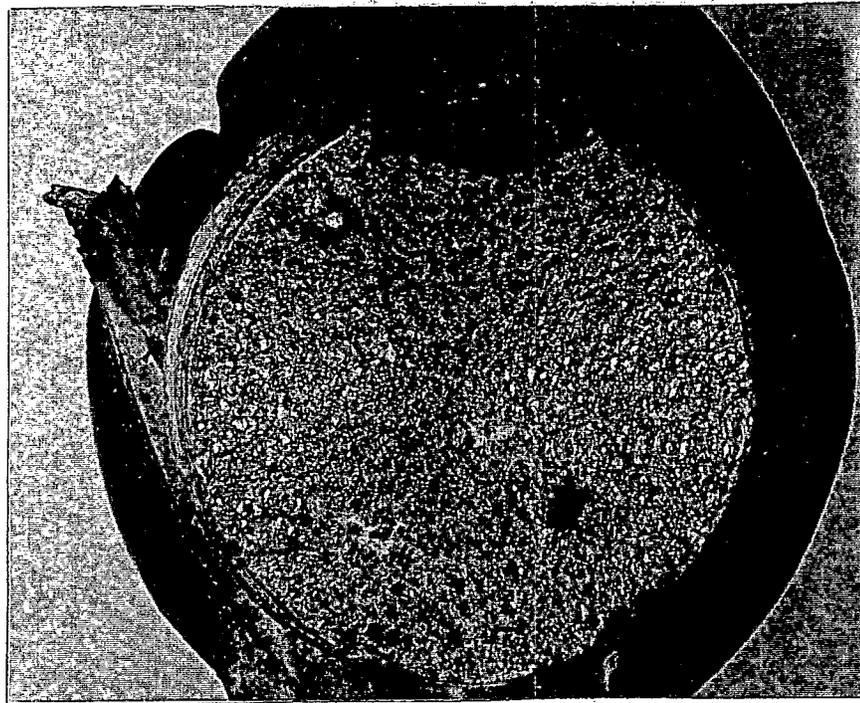
Figure 17 shows the appearance of the fracture face in the as found condition illustrating the degree of surface polish and rubbing. This bolt, in comparison with the other retrieved ones, had the maximum rubbing damage. This indicates that this bolt was cracked for a longer period of time than the others.

FIGURE 17. Appearance of the fracture face of hidden bolt H3 illustrating significant rubbing damage.

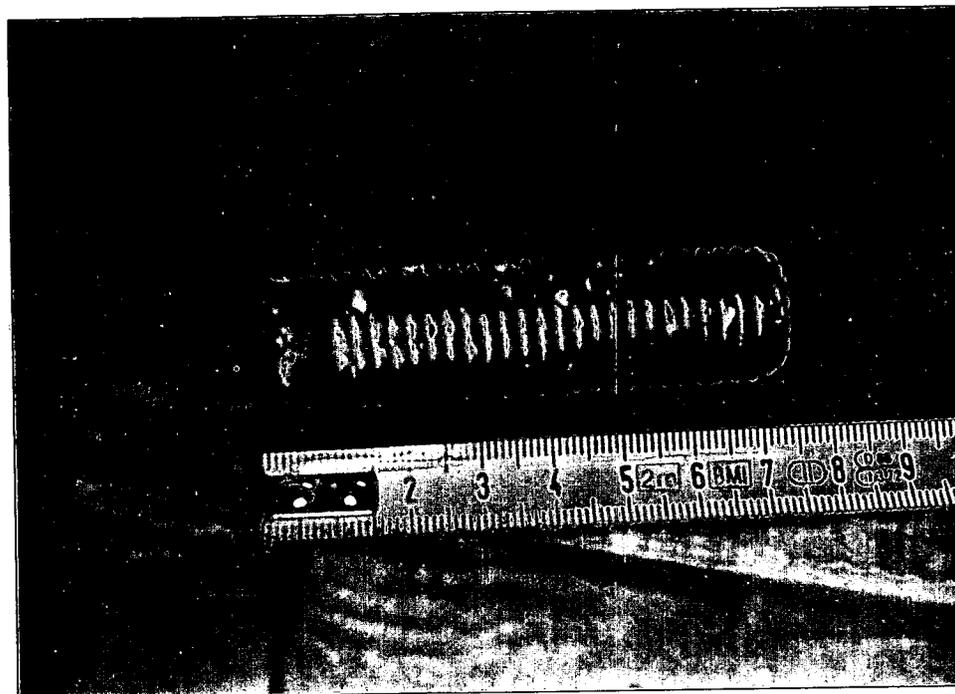
Figures 18, 19 and 20 show the appearance of the fracture surface of hidden bolt H3 after cleaning. The plane of fracture has a dished nature, similar to the fracture of the hidden bolt H2. The rubbing damage of the fracture surface had significantly erased the details of the fracture, therefore it is difficult to determine the fracture mode of the bolt. However, if one considers the similarity in the overall fracture morphology of this bolt with that of hidden bolts H1, H2 and H4 (which are either convex or concave in nature), it is safe to assume a similar fracture mode. That is, hidden bolt H3 probably failed under similar high stress, low cycle fatigue conditions.

FIGURE 18. Appearance of the fracture face of hidden bolt H3 after cleaning, illustrating significant rubbing damage. 4x

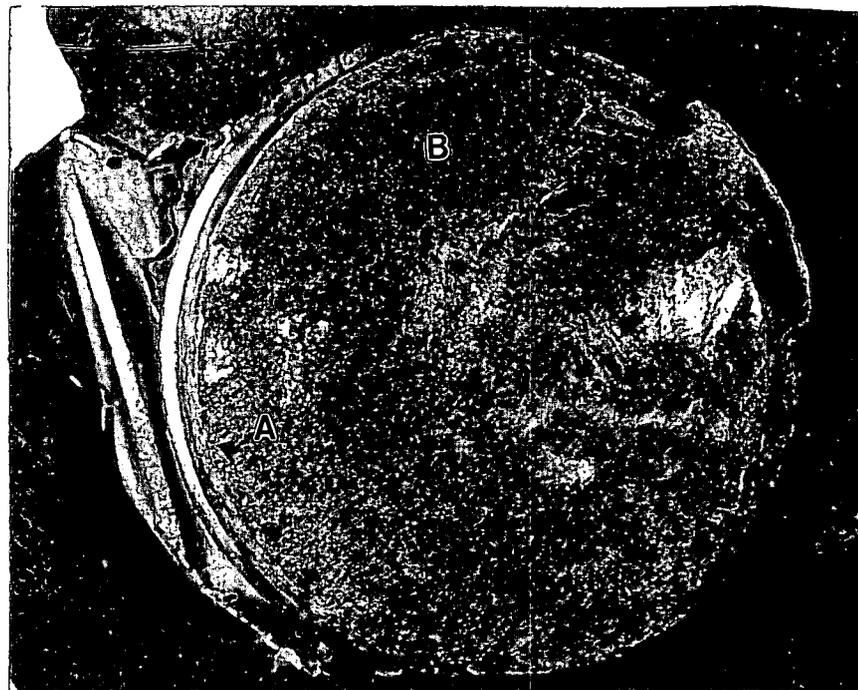
The overall appearance of hidden bolt H4 is illustrated in Figure 21. The plane of fracture appears to coincide with the thread root adjacent to the head of the bolt. Figures 22, 23 and 24 show different side views of the fractured end of the bolt in the as found condition. The overall appearance of the fracture face suggest fatigue fracture conditions.

FIGURE 21. Appearance of hidden bolt H4, as found condition.

FIGURE 22. Close-up side view of hidden bolt H4, as found condition.

FIGURE 23. Close-up view of the fracture face of hidden bolt H4, as found condition.

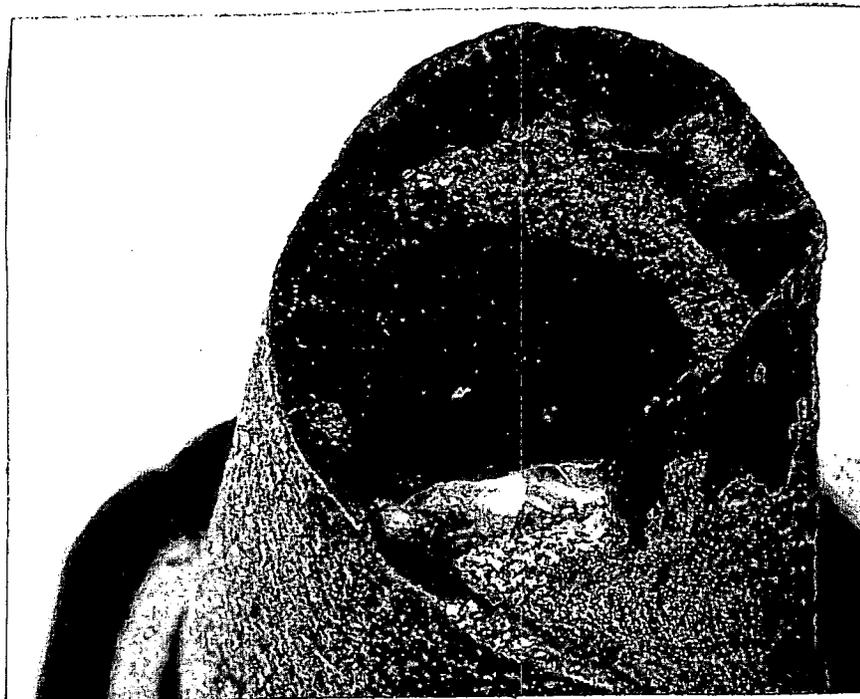
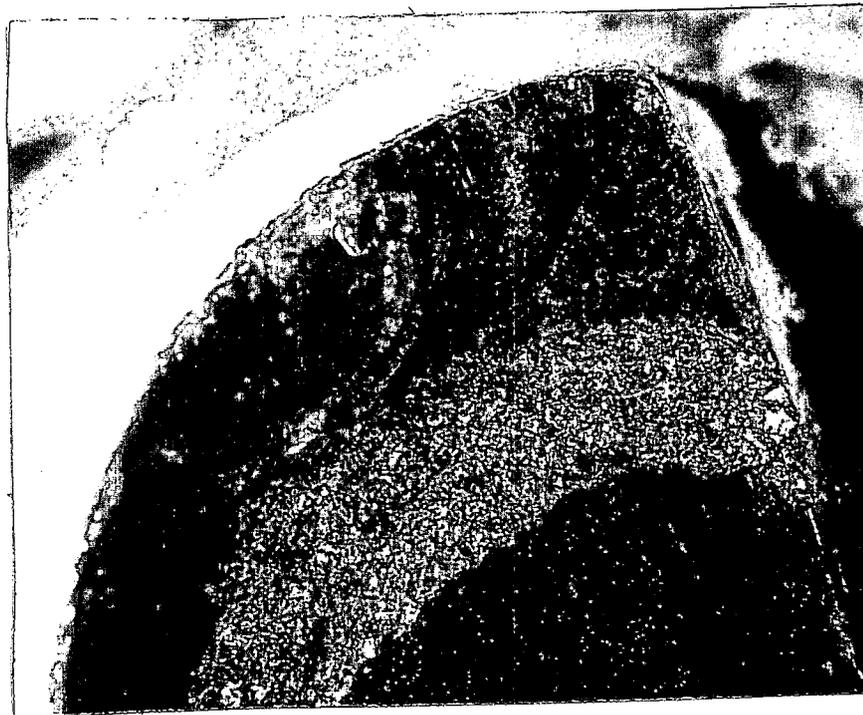
The appearance of the fracture face before and after cleaning is illustrated in Figures 30 and 31 respectively.

FIGURE 29. Close-up view of the fractured end of short dowel pin DS1, illustrating non-uniform wear.

FIGURE 30. Appearance of the fracture face of short dowel pin DS1, as found condition.

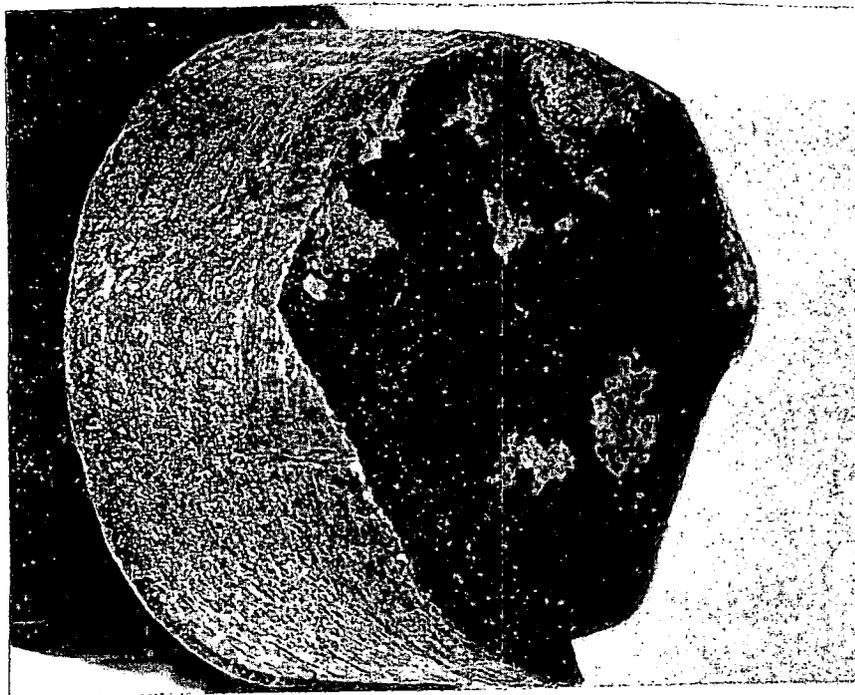
Figures 33 and 34 show the overall appearance of short dowel pin DS2. Figure 33 illustrates significant fretting wear in the vicinity of the fractured end which is indicative of axial movement in one direction (vibration). The fracture surface was severely oxidized, as shown in Figure 34. The red colored oxide is believed to have occurred during storage after removal.

FIGURE 33. Appearance of short dowel pin DS2, as found condition, illustrating uneven wear.

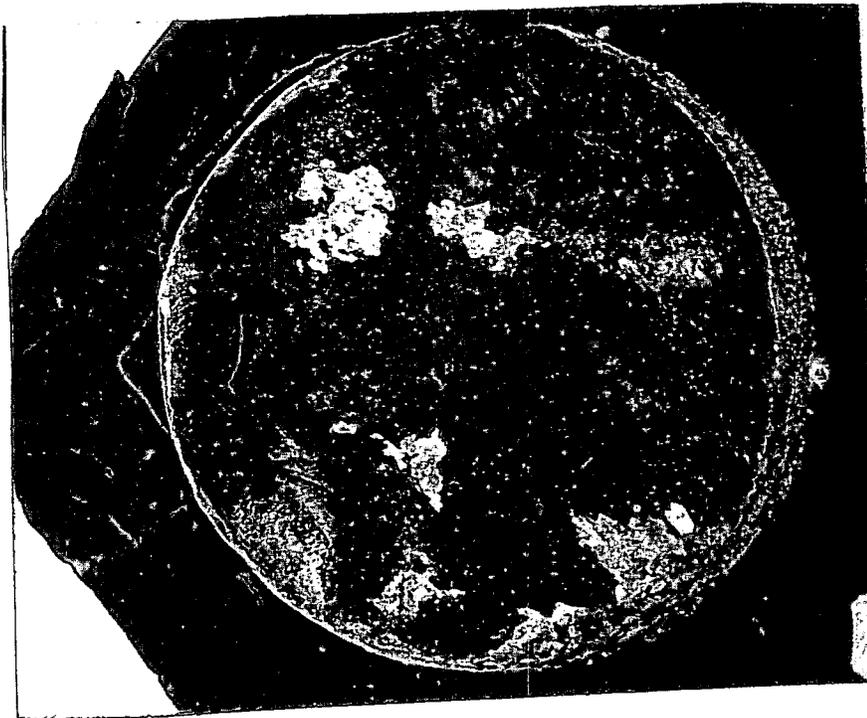
Figure 35 and 36 show the appearance of the fracture face after cleaning. Evidence of fatigue macroscopic features such as beach marks and thumbnails were evident on the upper portion. The rest of the fracture appears to an overload zone (45° inclined plane). The rubbing damage of the fracture surface indicates that the mating fracture surfaces had remained in contact for a longer period of time than that of DS1. This conclusion is supported by the degree of high temperature oxidation evident on DS2.

FIGURE 34. Appearance of the fracture face of short dowel pin DS2, as found condition.

FIGURE 35. Appearance of the fracture face of short dowel pin DS2 after cleaning, illustrating fatigue thumbnails and beach marks followed by an overload fracture on an inclined plane at approximately 45°. 5x.

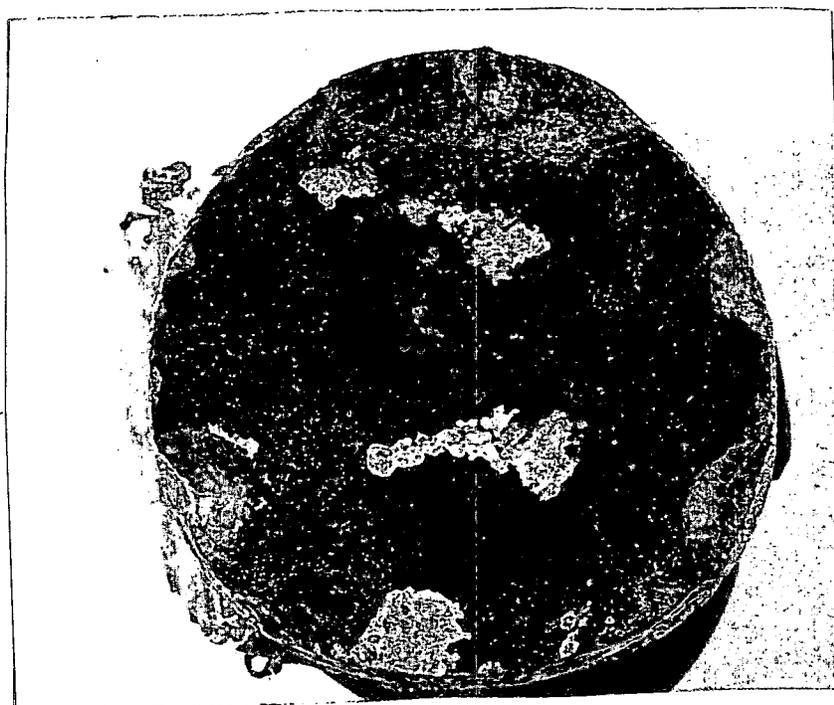
The appearance of long dowel pin DL1 in the as found condition is shown in Figures 37 and 38. Extensive wear is evident in the vicinity of the fractured end. The wear resulted in greater than a 50% reduction of the cross-sectional area. The fracture surface was also heavily oxidized. The red iron oxide appears to have occurred during storage. The fracture surface after cleaning is

FIGURE 37. Appearance of long dowel pin DL1 showing significant uneven wear, as found condition.
