SEAWALL INSPECTION
SAN ONOFRE NUCLEAR GENERATING STATION, UNIT 1

Prepared for:
SOUTHERN CALIFORNIA EDISON

Prepared by:
Impell Corporation
350 Lennon Lane
Walnut Creek, California 94598

Impell Report No. 01-0310-1473
Revision 1

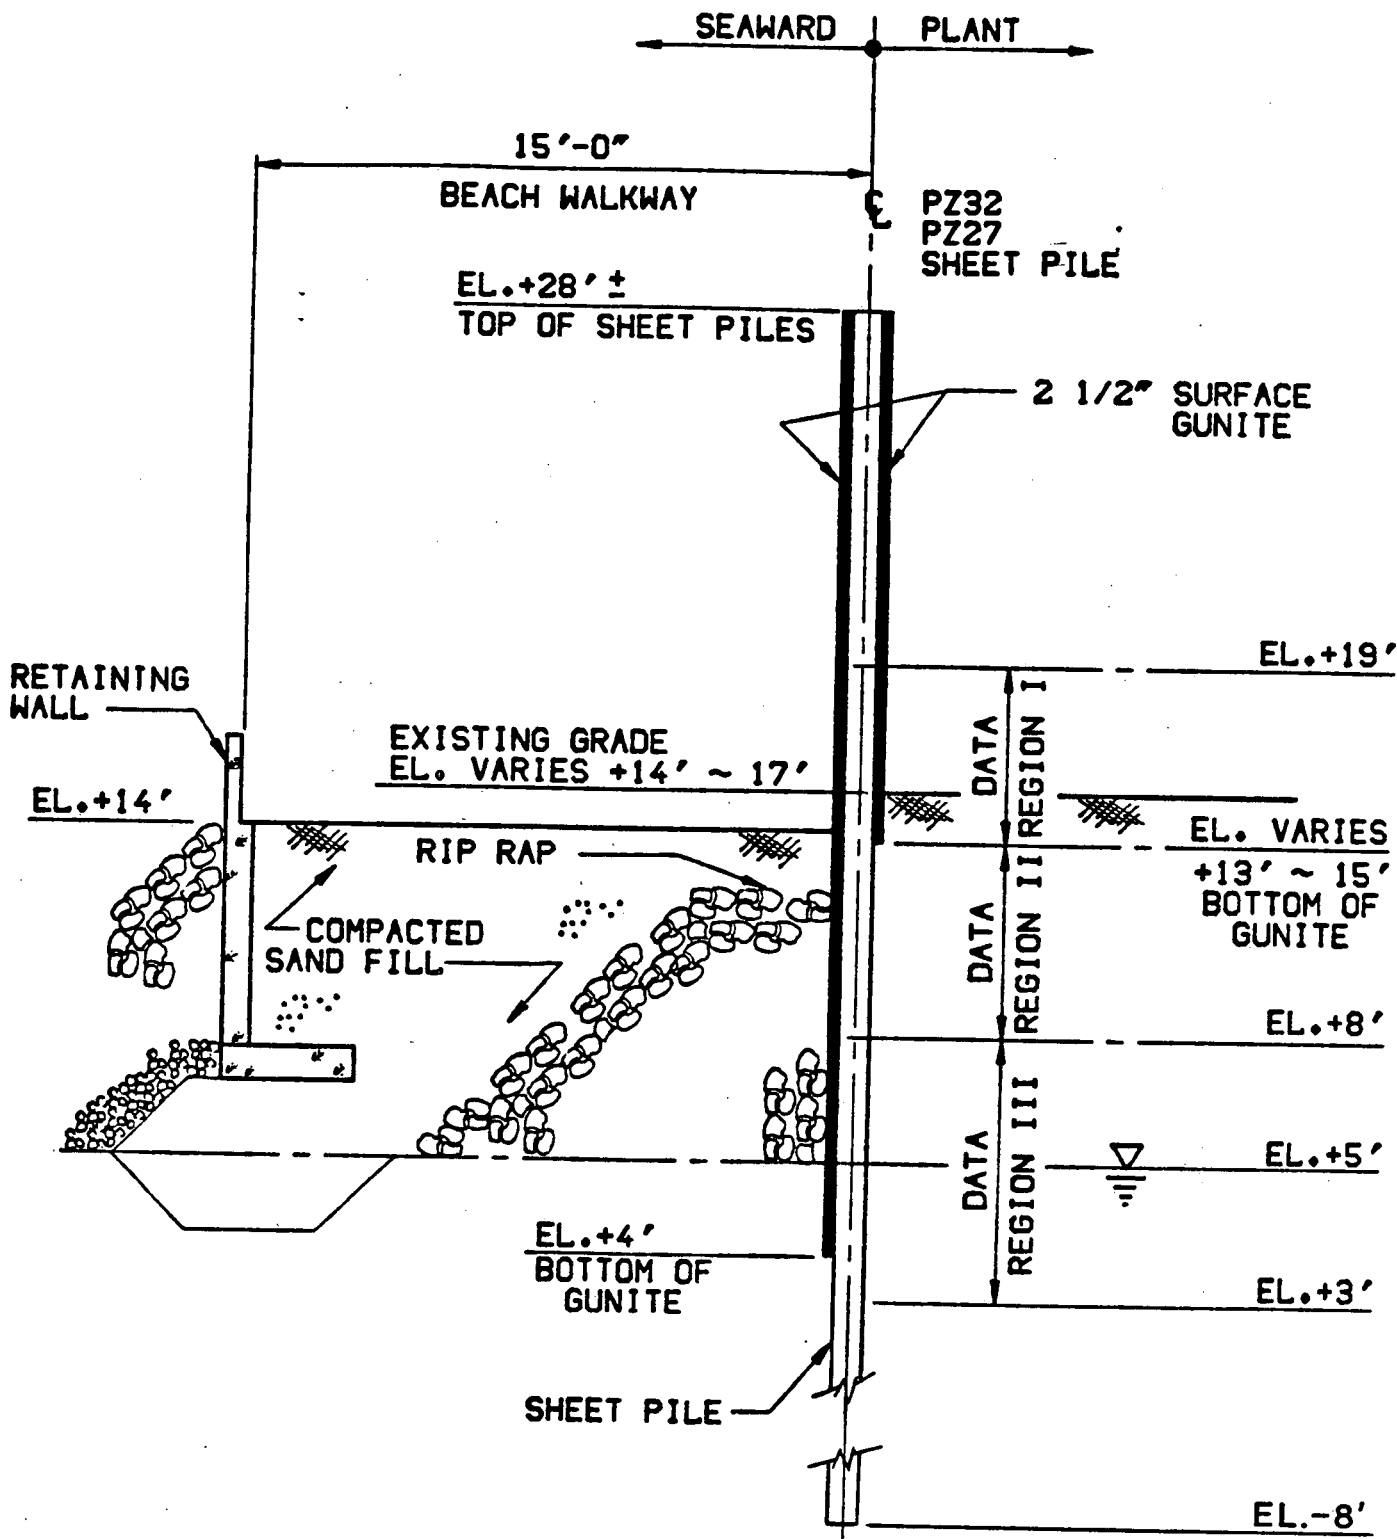
TYPICAL SEAWALL
FIGURE 1

Corrosion protection of the sheet piling consists of a coal tar epoxy coating and concrete gunite (with wire mesh) encasement. The gunite extends from the top of the seawall to ten feet below grade on the seaward side (elev + 4) and approximately one foot below grade on the plant side (elev + 13) (see Figure 1).

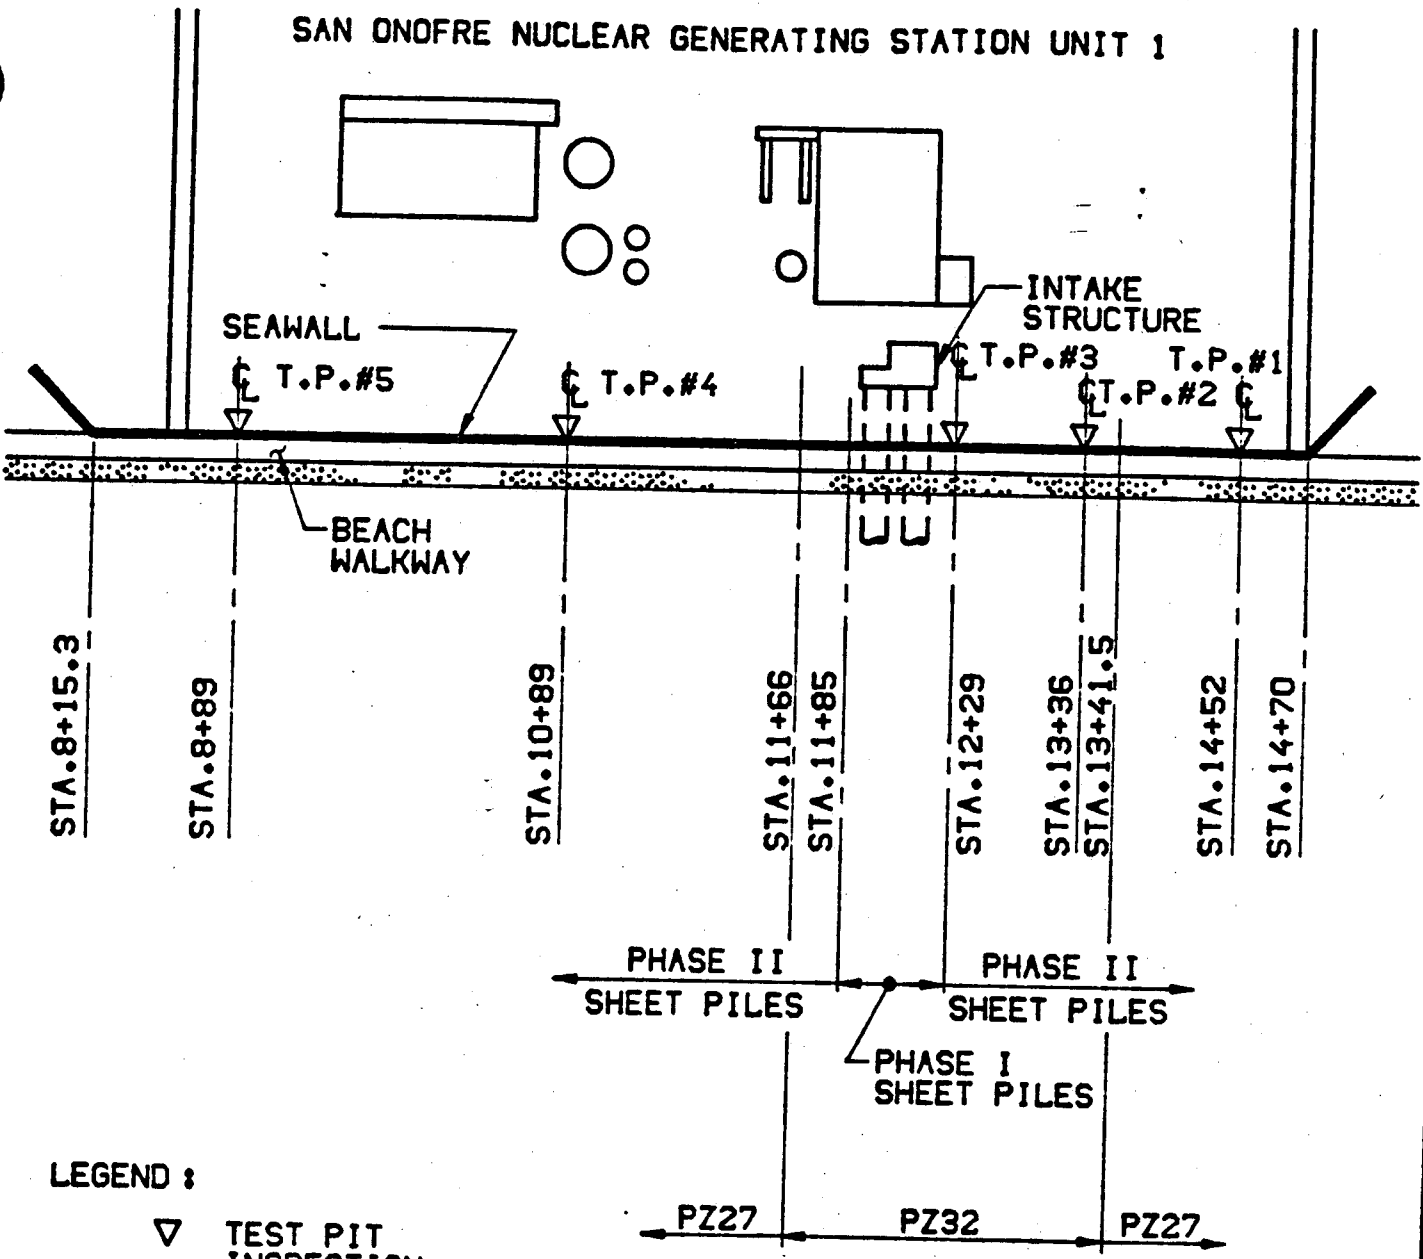
SEAWALL INSPECTION LOCATIONS
FIGURE 2

Inspection was performed at five locations along the seawall with four sheet piles being tested at each location. The five locations are shown on Figure 2. These locations were selected to provide a representative cross sampling of the seawall.

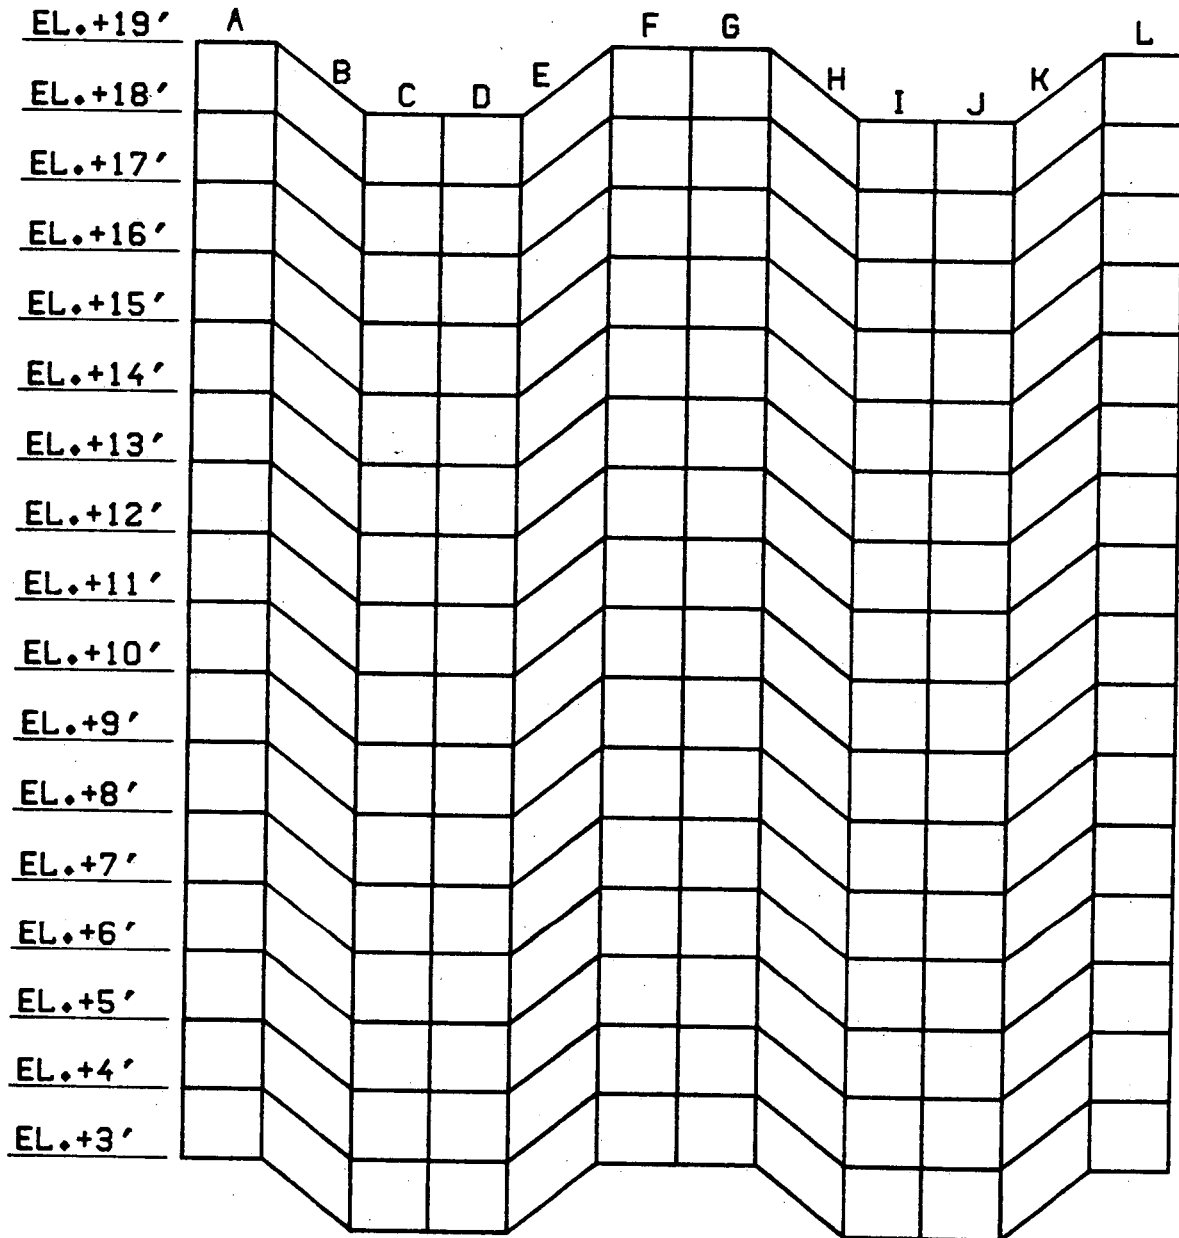
SAMPLE OF SHEET PILE GRID LAYOUT
FIGURE 3

Inspection of the seawall consisted of an extensive amount of data collection. Testing grid lines were laid out on the surface area of the four sheet piles at each inspection location. The horizontal grid lines were placed at one foot intervals between elevations +3 and +19 and the vertical grid lines were defined as the flange-web junctions and the interlocks of the sheet piles. See Figure 3 for example of grid lay-out. Visual inspection of each grid was performed by a SCE corrosion engineer and the pile surfaces were carefully photographed. Within each grid, an average of five ultrasonic thickness measurements were recorded. All pits with diameters greater than 3/8 inch were "mapped" and the maximum depth of the pits was measured by ultrasonic thickness equipment or pit depth gauges. See figure 4 for sample data sheet. All ultrasonic thickness and pit depth measurements were conducted by American Society of Non-Destructive Testing-TC-1A or American National Standards Institute-45-2-6 qualified SCE technicians. See Reference [12] for Inspection data and photographs.

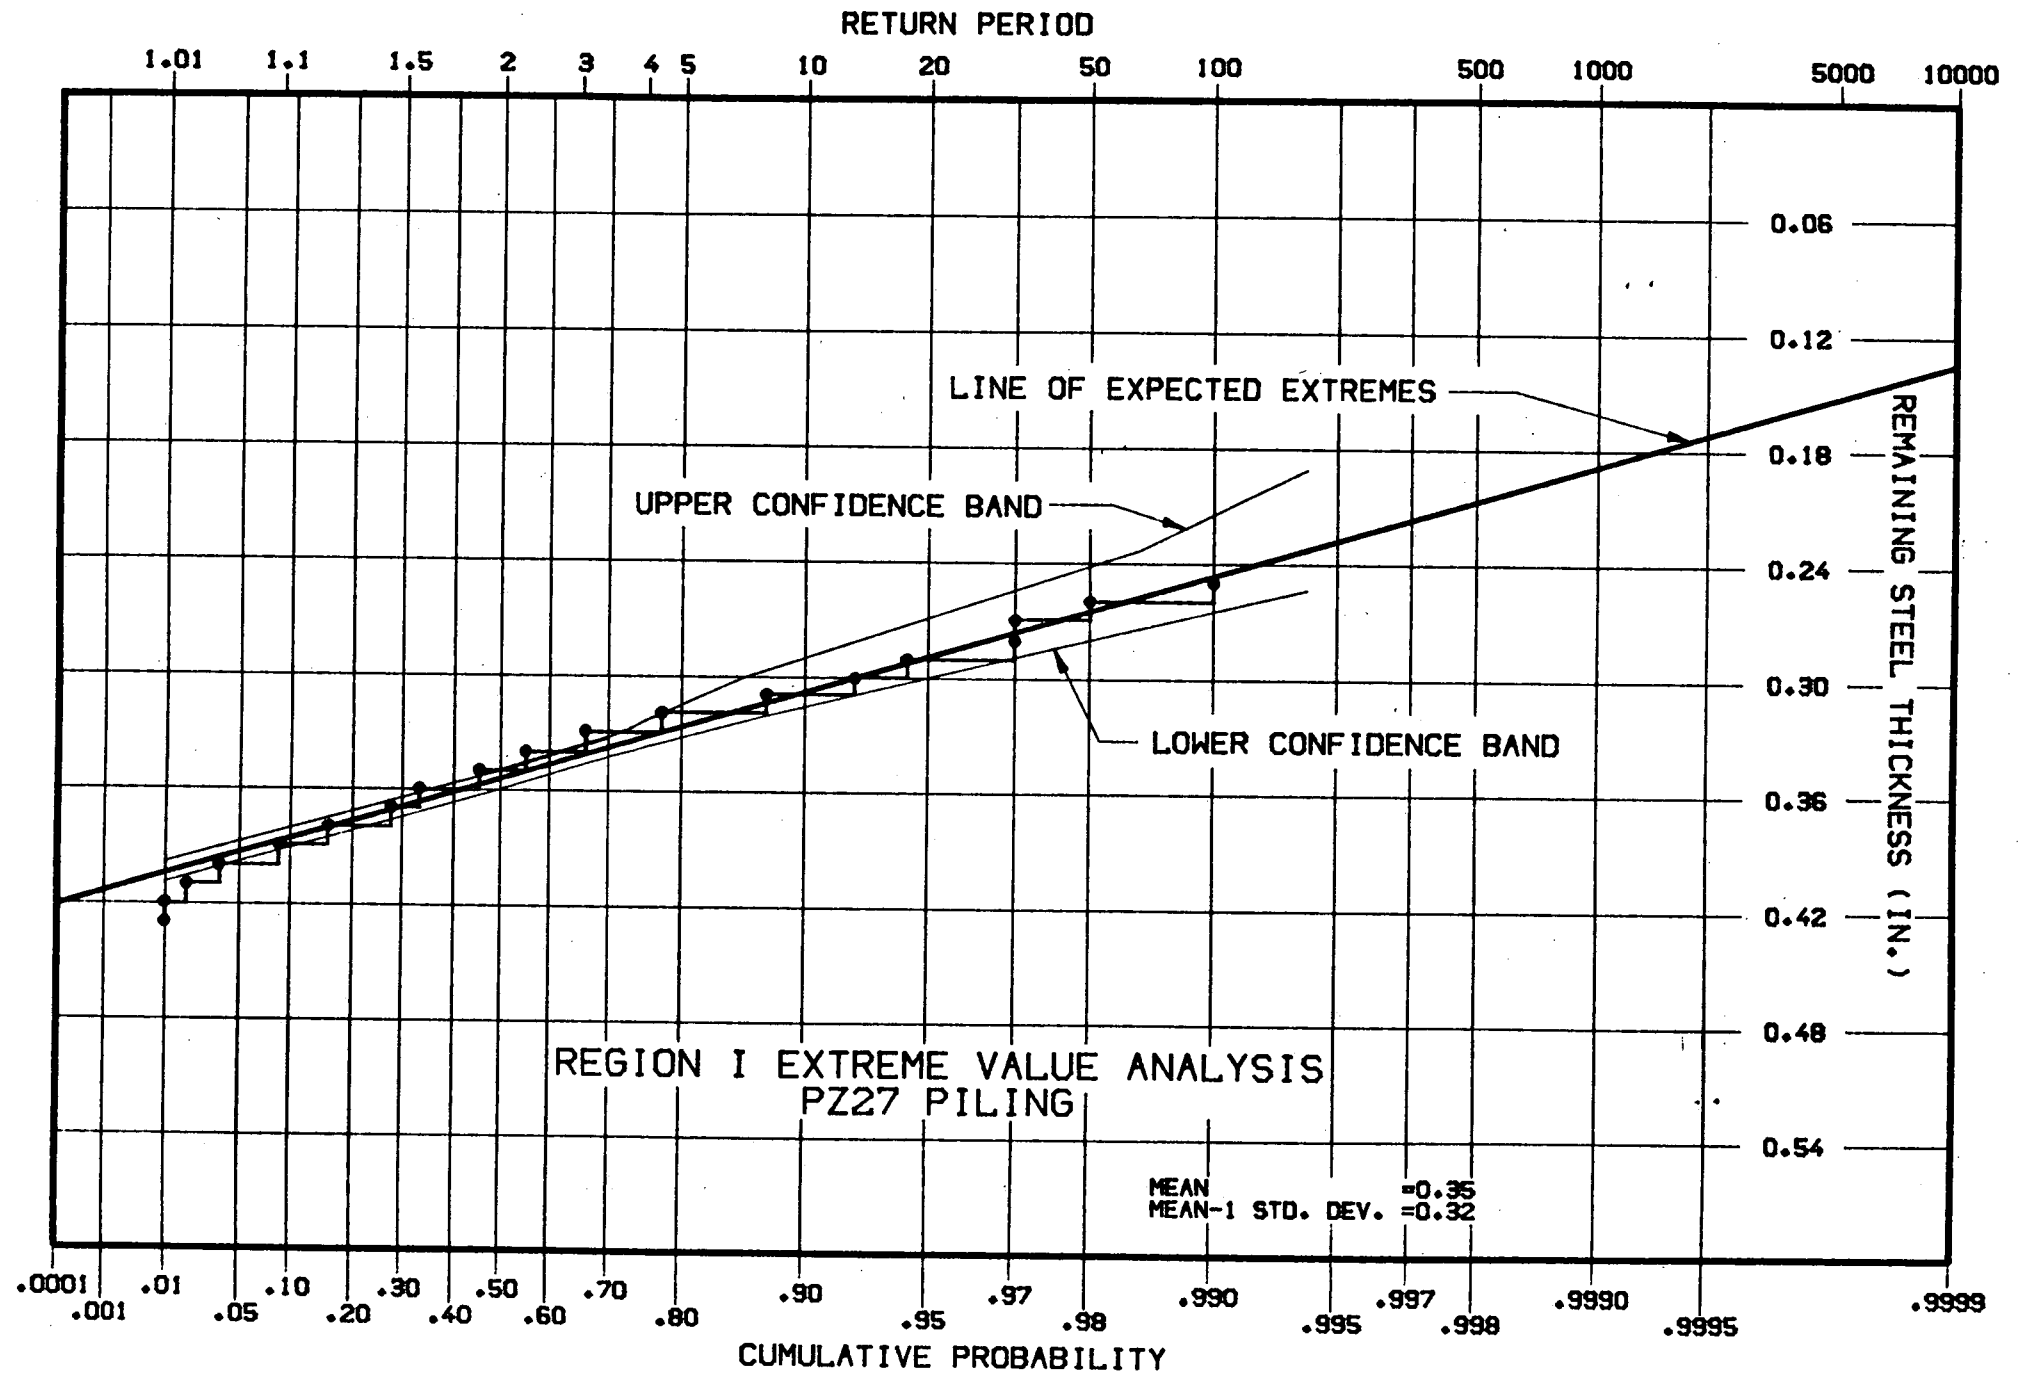
FIGURE 5 - EXTREME VALUE GRAPH

The corrosion effects in Region I were relatively free of any pitting damage. Therefore, the extreme values evaluated in each of the inspection grids were the ultrasonic thickness measurements of the steel thickness. These extreme values were statistically analyzed as discussed above and the results for the PZ27 piles are shown on Figure 5. The mean value for this Region is 0.35 inches. The mean minus one standard deviation is 0.32 inches.

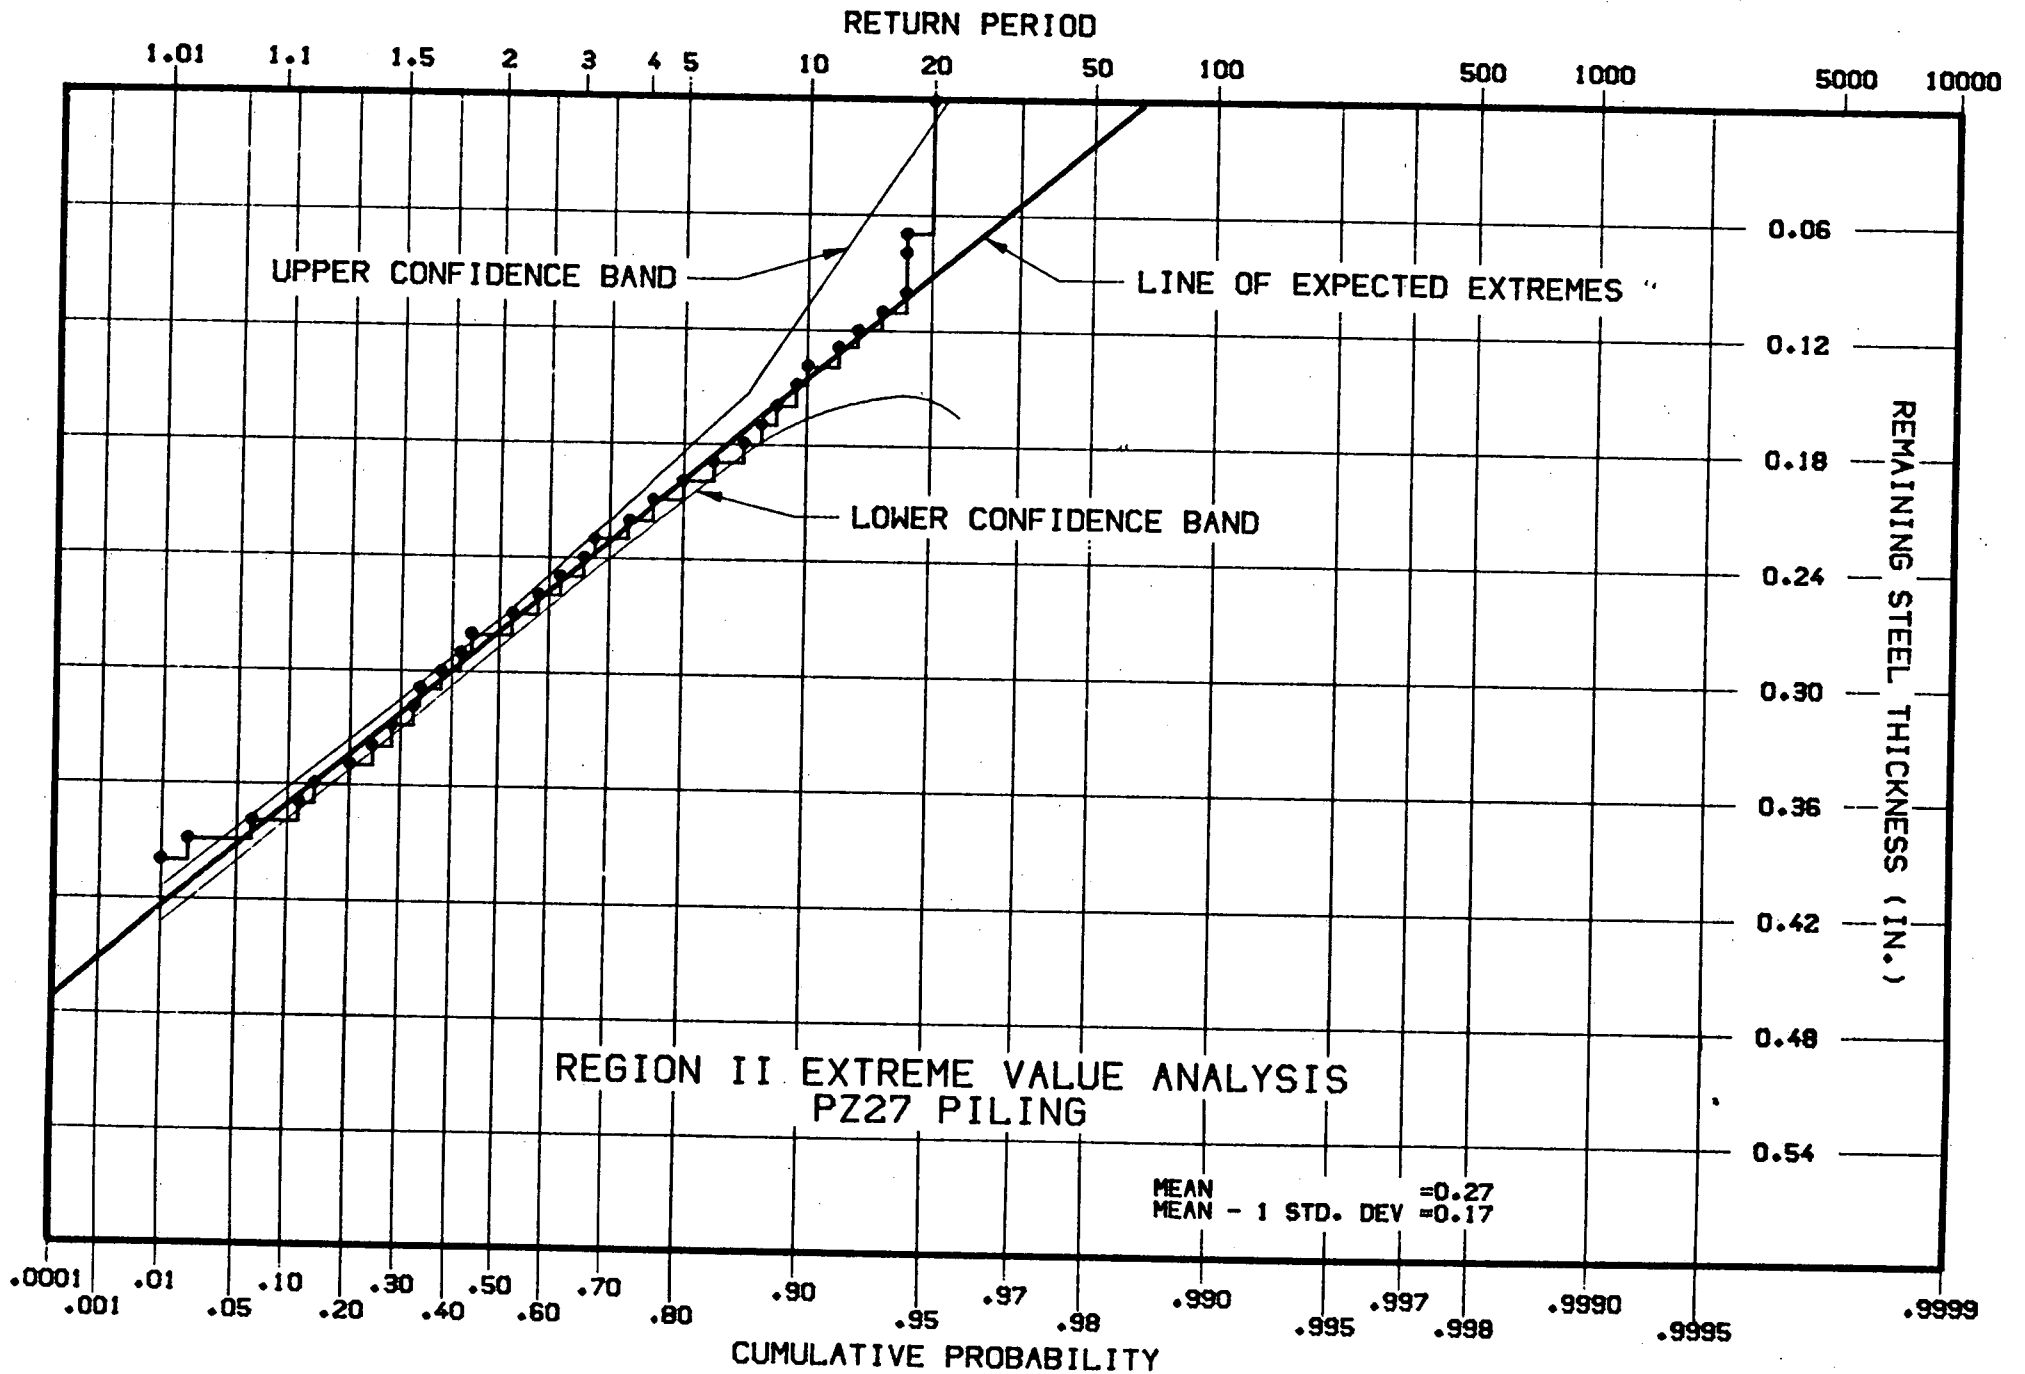
FIGURE 6 - EXTREME VALUE GRAPH

The corrosion effects in Region II is different than in Regions I and III because of the large occurrence of pitting. It is important to evaluate the effects of pitting since pitting can reduce the strength of the sheet piles. Thus, the extreme values evaluated in each of the inspection grids were the lesser of either the nominal steel thickness measurements or the minimum steel thickness measured in any pit. The results of the statistical analysis for Region II are shown on Figure 6. The mean value for this Region is 0.27 inches. The mean minus one standard deviation is 0.17 inches.

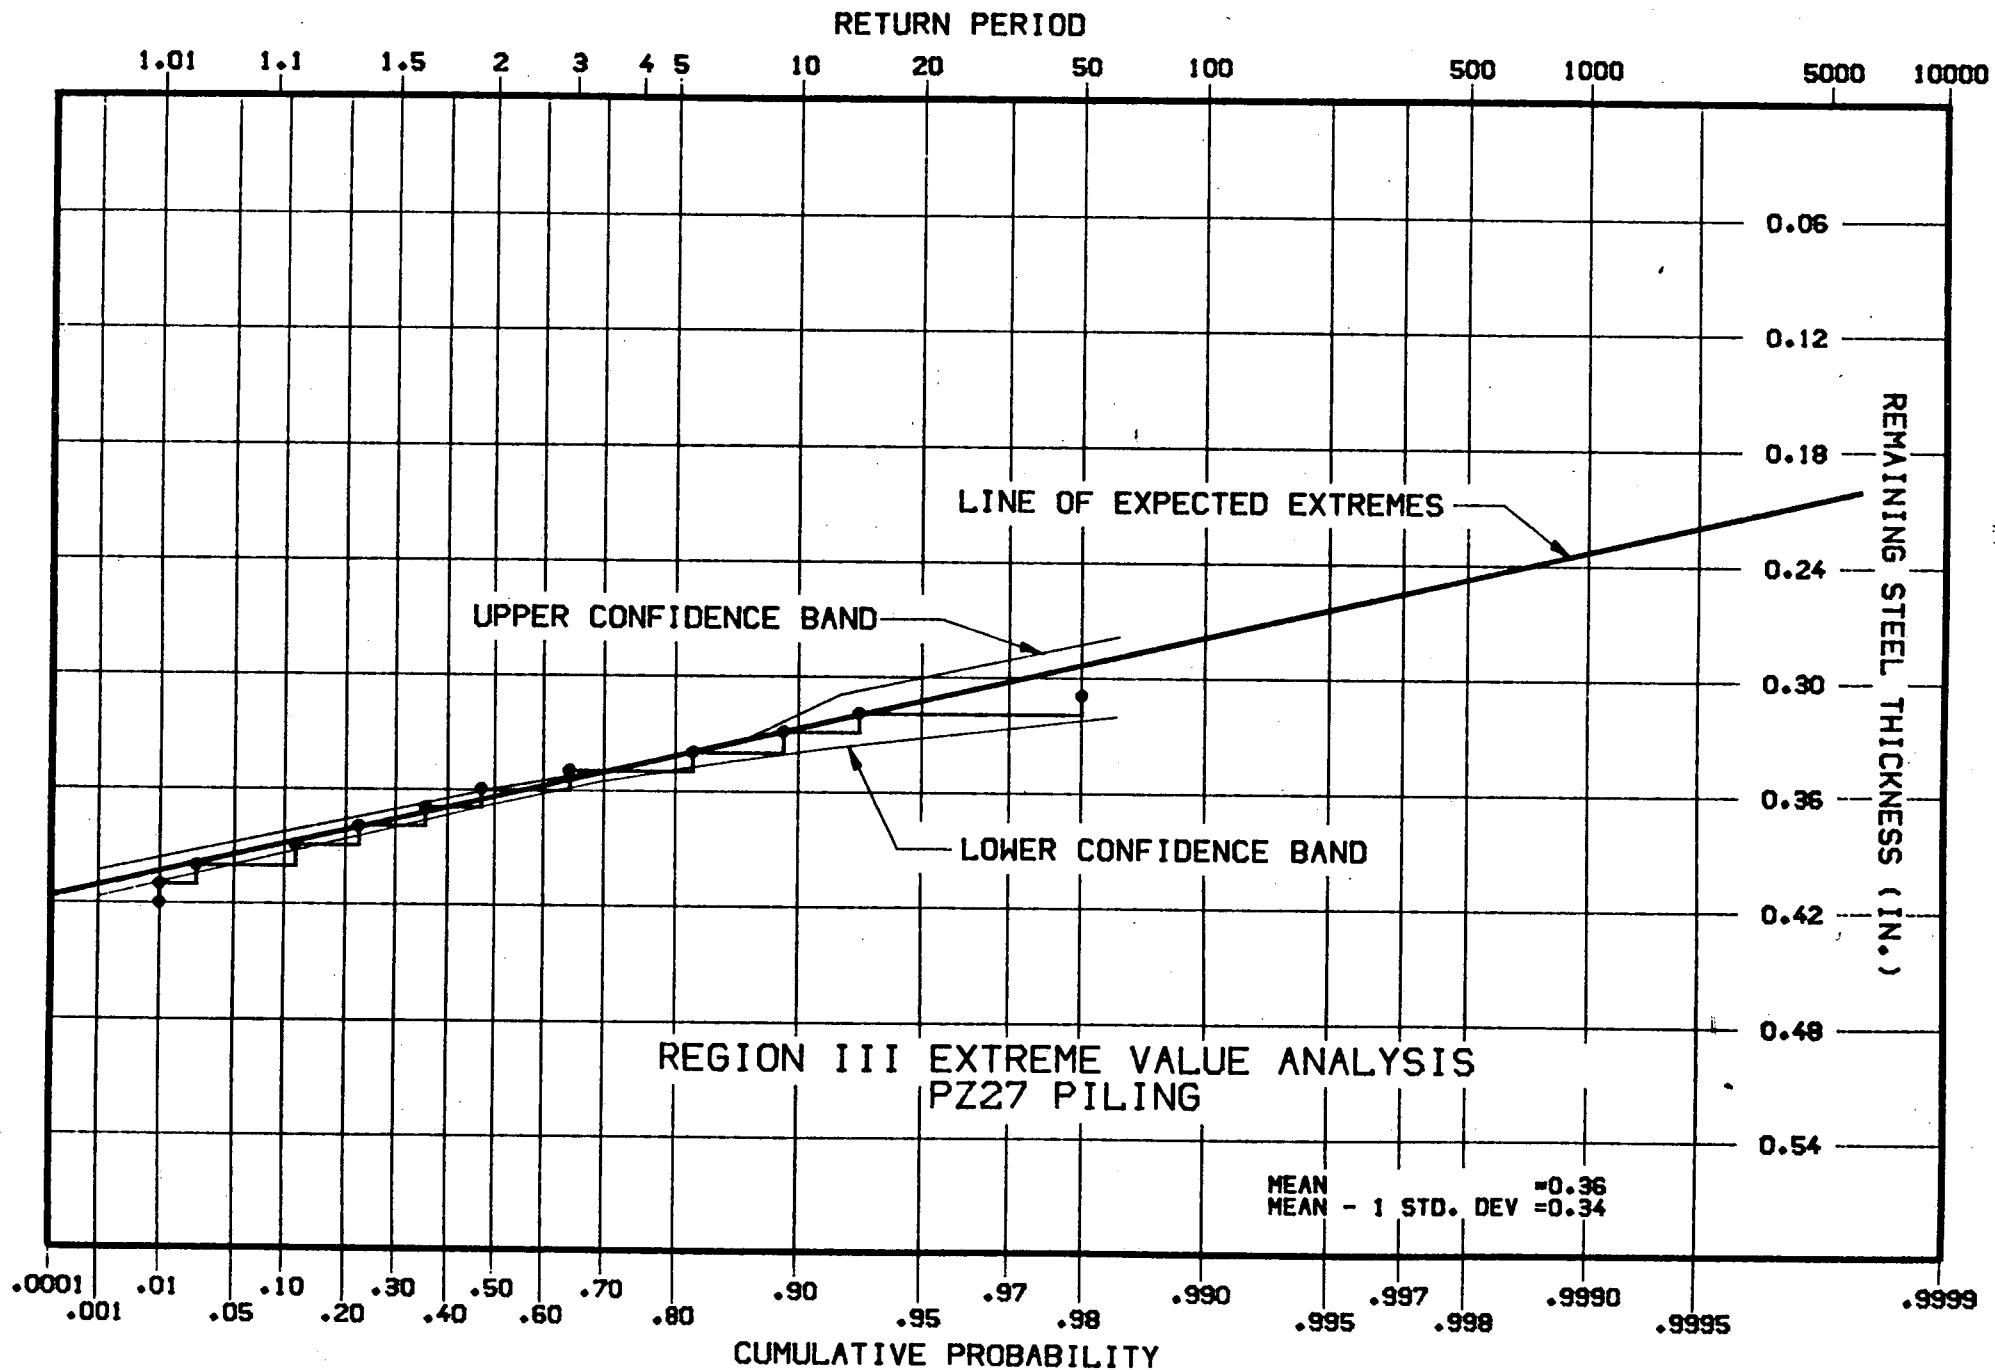
FIGURE 7 - EXTREME VALUE GRAPH

In each of the statistical analyses of the seawall, most of the plotted points fell within the control curves and, therefore, the data agrees with extreme probability theory. This shows that if the remainder of the seawall were examined, the corrosion characteristics can be expected to be highly similar to those identified in the sample pits. This indicates that the seawall can be adequately analyzed with the amount of inspection data obtained.

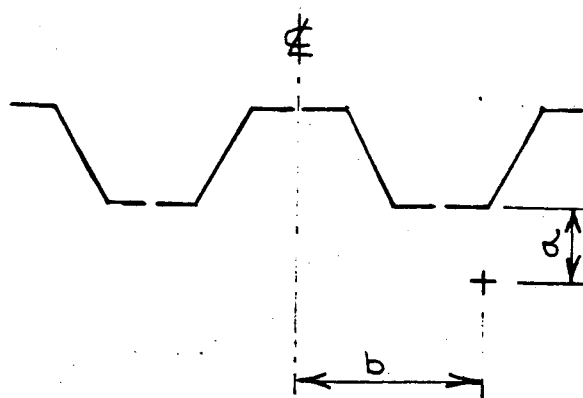
LOCATION OF SOIL SAMPLES

Sample C Elevation 5 ft. Pit No. 3, and Sample C Elevation 4 ft. Pit No. 1 taken near the wall on the plant side can be considered corrosive or moderately corrosive. These samples were taken at an elevation that is normally below the water table which would greatly restrict the availability of oxygen and thereby limit the progress of any corrosion reaction. Sample C, Elevation 11 ft. 6 in. Pit No. 4, which is corrosive, was removed from the sea side of the wall in an area where the wall is protected by a heavy cover of gunite.

In the area of the wall displaying the greatest corrosion (Grade to + 8 ft.) only one sample is considered to be moderately corrosive (test pit 3 sample D). All others are classed as mildly corrosive.

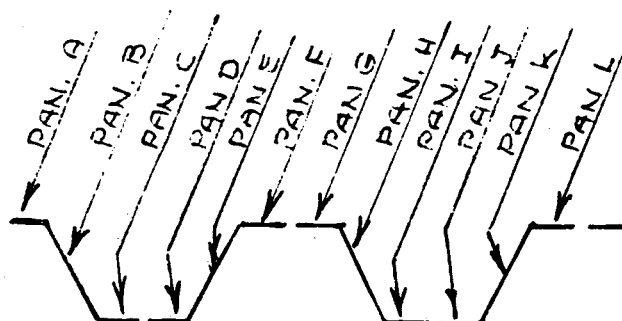
LOCATION OF SPECIMENS
CORED FROM SEA WALL

A total of ten coupon samples were extracted from the steel wall. These samples were numbered based on their test pit and field location. Five coupons displaying the most severe corrosion were submitted to a laboratory for test. These coupon samples designated as TP1-E13, TP2-H13, TP3-E12, TP4-E10.5, and TP5-E12.5 were extracted as shown in Table 3.

The nominal corrosion rates of coupons TP1-E13, TP4-E10.5, and TP5-E12.5 were not calculated since the average measured thickness of the coupon was about 0.38" (after cleaning and stripping off the corrosion products), which is equal to or larger than the reported original nominal thickness of 0.375".
