UPDATE REPORT ON IE BULLETIN 79-17

INSPECTIONS OF STAINLESS STEEL SAFETY RELATED  
PIPING CONTAINING STAGNANT, OXYGENATED,  
BORATED WATER

SAN ONOFRE NUCLEAR GENERATING STATION  
UNIT 1

October 5, 1979

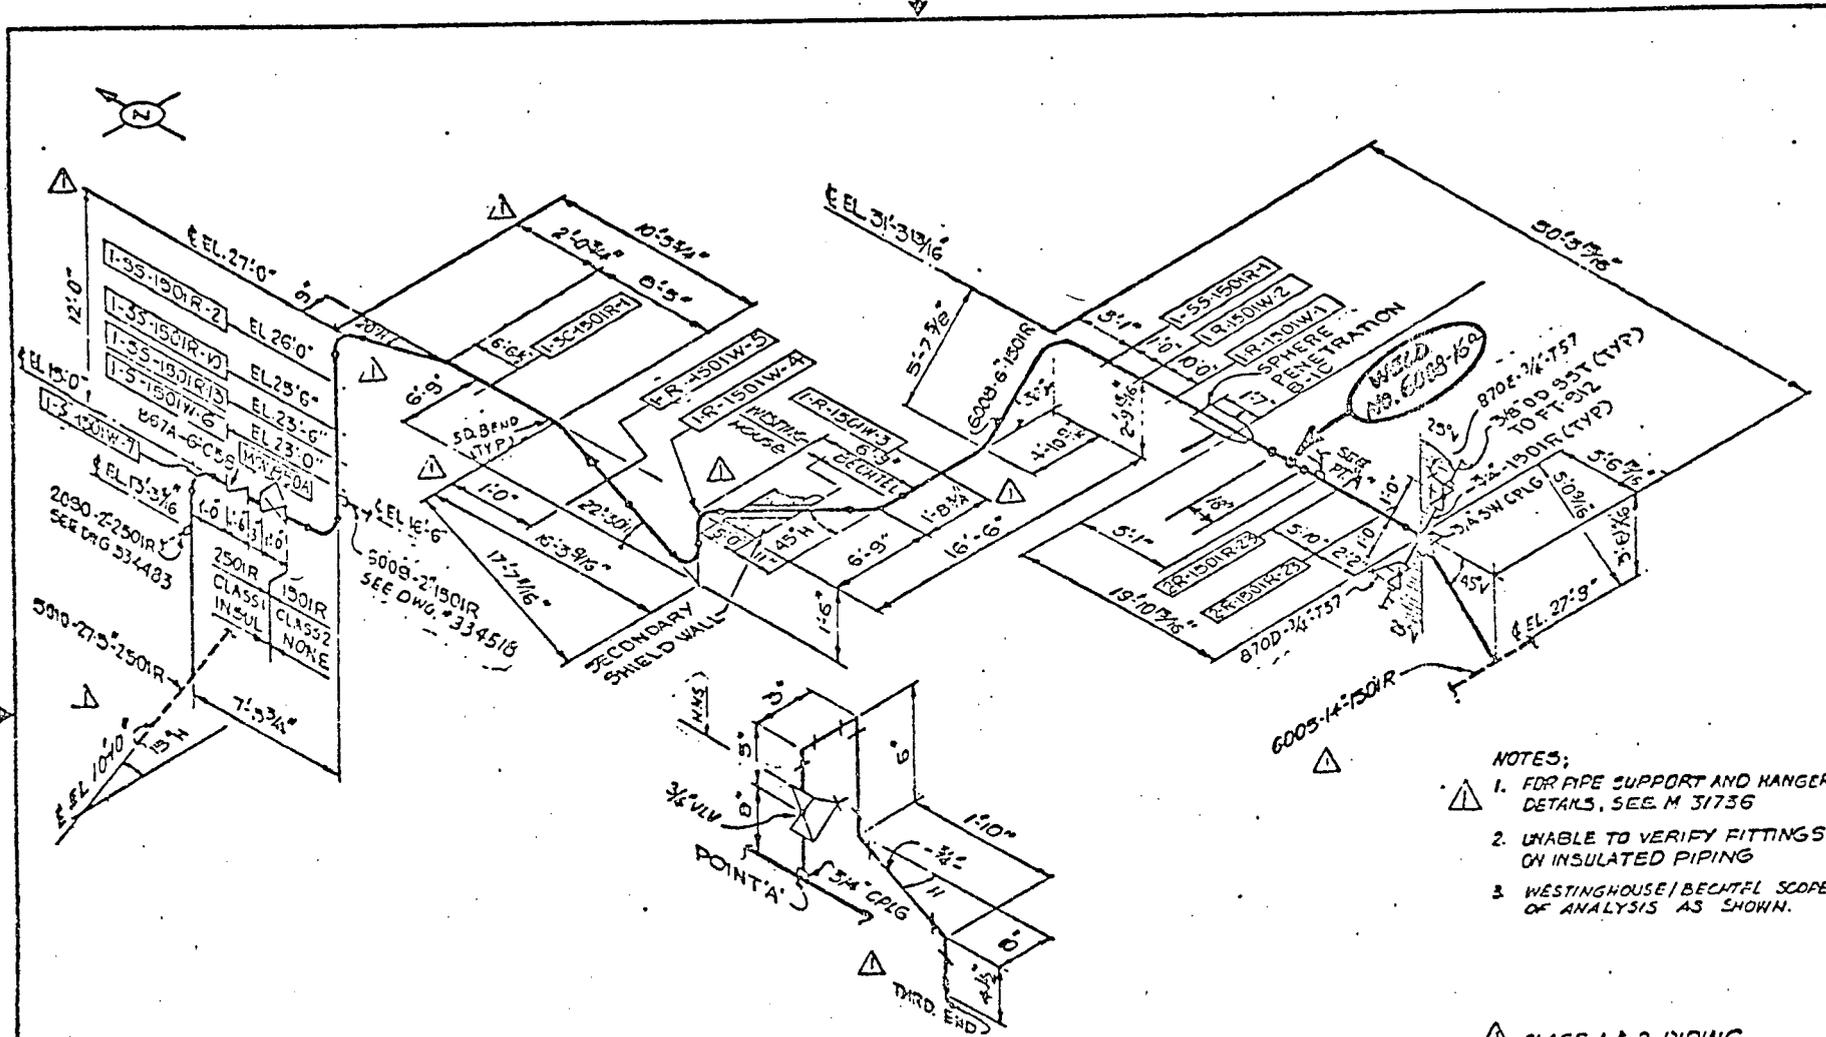
▲ 334583-2

An indication in Weld No. 6008-16a of Line No. 6008-6"-1501R was detected by ultrasonic methods on September 15, 1979. When radiographic examination produced inconclusive results, the decision was made to remove and replace the section in question.

An 18" section containing Weld No. 6008-16a was cut from the line and a replacement piece welded in. (Reference attached Dwg No. 334583 for weld locations.) The replacement piece was SA-312, type 316, schedule 80 pipe.

Repair, visual inspection and in-service leak testing was in accordance with the requirements of ANSI-B.31.1-1977. The hot pass of each new weld was dye penetrant inspected and the completed welds were radiographed.
