SAN ONOFRE NUCLEAR GENERATING STATION

Subject: Docket No. 50-206
30-Day Report
Licensee Event Report No. 89-030
San Onofre Nuclear Generating Station, Unit 1

Facility Name (1) SAN ONOFRE NUCLEAR GENERATING STATION, UNIT 1						Docket Number (2) 0 5 0 0 0 2 0 6				Page (3) 1 of 0 9		
Title (4) POTENTIAL DIVERSION OF EMERGENCY CORE COOLING SYSTEM RECIRCULATION FLOW THROUGH A SPRING-LOADED CHECK VALVE

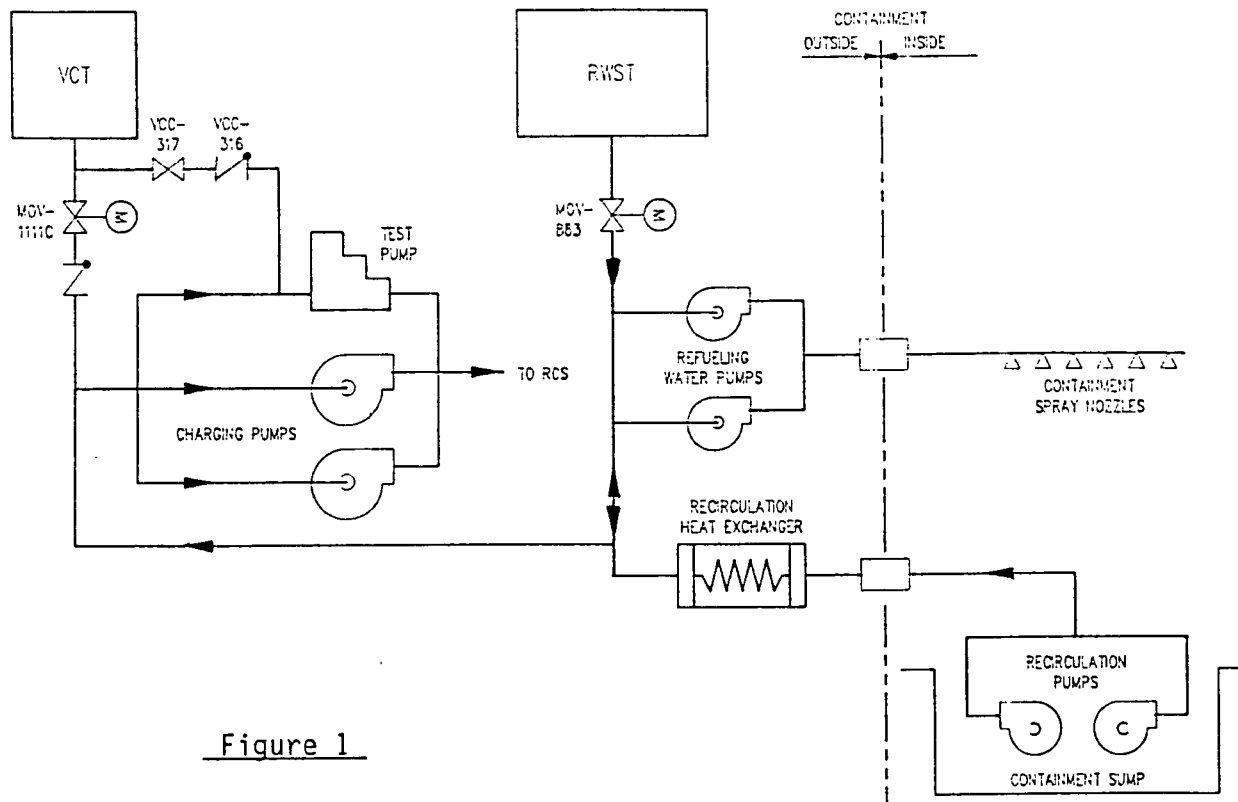
Figure 1

Spring-Loaded Check Valve (VCC-316) (See Figure 1):

A 1/2 inch line connecting the Test Pump (TP) suction line to the VCT upstream of the VCT outlet valve was installed during original plant construction to function as a thermal relief for the test pump suction piping if the test pump was operated with its discharge valve shut. The TP discharge relief valve originally relieved to the TP suction line. In 1983, the discharge of the TP discharge relief valve was rerouted to the Seal Water Heat Exchanger (SWHE) [HX] inlet line, which is cooled by Component Cooling Water (CCW) [CC]. Therefore, the thermal relief line is no longer necessary.

A spring loaded check valve (VCC-316) on the thermal relief line is designed to preclude the diversion of water from the test pump suction line to the VCT during the recirculation phase of SI. The check valve is set to open at a differential pressure of 75 pounds per square inch (psid) across the valve, which is greater than the calculated differential pressure between the suction line and the VCT.

On December 28, 1989, at 1040, it was determined that previous evaluations of post-LOCA recirculation flow from the containment sump to the reactor core incorrectly credited continued post-accident pressurization of the non-seismically qualified VCT to prevent diversion of recirculation fluid through the 1/2 inch TP thermal relief line. The flow diversion would be expected to occur during certain postulated LOCA scenarios (see Safety Significance, Section F) when the differential pressure across the spring loaded check valve exceeds the spring loading (75 psid). This flow diversion, if not discovered and corrected, could lead to a condition where containment sump inventory was insufficient to maintain continued recirculation flow.

Previous evaluations of recirculation flow after a LOCA, incorrectly credited continued post-accident pressurization of the VCT in order to prevent diversion of the recirculation flow through the spring loaded check valve.

Immediate action was taken to preclude this flow diversion by closing a manual isolation valve (VCC-317) on the TP thermal relief line.

To preclude any flow diversion to the VCT through this line, an isolation valve downstream of VCC-316 was closed and is being administratively controlled in the closed position. The closure of this valve prevents any diversion of recirculation flow to the VCT via the spring loaded check valve.

- a. An engineering evaluation will be performed to determine if the spring loaded check valve will be removed or modified.
- b. As described in the above root cause discussion, the principle conclusions and recommendations are identified in SCE's October 3, 1988 submittal to the NRC. Corrective actions are being implemented to address these conclusions which include: (1) a re-organization with responsibility for design functions and the design basis focused in one department, (2) augmentation of in-house engineering resources and performance of the majority of conceptual engineering in-house, and (3) the establishment of a design basis documentation (DBD) program to recapture and maintain the design basis.
