Subject: Docket No. 50-206
30-Day Report
Licensee Event Report No. 90-011
San Onofre Nuclear Generating Station, Unit 1

LICENSEE EVENT REPORT (LER) TEXT CONTINUATION

Plant: San Onofre Nuclear Generating Station
Unit: One
Reactor Vendor: Westinghouse
Event Date: May 15, 1990
Time: 0243

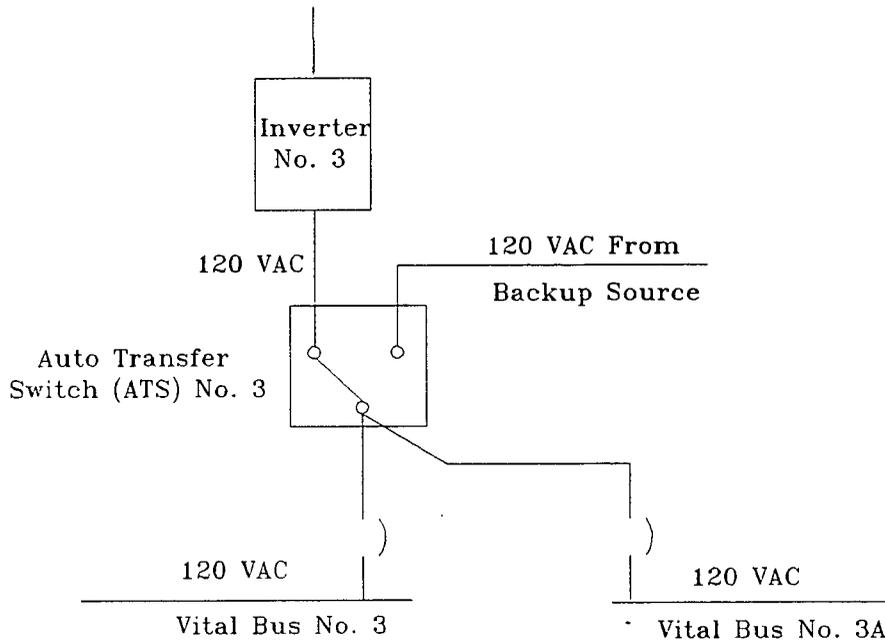
Figure - Power Supply for Vital Busses 3 and 3A

Vital Bus 3 provides power to various instrumentation and controls including the circuitry for the SG C high level trip of the FCVs. Vital Bus 3A provides power to other circuits including Train A of the AFW system.

The ATS 3 transfer and the subsequent SG C main feedwater control valve closure was initiated by an inadvertent short to ground of a valve control cable for AFW pump G-10. The short to ground occurred while connecting a control cable in a valve conduit box while the circuit was energized. When the short circuit reduced the voltage on the vital bus below the auto-transfer set point, ATS 3 transferred 120 VAC buses 3 and 3A from their normal power source (Inverter 3) to their backup source.

The ATS break-before-make transfer briefly de-energized the SG C high level FCV closure channel bistable and actuation relay. When vital buses 3 and 3A were re-energized on the backup power source, the SG C high level FCV closure actuation relay re-energized before the bistable trip condition cleared thus initiating closure of the FCV for SG C. The SG high level condition immediately cleared, but the seal-in design feature of the feedwater controls on SG high level blocked automatic re-opening of the SG C main feedwater control valve and the valve closed. With the FCV closed, the rate at which the SG level dropped was such that there was little time for operators to assume manual control and re-establish flow to the SG before procedures require manual action to trip the reactor.

- a. Two of the three ATSs were tested after this event. These tests revealed that transfer occurred in about 110 to 120 milli-seconds on power loss and about 200 to 230 milli-seconds for a simulated brief short circuit. A relay/bistable race occurred in all cases. The transfer time characteristics of the ATSs were found to be in accordance with their design; the observed variations were due to: 1) the condition of the individual ATS, 2) the phase relationship of the inverter and the backup power source at the time of transfer, and 3) most significantly the voltage at the time of the transfer. The tests also demonstrated that with the high SG level closure of the FCVs disabled, no other unacceptable interactions were identified. The remaining ATS had been tested with the reactor at power with no adverse interaction.

- a. SCE is reviewing the design of the SG high level trip of feedwater control valves and their power supplies in order to determine corrective actions which would close the SG FCVs on a high SG level and which will not be susceptible to spurious actuation. It is anticipated that these corrective actions will be identified and a schedule for implementation developed by December 1990.
- b. As discussed in Section D.1, a HPES investigation of the events which led up to the short circuit is continuing. Any appropriate corrective actions resulting from this investigation will be implemented.
