LICENSEE EVENT REPORT (LER)																									
Facility Name (1) SAN ONOFRE NUCLEAR GENERATING STATION, UNIT 1										Docket Number (2) 0 5 0 0 0 2 0 6				Page (3) 1 of 1											
Title (4) UNIT 1 CV-305 AND FCV-1112 SINGLE FAILURE DEFICIENCY WITH HOT LEG RECIRCULATION																									
EVENT DATE (5)			LER NUMBER (6)				REPORT DATE (7)			OTHER FACILITIES INVOLVED (8)															
Month	Day	Year	Year	///	Sequential Number	///	Revision Number	Month	Day	Year	Facility Names		Docket Number(s)												
1	0	1	2	8	19	8	19	---	0	2	5	---	0	0	1	1	1	3	8	9	NONE		0 5 0 0 0		
OPERATING MODE (9) 1			THIS REPORT IS SUBMITTED PURSUANT TO THE REQUIREMENTS OF 10CFR (Check one or more of the following) (11)																						
POWER LEVEL (10) 0 9 0 ////////////////////			<input type="checkbox"/> 20.402(b)				<input type="checkbox"/> 20.405(c)				<input type="checkbox"/> 50.73(a)(2)(iv)				<input type="checkbox"/> 73.71(b)

SAN ONOFRE NUCLEAR GENERATION STATION	DOCKET NUMBER	LER NUMBER	PAGE
UNIT 1	05000206	89-025-00	2 OF 11

Plant: San Onofre Nuclear Generating Station
Unit: One
Reactor Vendor: Westinghouse
Event Date: 10-12-89
Time: Approximately 1445

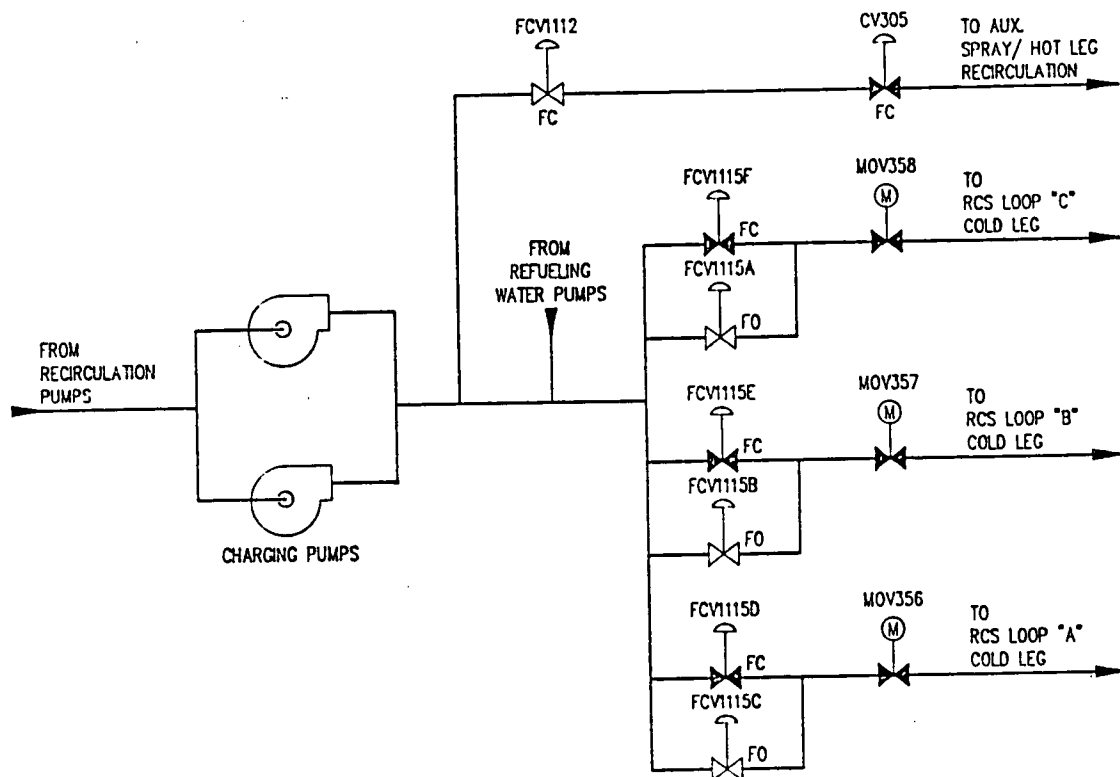
FIGURE 1

CLR flow is from the containment sump by means of either of two containment recirculation pumps and a recirculation heat exchanger to the suction of the charging pumps. The charging pumps then provide this flow to the RCS cold legs (loops A, B, or C) via three cold leg flow control valves (FCVs) (FCV-1115D, E, and F). The FCVs are pneumatically operated by either instrument air or Backup Nitrogen System (BNS) [LE]. These valves are used to regulate the flow into their respective cold legs (see figure 1).

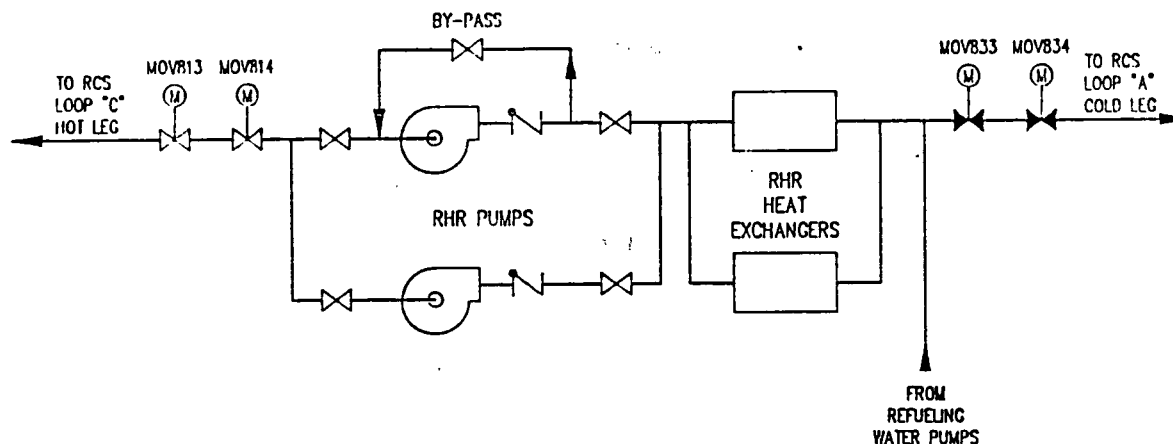
FIGURE 2

The primary HLR flow path is susceptible to a single active failure because there are points where flow passes through a single valve. To protect against the consequences of such a single active failure, an alternate HLR flow path is provided. Recirculated coolant from the discharge of the refueling water pumps enters the Residual Heat Removal (RHR) heat exchanger outlet. Coolant then flows in the reverse direction through the RHR heat exchangers, through a bypass line around the east RHR pump, and into the loop "C" hot leg (see figure 2).

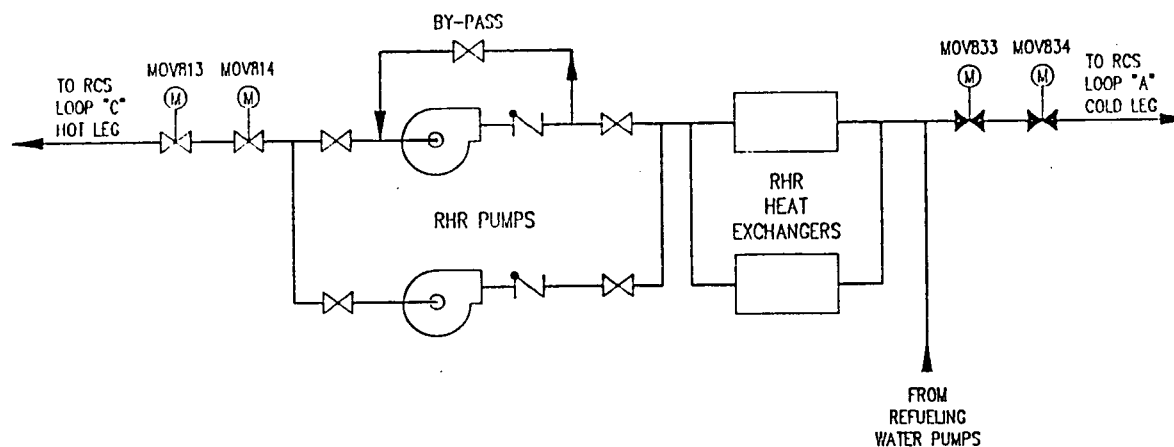
FIGURE 2

The primary HLR flow path is susceptible to a single active failure because there are points where flow passes through a single valve. To protect against the consequences of such a single active failure, an alternate HLR flow path is provided. Recirculated coolant from the discharge of the refueling water pumps enters the Residual Heat Removal (RHR) heat exchanger outlet. Coolant then flows in the reverse direction through the RHR heat exchangers, through a bypass line around the east RHR pump, and into the loop "C" hot leg (see figure 2).
