| LICENSEE EVENT REPORT (LER) | | | | | | | | | | | | | | | | | |
|--|---|---|--|---|---|---|---|---|---|--|---|---|---|---|---|--|--|
| SAN ONOFRE NUCLEAR GENERATING STATION, UNIT 1 | | | | | | | | | | 0 5 0 0 0 2 0 6 | | | | 1 of 1 1 | | | |
| Title (4) Containment Spray Flow Limiter Valve Actuator Incorrectly Coupled | | | | | | | | | | | | | | | | | |

| SAN ONOFRE NUCLEAR GENERATION STATION | DOCKET NUMBER | LER NUMBER | PAGE |
|---|---|---|---|
| UNIT 1 | 05000206 | 91-001-01 | 2 of 11 |

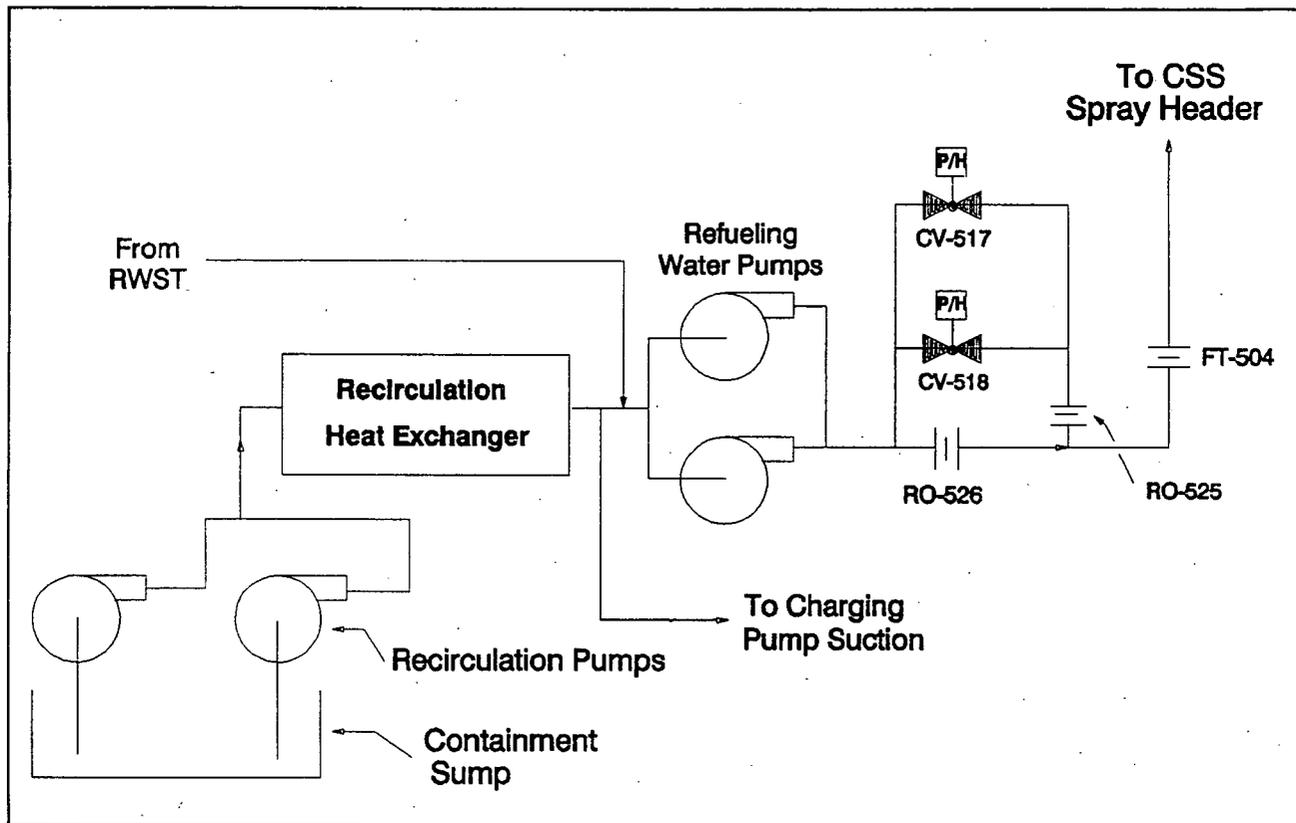
Figure 1 - Spray Flow Limiter System During Recirculation

During periods of low spray, flow rates would drop to approximately 500 gpm as the result of isolating the RO-525 flow path by closing CV-517 and CV-518.
