SAN ONOFRE NUCLEAR GENERATING STATION

Subject: Docket No. 50-206
Supplemental Report
Licensee Event Report No. 91-001, Revision 3
San Onofre Nuclear Generating Station, Unit 1

LICENSEE EVENT REPORT (LER)																																					
Facility Name (1) SAN ONOFRE NUCLEAR GENERATING STATION, UNIT 1										Docket Number (2) 0 5 0 0 0 2 0 6			Page (3) 1 of 1 5																								
Title (4) Containment Spray Flow Limiter Valve Actuator Incorrectly Coupled																																					
EVENT DATE (5)			LER NUMBER (6)				REPORT DATE (7)			OTHER FACILITIES INVOLVED (8)																											
Month	Day	Year	Year	///	Sequential Number	///	Revision Number	Month	Day	Year	Facility Names		Docket Number(s)																								
0	1	0	7	9	1	9	1	---	---	---	NONE		0 5 0 0 0																								
OPERATING MODE (9)			THIS REPORT IS SUBMITTED PURSUANT TO THE REQUIREMENTS OF 10CFR (Check one or more of the following) (11)																																		
POWER LEVEL (10)

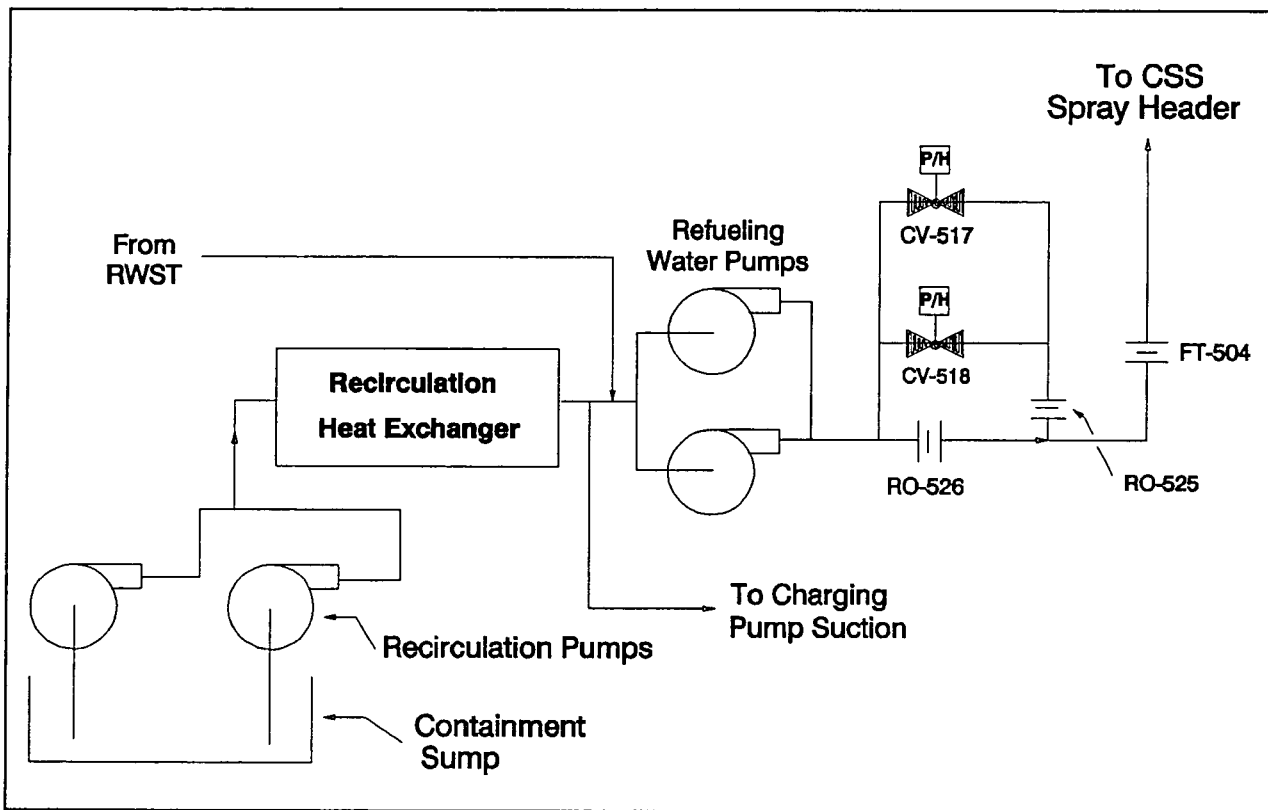
Figure 1 - Spray Flow Limiter System During Recirculation

depend on the number of RWPs running and containment backpressure. During periods of low spray, flow rates would drop to approximately 500 gpm as the result of isolating the RO-525 flow path by closing CV-517 and CV-518.
