**Steam Generator Inspection Program  
Return to Power Report  
San Onofre Nuclear Generating Station  
Unit 1  
September, 1982  
Southern California Edison Company**

**Volume I**

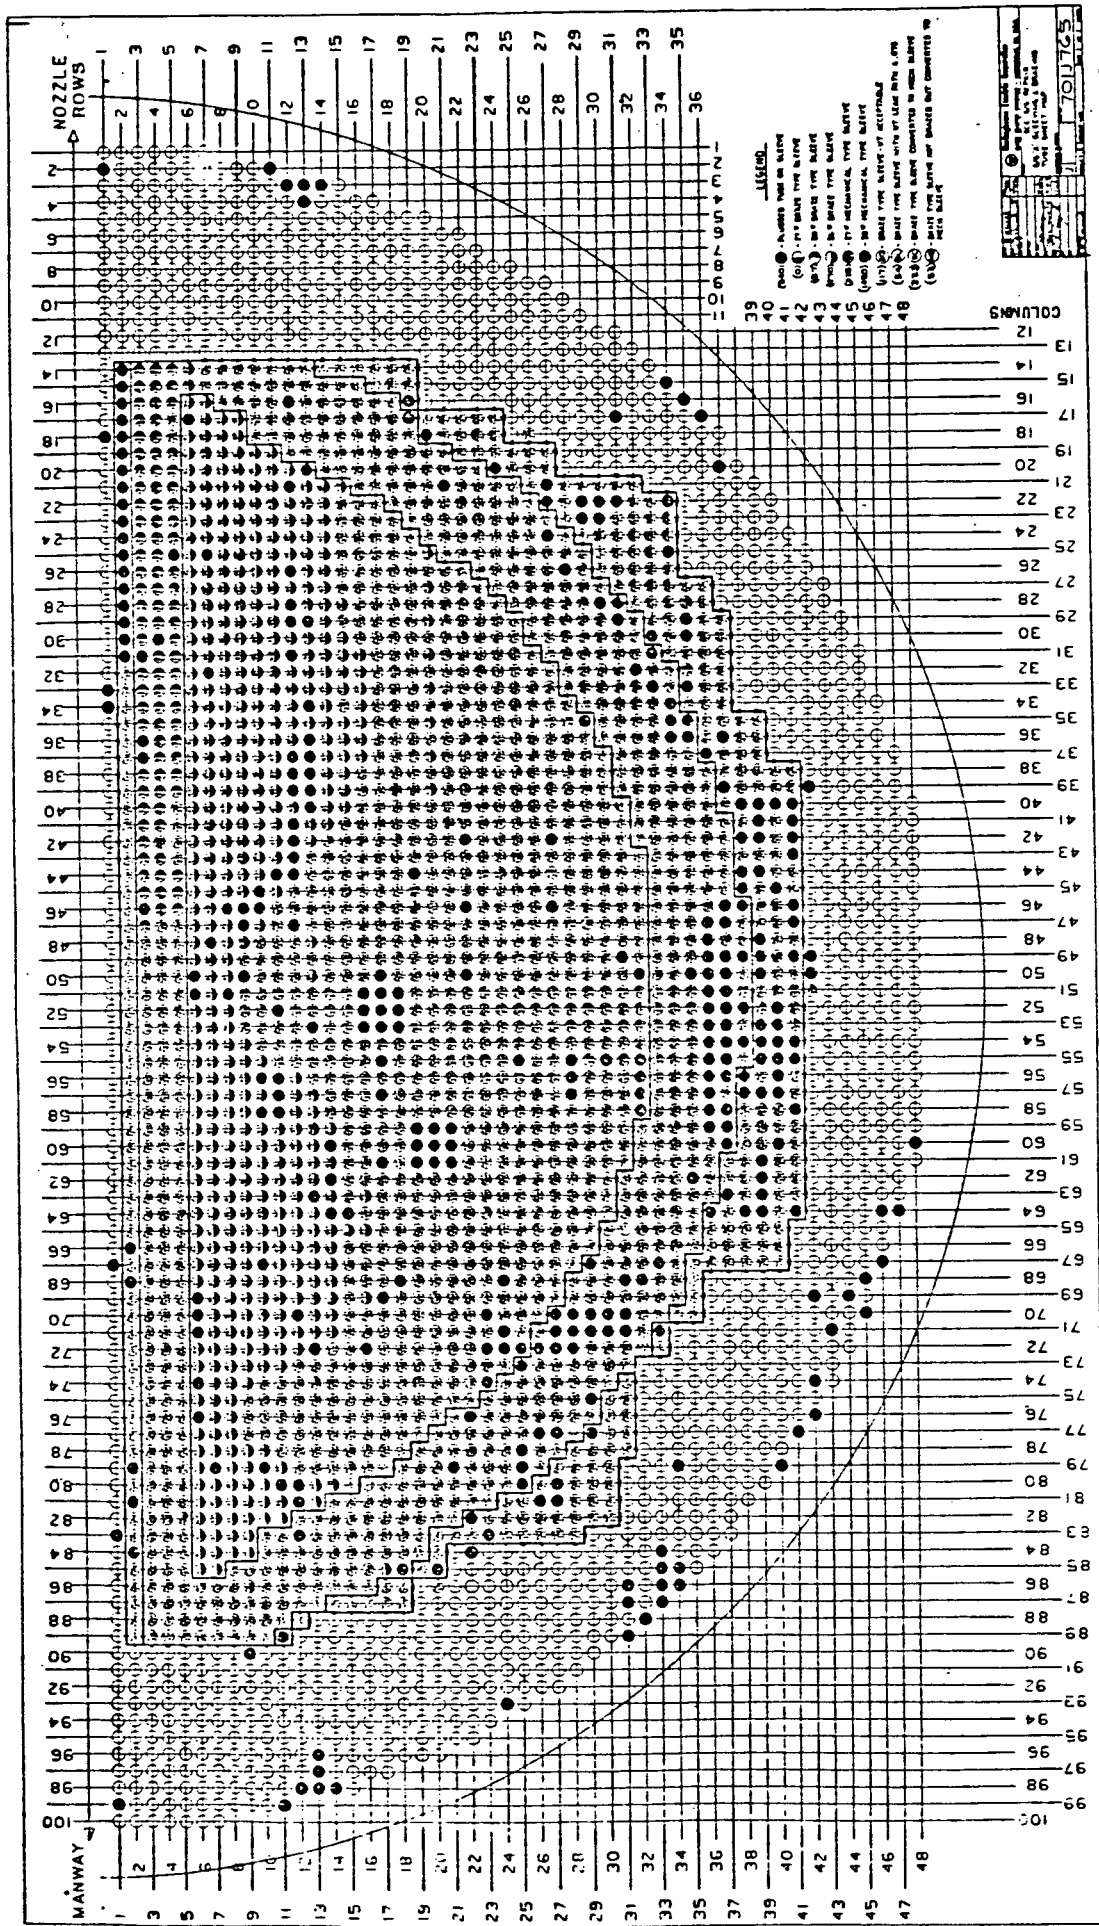
FIGURE A-1

SG-A 1981 SLEEVING REPAIR BOUNDARY

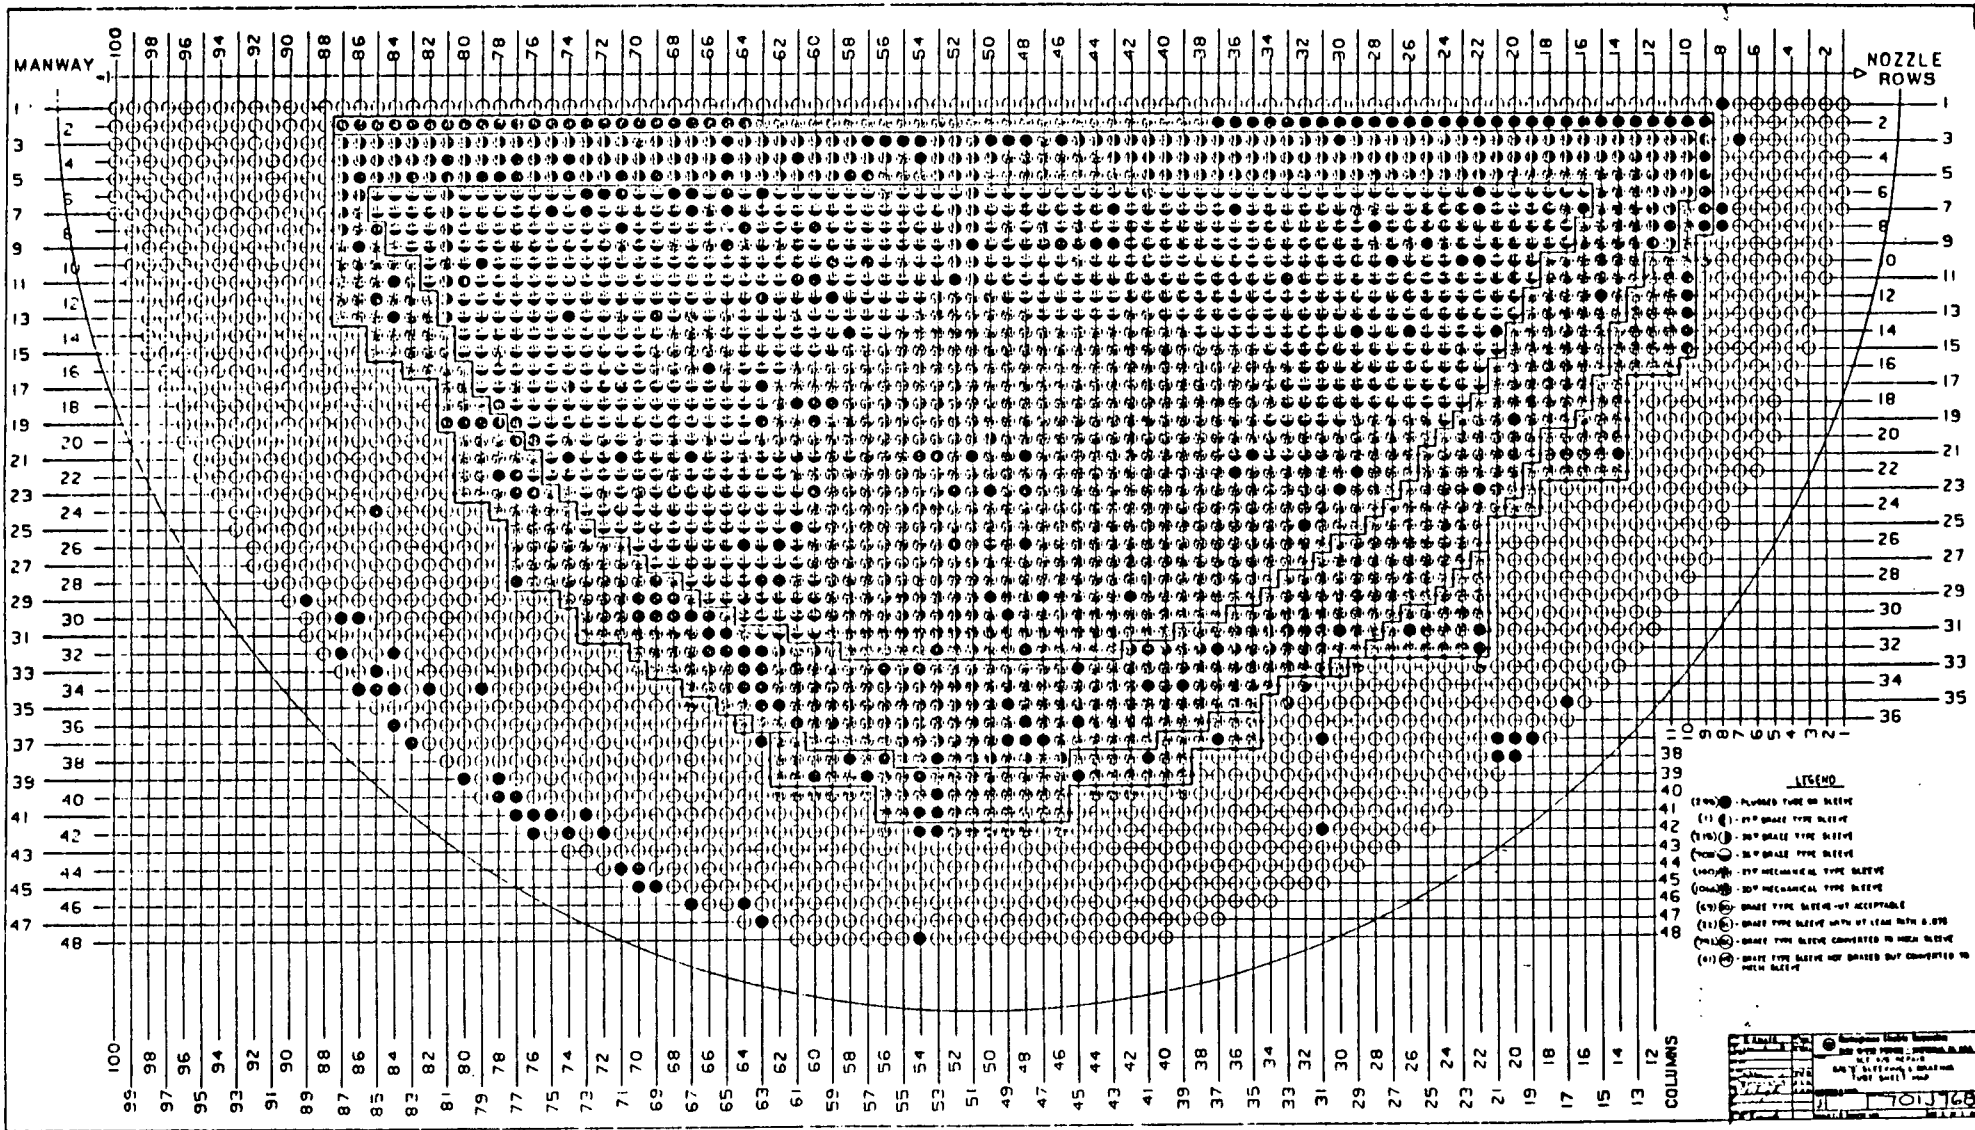
FIGURE A-2

SG-B 1981 SLEEVING REPAIR BOUNDARY

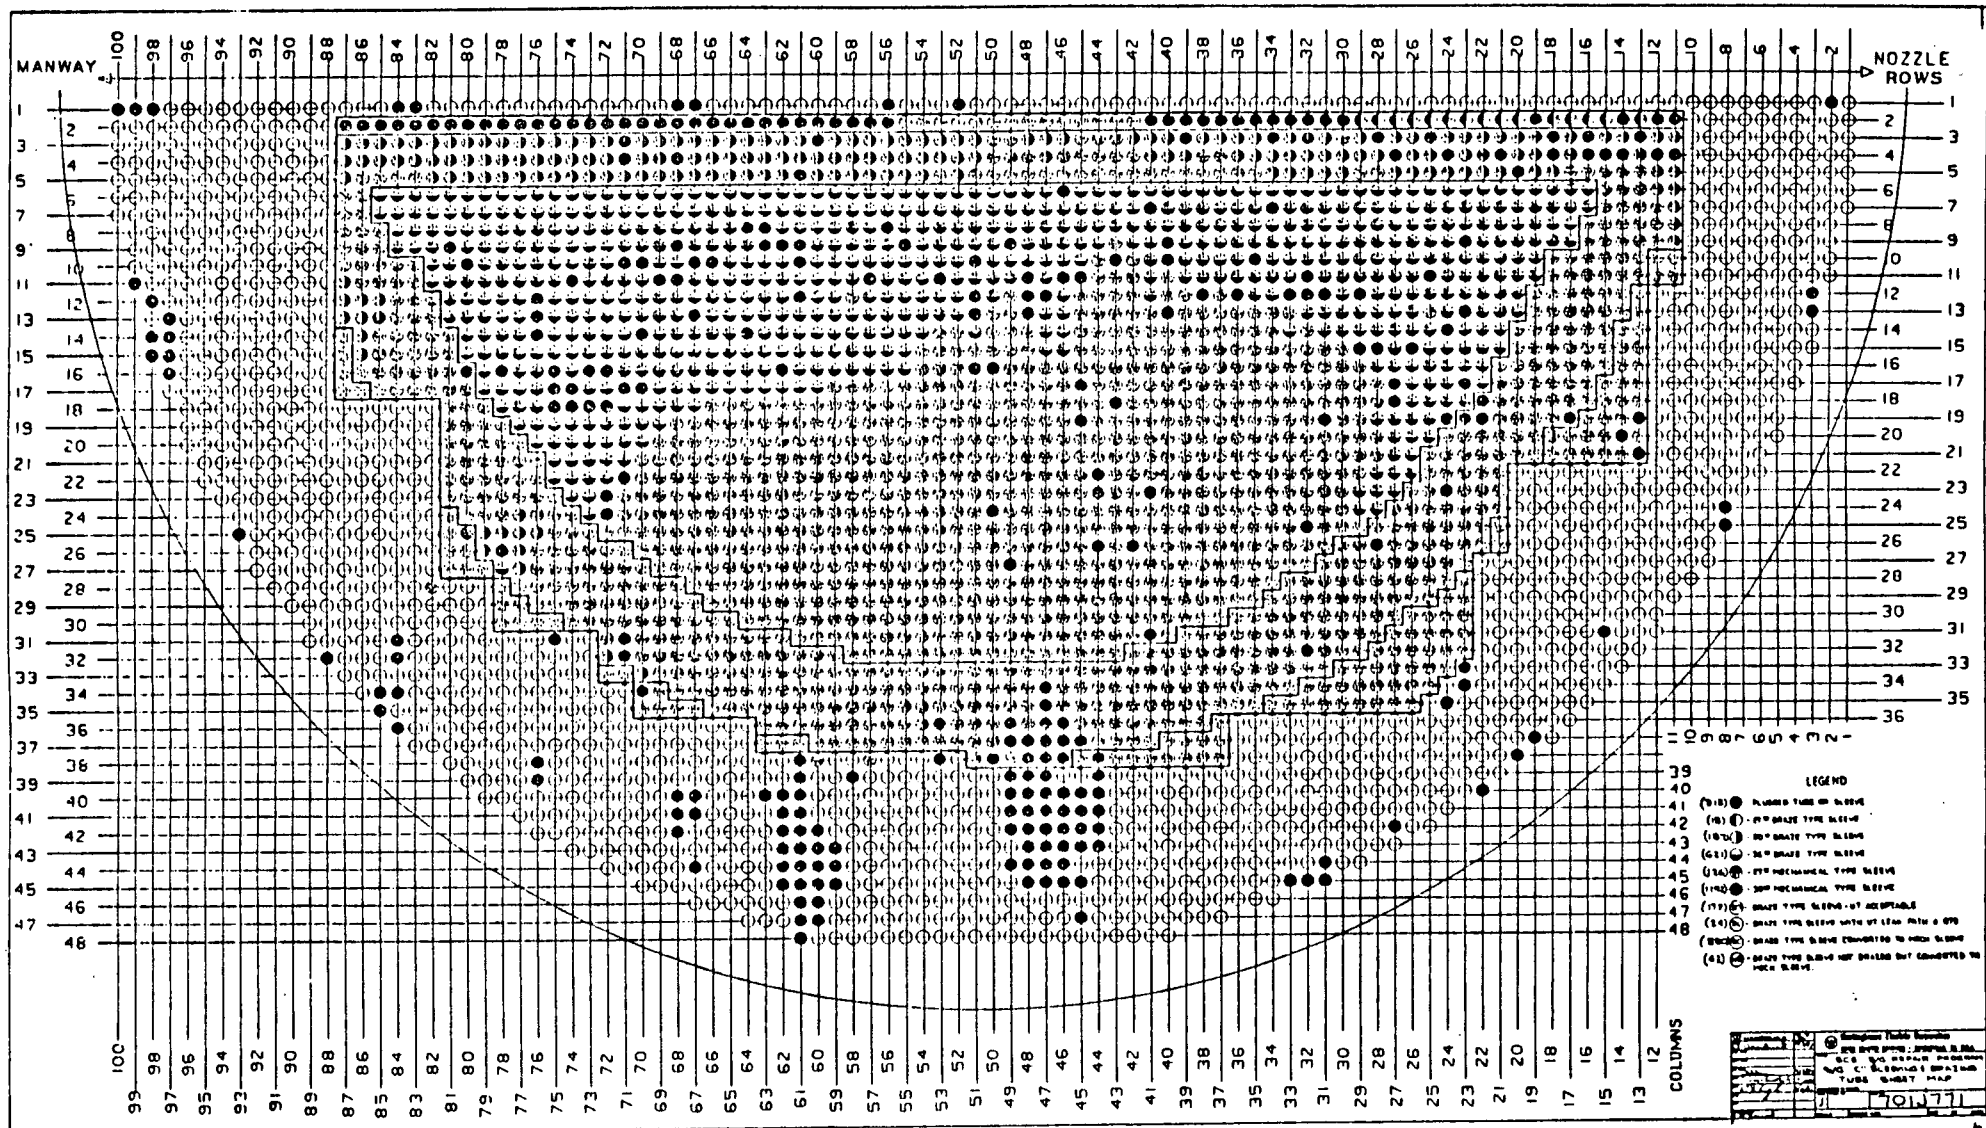
FIGURE A-3

SG-C 1981 SLEEVING REPAIR BOUNDARY

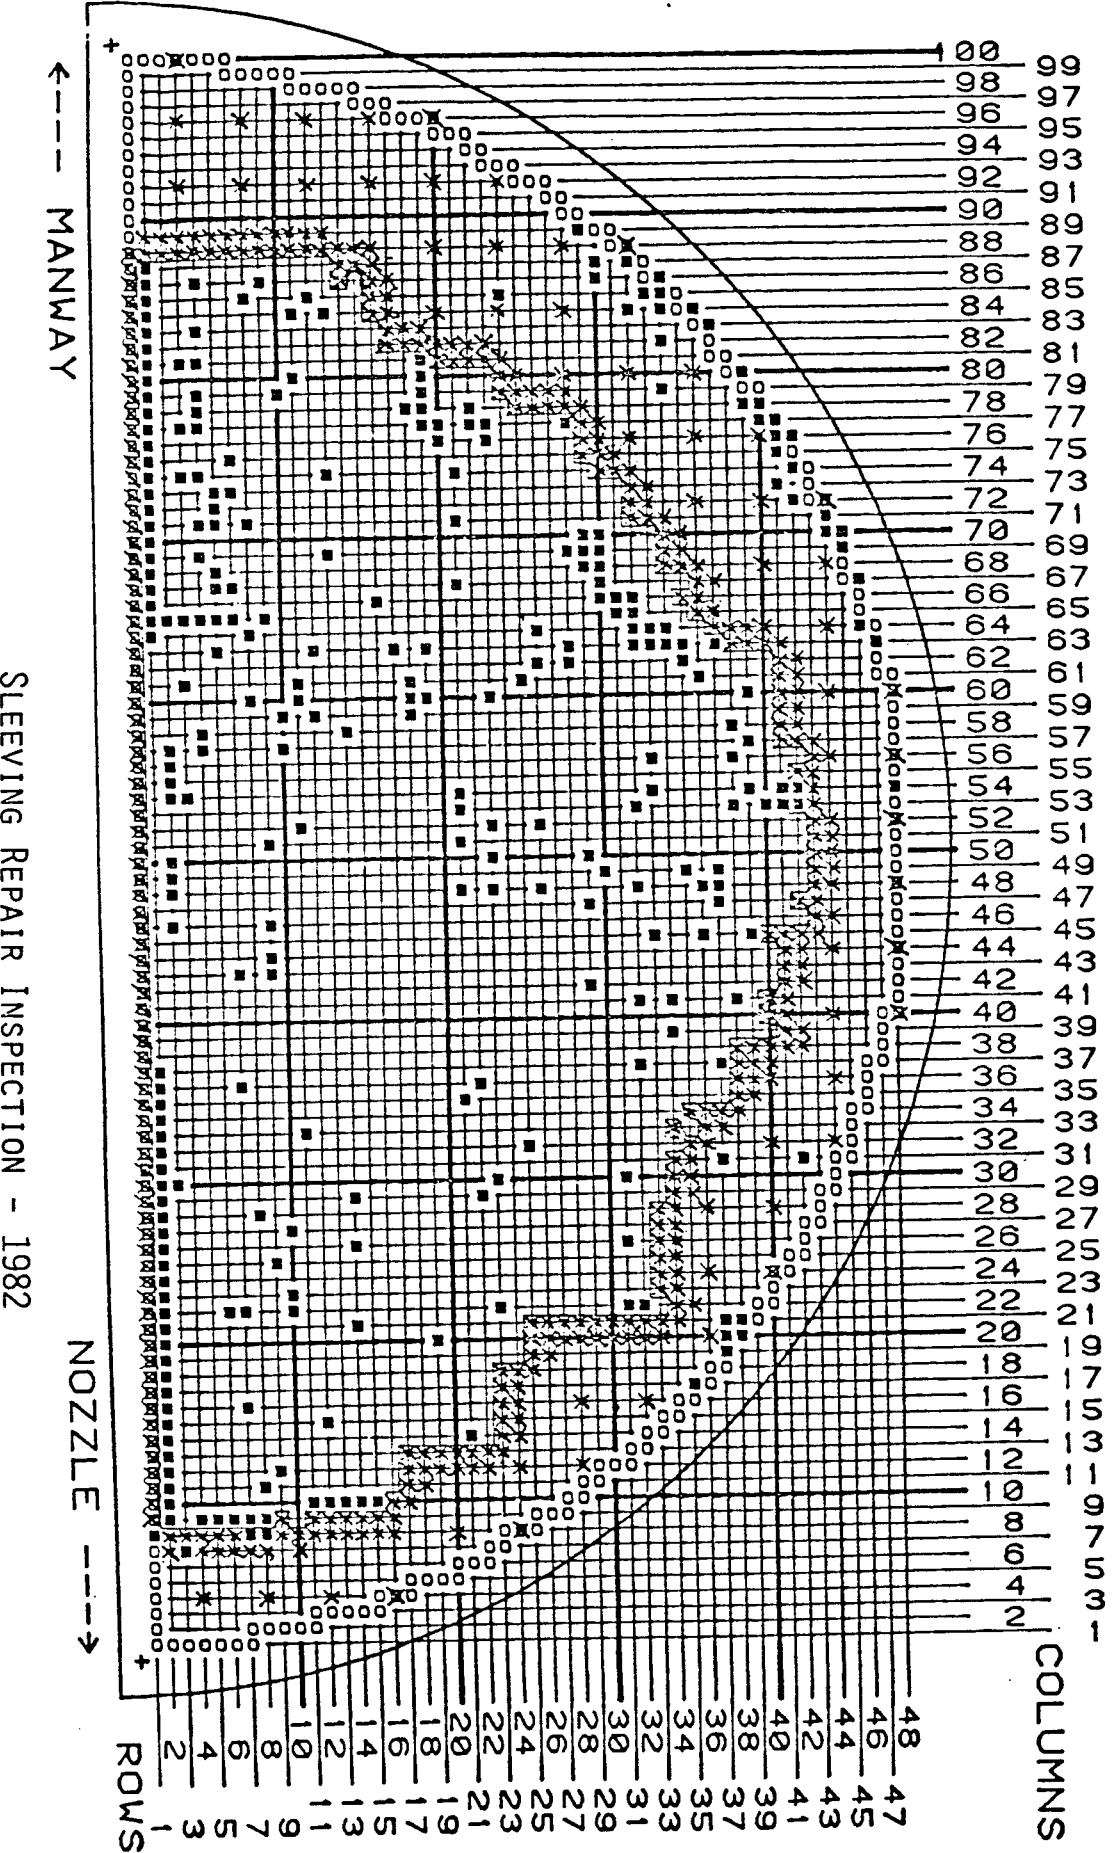
FIGURE A-11

A total of 396 tubes were inspected from among the 1357 peripheral tubes for a percentage of 29%. No indications of IGA at the top of the tube sheet were observed.

TUBES INSPECTED: X=396

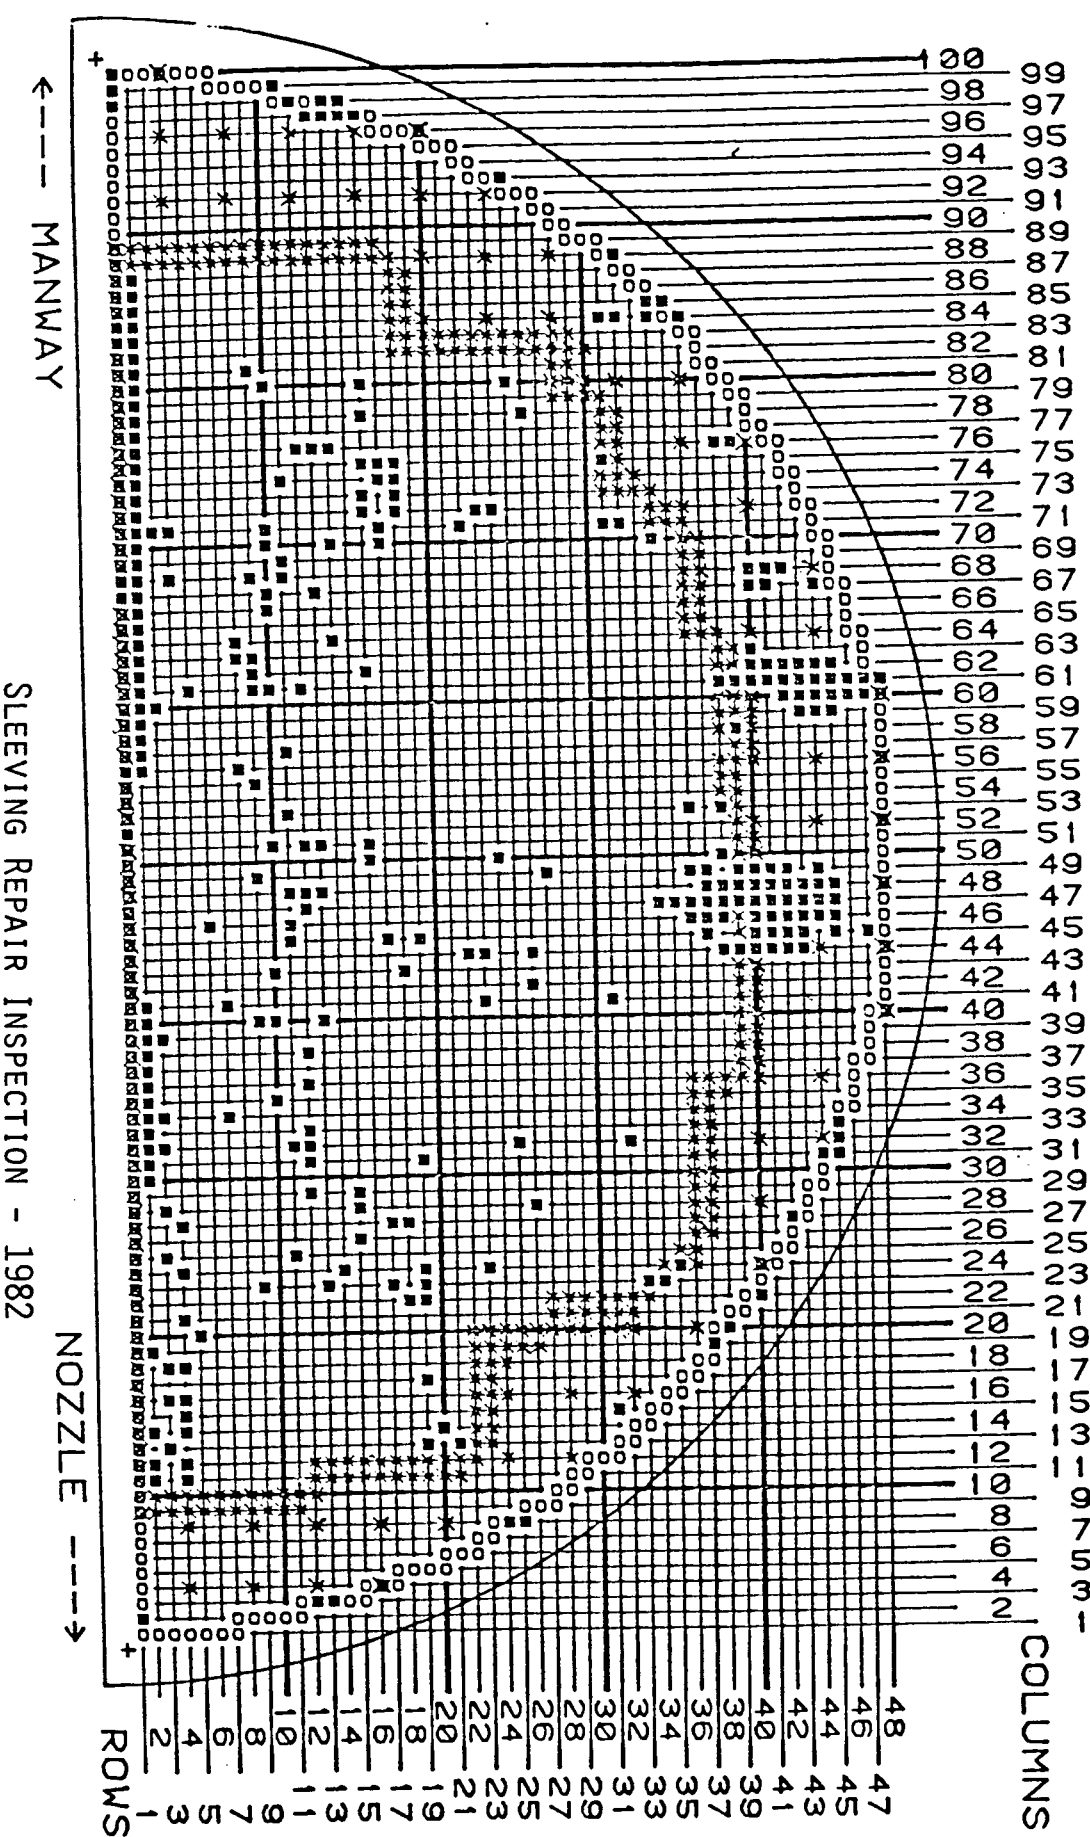
FIGURE A-12

A total of 394 tubes were inspected from among the 1419 peripheral tubes for a percentage of 28%. A total of 7 tubes had possible IGA indications at the top of the tube sheet by the 4x4 probe and were then inspected using the RPC probe. From the RPC inspection, 6 of the tubes had indications recorded as less than 20% and one (R22-C20) as 40%. Each tube was in the basic inspection pattern within 2 rows or columns of the sleeving repair boundary as shown in Figure A-12.

INDICATIONS BY 4X4 AND RPC = 7

The repair criteria stated in F.1 above were applied to the inspection findings. As a result, one tube in SG-A was plugged; in SG-C, seven tubes were plugged due to IGA indications and an additional 13 adjacent tubes were plugged in response to the broad boundary plugging criterion. The resultant plugging locations for steam generators A and C are shown in Figures A.13 and A.14. In addition, one tube in SG-B was plugged due to a wastage type thinning indication above the top of the tube sheet as discussed in F.2 above.

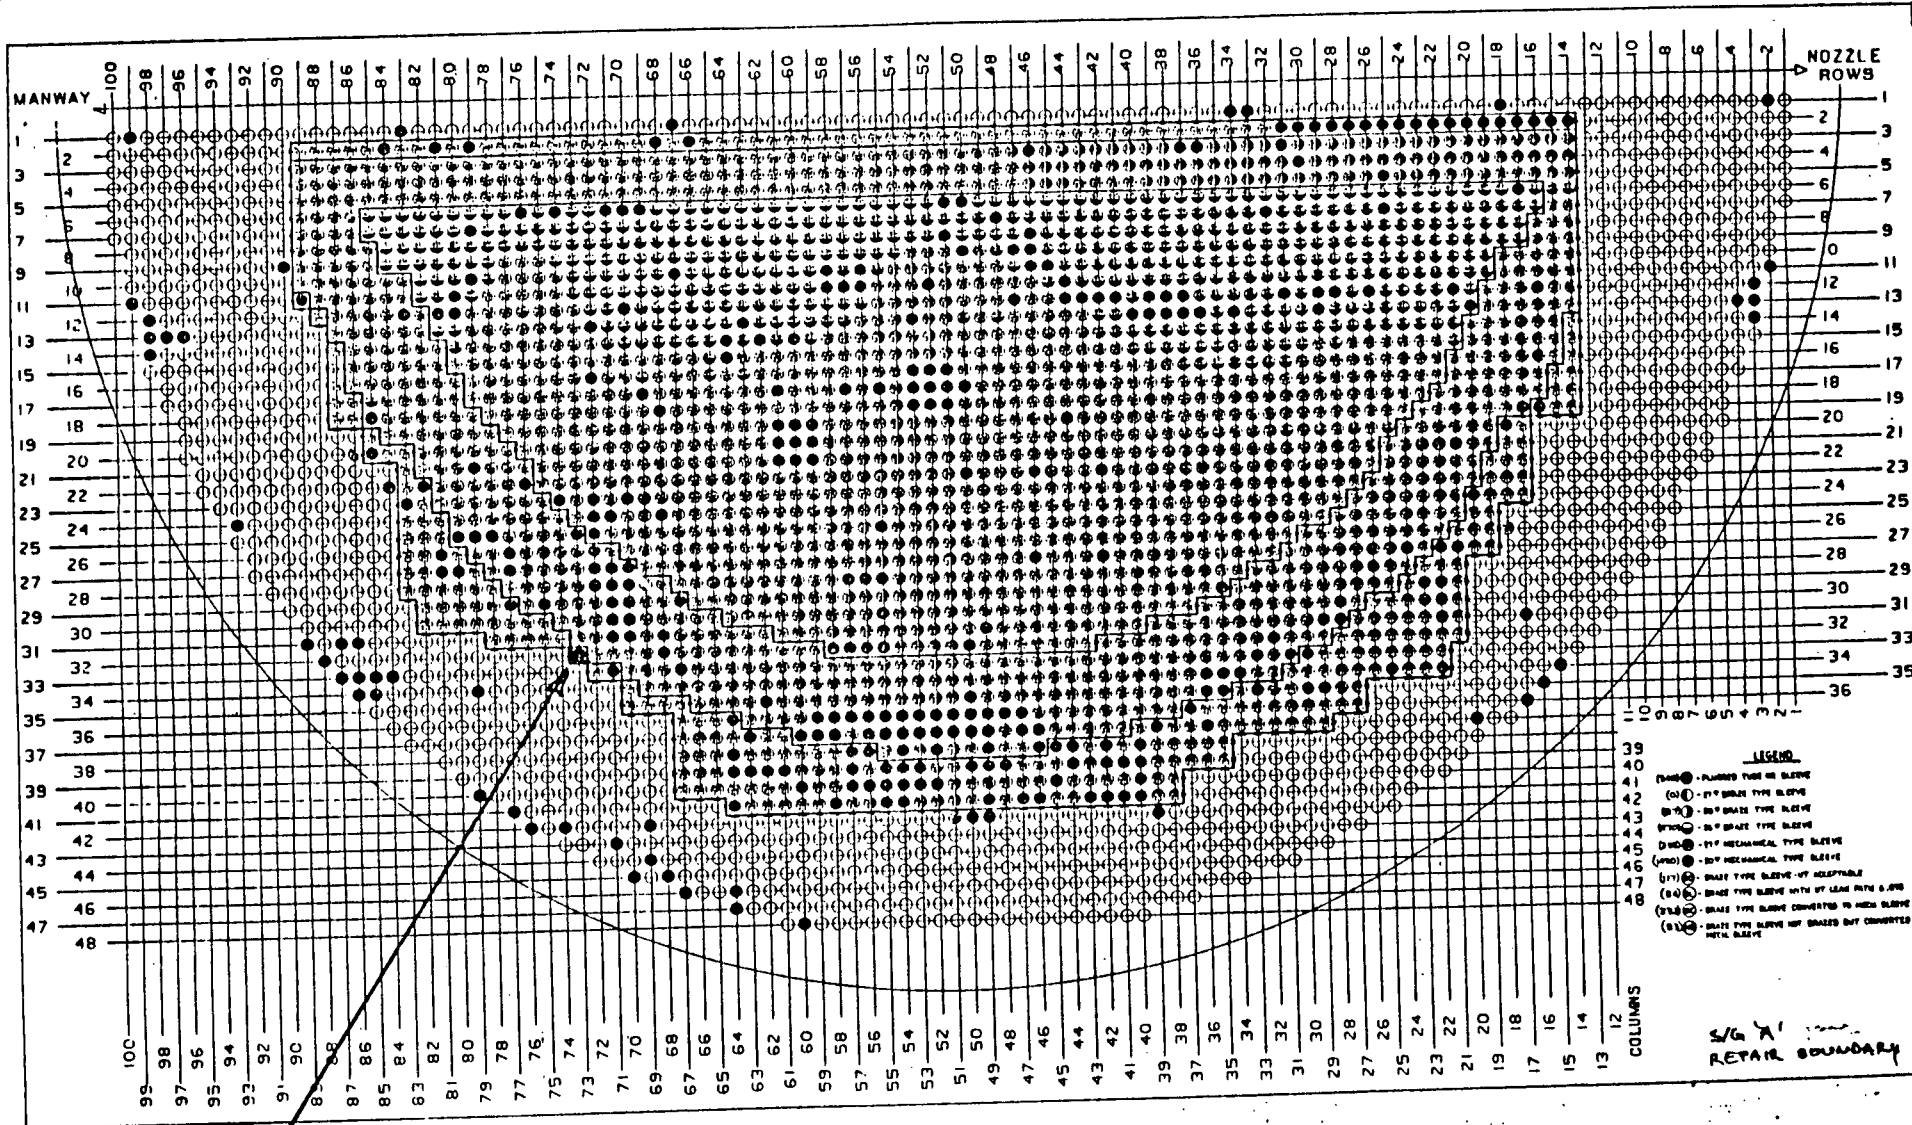
PLUGGING REPAIR DUE TO IGA INDICATIONS IN NON-SLEEVED TUBES

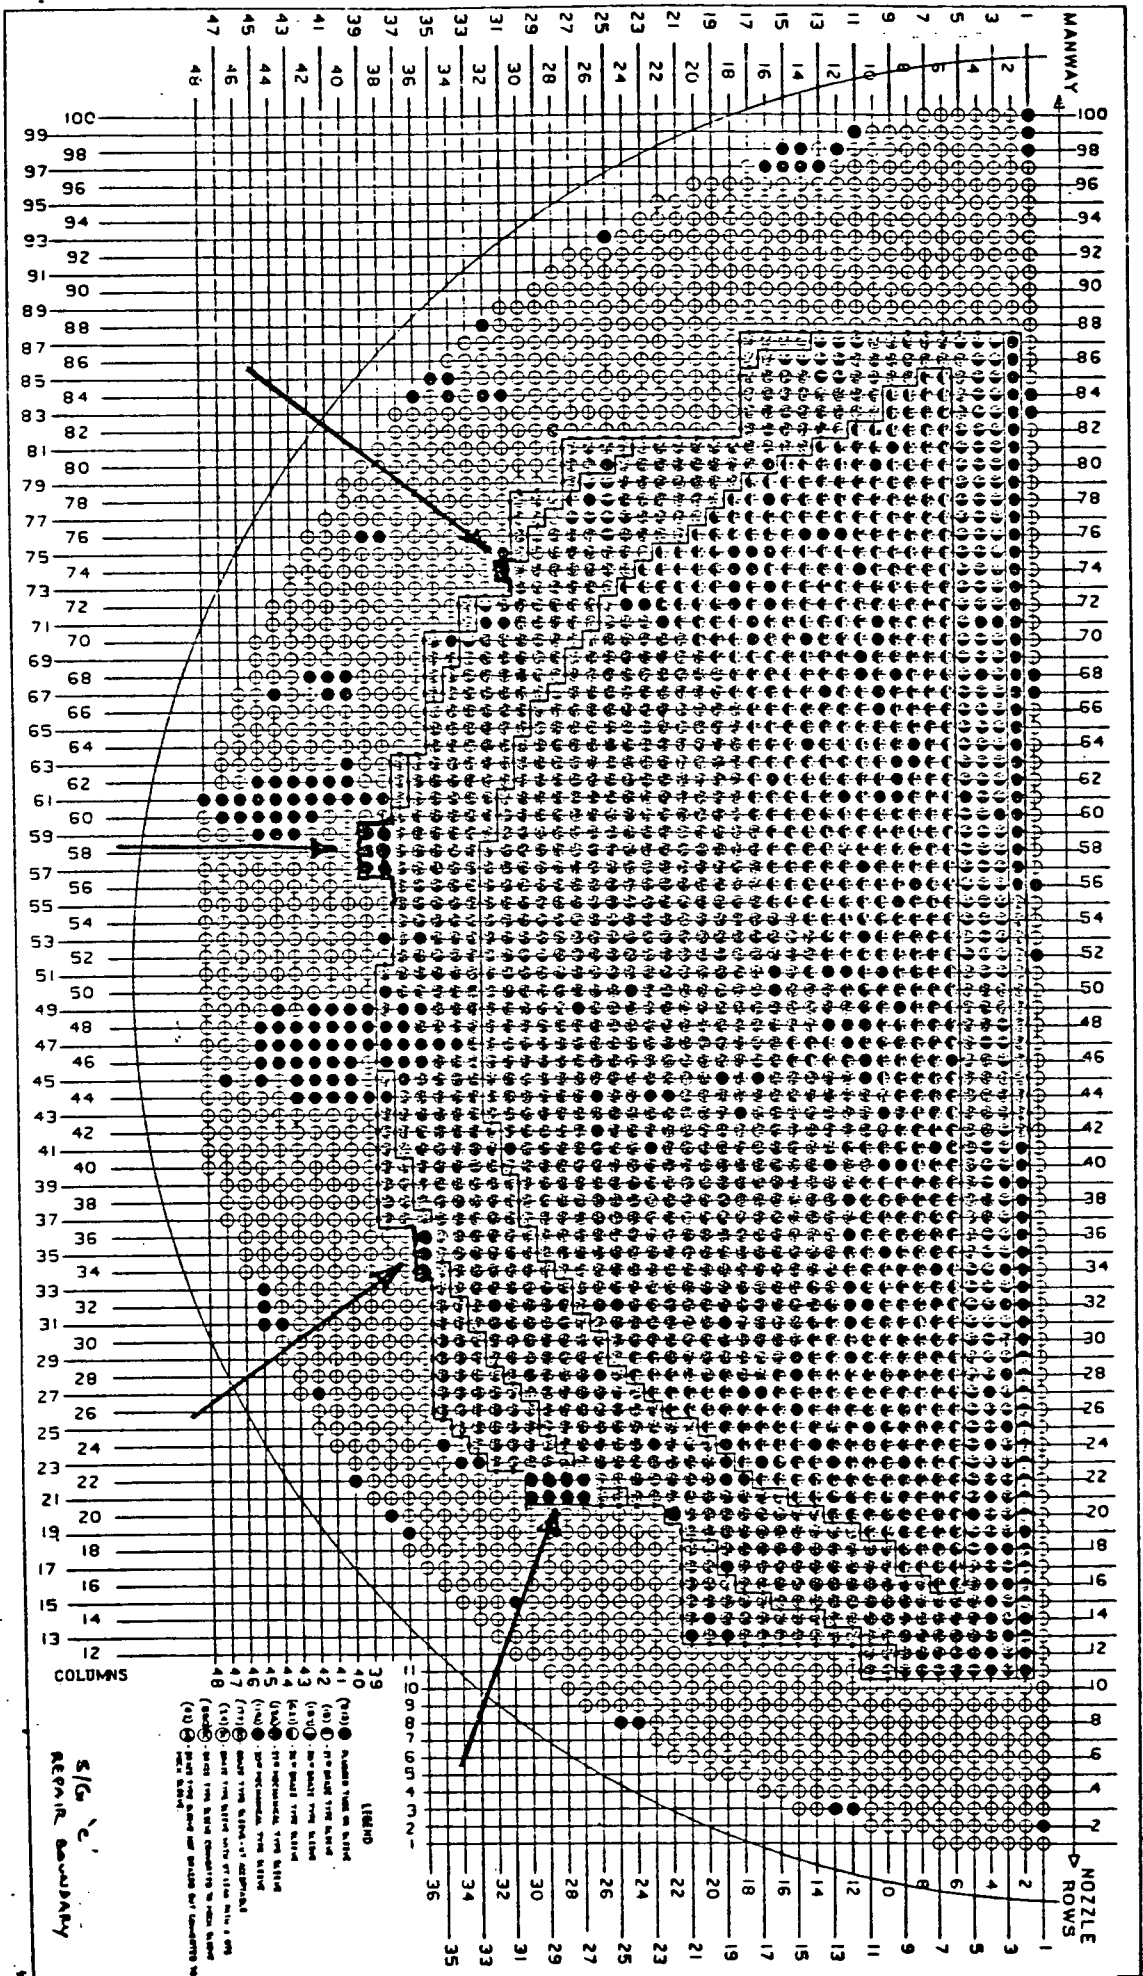
PLUGGING REPAIR DUE TO IGA INSPECTION OF NON-SLEEVED TUBES SG-C

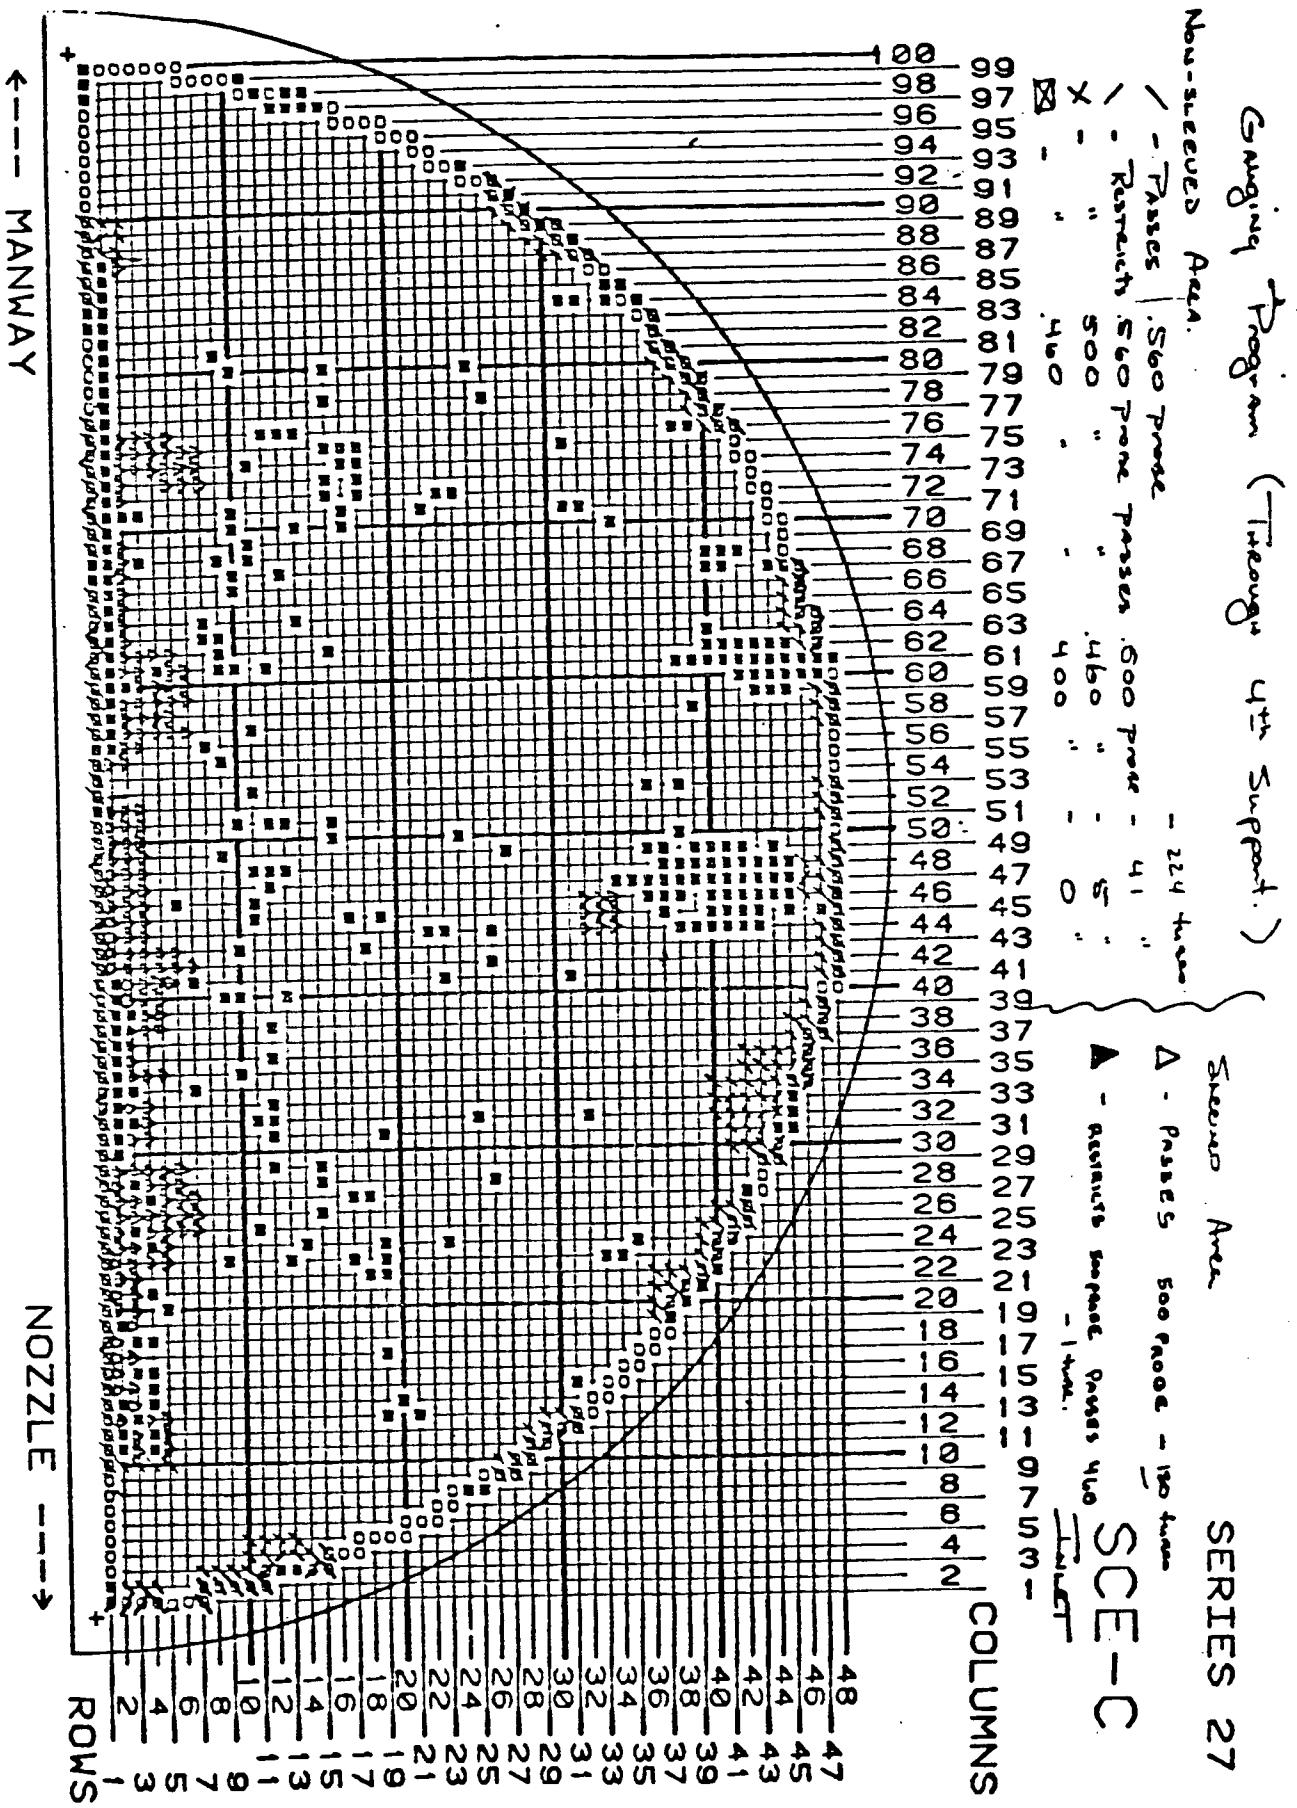
Figure B-4: Restriction Locations, SG-C Hot Leg

1 - RESTRICTS .560 PROBE PASSES .500 PROBE (41) X - RESTRICTS .500 PROBE PASSES .460 PROBE (6)  
 INLET

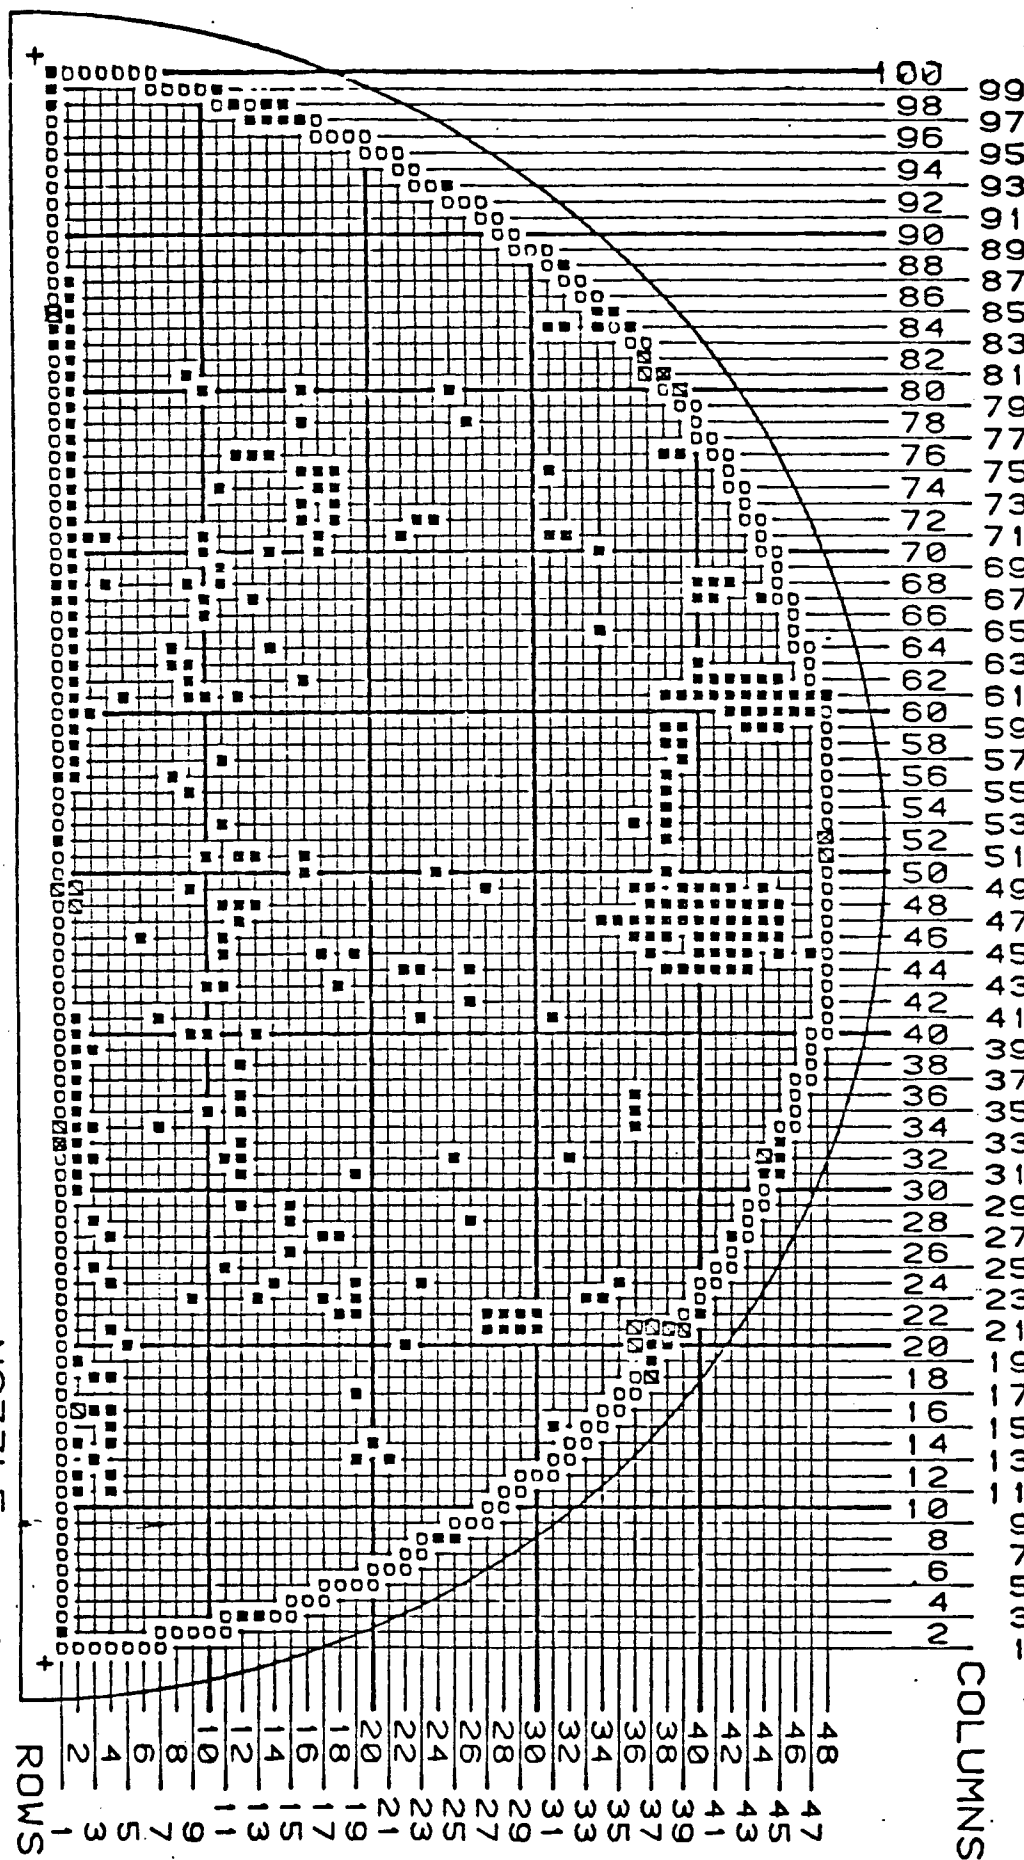
FIGURE B-6: RESTRICTION LOCATIONS, SG-C COLD LEG

⊞- RESTRICTED w/460 PASSED 400 (1 TUBE)
