STRUCTURAL EVALUATION

AND REPAIR OF

SONGS 1

INTAKE STRUCTURE

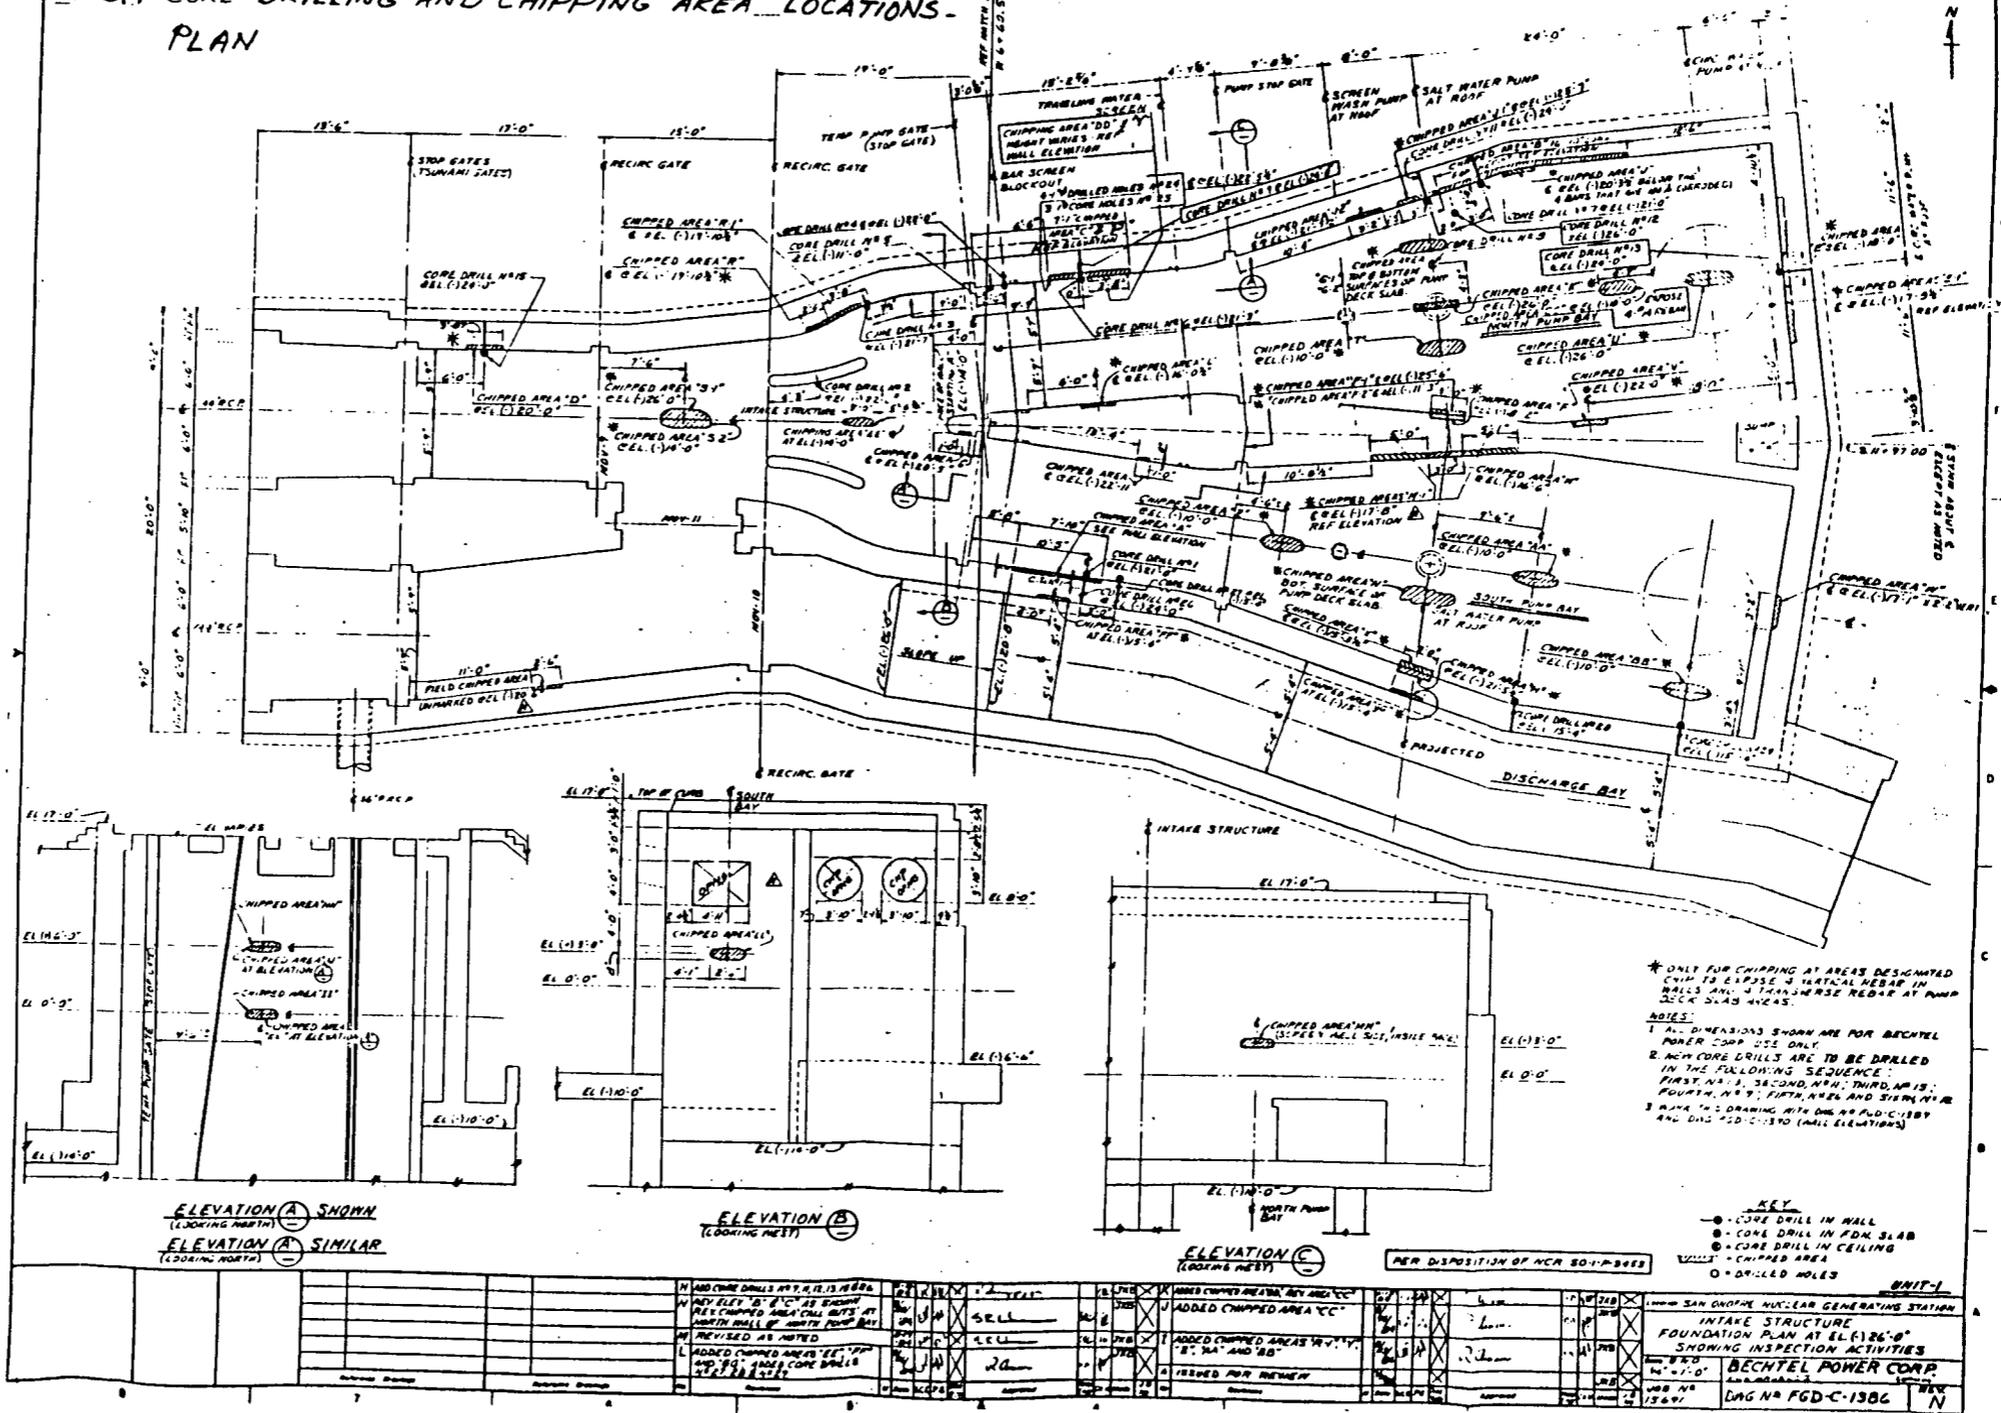
FIG. 1 CORE DRILLING AND CHIPPING AREA LOCATIONS PLAN

The cores were utilized in identifying delamination areas which were found to indicate the presence of corroded reinforcing steel nearby. The presence of delaminations and condition of reinforcing steel varied considerably through the structure, however the six cores drilled completely through the walls and floor to backfill consistently indicated that no corrosion of the reinforcing steel existed, nor was there any evidence of delaminations on the outside of the walls and floor against fill. Three additional cores were taken through the south wall which separates the intake from the discharge. These cores were taken to verify the condition where flow occurs across both faces of a single wall. Summaries of observations on the cores are given in Table 1. Locations of the cores are shown on Figures 1-3.

Concrete chipping in designated areas allowed (1) an evaluation of the exposed reinforcing steel to estimate the functional amount remaining and (2) permitted assessment of the continuity of the delamination more easily than would be permitted by coring. The observed conditions vary considerably in different areas of the structure, ranging from total loss of the reinforcing steel by corrosion to reinforcing steel in excellent condition with no sign of corrosion. Summaries of the observations made at these chipped areas are given in Table 2. Locations of the chipped areas are also identified on Figures 1-3.
