AEOD TECHNICAL REVIEW REPORT *

UNIT: San Onofre 1
DOCKET NO.: 50-206
LICENSEE: Southern California Edison
NSSS/AE: Westinghouse/Bechtel

TR REPORT NO.: AEOD/T333
DATE: October 31, 1983
EVALUATOR/CONTACT: Harold Ornstein

SUBJECT: DEGRADATION OF SALT WATER COOLING SYSTEM - CAUSED BY A LOSS OF INSTRUMENT AIR

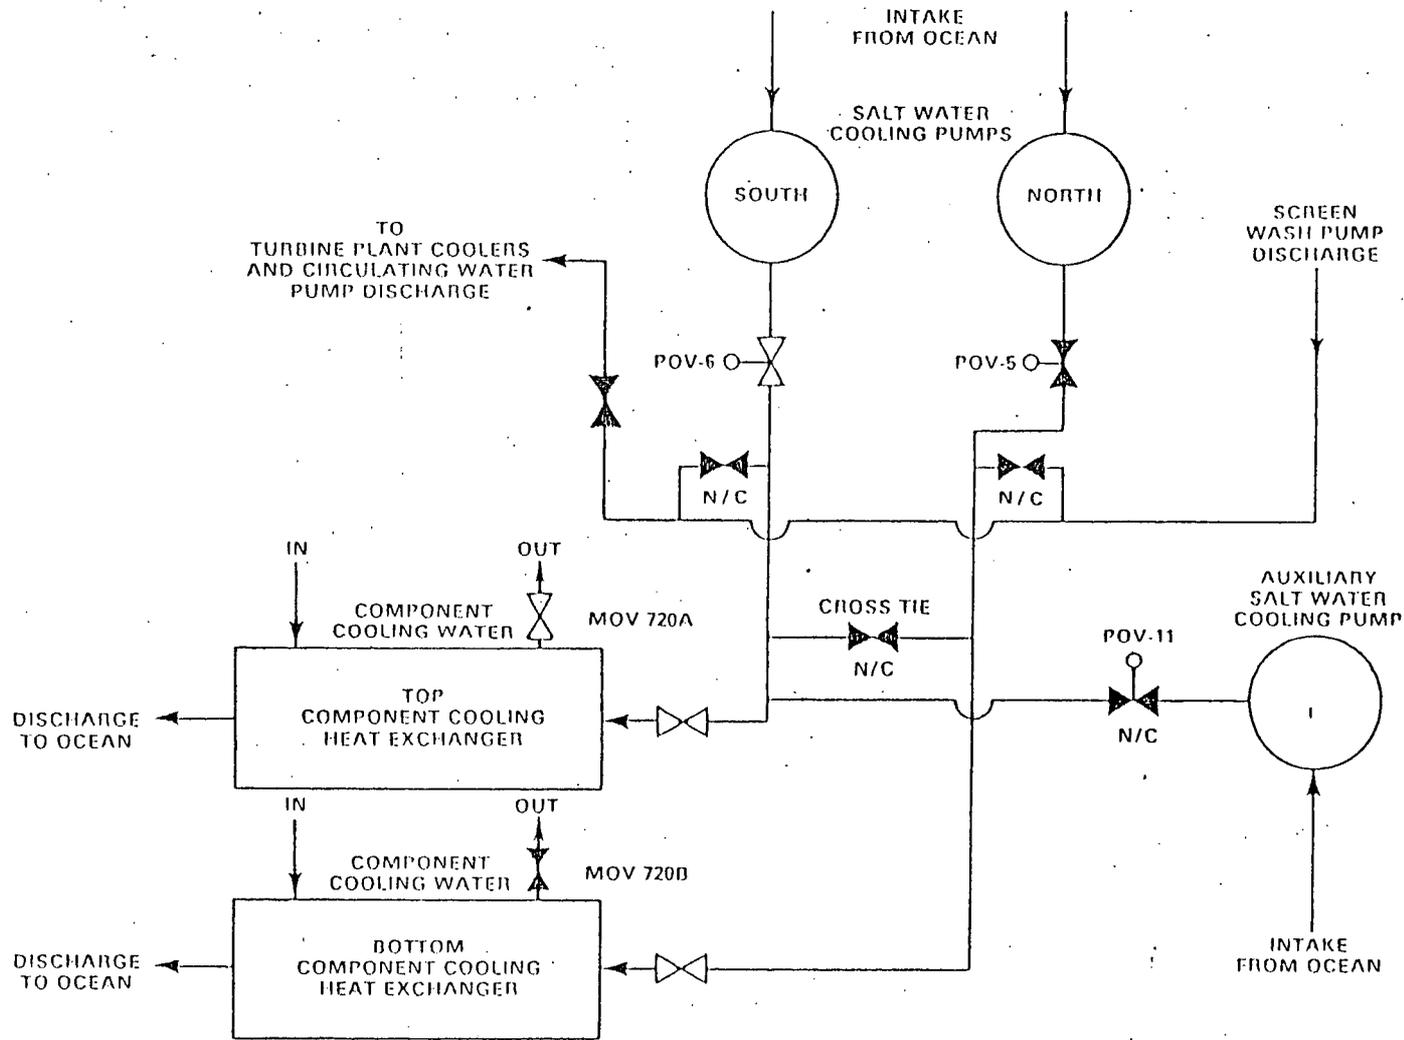
Figure 1 Salt water cooling system.

On March 16, 1983 while the plant was in an extended outage, a worker punctured the instrument air line to the (SWC) pumps' charge valves.* The worker had been drilling concrete for rebar installation when he inadvertently drilled into the instrument air line. The instrument air line was a field run line which was embedded in concrete, and its exact location was not indicated on the available drawings.

The SWC pumps' discharge valves are designed to fail in place upon loss of air (see Figure 1). Since the south SWC pump was operating, when the air was lost, the south SWC pump's discharge valve remained open and that train continued to function normally. The north SWC pump was off when the air was lost. Therefore its discharge valve remained closed upon the loss of air. There is a backup nitrogen accumulator on the south SWC pump discharge valve; however, the licensee was uncertain of the accumulator's capability of closing the valve had closure been required. (It was known that the discharge valve could be opened with accumulator nitrogen upon loss of instrument air; however, the licensee was not sure that the discharge valve could be closed under such conditions). As shown in Figure 1, in order to assure proper system operation and preclude backflow through the idle train the discharge valve on the idle SWC pump must be closed if the cross-tie valve is open or if the auxiliary SWC pump is in operation. Similarly, the auxiliary SWC pump had an air operated discharge valve without an accumulator; the loss of air rendered that valve inoperable. In essence, the loss of instrument air degraded the multi-train SWC system to a single train system.

1. Install check valves in the SWC pump discharge lines.
2. Lock open the existing SWC pump discharge valves.
3. Provide nitrogen accumulators for all POV's in the system.
