SUBJECT: PRESSURE LOCKING OF FLEXIBLE DISK WEDGE-TYPE GATE VALVES

AEOD EVALUATION OF PRESSURE LOCKING OF FLEXIBLE
DISK WEDGE-TYPE GATE VALVES

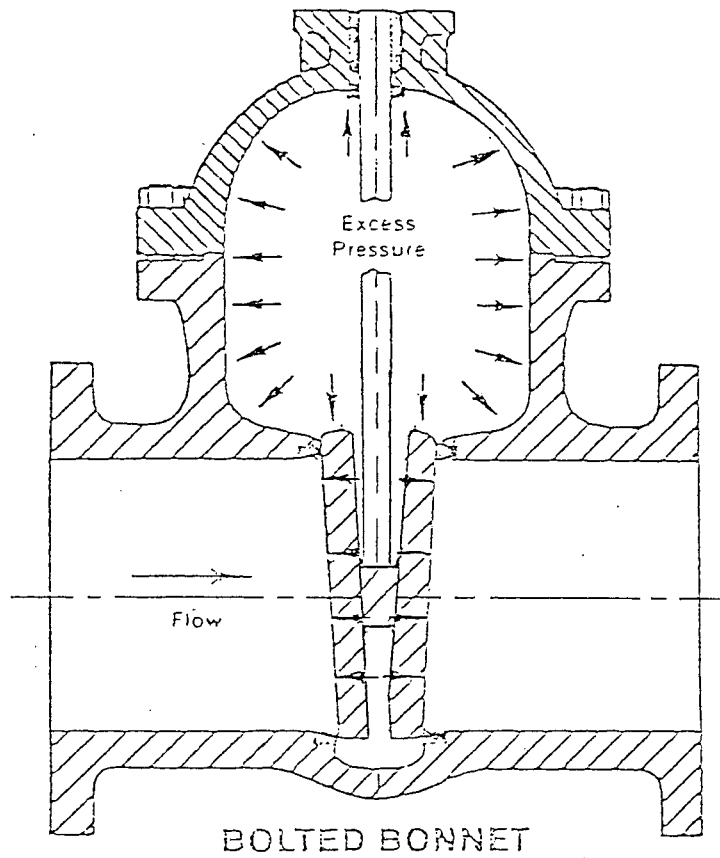
Figure
OVERPRESSURIZATION
OF BONNET CAVITY

The design of a flexible disk wedge-type gate valve is such that it allows the valve disk to seal and be seated against both seats at the same time when the valve is closed. It is also characteristic of flexible disk gate valves that fluid may enter and become trapped in the bonnet cavity when the valve is closed. This results when the valve has a differential pressure across the disk in the closed position. The pressurized side of the flexible disk can move away slightly from its seat, allowing high pressure fluid to enter the neck or bonnet cavity. With time, the bonnet cavity pressure and the pressurized pipe line pressure will tend to equalize. If pressure in the pipe is subsequently decreased, the pressurized side of the disk will move back against its seat. In such a case, water at a higher pressure than the line can become trapped in the bonnet cavity. If no internal or external differential pressure equalizing path for the bonnet is provided, pressure locking may occur, i.e., the pressure differential can cause the forces on the disc/seat ring seals to become sufficiently high that the valve cannot be opened. This phenomena is illustrated in the figure. The locking problem can be corrected by providing venting arrangements which allow the bonnet pressure to quickly equalize with the pressure upstream or downstream of the disk. One solution is to install a vent line which connects the bonnet chamber to the valve body upstream or downstream of the disk as appropriate. Another solution is to drill a small hole in either the upstream (or downstream) facing disk to allow the between-disk (bonnet) region to be at the same pressure as the upstream (or downstream) piping.
