**RE: Uranium One USA, Willow Creek ISR Operations, 2013 Annual Inspection Report, Permit No. 478**

## ANNUAL INSPECTION REPORT

**Company:** Uranium One USA, Willow Creek ISR Project, Permit No. 478

**Date of Inspection:** October 24, 2013

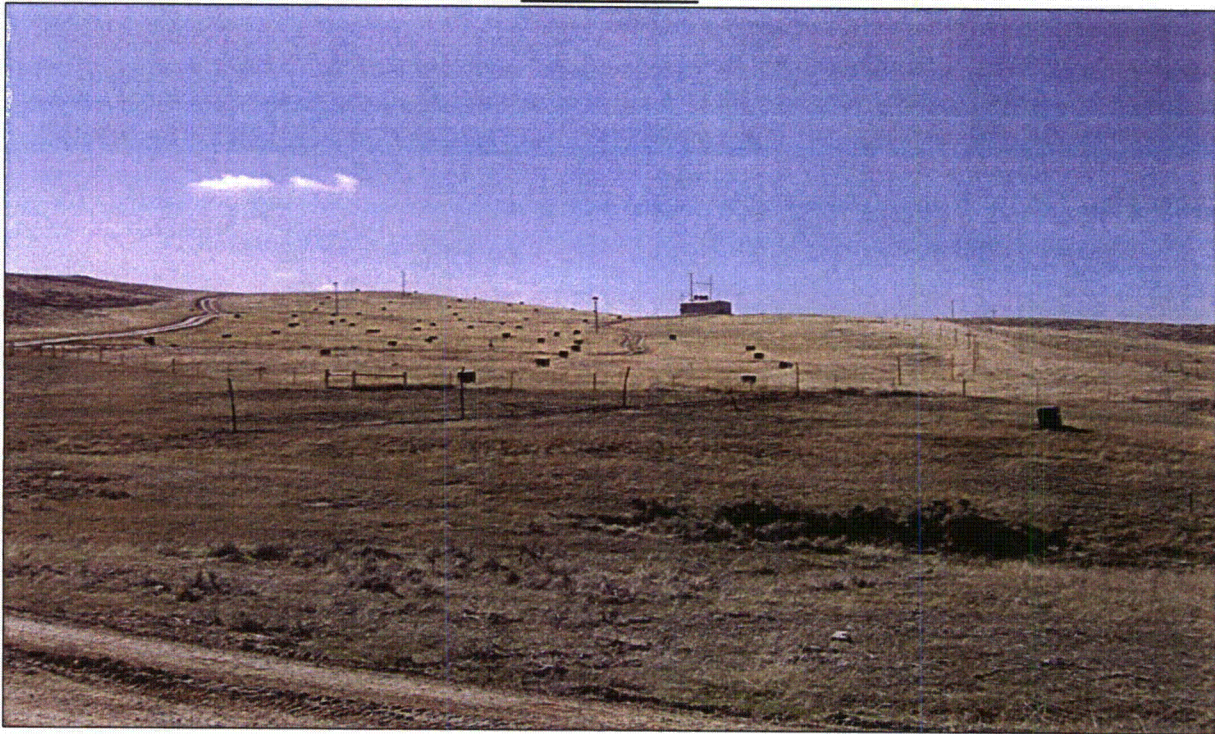
Thistle, was heavy. Uranium One was cognizant of the problem and has been implementing a weed spraying program which was showing an effective kill in Module 7-4. Module 7-5, which also received interim seeding reclamation during the 2011-2012 reporting period was observed from a distance and noted to be showing strong regrowth of seed mix vegetation with no significant signs of weed infestation (**Photo #1**). Overall, weed control efforts observed in Mine Unit 7 appeared to be effective. No significant signs of erosion were noted while viewing Mine Unit 7.

**Photo #1** – View of vegetative regrowth in Christensen Ranch (CR) Mine Unit 7-5.

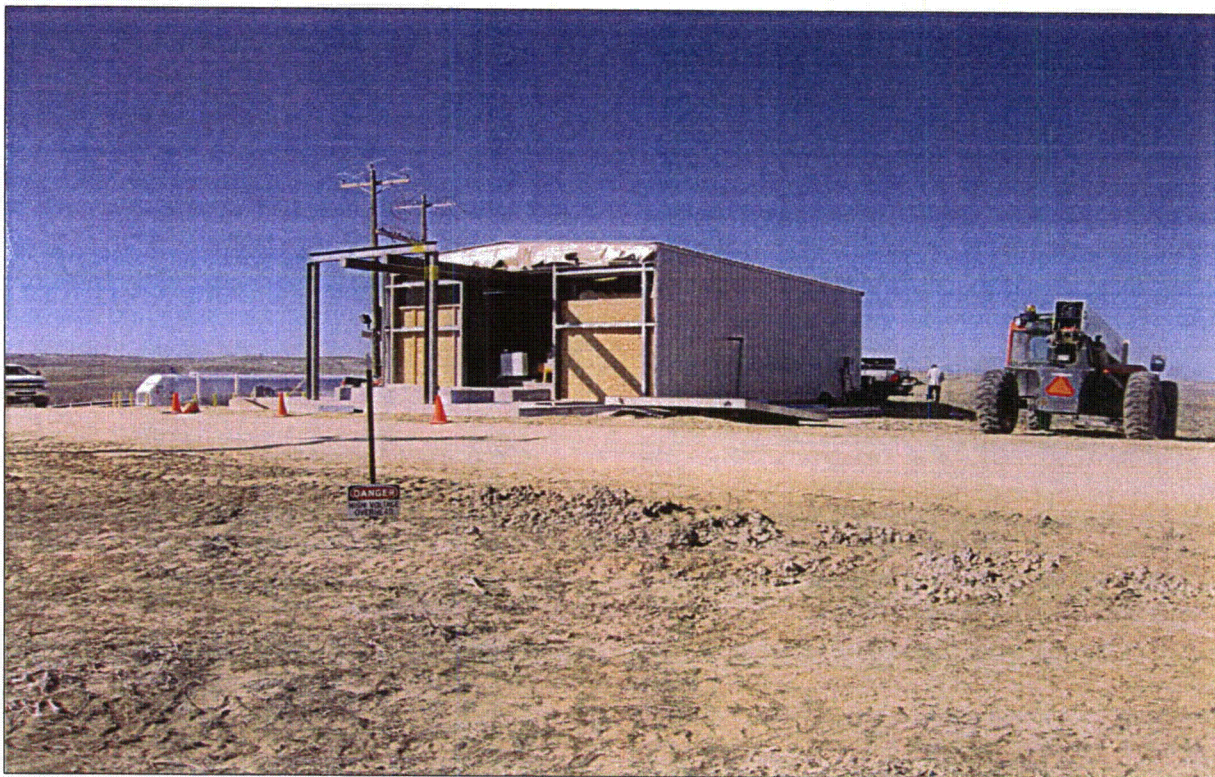
Mine Unit 8 was in active production at the time of inspection. In route to Mine Unit 8, construction activities were observed at the Mine Unit 8 Booster Station where the building was being expanded to accommodate larger pumps for the addition of the Mine Unit 10 trunkline connection to the trunkline from the Christensen Ranch Satellite. No concerns were noted with these activities (**Photo #2**). Seeding and erosion control work is on-going in the mine unit. Growth of interim seed mix vegetation in the areas viewed in Modules 8-1 and 8-2 has been marginal and as observed at other disturbed areas throughout the mine site, growth of Russian Thistle has been significant. However, it was evident that weed spraying efforts have been showing an effective kill. Overall, slope erosion control with matting appeared to be effective (**Photo #3**).

**Photo #2** – Construction of addition onto CR Mine Unit 8 Booster Station.

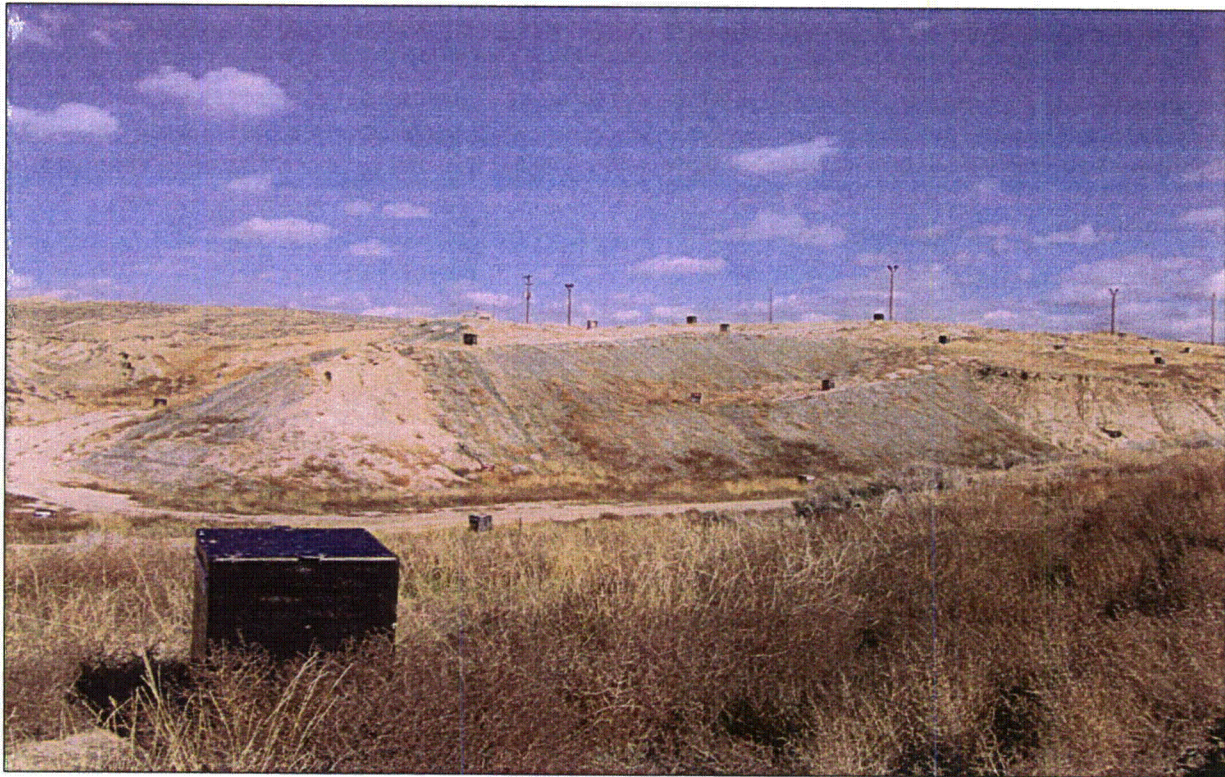
**Photo #3** – View of slope erosion control utilizing matting in CR Mine Unit 8.

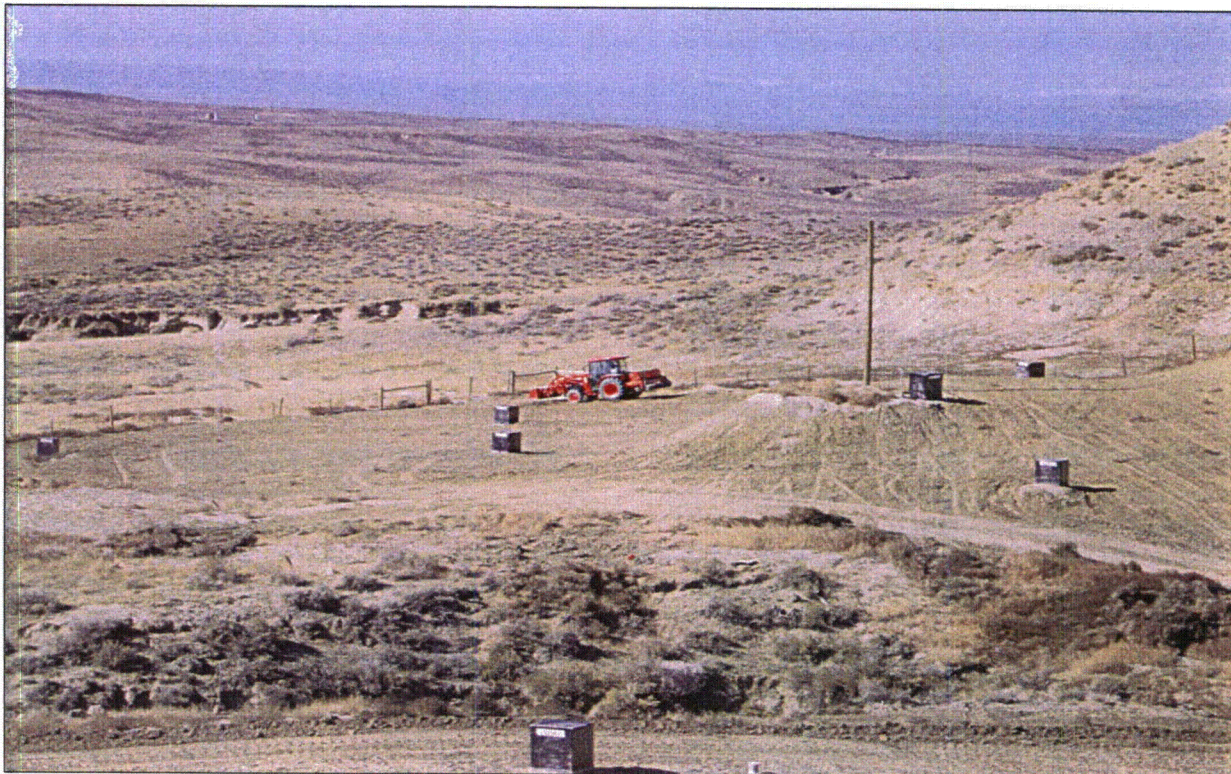
Seeding and sediment control work was active in Module 8-4/5 at the time of the inspection. The area had been effectively recontoured and placement of weed control matting and wattles was observed (**Photos #4 & #5**). Additionally, Uranium One has implemented bedrock cobbles and small boulders turned up during development of the mine unit as energy dissipating type structures to slow surface water run-off and sediment transport. At the time of the inspection, it was not certain how effective these rock structures will be and the Operator was advised to add additional rock energy dissipaters or other erosion control measures to some areas that were showing signs of minor erosion and potential topsoil loss (**Photo #6**).

**Photo #4** – View of interim seeding operations in CR Mine Unit 8-4/5.

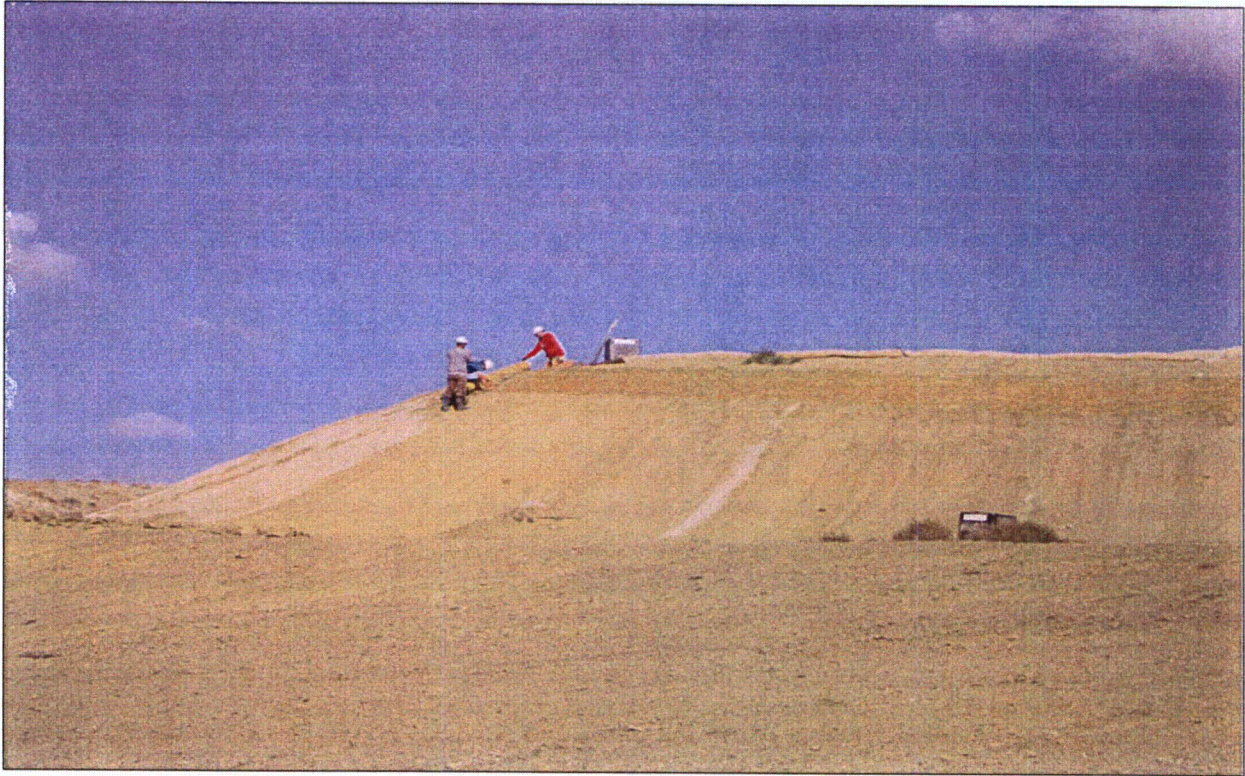
**Photo #5** – Placement of erosion control matting in CR Mine Unit 8-4/5.

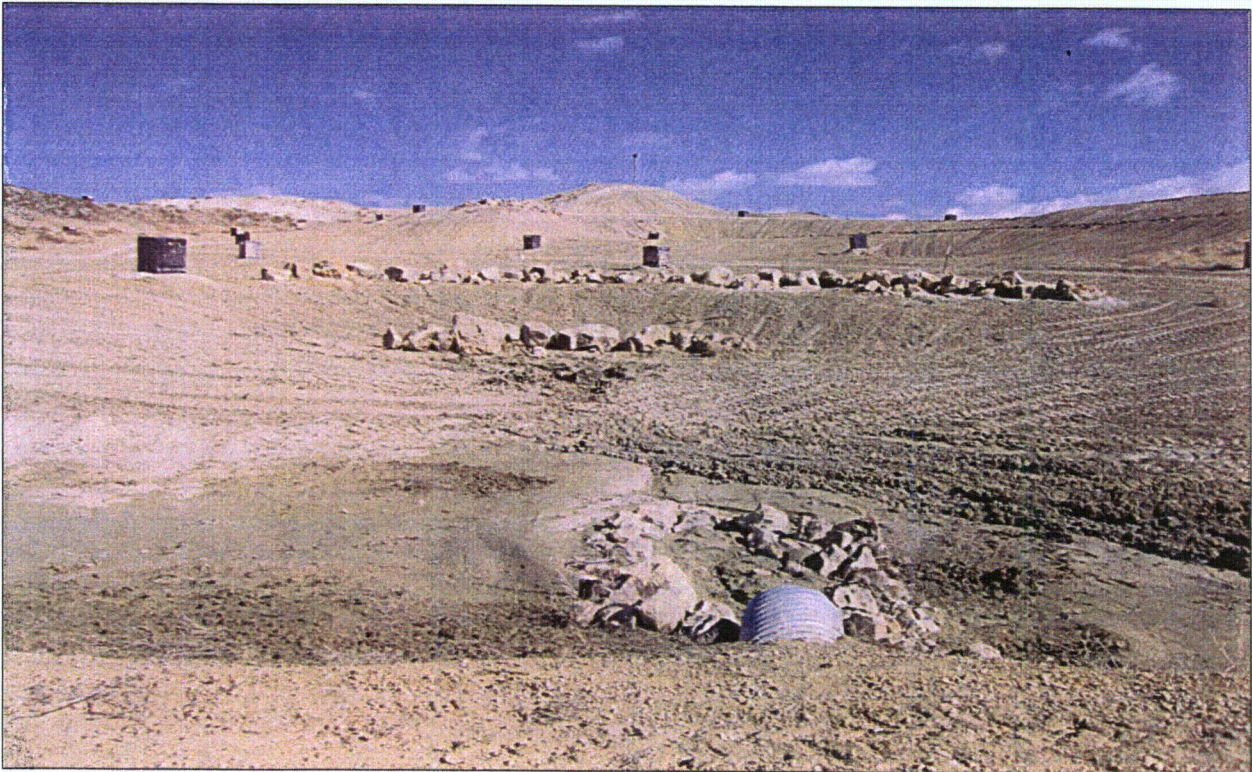
**Photo #6** – View rock energy dissipater type structures in CR Mine Unit 8-4/5.

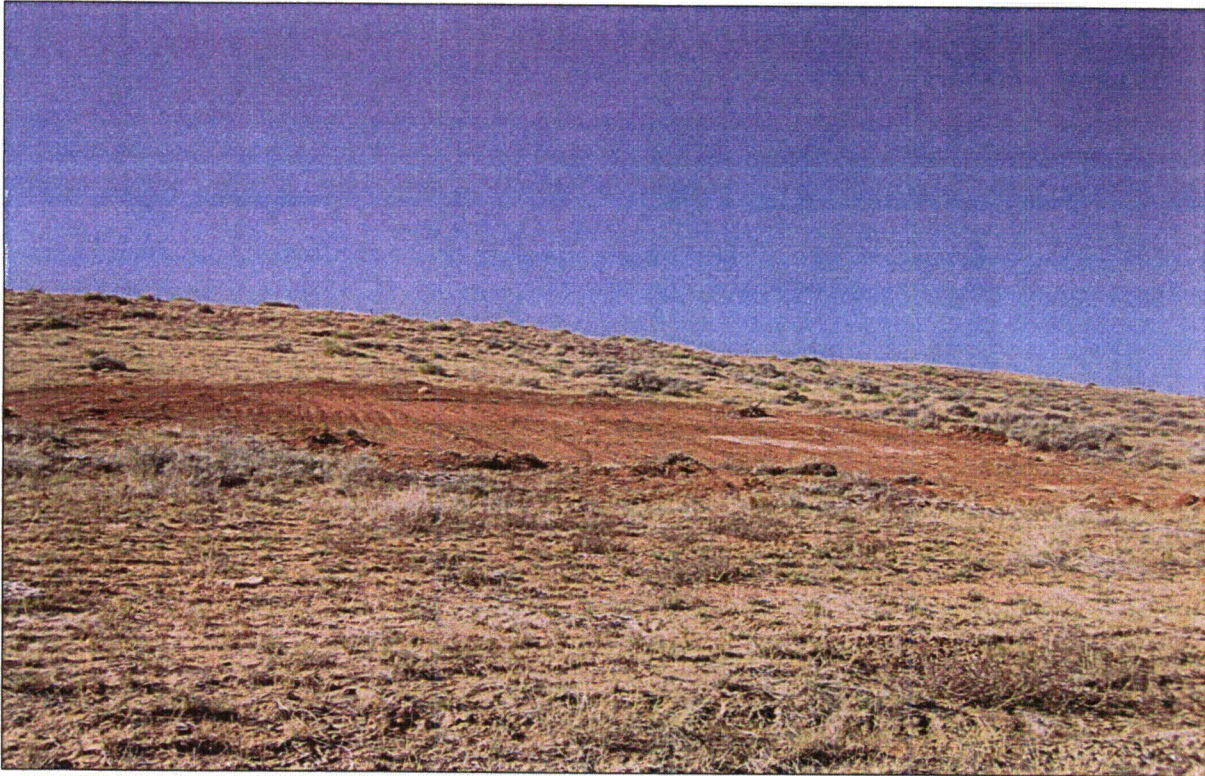
Reclamation of delineation holes in proposed Mine Unit 9 was viewed during the inspection. The sites were drilled in late 2011 and early 2012. The sites had been recontoured, topsoiled and reseeding had been performed within the past month (**Photo #7**). No concerns were noted. Locations where historical boreholes had been identified and plugged and abandoned were marked with a poly pipe riser (**Photo #8**).

**Photo #7** – View of delineation hole site reclamation in proposed CR Mine Unit 9.

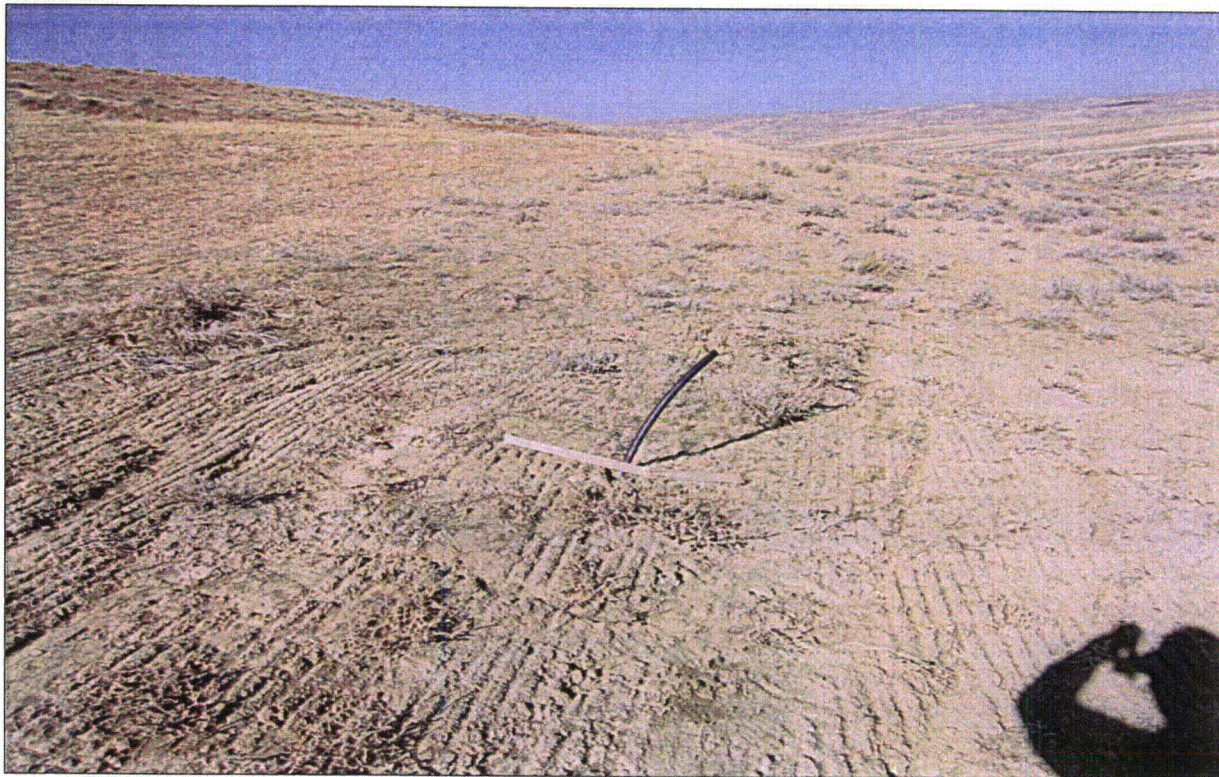
**Photo #8** – View of historic borehole marking in proposed CR Mine Unit 9.

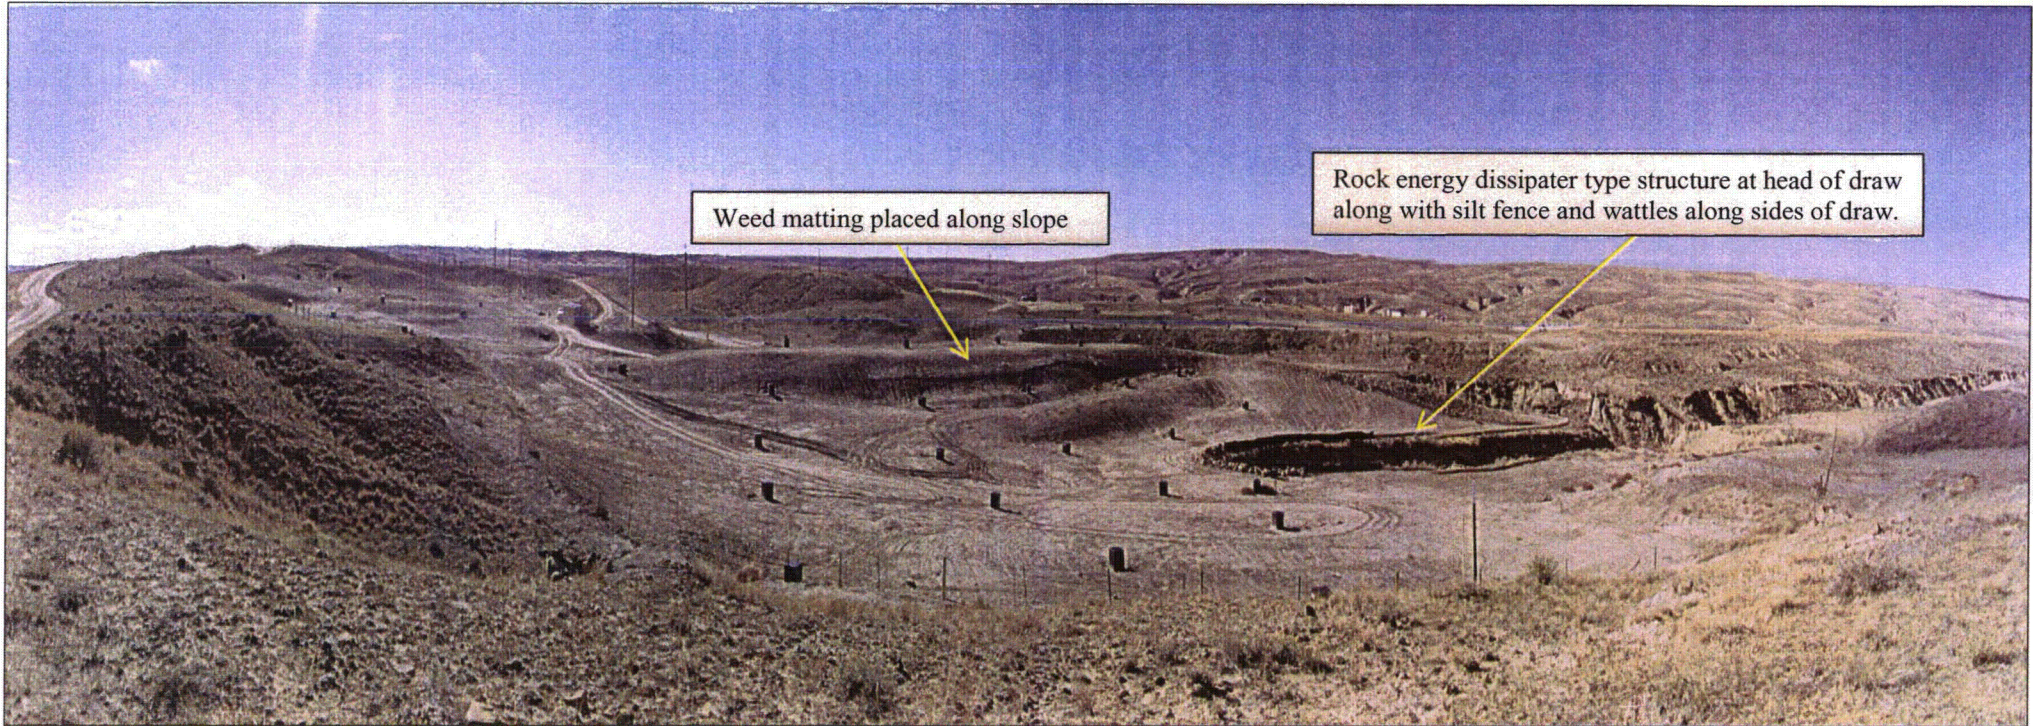
Weed growth was very minimal in the areas observed. Sediment control structures were observed to be in place, most notably placed along drainage head-cuts and along the top of drainage side slopes. Some erosion control matting was observed along the side slopes in upland areas; however, due to the very limited vegetation in the disturbed areas, the Operator was advised to implement additional erosion control measures along these side slopes to prevent potential topsoil loss in the event of a significant precipitation event (**Photo #9**). No significant signs of erosion were observed during the inspection.

**Photo #9** – View of site recontouring and erosion control measures placed around drainage in Christensen Ranch Mine Unit 10B.

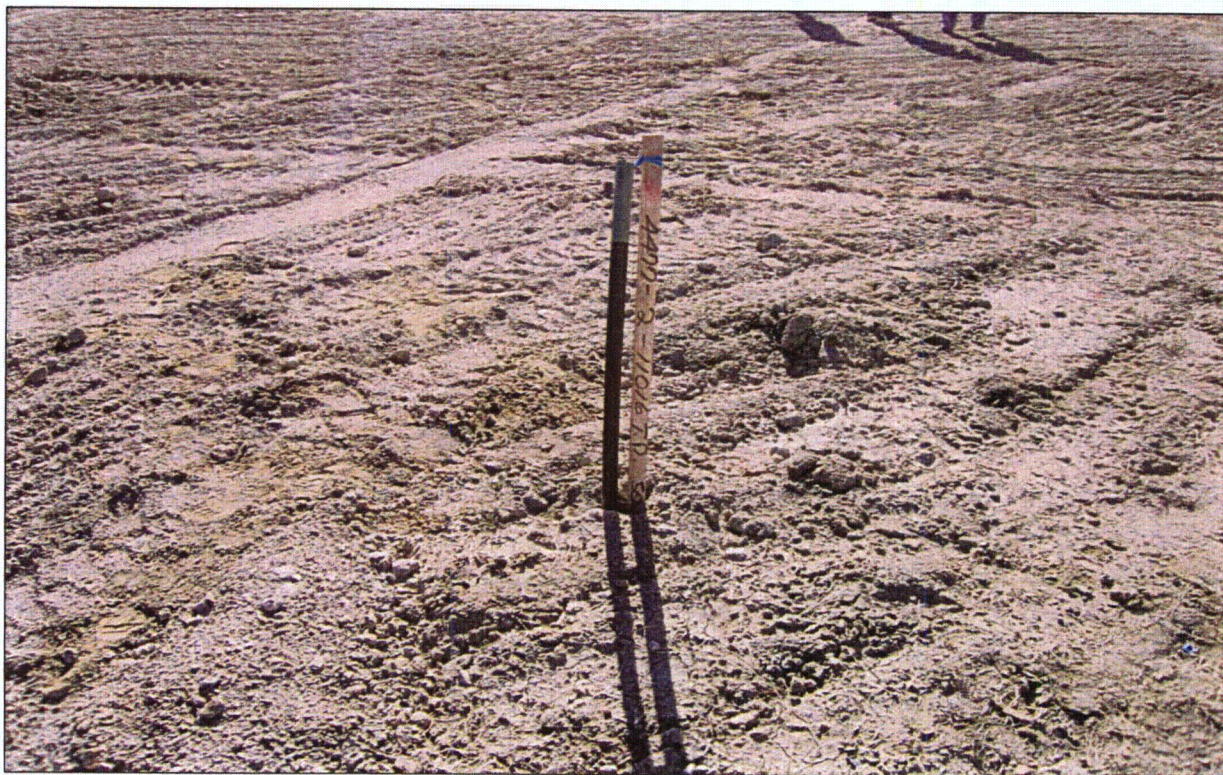
The Operator has been authorized by LQD (July 3, 2013 authorization letter from Mark Taylor) to temporarily surface cap approximately 200 pilot holes associated with Mine Unit 10B, Modules 10-7 and 10-8. Some of these temporarily surface capped holes were observed during the inspection. The pilot hole locations were observed to be marked with black poly pipe risers and wood lath labeled with the hole name and total depth (**Photo #10**). In accordance with LQD's approved method for temporarily capping the holes, remnants of the Styrofoam sealant used in the pilot hole were observed at the surface next to the hole marker (**Photo #11**). Per LQD's authorization letter, Uranium One is to re-enter these temporarily surface capped holes on or before January 1, 2015 in order to complete permanent reclamation or to complete as mine production or injection wells.

**Photo #10** – Temporarily surface capped pilot hole marking in CR Mine Unit 10B.

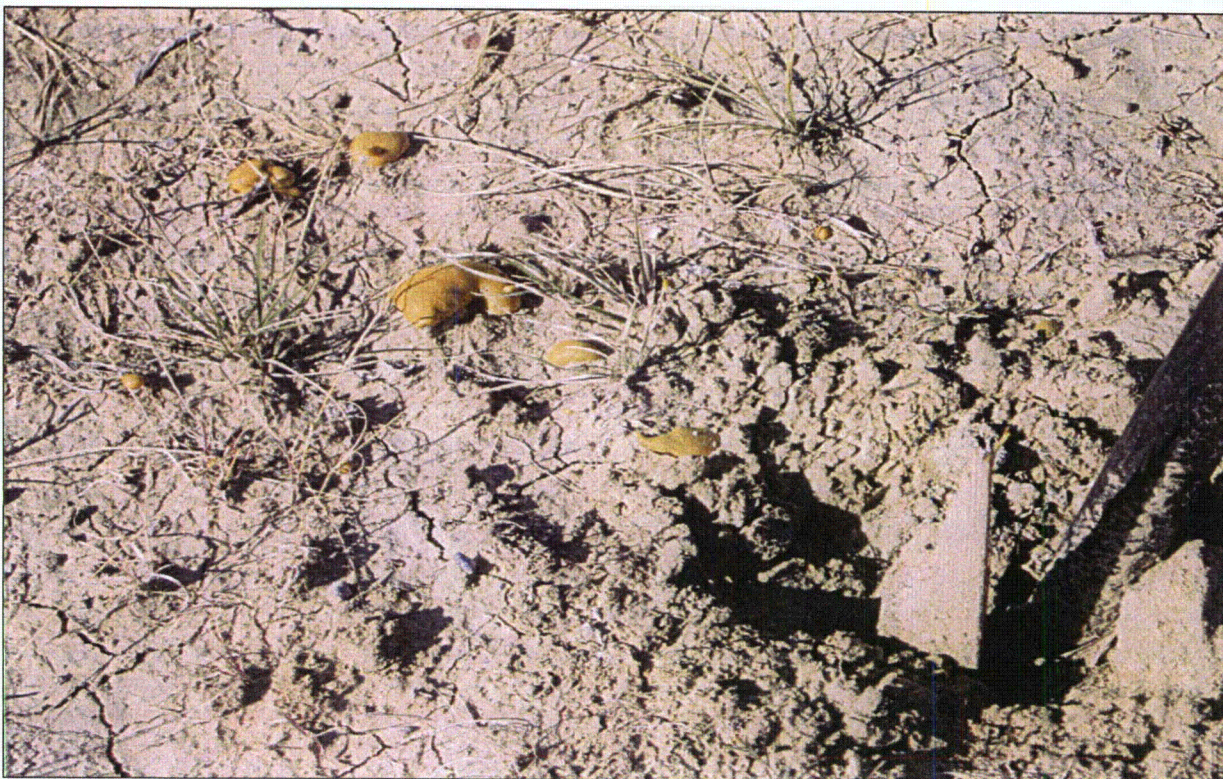
**Photo #11** – View of remnant Styrofoam sealant next to temporarily surface capped pilot hole.

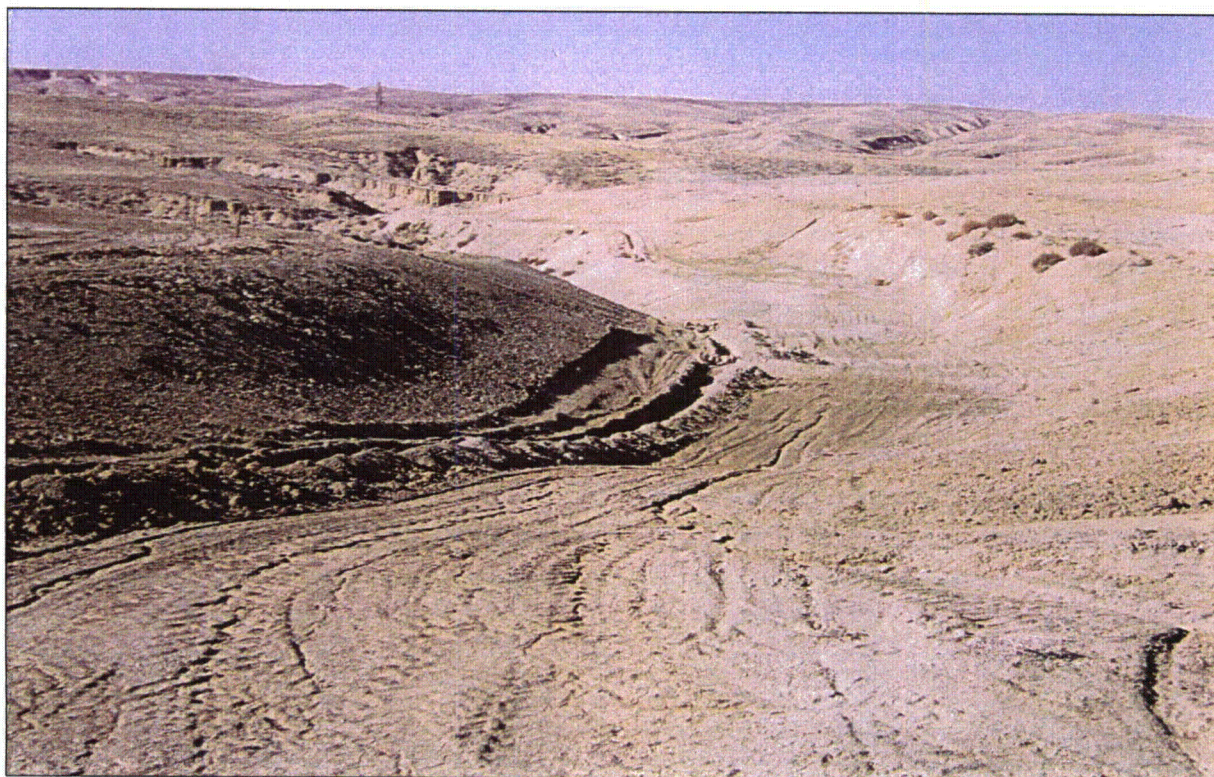
During inspection of the temporarily capped pilot holes, it was evident that additional sediment control was needed in this area of Mine Unit 10 following the recent surface disturbance from drilling operations. Specifically, sediment control is needed to prevent loss of topsoil and sedimentation into adjacent drainages (**Photo #12**). The following day after the inspection, Luke McMahan contacted Uranium One via email and stressed the importance of sediment control in this area. Please note, the email made reference to the subject area as "Mine Unit 11" which was in error. As discussed here, the area of concern is Mine Unit 10, Modules 10-7 and 10-8. The subject email has been placed in the permanent inspection file for Permit No. 478.

**Photo #12** – Disturbance requiring additional sediment control in CR Mine Unit 10B.

Due to the much incised terrain in some of the development areas, specifically in Mine Unit 10 and the proposed Mine Unit 11, Uranium One is strongly encouraged to continue implementing aggressive efforts to control erosion which could potentially result in topsoil loss and sedimentation into drainages. Additionally, the Operator is strongly encouraged to exercise minimal disturbance of native vegetation in development areas in order to leave natural sediment control measures in place. LQD recognizes the difficulty of developing wellfields in this rough terrain and feels that close communication between LQD and the Operator at the beginning stages of extensive development activities will ultimately assist both parties in implementing successful best management practices. As a basis for future inspections, both LQD inspectors and the Operator should continue to focus on observing, discussing and implementing effective methods for sediment control in topographically challenging areas.

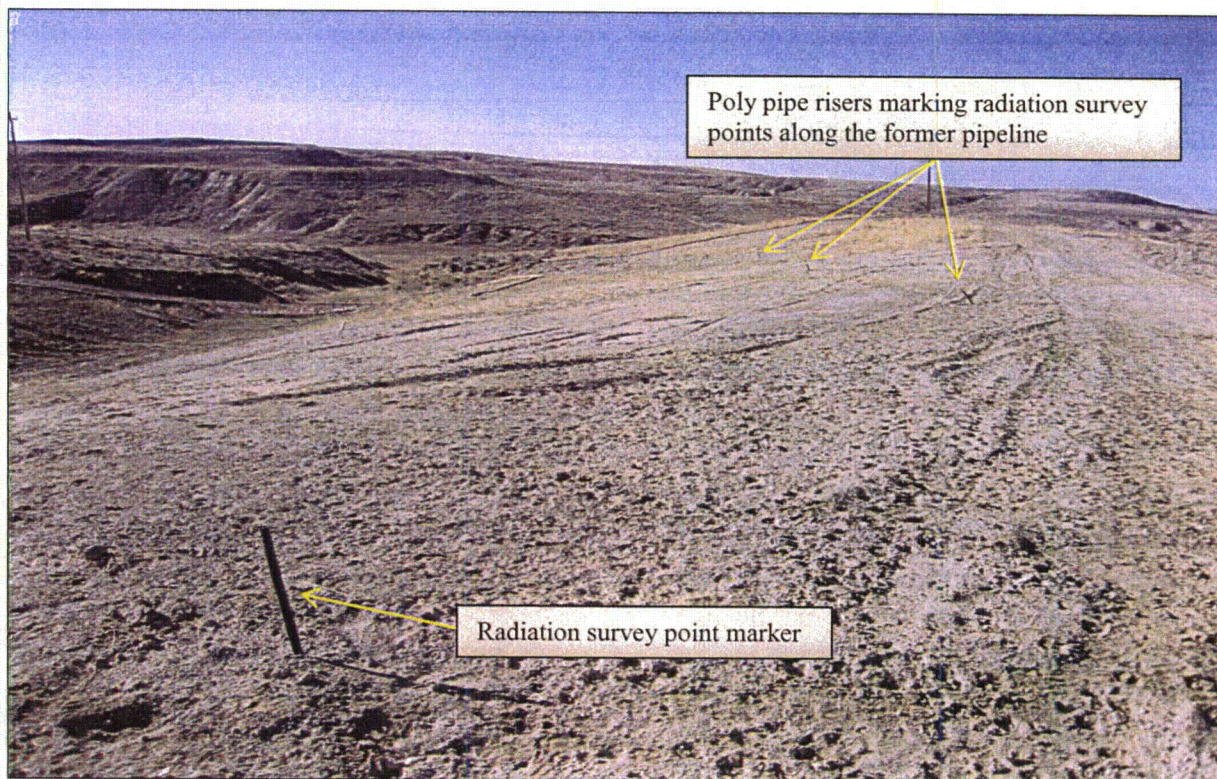
In Mine Units 7, 8 and 9, the well header houses, buried trunk lines, and manholes leading to the buried trunk lines had mostly been removed as noted in previous inspections. In Mine Units 8 and 9, areas where buried wellfield pipeline has been removed were viewed during the inspection. The pipeline trenches had been backfilled and contoured. A radiation survey had been conducted in the area and survey points were marked with poly pipe risers per NRC requirements (**Photos #13 & 14**). To date, all remaining wellfield pipeline has been removed and is being prepared for shipment to Shirley Basin for 11(e) byproduct disposal. It was noted

**Photo #13** – View looking northwest of wellfield pipeline removal area Irigaray Mine Unit 9.

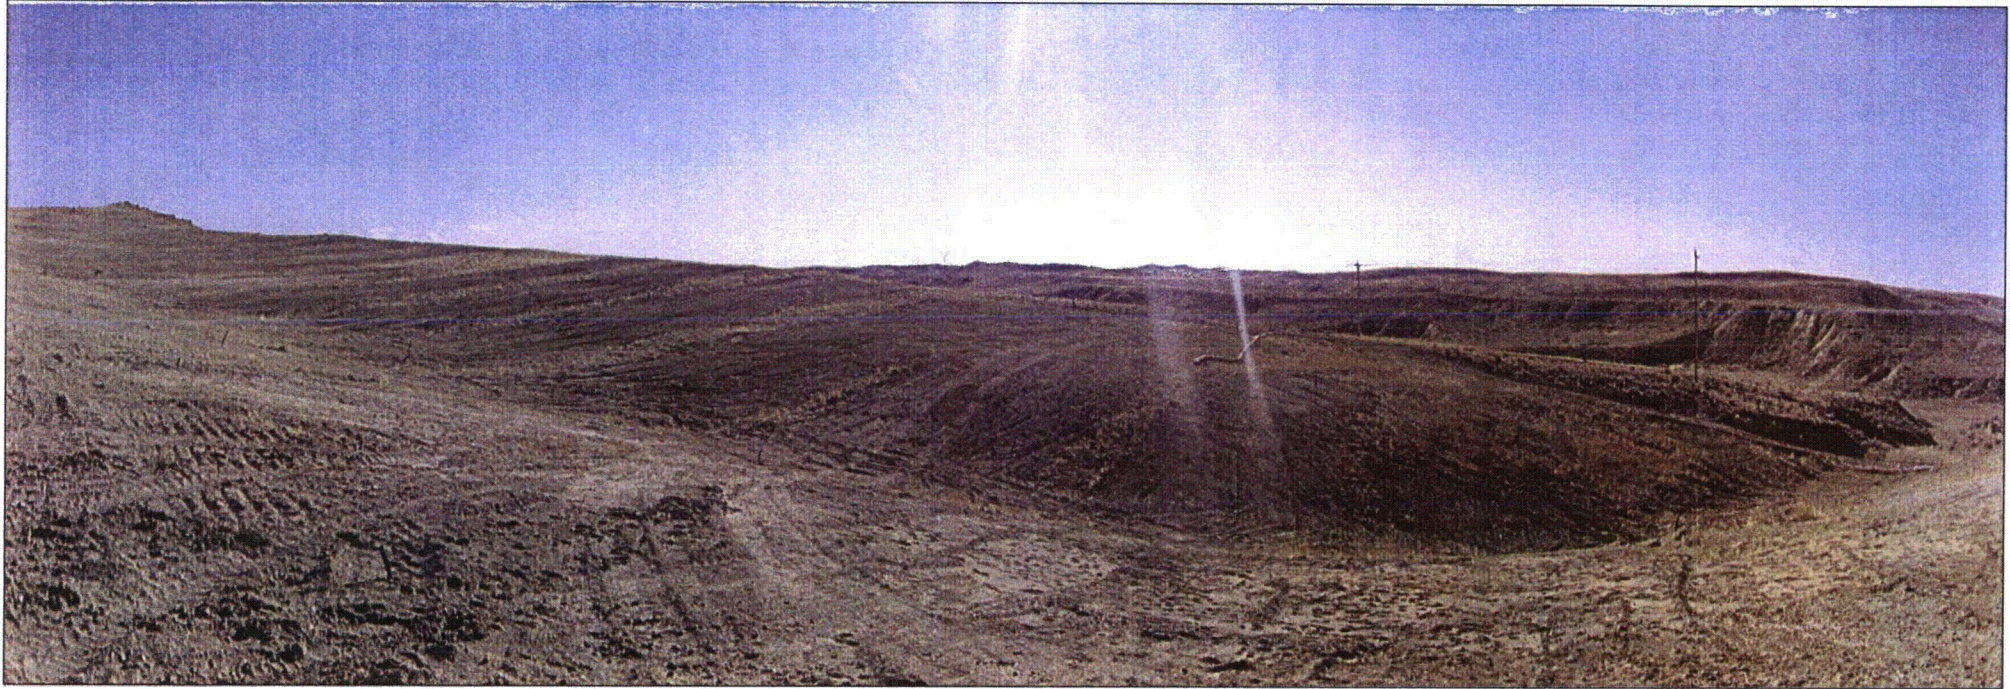
**Photo #14** – View looking southwest of wellfield pipeline removal area Irigaray Mine Unit 9. Radiation survey point markers are present along the former pipeline corridors but not visible in this photograph.
