January 21, 2010
File No.: 16977.07.2-ALB10RP001

**SUBJECT: STABILITY ANALYSIS OF THE LARGE TAILING IMPOUNDMENT
HOMESTAKE GRANTS PROJECT
GRANTS, NEW MEXICO**

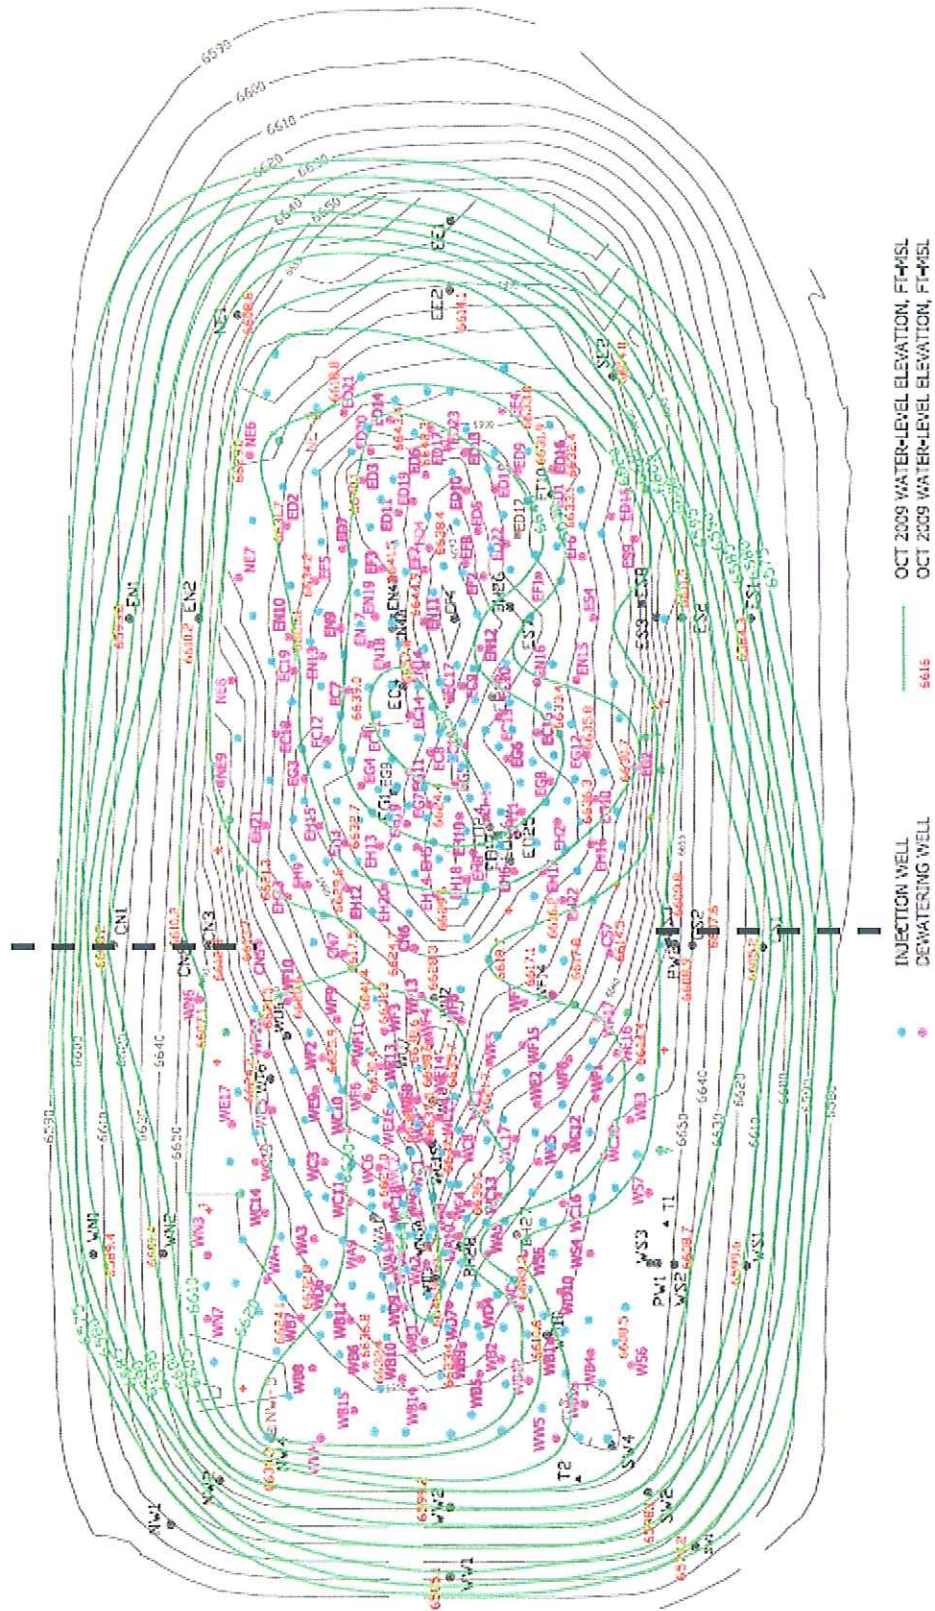
Subsequent to that report, you requested that I perform the recommended stability analysis. That analysis has been completed, and this letter reports the results. Stability analysis was performed on cross-sections of the north and south slopes of the impoundment. The analyzed cross-sections are north-south lines that intercept piezometers CN1 and CS1 on the north and south slopes, respectively (Figure 1).

Figure 1 – Locations of CN1 and CS1 Cross-sections of Large Tailing Impoundment

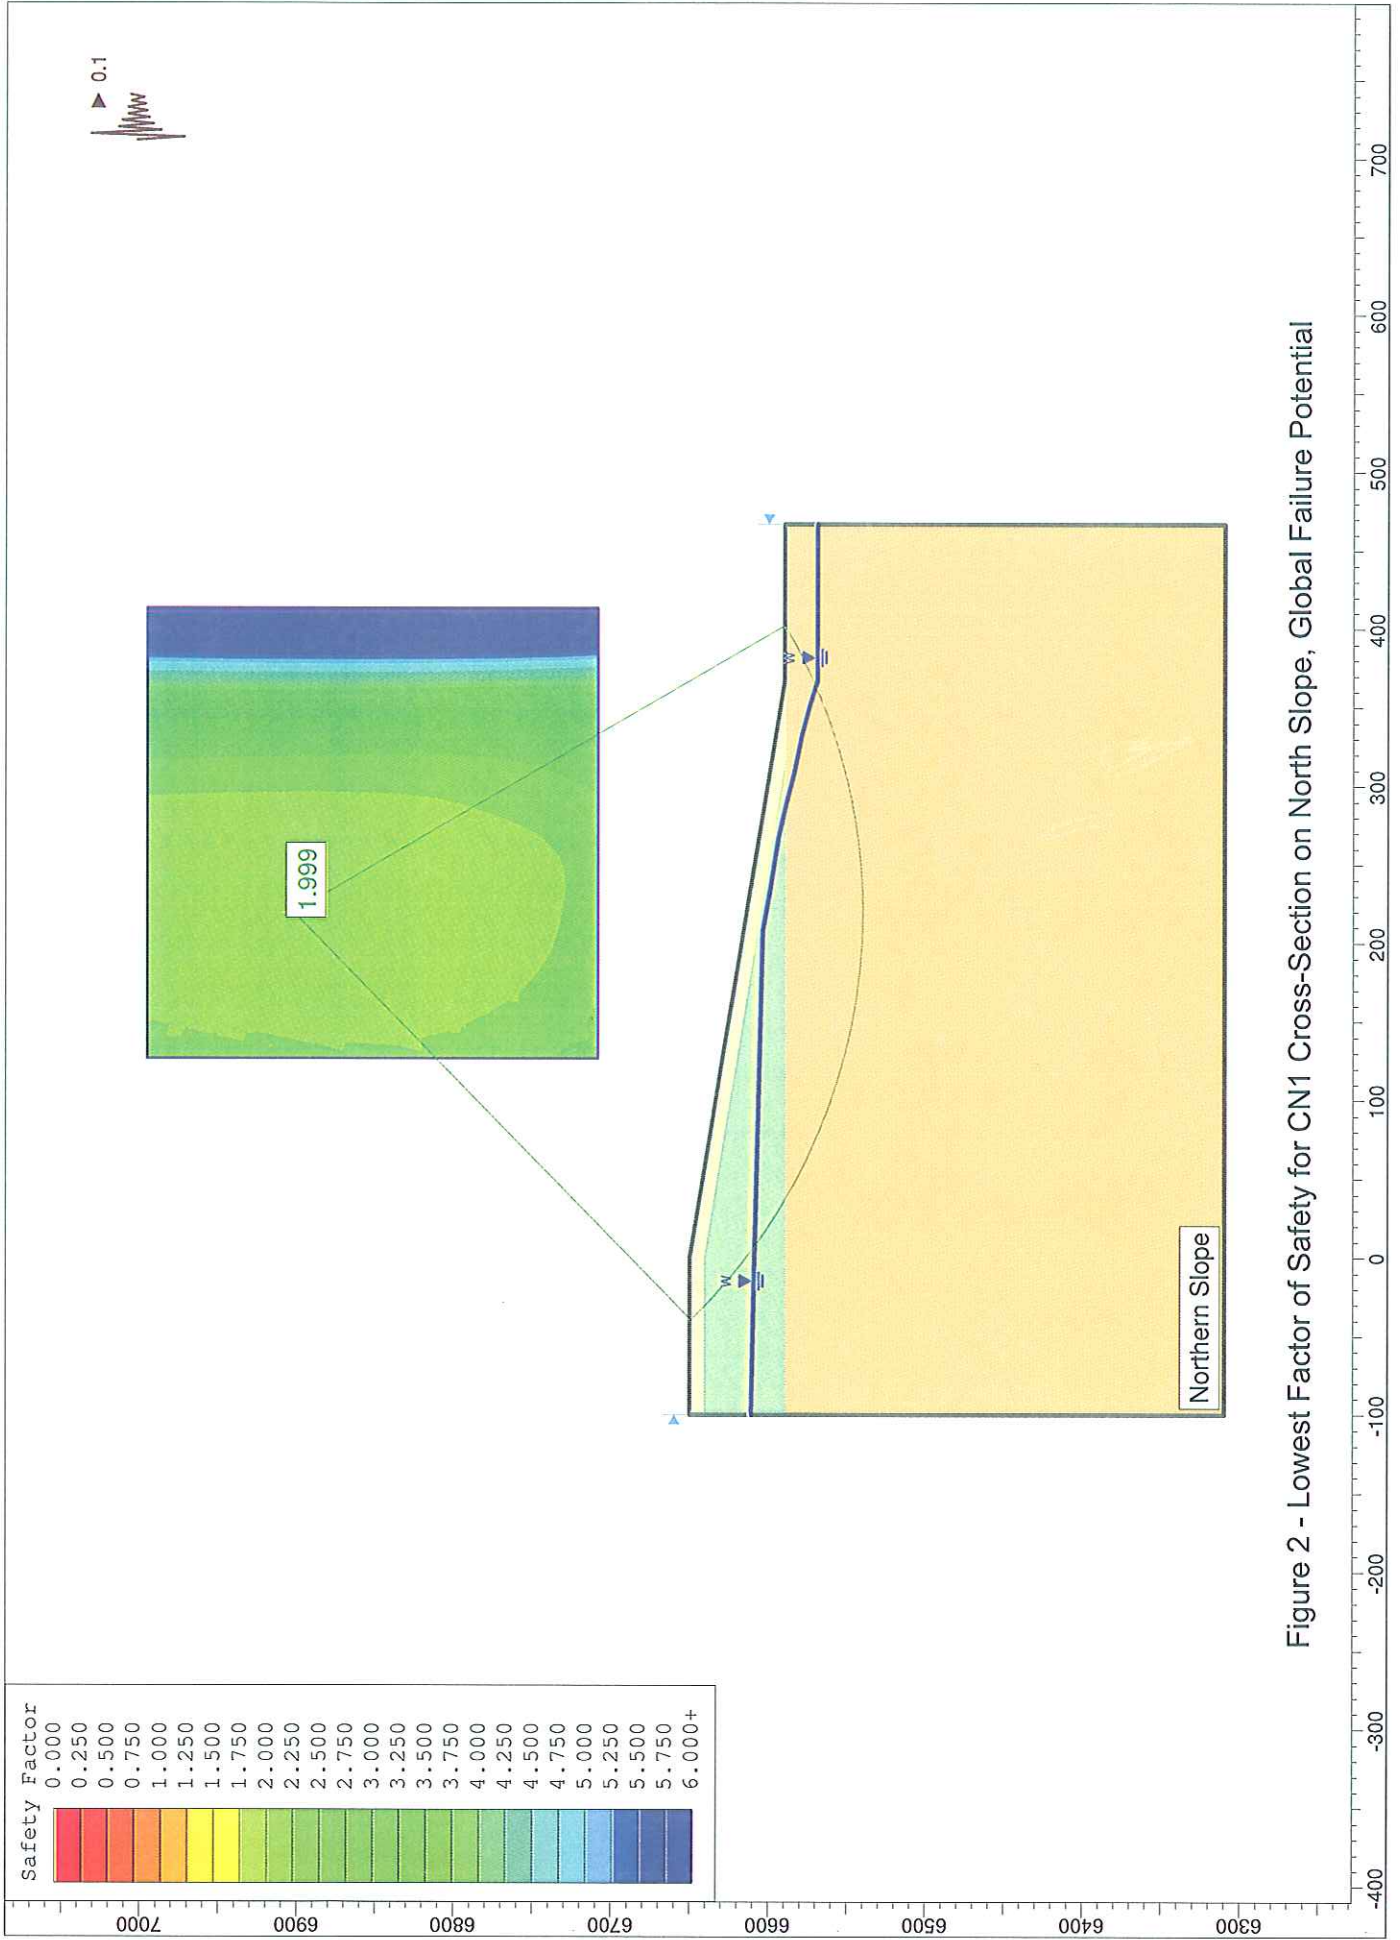
The potential failure surface limits were set to search 1) potential global failure surfaces throughout the entire length of slope as well as above the top and below the toe of the slope (Figure 2 and 3) and 2) shallower potential failure surfaces within the slope (Figures 4 and 5). The attached figures display the potential failure surface with the lowest factors of safety, rounded to the nearest tenth, against rotational failure in each slope analysis. The lowest factors of safety for the north slope section are 2.0 and 2.3 for deep-seated global slope failure and for shallower failures within the slope,

Figure 2 - Lowest Factor of Safety for CN1 Cross-Section on North Slope, Global Failure Potential

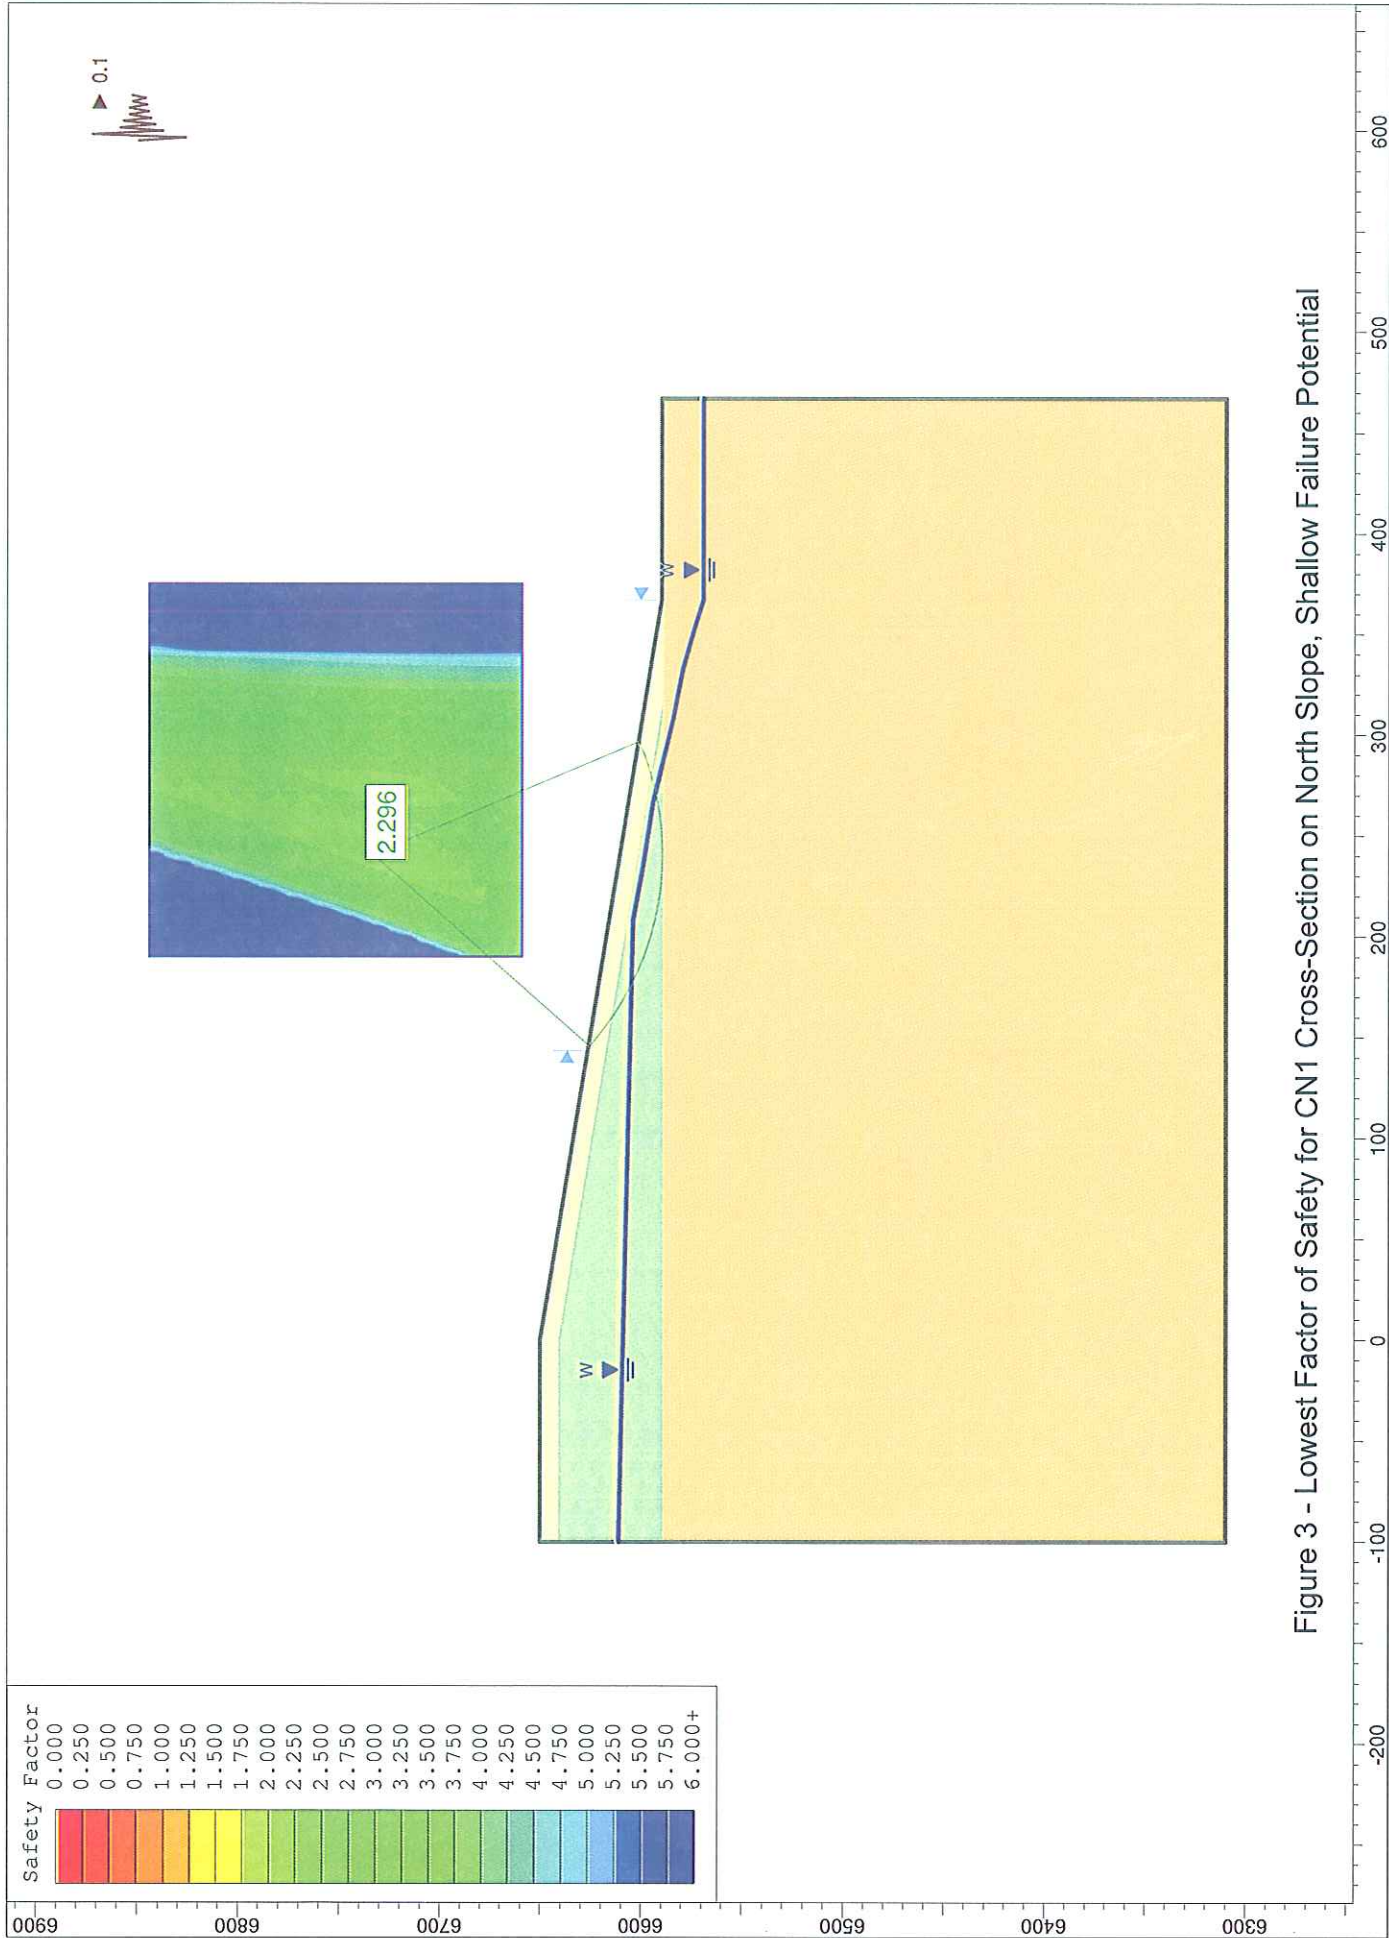
Figure 3 - Lowest Factor of Safety for CN1 Cross-Section on North Slope, Shallow Failure Potential

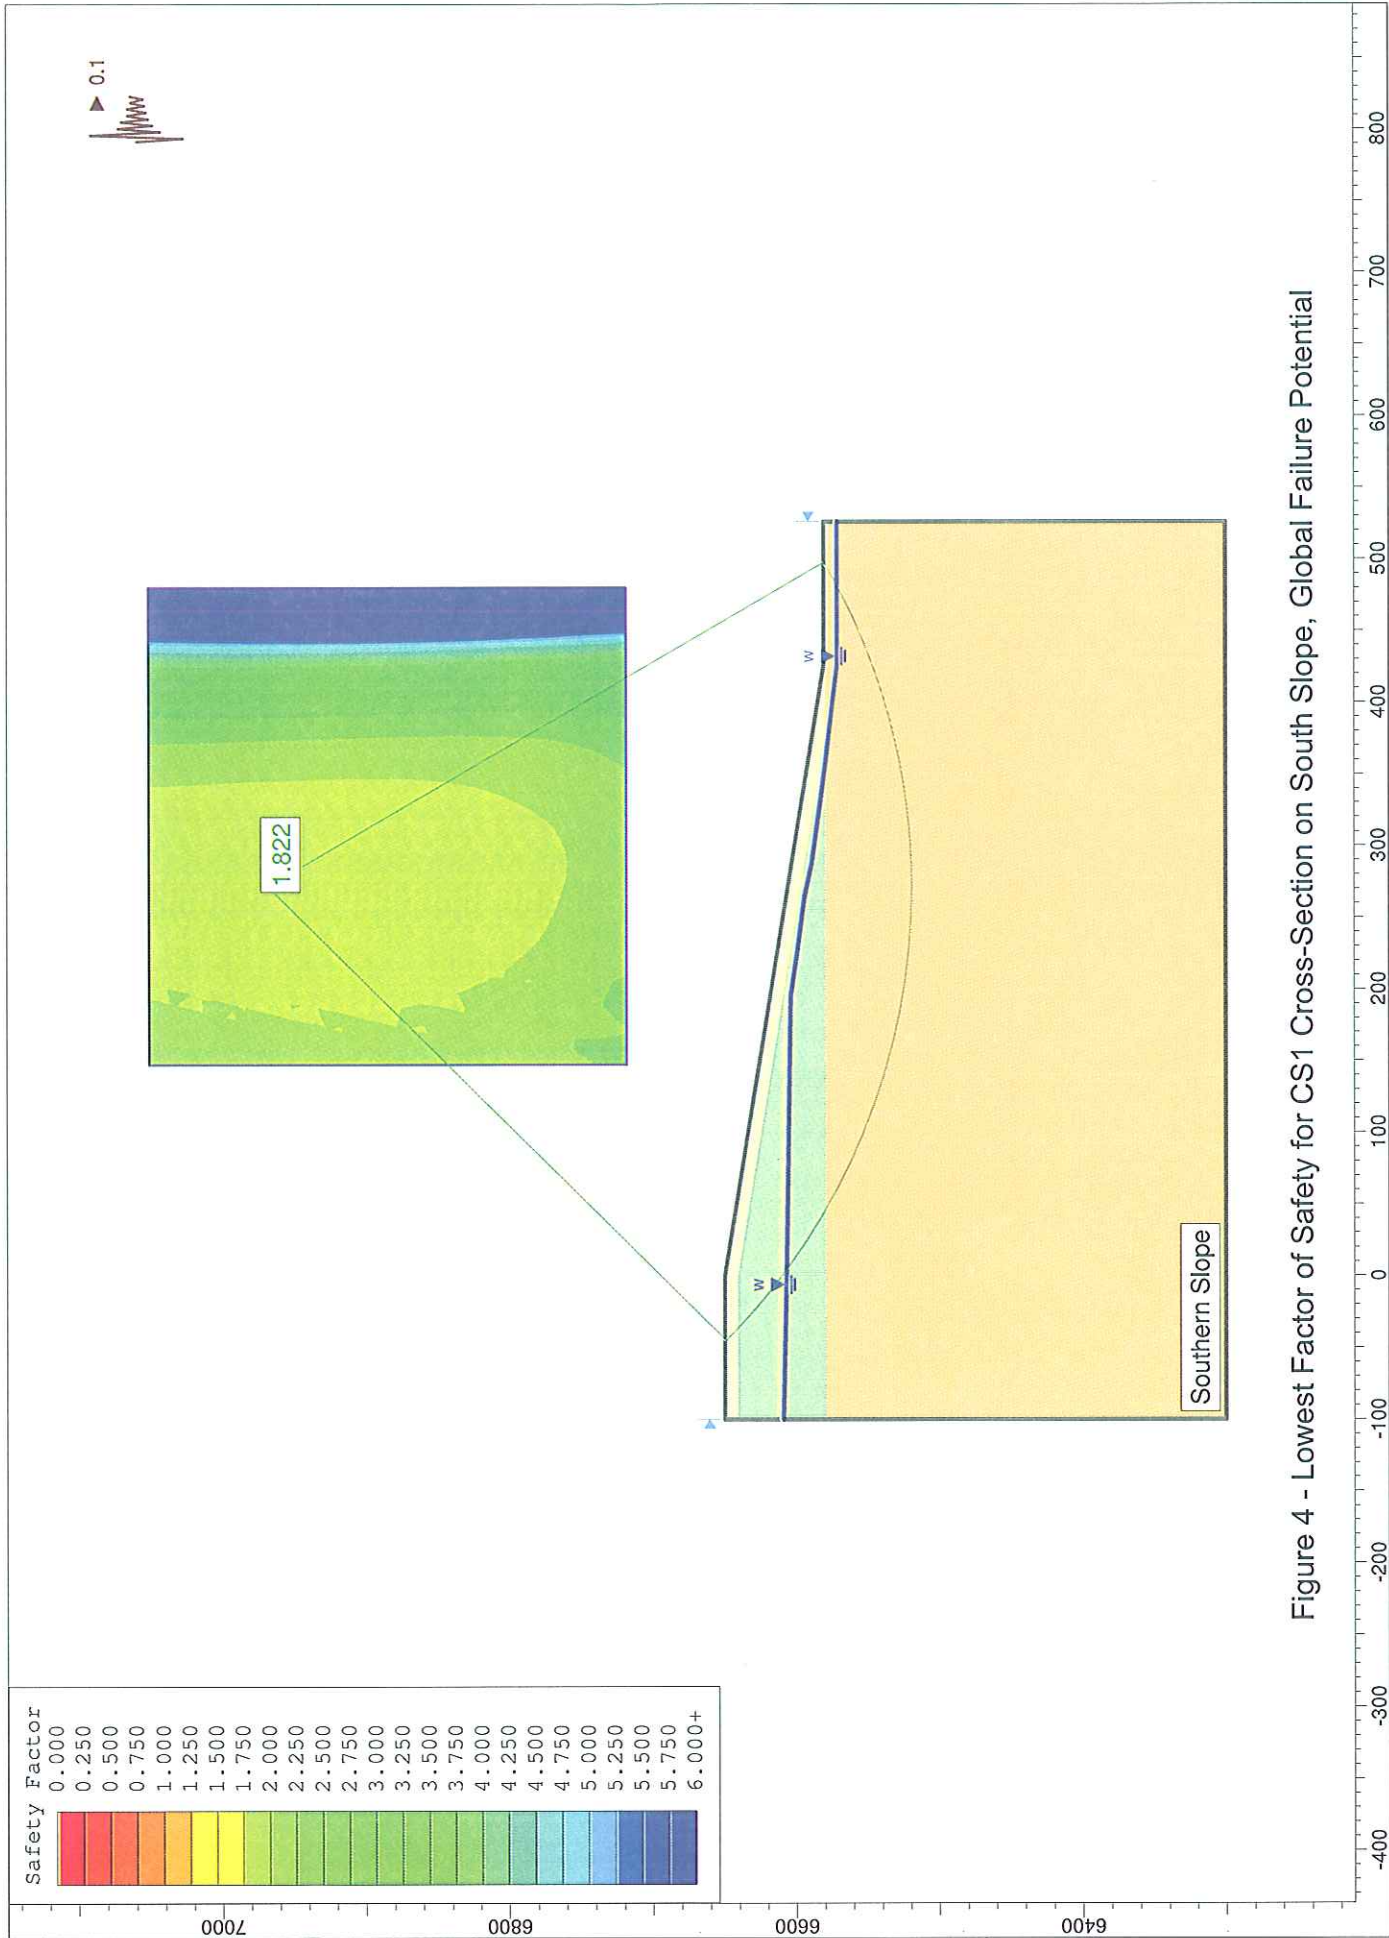
respectively. The lowest factors of safety for the south slope section are 1.8 and 2.1 for deep-seated global slope failure and for shallower failures within the slope, respectively. All of these factors of safety are well above the minimum required value of 1.0.

Figure 4 - Lowest Factor of Safety for CS1 Cross-Section on South Slope, Global Failure Potential

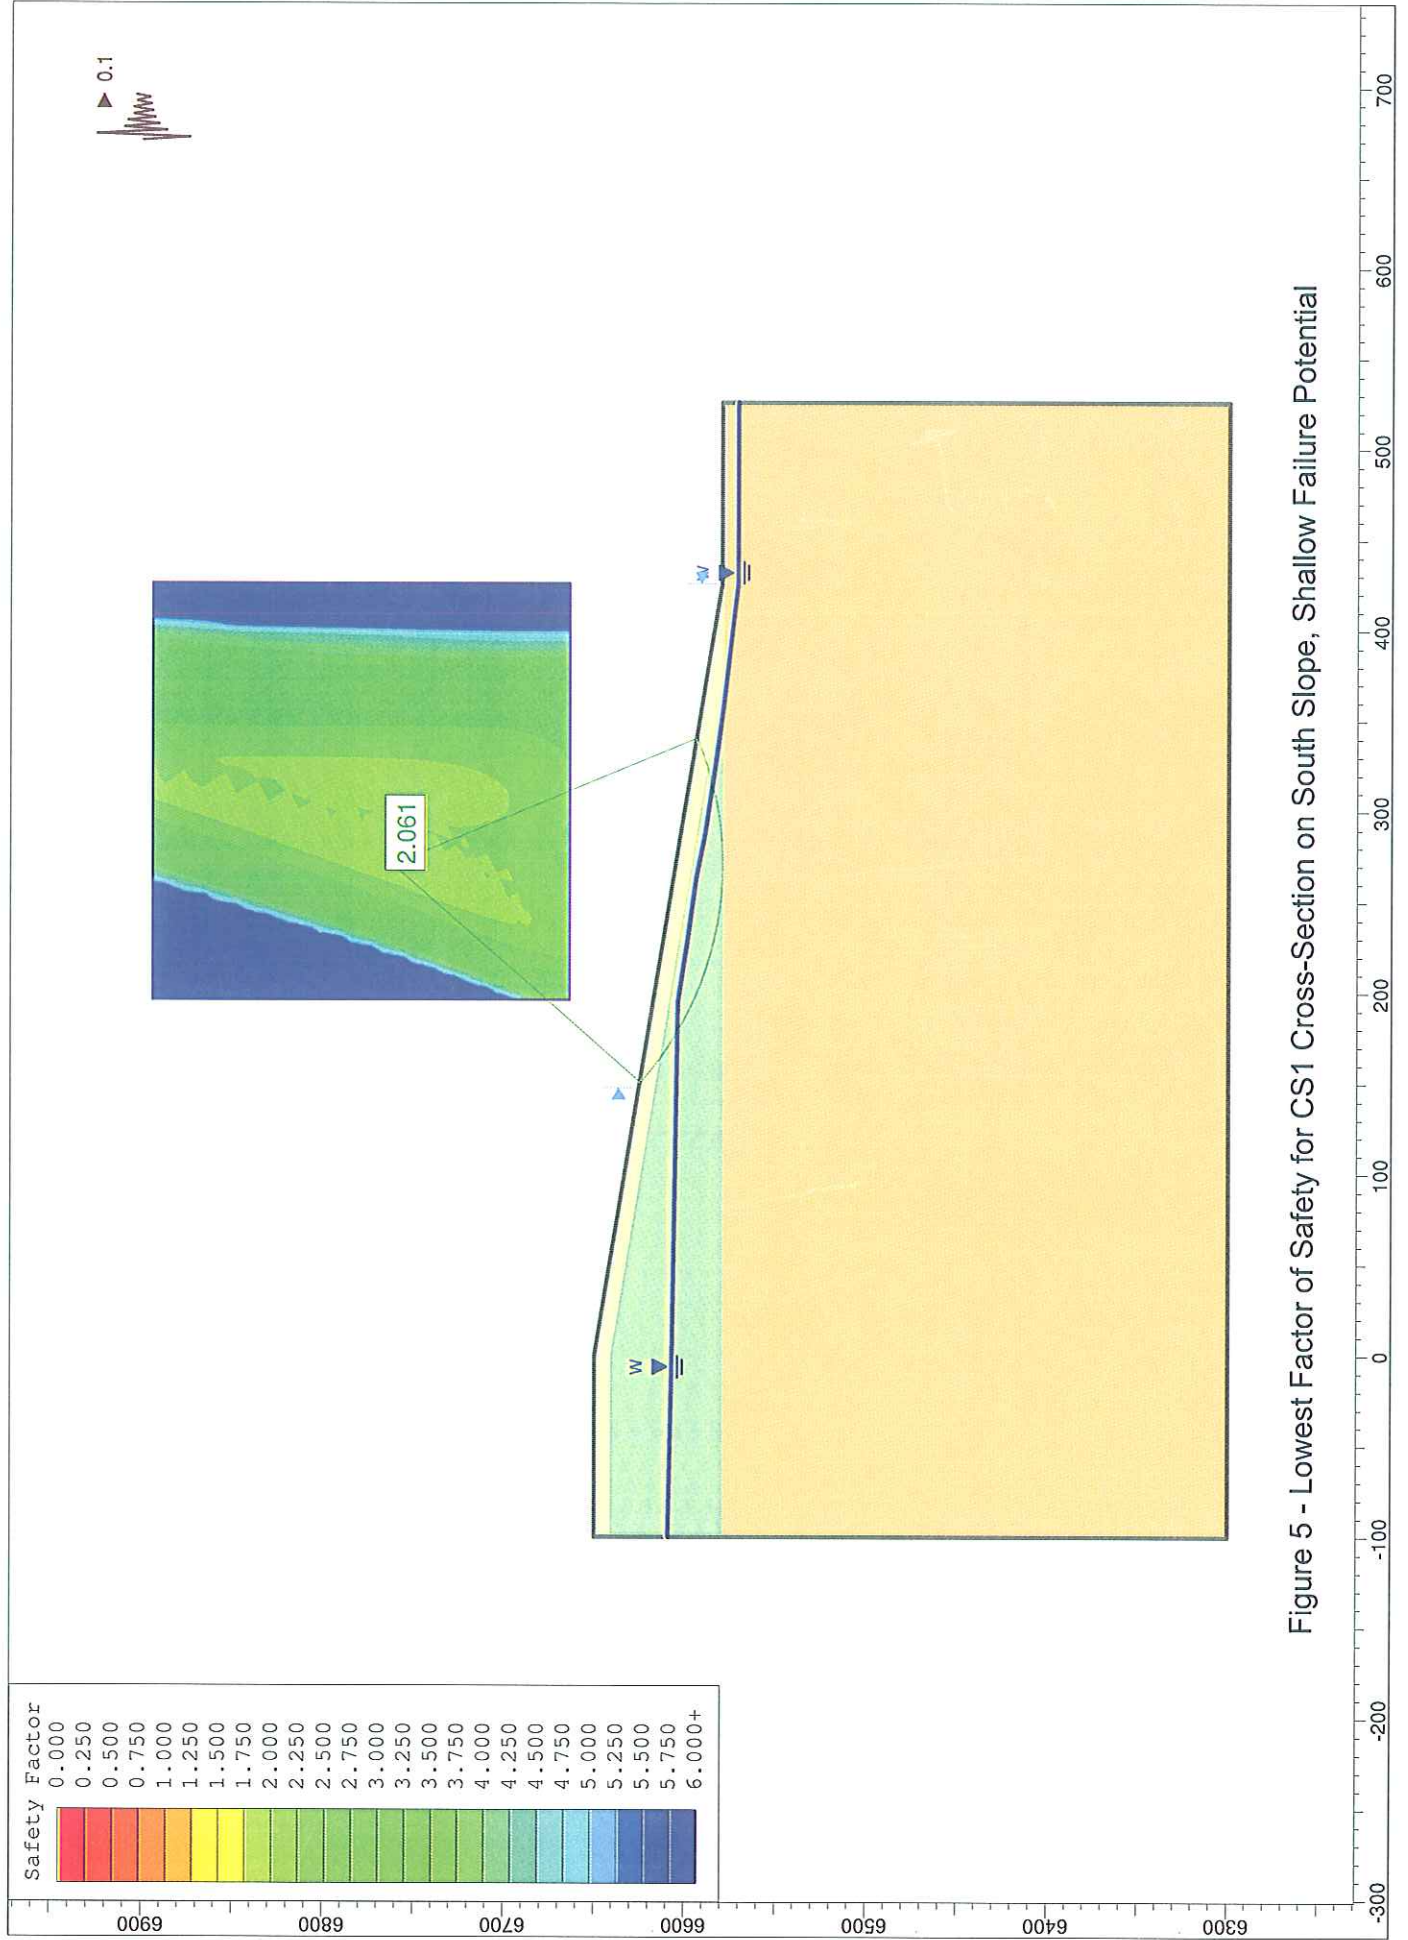
Figure 5 - Lowest Factor of Safety for CS1 Cross-Section on South Slope, Shallow Failure Potential
