**Re: Summary of 2013 Annual Inspection, Lost Creek ISR Project, Permit #788**

**Wyoming Department of Environmental Quality (WDEQ)- Land Quality Division (LQD)**  
**Inspection Memorandum**

File: Lost Creek ISR, LLC – Permit 788

Subject: Annual Inspection

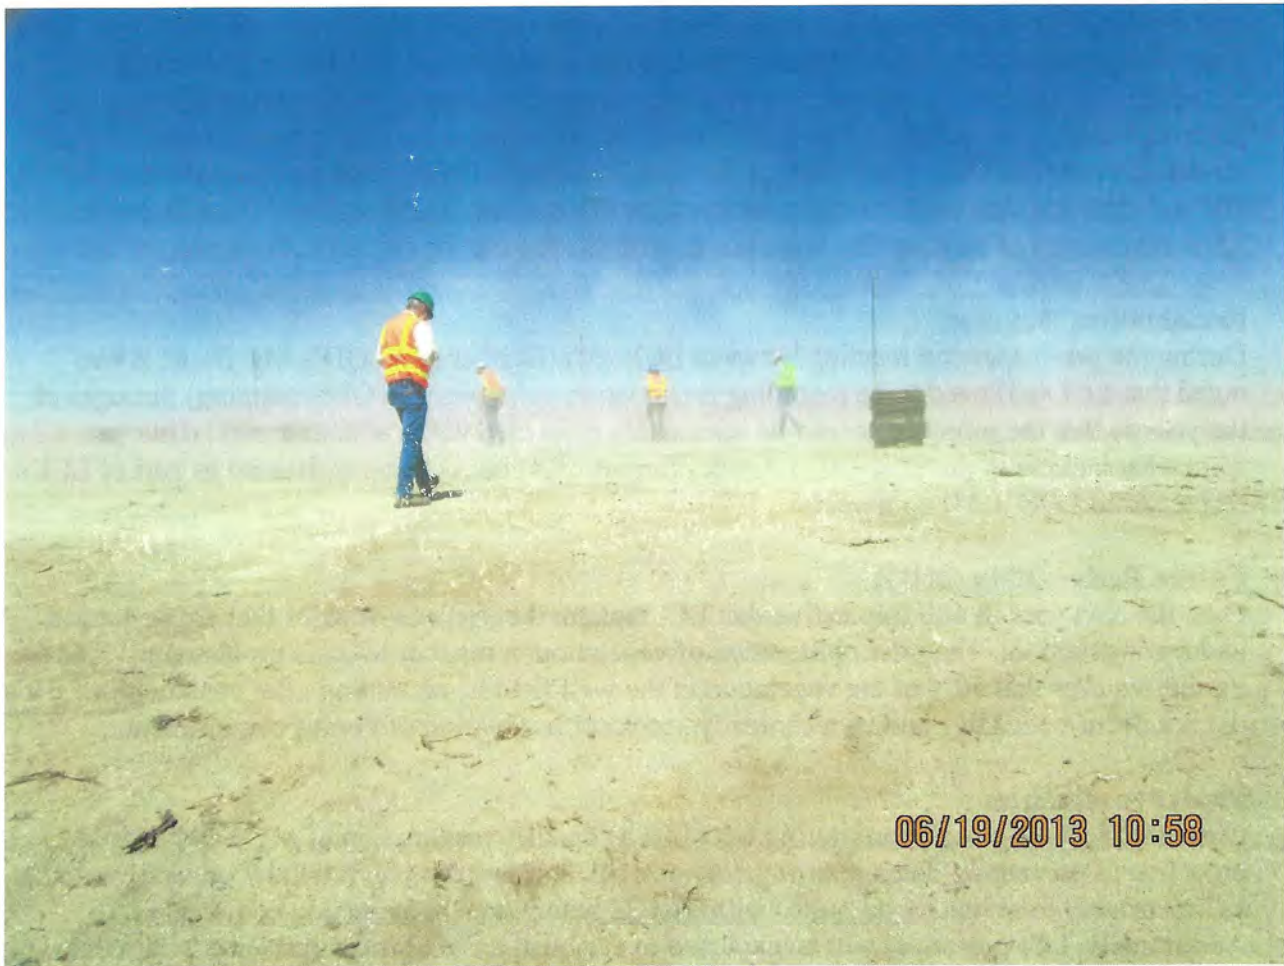
During this Annual Inspection a veritable “sand-storm” had developed across the MU1 well field in response to the 25 mph sustained winds and 35 mph gusts that were occurring that day. No photos were taken of that phenomenon on November 6, 2013 because it was too difficult to photograph. However, the field inspection participants duly noted the intensity of the wind during the Inspection as well as the large amounts of topsoil blowing off the MU1 well field. Another windy day during the summer at the site was captured in the photo below.

**Figure 1: This depicts a high-wind day in the MU1 well field at the Lost Creek site. The date stamp on the photo above is accurate, indicating it was taken on June 19, 2013. This type of topsoil loss due to the degradation of the vegetation (see roots of sagebrush in photo) is truly incalculable.**

**LCI is expected to formally respond to the topsoil loss problem associated with the excessive degradation of vegetation in the MU1 well field. That formal response should include a written action plan to be submitted no later than December 31, 2013. In the absence of a plan, LQD will have no choice but to pursue enforcement action for the failure to meet Permit commitments with regard to the degradation of the vegetation in well field MU1.**

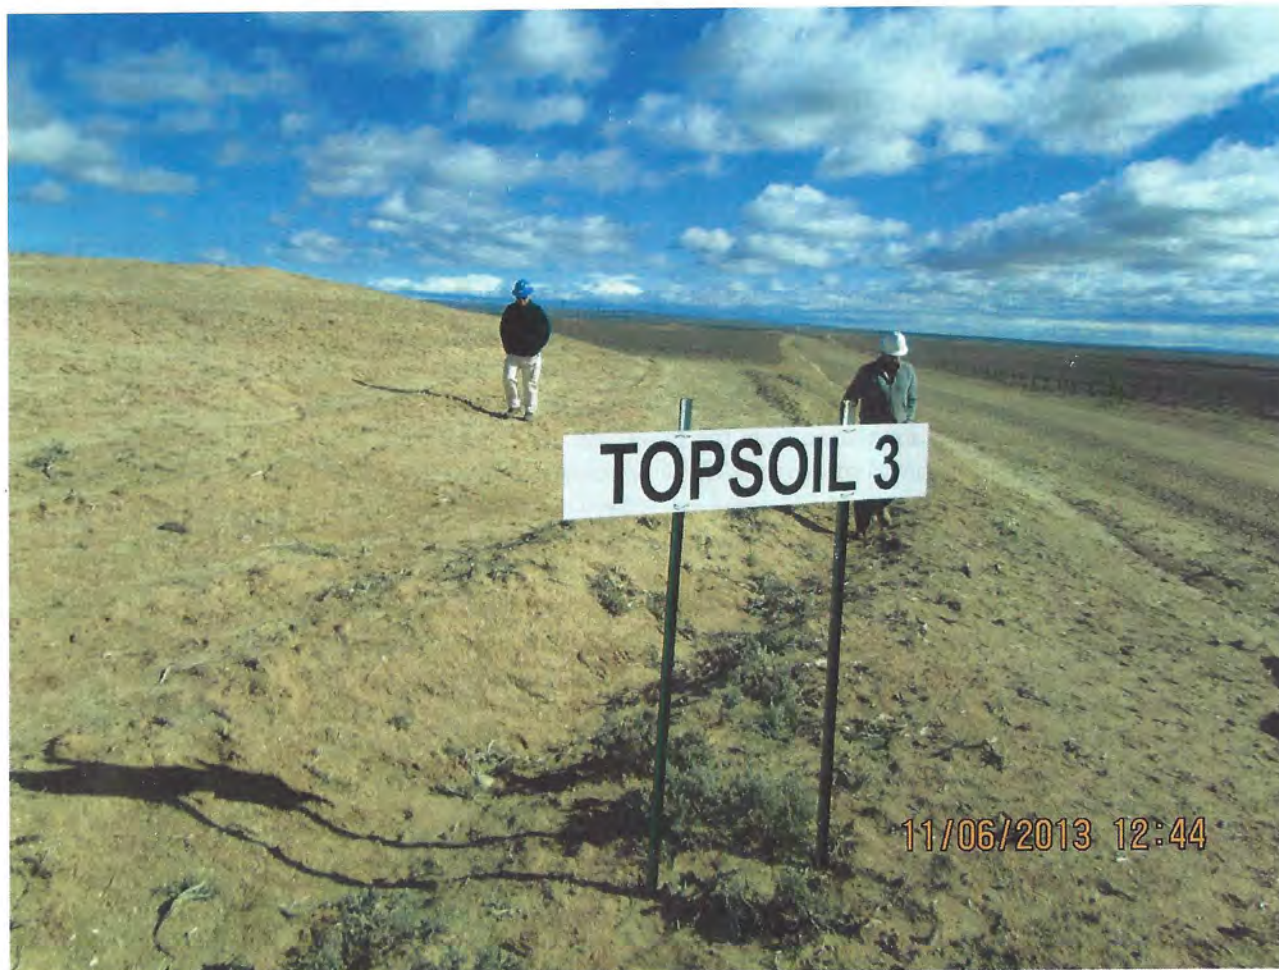
**Figure 2:** This photo was taken on November 6, 2013 on a very windy day. Absolutely no topsoil was seen blowing off any of the site's topsoil stockpiles during this Inspection. Whereas the MU1 well field, on this day, looked like it did in the above photo from June 2013.

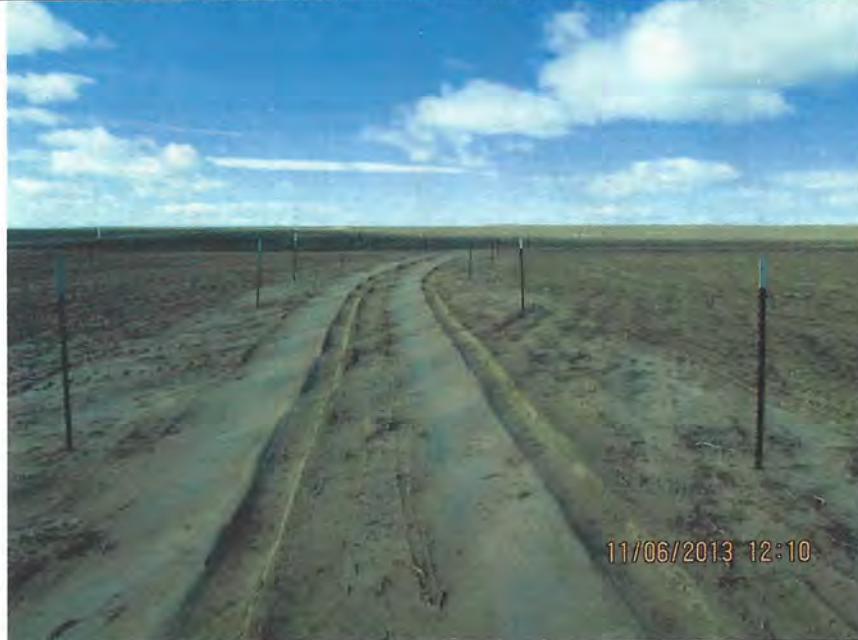
**Photo Number 1:** This depicts the travel route established leading to the DDW-1 well head. Areas outside this travel route were recently reseeded in the fall of 2013. This method of travel route establishment is applauded and should be implemented at other locations across the site, where vehicular travel is intended to be restricted.

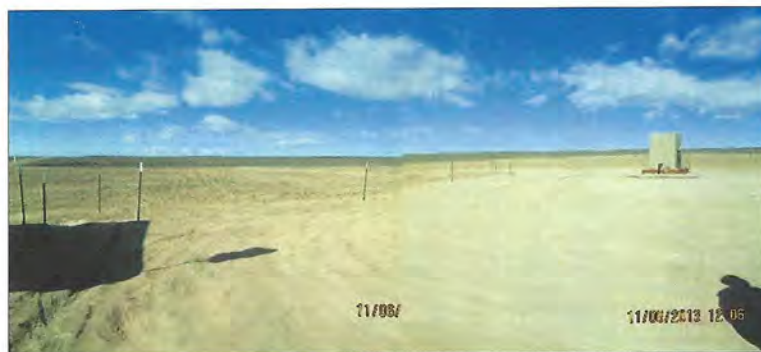
**Photo Number 2:** This is a panoramic view of a portion of the DDW-1 well pad and associated travel route delineated by t-posts. The structure in this view is the well head housing. The shadow on the left side of the photo is from the pump-house for DDW-1. The view is looking west by northwest. Recent (fall 2013) reclamation (in the form of reseeded) is evident beyond the t-posts.

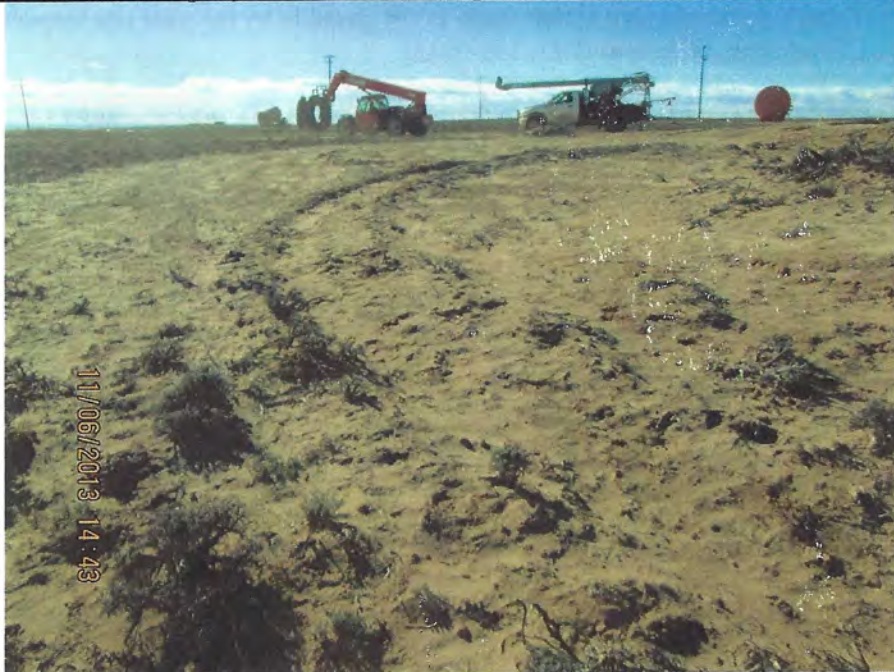
**Photo Number 3: This depicts the toe ditch at the south end of topsoil stockpile #6. It is in constant need of maintenance due to its proximity to the road leading to the Plant Site.**

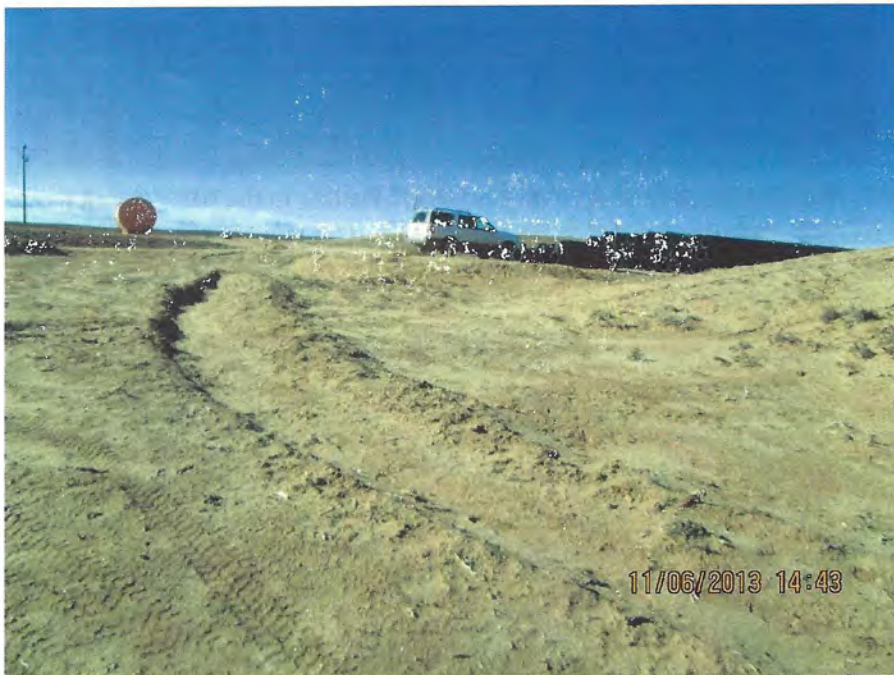
**Photo Number 4: This depicts the toe ditch in the south end of the topsoil stockpile at DDW-4.**

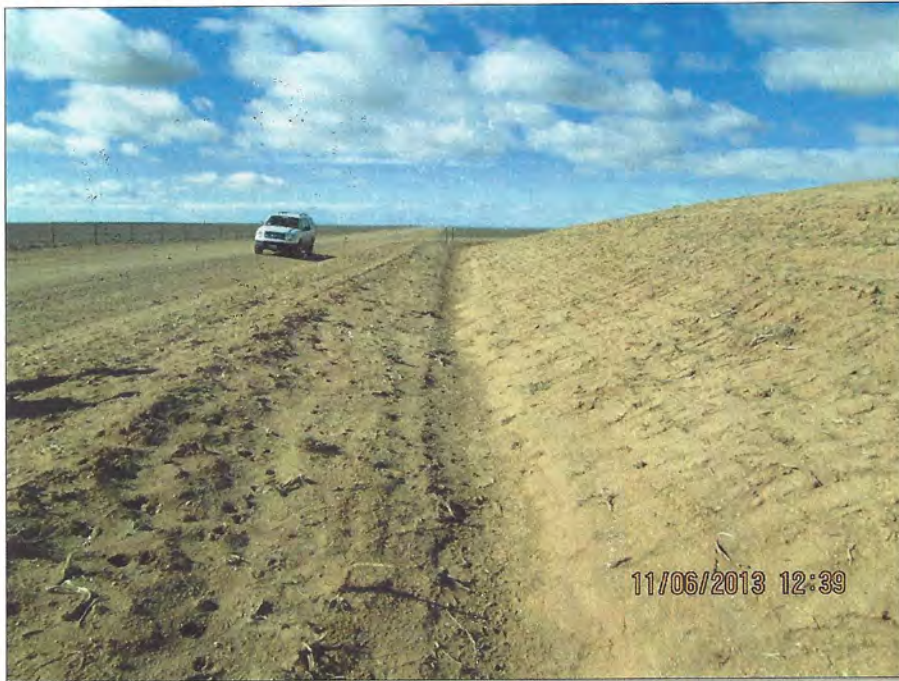
**Photo Number 5: This depicts the toe ditch on the south face of topsoil stockpile #2. This view is looking west. The LCI project's access road is on the left side of this photo. This ditch is in good condition.**

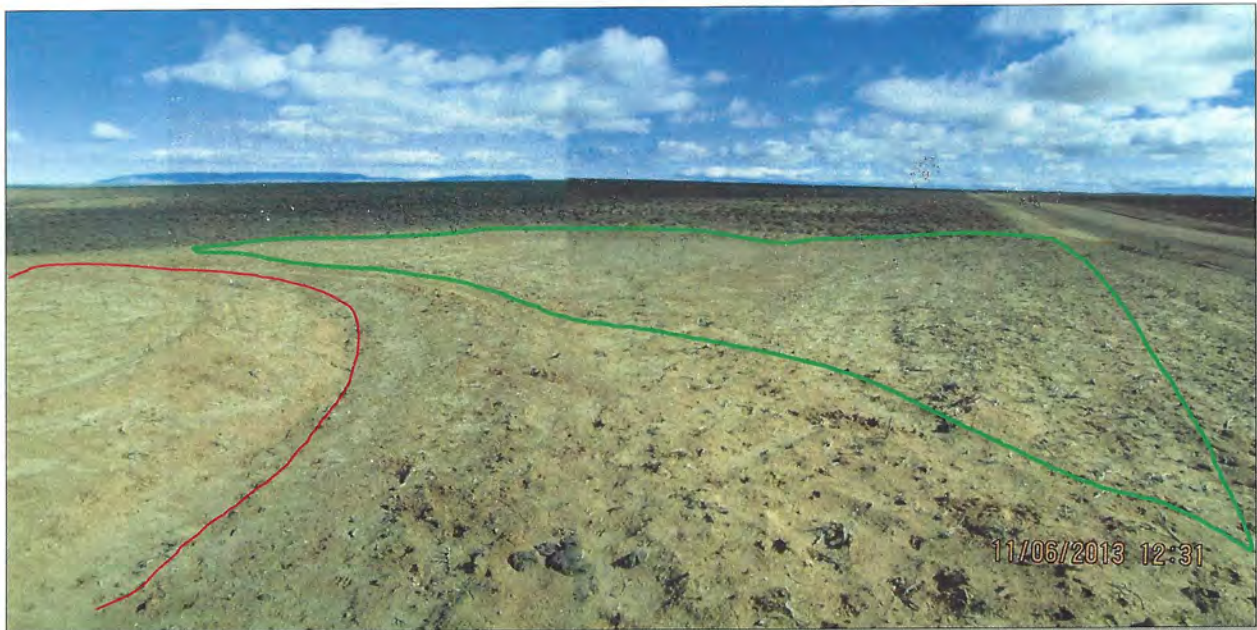
**Photo Number 6: This depicts the east edge of topsoil stockpile #1. The view is looking east. In addition to depicting the stockpile's toe ditch (indicated with a red line), this panoramic also depicts a triangular-shaped area of reclamation (indicated with a green outline). This reclamation was necessary due to the route that scrapers took when approaching this stockpile during its construction.**

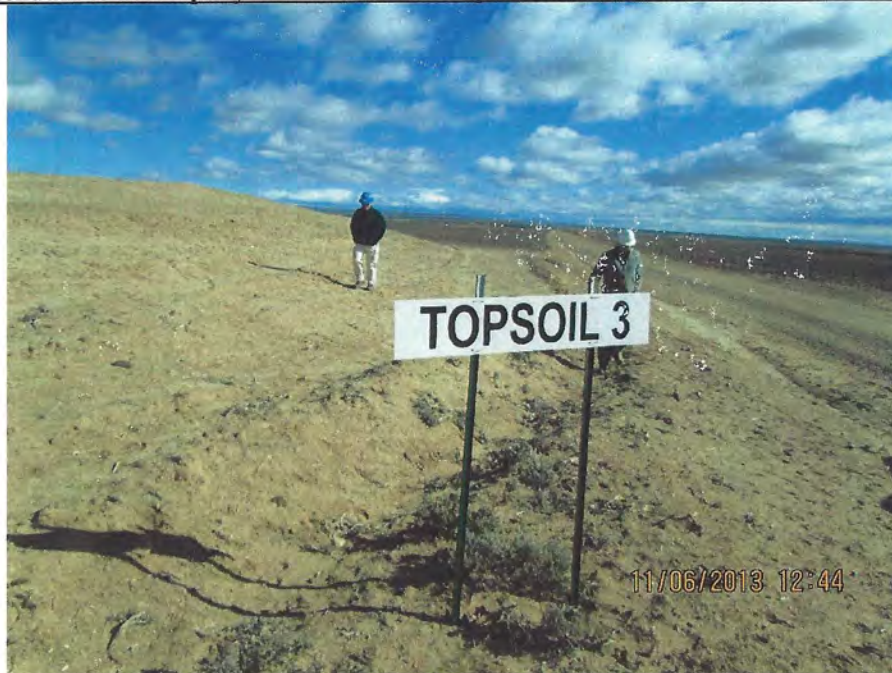
**Photo Number 7: This depicts the sign identifying topsoil stockpile 3. The view is looking east.**

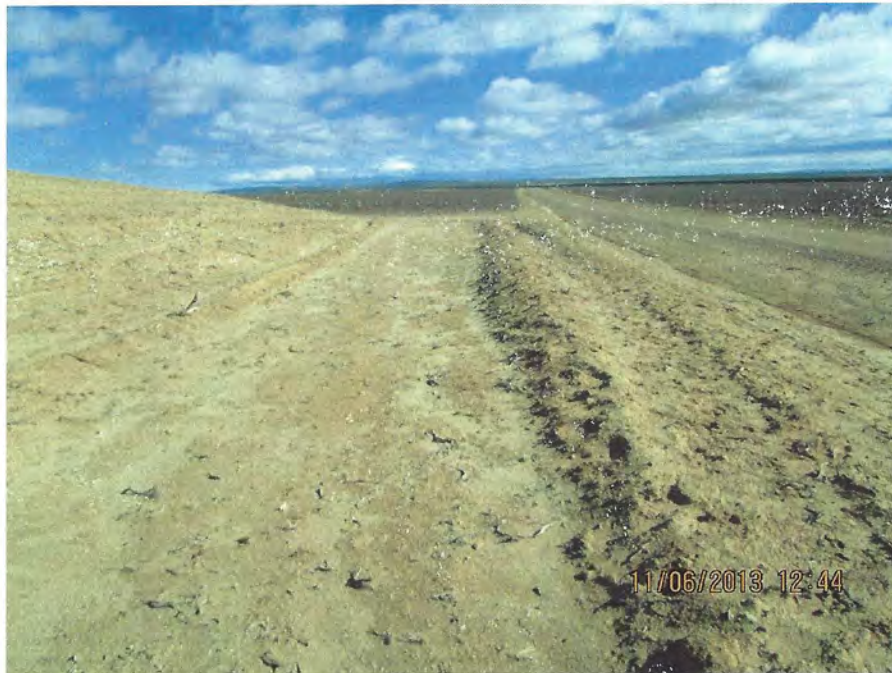
**Photo Number 8: This depicts the toe-ditch around topsoil stockpile 3. It is in good condition here but is in need of some extra definition in some locations.**

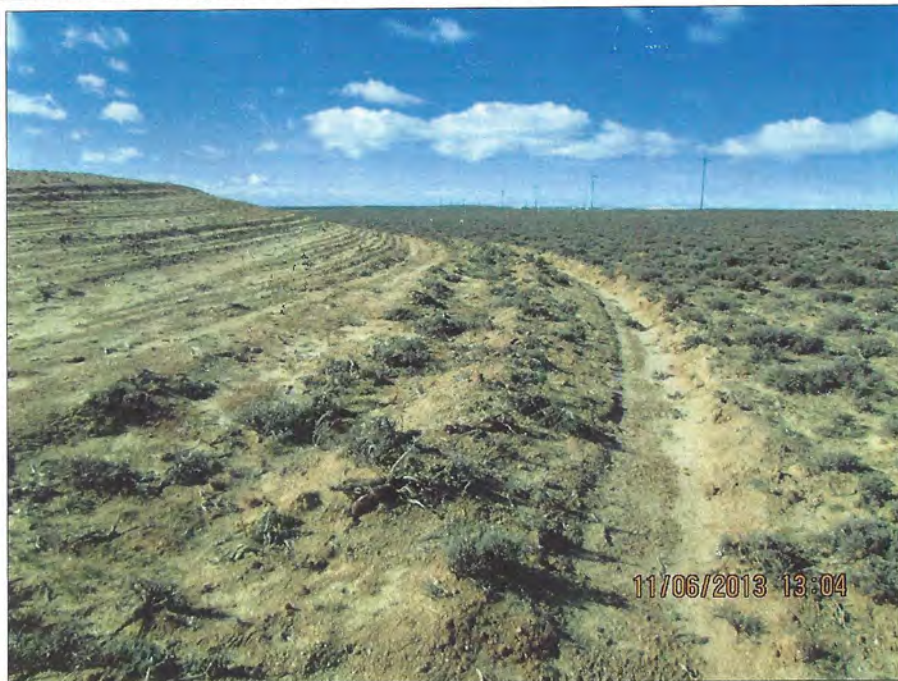
**Photo Number 9: This depicts the toe ditch at the northwest corner of topsoil stockpile #4.**

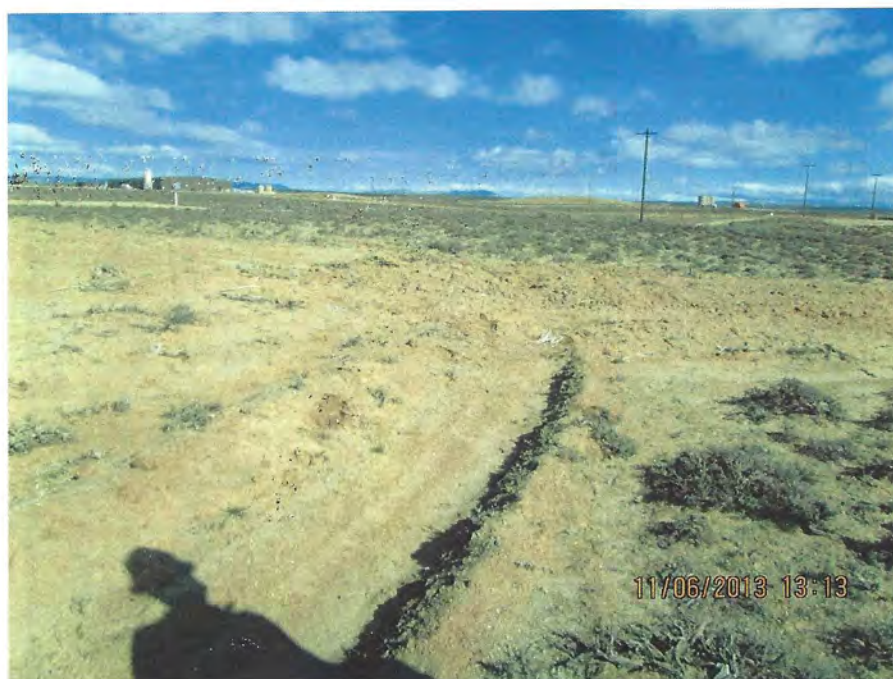
**Photo Number 10: This depicts the east end of the toe ditch around topsoil stockpile #5. This area needs to be redefined. View is looking northeast.**

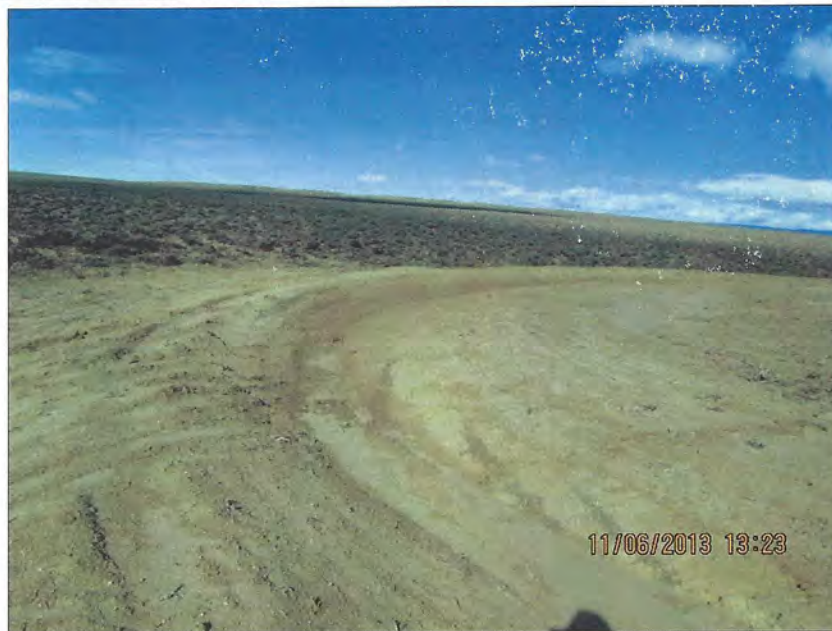
**Photo Number 11: This depicts the toe-ditch around topsoil stockpile #8. It is an exemplary ditch around the entire perimeter of the stockpile. This view is looking toward the northwest. Note the accumulation of coarse grained sands on the surface. This is due to the winnowing of finer materials from the topsoil due to wind erosion.**

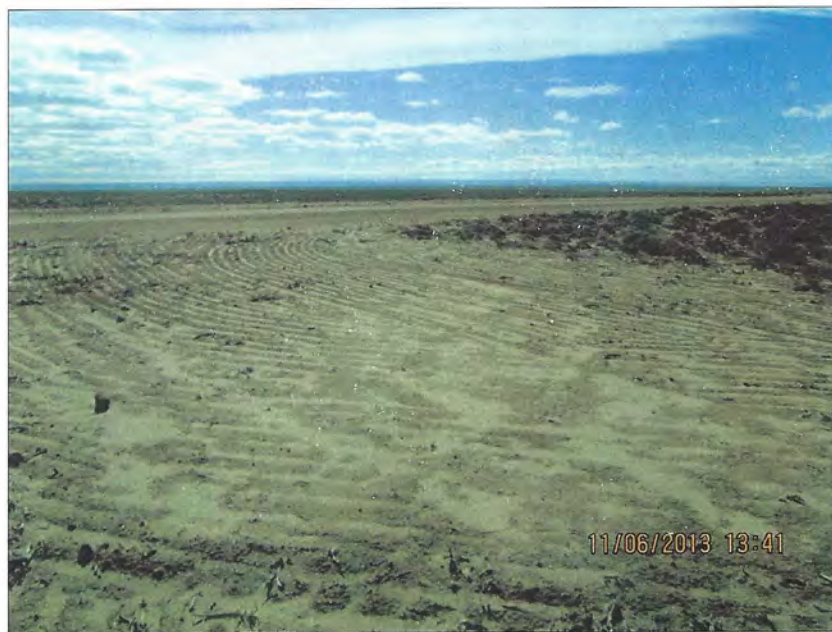
**Photo Number 12: This depicts the southwest corner of topsoil stockpile #10. It depicts a reclaimed area (where the scrapers drove during the stockpile's construction). The coarse sands (light colored materials) cap the surface here because of winnowing of finer portions of the topsoil due to wind erosion.**

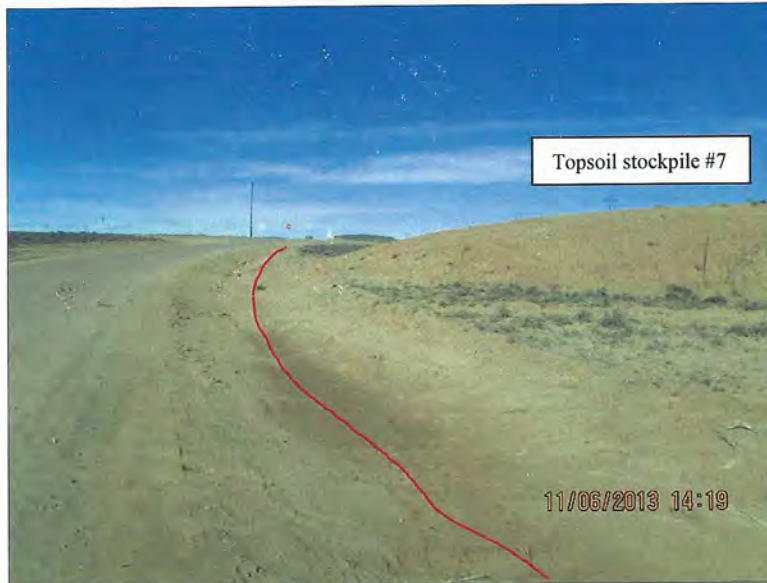
**Photo Number 13:** This depicts the west edge of topsoil stockpile #7. This stockpile is immediately adjacent to the road that leads to MU1 from the Plant Site. This view is looking north. The road ditch indicated with a red line in this photo also (currently) functions as the stockpile's toe-ditch. This is an unacceptable geometry and must be remedied immediately. The topsoil stockpile must have a unique and wholly separate toe ditch from the road's ditch.

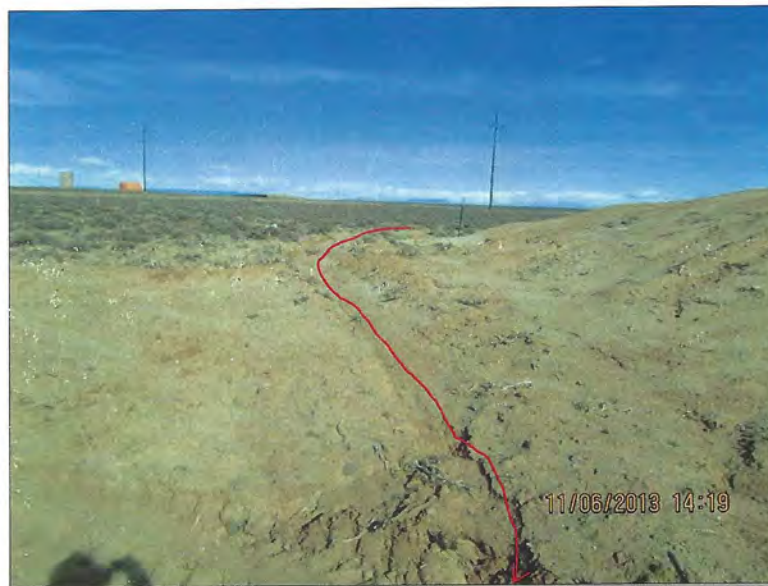
**Photo Number 14:** This depicts the northwest corner of topsoil stockpile #7. The portion of the stockpile's toe ditch that runs along the north edge of the stockpile is indicated here with a red line. The red arrow (bottom of the photo) indicates where that toe ditch empties (via rills) into the road's borrow ditch. As indicated in the caption for Photo Number 13, above, this is unacceptable and must be redesigned. Topsoil will be lost to the road's ditch if this is left as-is.

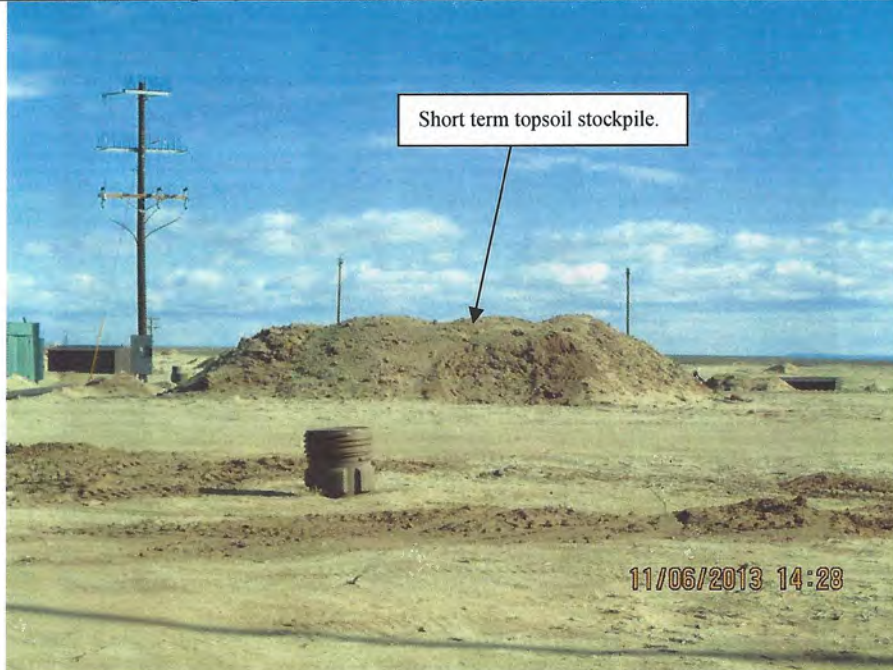
Report depicts long term topsoil stockpiles, no short term topsoil stockpiles were indicated. However, several short-term topsoil stockpiles were noted in the MU1 well-field. **All of the site's short-term topsoil stockpiles must be documented in the Annual Report (including their locations, volumes, and intended destination).**

**Photo Number 15: Short term topsoil stockpile in Mine Unit 1. The site's short term topsoil stockpiles must be inventoried and reported in the Annual Report.**

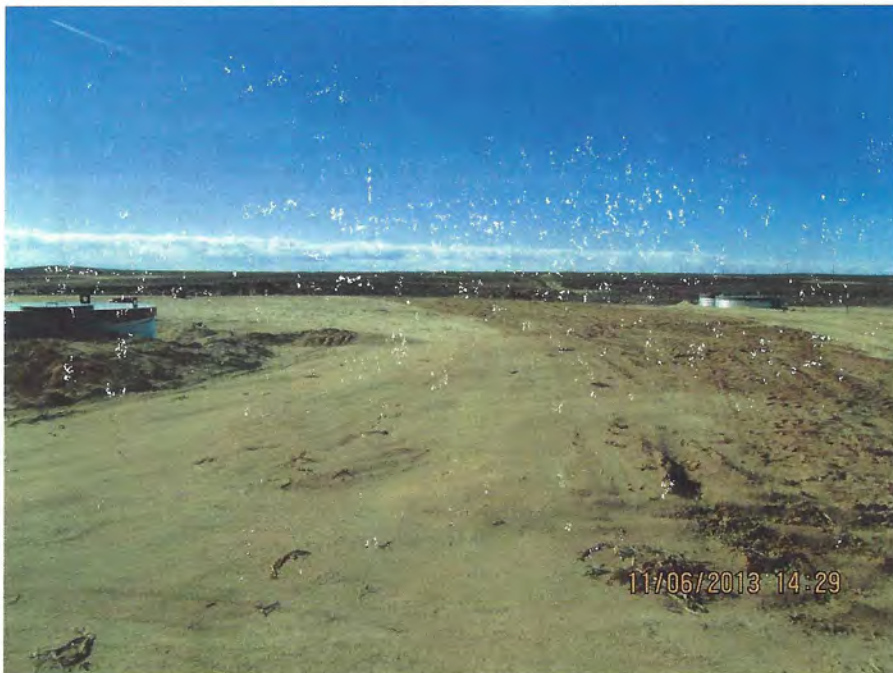
**Photo Number 16: This depicts an area at the northwest corner of MU1 where some topsoil has been respread adjacent to a proposed travel route. Care must be taken in these scenarios to ensure topsoil is not trampled once it is reapplied.**

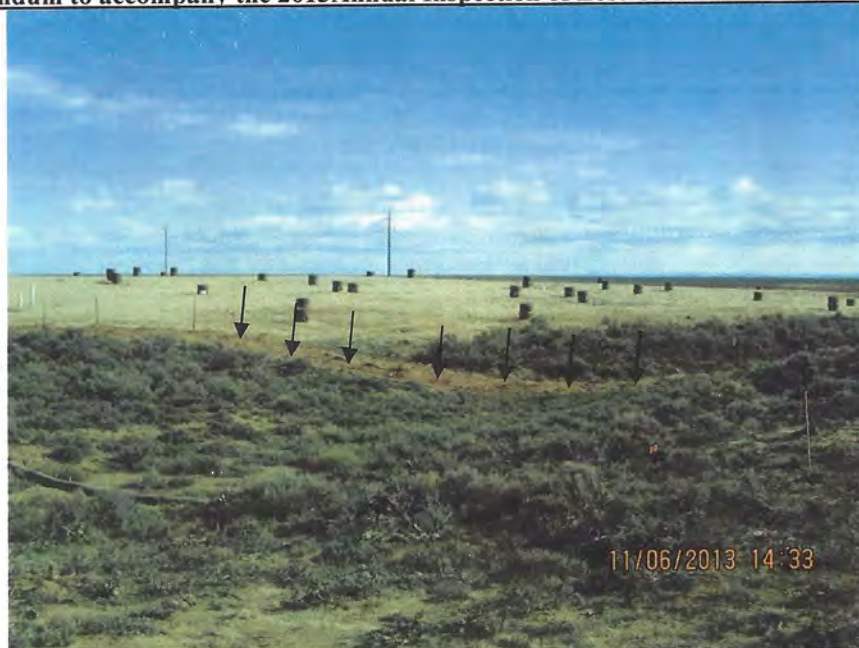
**Photo Number 17: The black arrows depict the repair (reclamation) of an unauthorized travel route coming from the west edge of MU1 across the drainage and heading westward. Well heads in the west end of MU1 are visible in the background in this photo.**

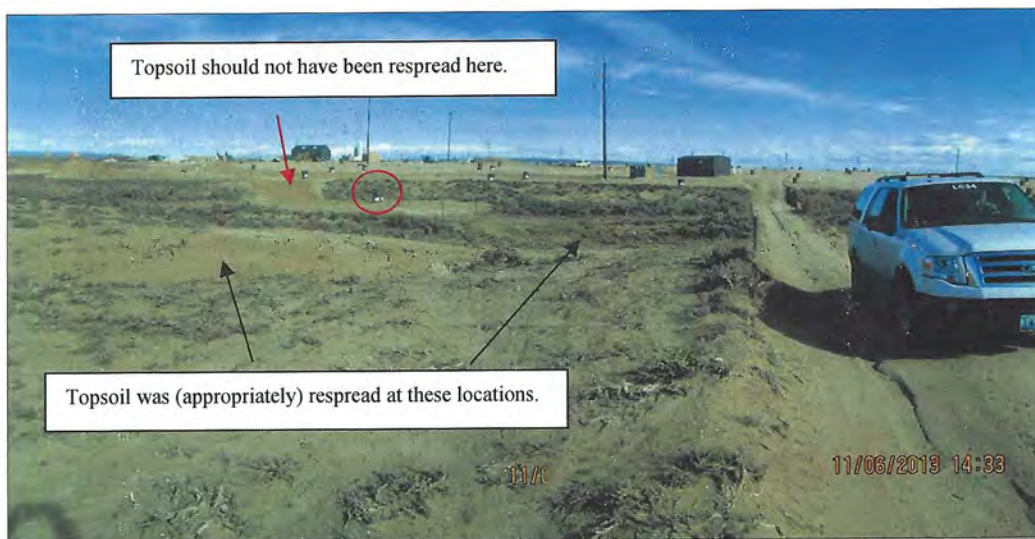
**Photo Number 18: This depicts an area just north of the east-west road that runs west out of the MU1 well field. This view is looking east. The areas indicated with arrows were respread with topsoil since the September 2013 site inspection. The respreading of topsoil on the areas indicated with the black arrows was necessary due to unauthorized vehicular travel on native ground. However, the area indicated with the red arrow should not have been respread with topsoil, as it was the only travel route to the well head indicated with a red circle. The topsoil spread at this location will have to be stripped and a formal travel route will need to be established to the indicated well head.**

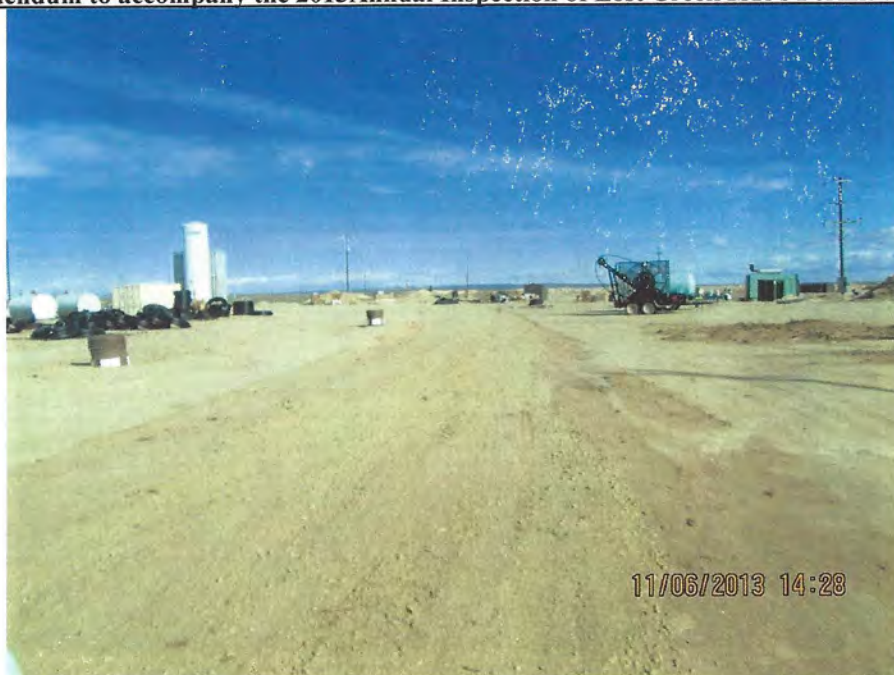
**Photo Number 19: This depicts a recently-established travel route (covered with gravel) within MU1. It is expected that this travel route will somehow be cordoned-off from the areas adjacent to it.**

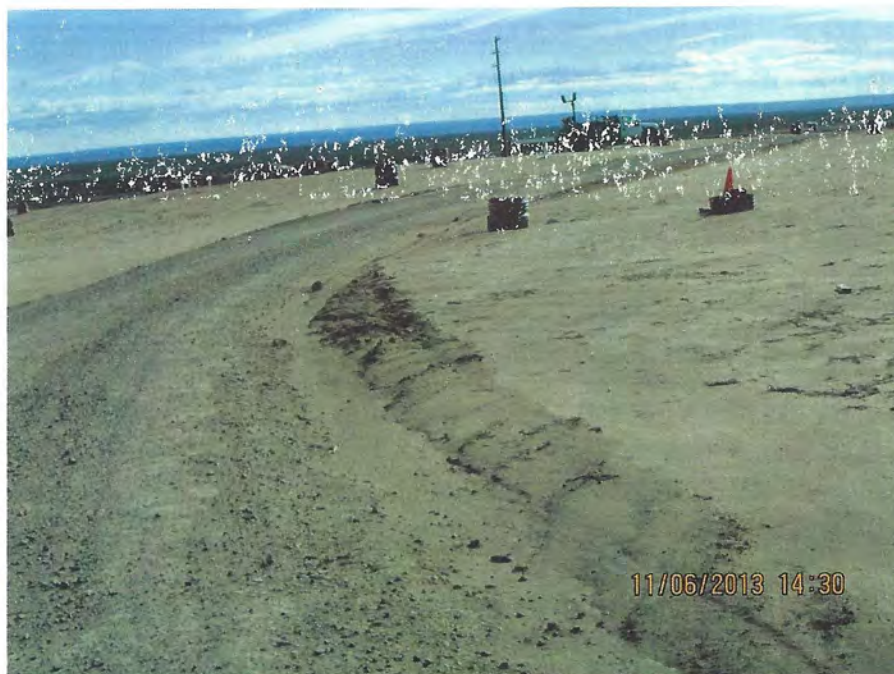
**Photo Number 20: This depicts another recently-built travel route within MU1.**

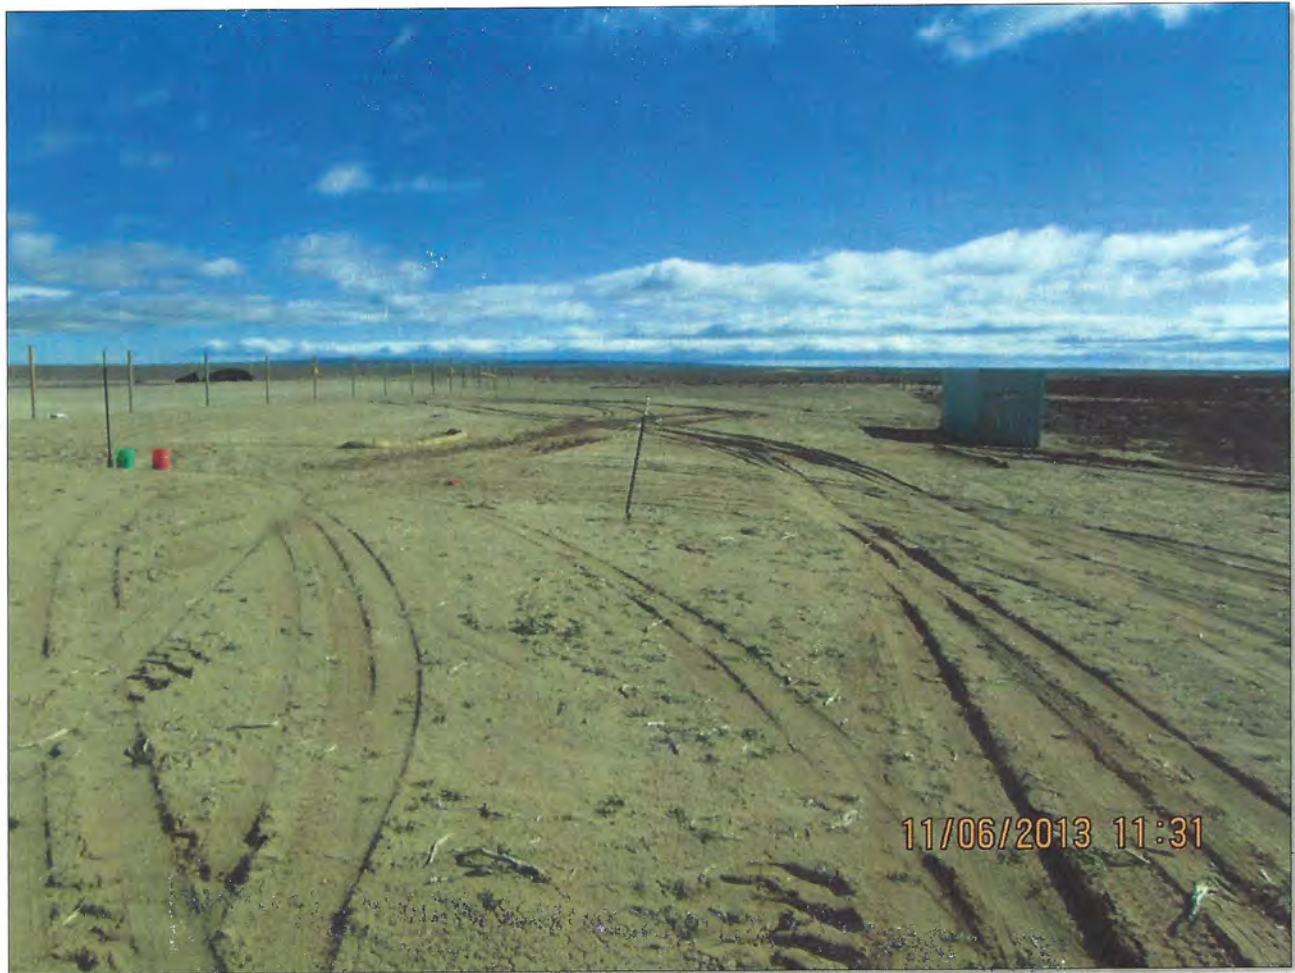
**Photo Number 21: This view looking east depicts the area south of the ponds in the Plant Site (i.e. in the southeast corner of the Plant Site) where tire tracks are evident on recent reclamation. This area was reclaimed as part of the recent reconstruction of the Plant's parking lot (i.e. the resloping of the parking lot to ensure that it drains to the east). However, soon after this area was reclaimed, the large trucks that come onto the site to refill the HCl acid storage tanks (immediately behind the viewer in this vantage point) were forced to pull into this area. This oversight was noticed during this Inspection, and LCI staff are aware of the problem. It is anticipated that topsoil will be stripped from this area, and that metal t-posts will be relocated to enable the large trucks to have the space needed to fill the HCl tanks.**

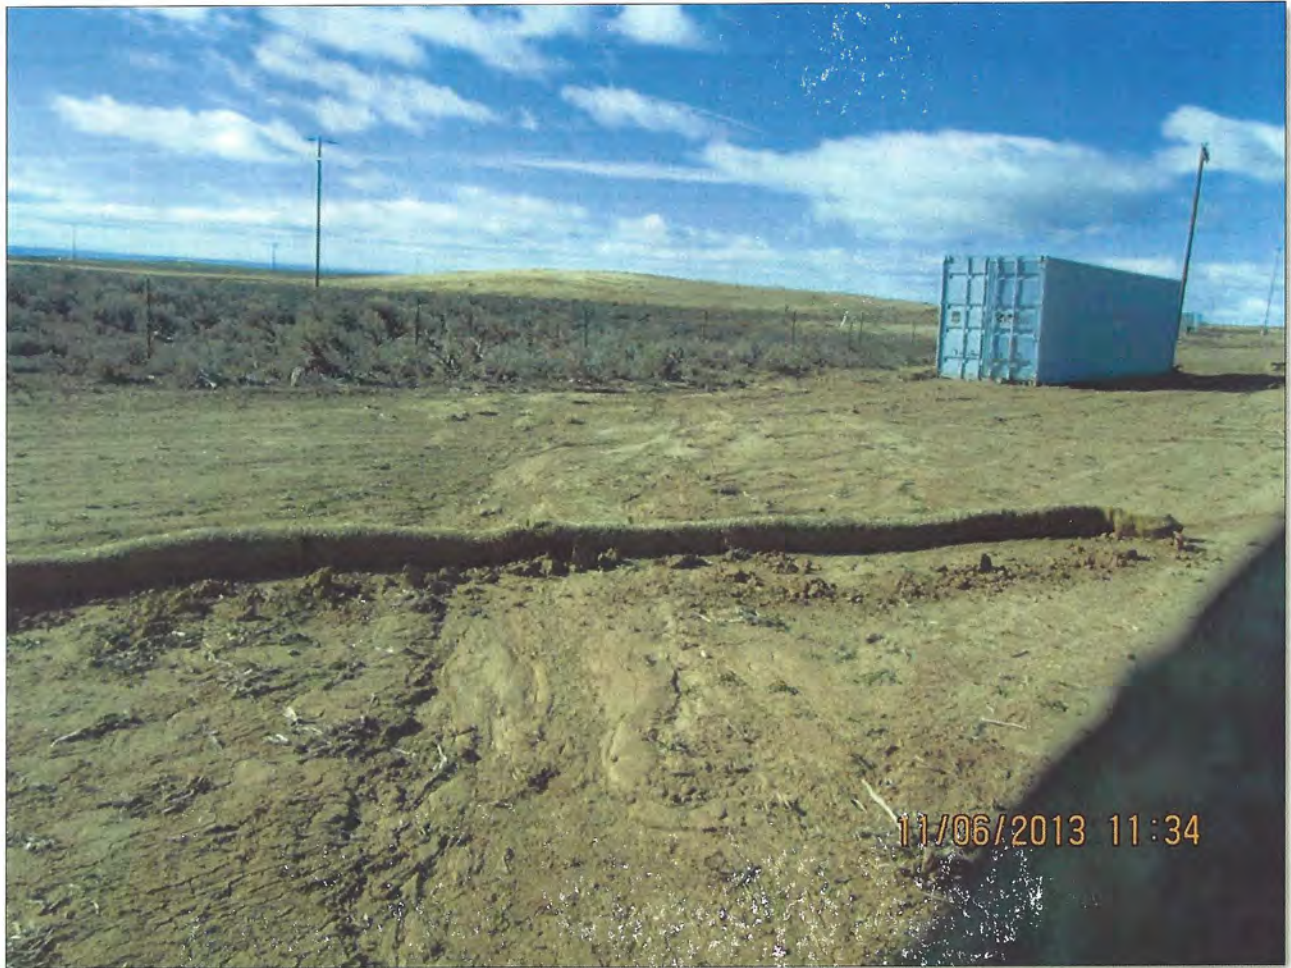
**Photo Number 22: This a view looking down gradient (south) where the diversion ditch that goes around the east side of the site's ponds enters native ground. This area was recently reclaimed (seeded) earlier this fall (2013) and was tested by the numerous precipitation events that occurred in September and October. While evidence of the run off associated with those precipitation events is evident in this picture, the reclamation held-up extremely well. Once vegetation is established here, this area will most likely be well-equipped to absorb any/all storm events that may occur.**

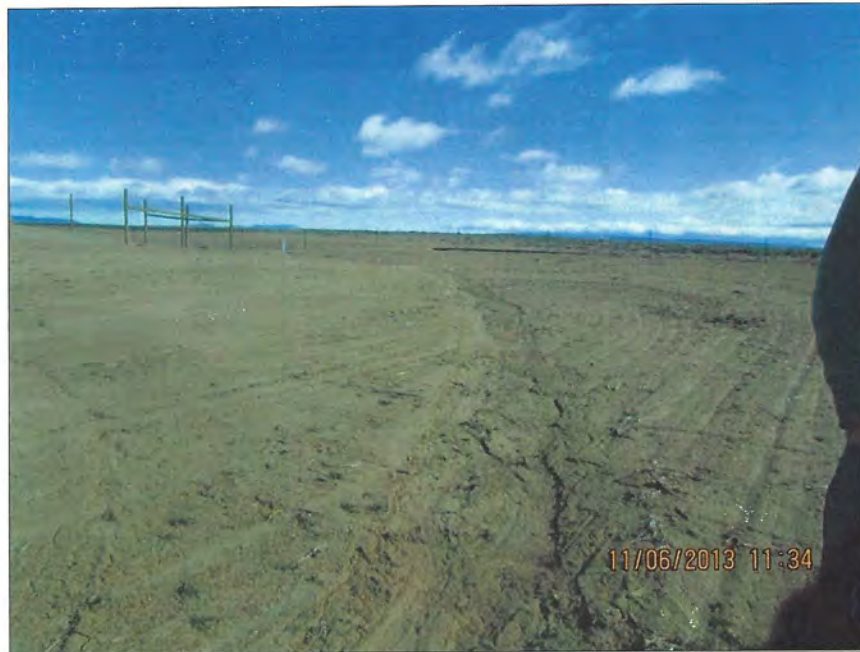
**Photo Number 23: This is a view looking up gradient from the same vantage point that is in the previous photo (Photo Number 22). Considering this is brand new reclamation with zero vegetation that experienced four large precipitation events in a three-week period of time, this reclamation looks really good.**

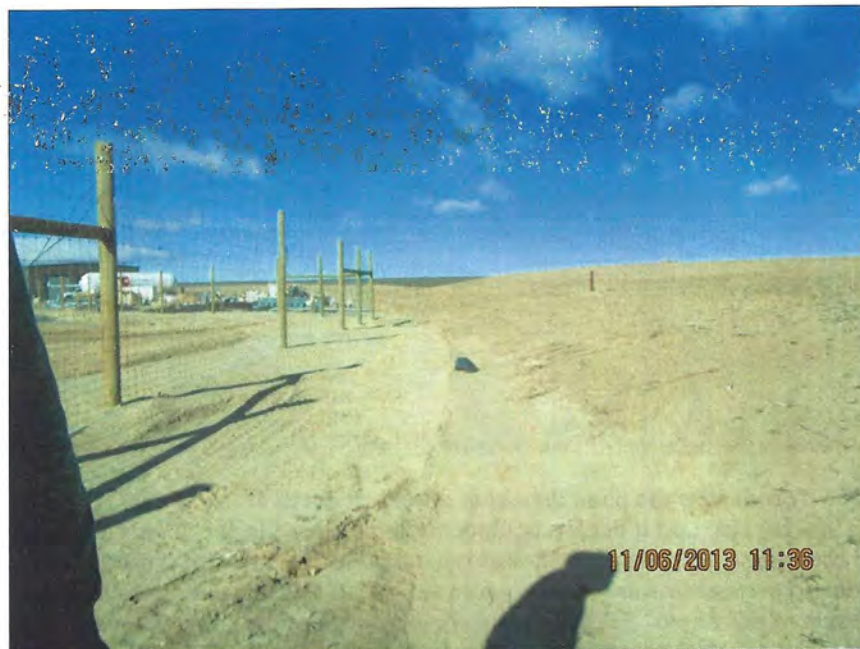
**Photo Number 24: This is a view looking north along the diversion ditch that runs along the east side of the ponds. There are no concerns with the ditch's construction. Some trash is evident in the middle of the photo.**

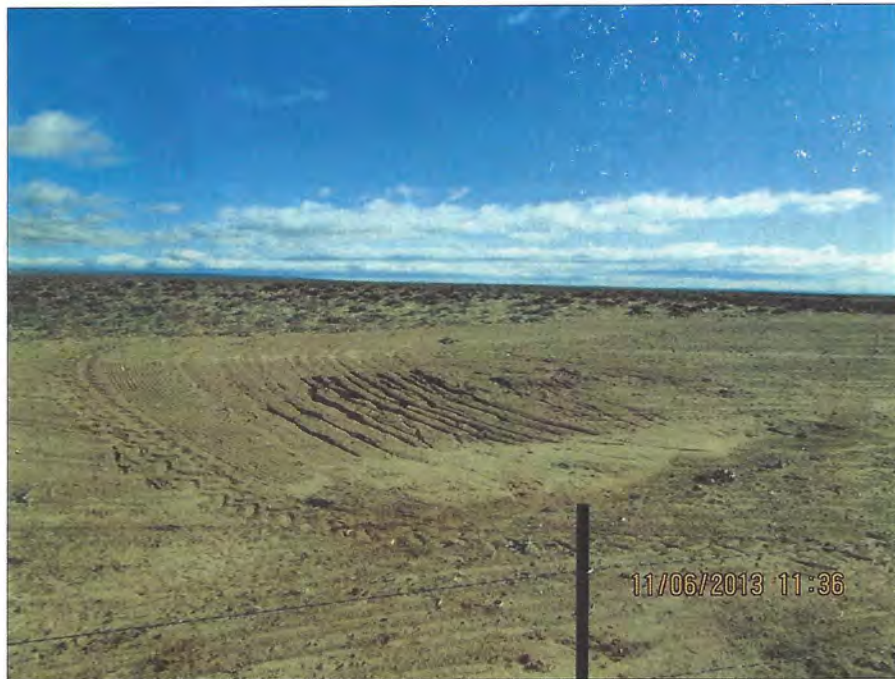
**Photo Number 25: This depicts some rilling on the newly reclaimed area east of the pond diversion ditch. These rills will need to be repaired.**

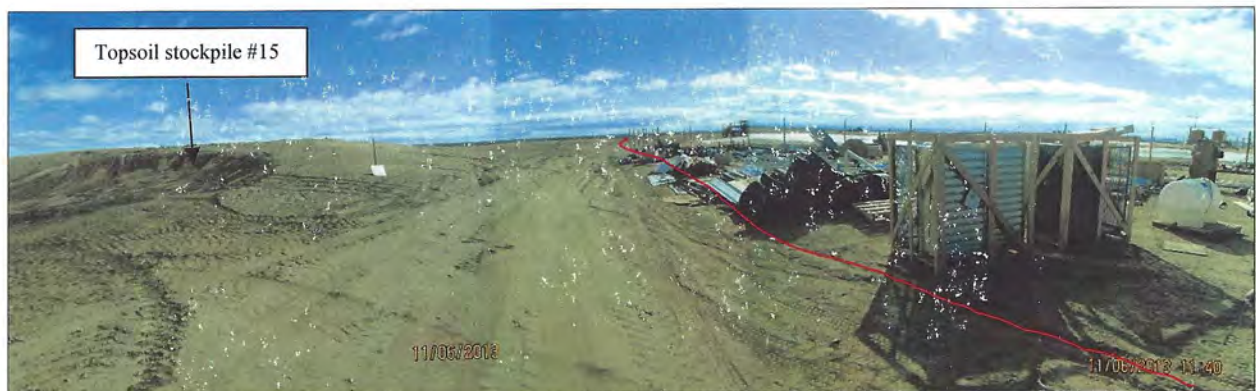
The portion of the drainage ditch in the Plant Site that is north of the ponds was noted during this Inspection as having some equipment placed within the ditch's channel (see Photo Addendum). This is an unacceptable practice and must be addressed promptly. **By the next Inspection (December 18, 2013) the equipment stored in the diversion ditch in the Plant Site must be moved**, and the diversion ditch must be cordoned-off (with metal t-posts or adequate signage or both) to prevent that from happening in the future.

**Photo Number 26: This depicts the pond diversion ditch just north of the ponds. The ditch runs east-west here. This view is looking east and it depicts equipment being stored in the ditch's channel (red line). This is unacceptable and the equipment must be removed immediately. LCI staff will need to cordon-off the ditch's path at this location to prevent unwanted equipment storage at this location in the future. Topsoil stockpile #15 is on the left side of this photo. Materials had recently been removed from topsoil stockpile #15, which explains the recent scar indicated by the black arrow in this photo. A more well-defined toe-ditch will need to be created along the flank of topsoil stockpile #15.**

- 2) Remove all of the equipment that was noted in this Inspection as being stored in the diversion ditch in the Plant Site and cordon-off the diversion ditch to prevent future misuse (Deadline is December 18, 2013),

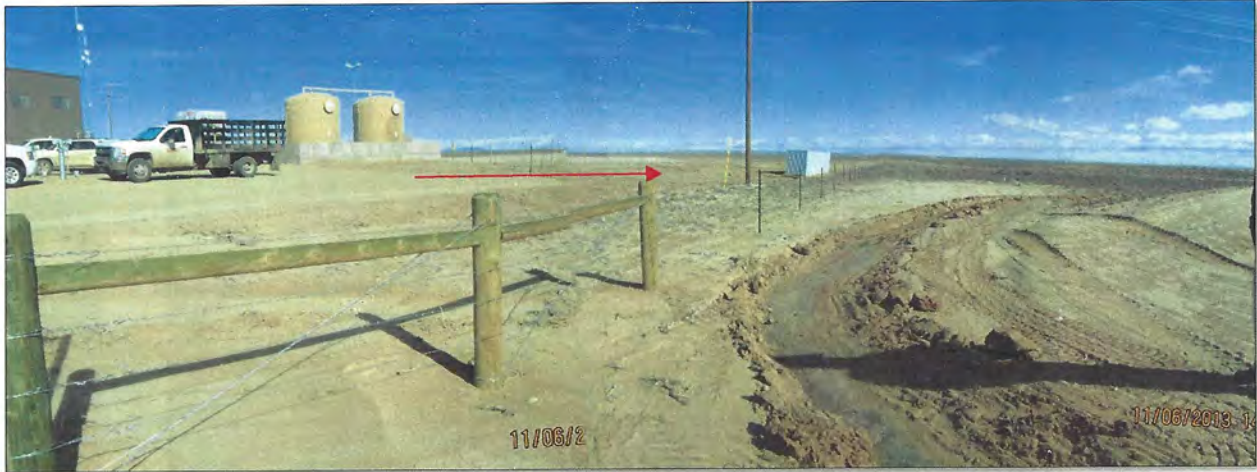
**Photo Number 27:** This depicts the south edge of the Plant Site's parking area (left side of photo) and the north edge of topsoil stockpile #6 (right side of photo). This area had water accumulating during the late September 2013 precipitation event. Since then, LCI staff have resloped the parking area to drain toward the east (see red arrow) and the toe ditch around topsoil stockpile #6 has been reestablished.

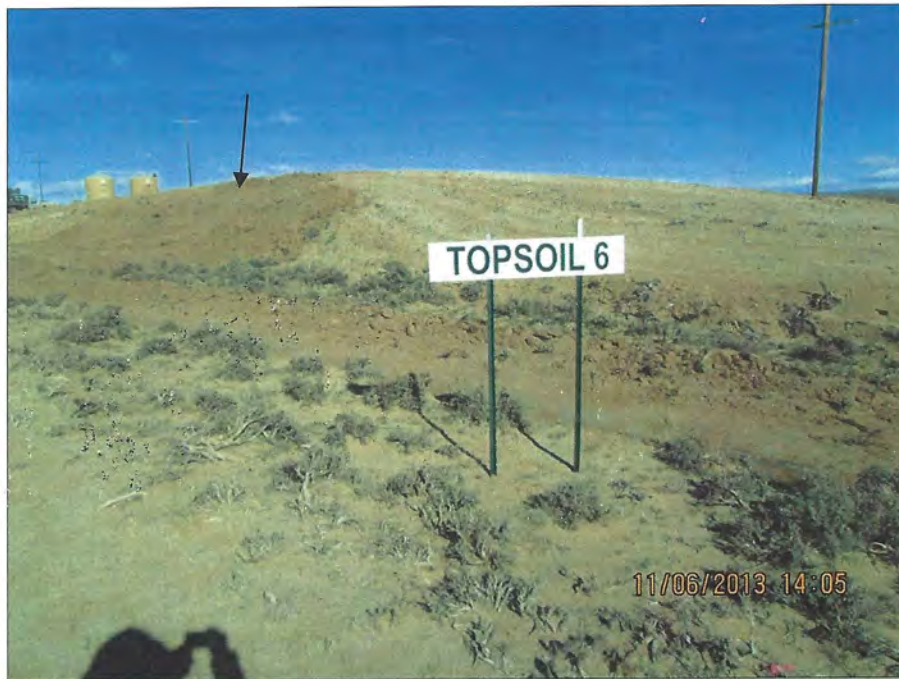
**Photo Number 28:** This depicts the southwest corner of topsoil stockpile #6. The recent scar (indicated by the black arrow) is due to the recent reclamation of the temporary office complex to the west of here.
