**Re: Summary of 2013 Annual Inspection, Lost Creek ISR Project, Permit #788**

**Wyoming Department of Environmental Quality (WDEQ)- Land Quality Division (LQD)**  
**Inspection Memorandum**

File: Lost Creek ISR, LLC – Permit 788

Subject: Annual Inspection

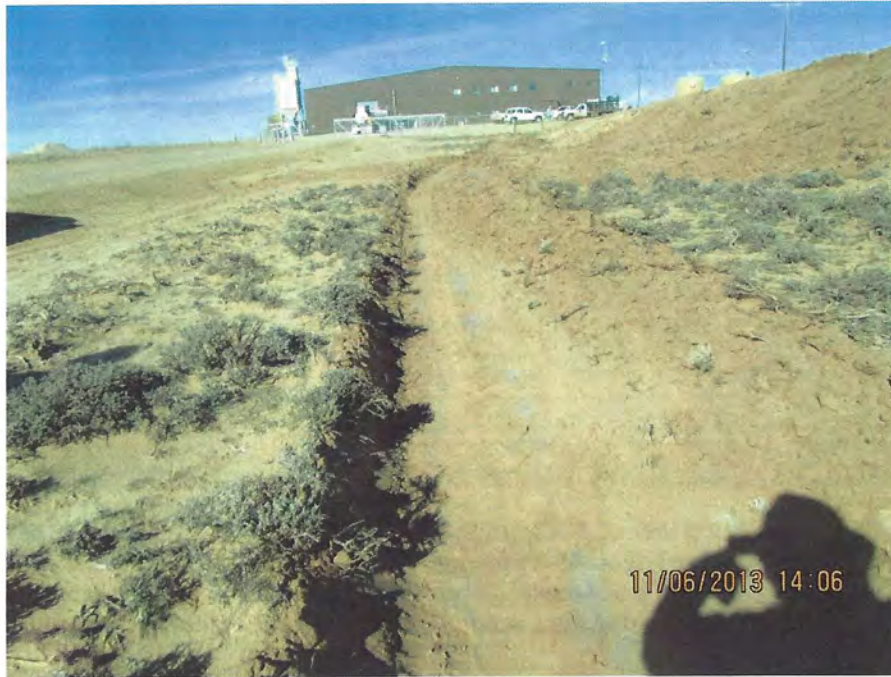
**Photo Number 29: This is a view looking north along the west flank of topsoil stockpile #6. The toe ditch here was also recently reestablished.**

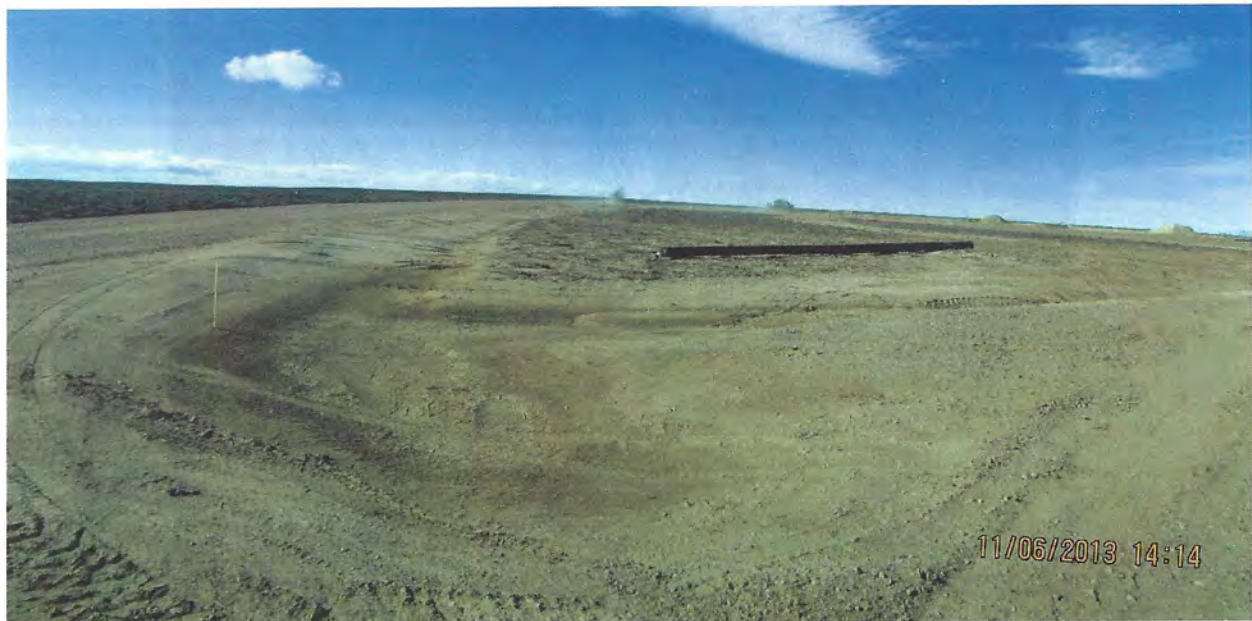
**Photo Number 30: This is looking west at the intersection between the fire access road to the Plant Site with the main access route to the Plant Site. A culvert will need to be installed under the fire access route at this location due to the accumulation of materials indicated by the red oval.**

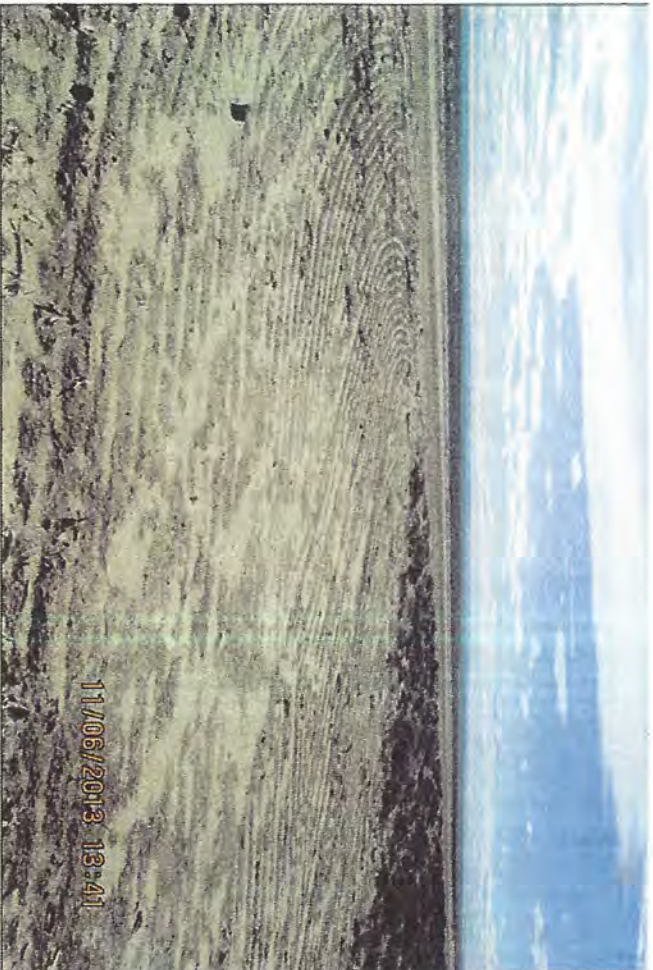
It was also noted during the Lost Creek ISR 2013 Annual Inspection, that patches and pockets of coarse sand covered the low-lying surfaces on the topsoil stockpiles (i.e. in the furrows created during seeding/discing). Further scrutiny of these coarse sand pockets revealed that they were pervasive at the surface as a result of the loss of finer soil particles (to previous wind erosion). Additionally, it was noted that a soil crust had formed on all of the topsoil stockpiles (subsequent to the loss of the finer soils to wind erosion). The crust and pockets of coarse sands appeared to be preventing further topsoil loss in the strong winds (via a sort of "armoring" effect).

This photo depicts the furrows in and around TS#10 at the Lost Creek Site. The light colored materials are coarse-sized grains of sand. These coarse sand grains appear to be the remnants of the upper one-inch of topsoil that is left behind after winnowing (removal) of the finer particle sizes in the topsoil due to heavy winds. The coarse sand grains, along with the soil crust that has formed in this stockpile over the year it has been in existence, appear to provide a wind-resistant armor. The armor prevented any wind erosion from occurring at this location during the 2013 Annual Inspection of the Lost Creek ISR site on November 6, 2013. The winds during the Inspection were estimated to be between 25 - 35 mph.
