UNITED STATES  
NUCLEAR REGULATORY COMMISSION  
OFFICE OF NUCLEAR REACTOR REGULATION  
OFFICE OF NEW REACTORS  
WASHINGTON, DC 20555-0001

February 25, 2014

NRC INFORMATION NOTICE 2014-03: TURBINE-DRIVEN AUXILIARY FEEDWATER  
PUMP OVERSPEED TRIP MECHANISM ISSUES

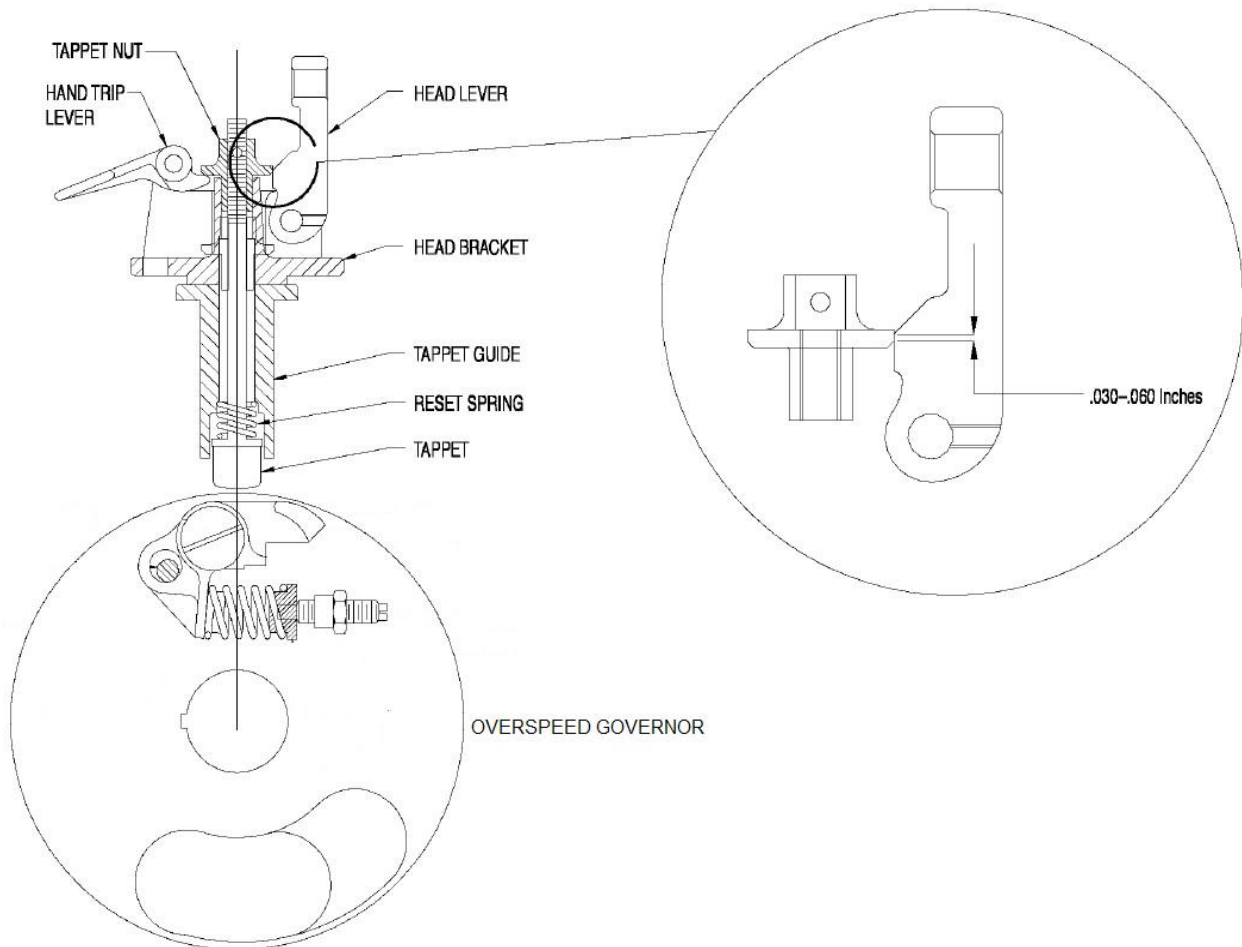
On January 13, 2012, during recovery from a loss of offsite power event at Wolf Creek Generating Station, Unit 1, the TDAFW pump overspeed trip mechanism unexpectedly actuated as operators were securing the pump. The licensee, Wolf Creek Nuclear Operating Corporation, determined that the cause of the unexpected actuation was inadequate engagement between the head lever and tappet nut on the overspeed trip mechanism (reference Figure 1 on the next page). The preventive maintenance procedure for adjusting the mechanism had been changed (specifically, removing steps that prescribed direct measurement of the tappet nut engagement), and instead relied on visual inspection. A similar event occurred on November 17, 2009, but corrective actions at the time did not adequately address the issue, making it likely that the conditions leading to the trip were present for an extended period of

time. As a result of the latest event, the licensee implemented corrective actions that included replacing the trip tappet nut, hand trip lever, and trip linkage spring. In addition, the licensee developed a more precise method of measuring adequate engagement of the head lever to the tappet nut. Additional information is available in NRC Augmented Inspection Team Follow-up Report 05000482/2012009, dated August 6, 2012, and can be found on the NRC's public website in the Agencywide Documents Access and Management System (ADAMS) under Accession Number [ML12227A919](#).

<sup>1</sup>Figure 1 Generalized depiction of a turbine overspeed trip mechanism
