UNITED STATES  
NUCLEAR REGULATORY COMMISSION  
OFFICE OF NUCLEAR REACTOR REGULATION  
OFFICE OF NEW REACTORS  
WASHINGTON, DC 20555-0001

February 25, 2014

NRC INFORMATION NOTICE 2014-03: TURBINE-DRIVEN AUXILIARY FEEDWATER  
PUMP OVERSPEED TRIP MECHANISM ISSUES

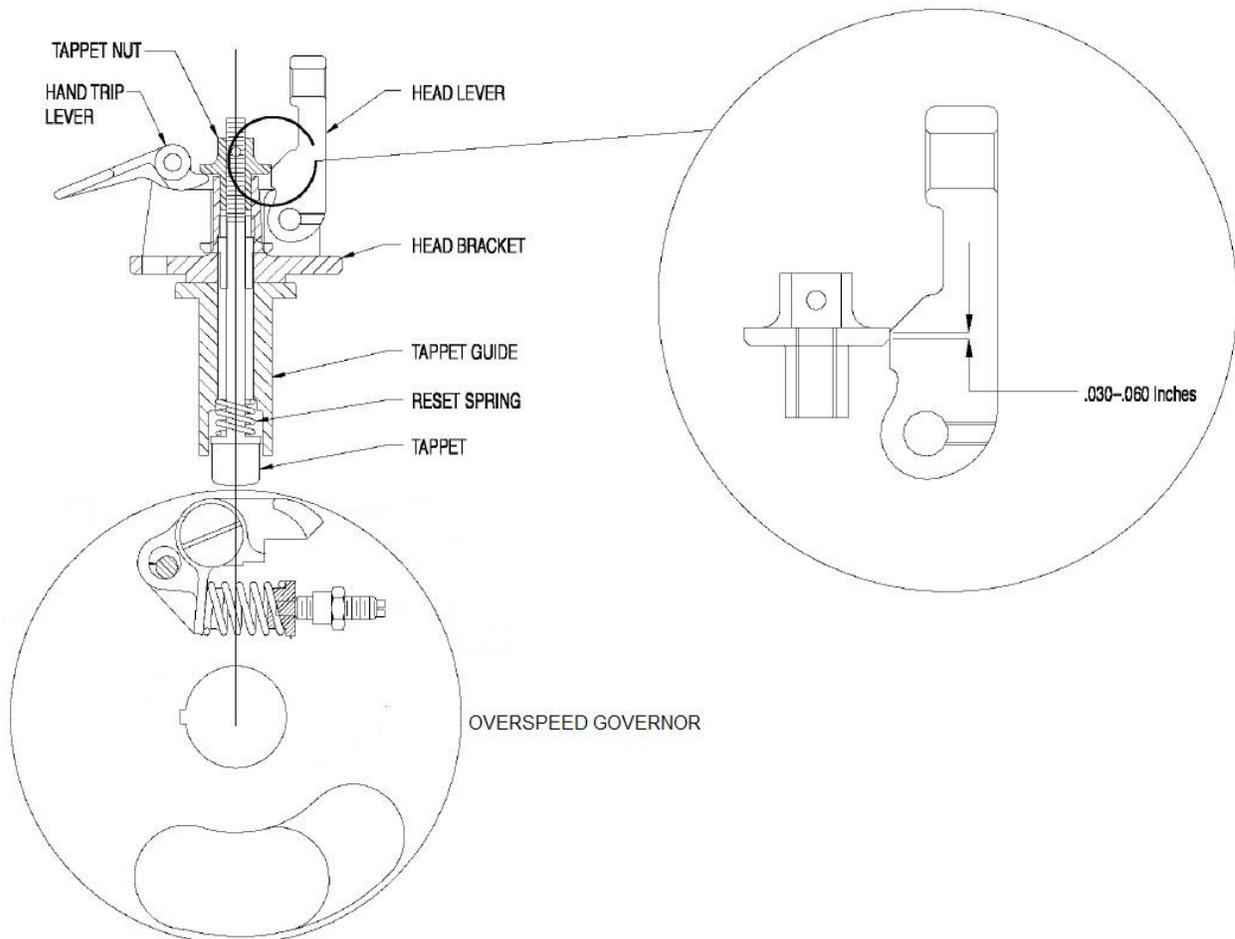
<sup>1</sup>Figure 1 Generalized depiction of a turbine overspeed trip mechanism

On January 13, 2012, during recovery from a loss of offsite power event at Wolf Creek Generating Station, Unit 1, the TDAFW pump overspeed trip mechanism unexpectedly actuated as operators were securing the pump. The licensee, Wolf Creek Nuclear Operating Corporation, determined that the cause of the unexpected actuation was inadequate engagement between the head lever and tappet nut on the overspeed trip mechanism (reference Figure 1 on the next page). The preventive maintenance procedure for adjusting the mechanism had been changed (specifically, removing steps that prescribed direct measurement of the tappet nut engagement), and instead relied on visual inspection. A similar event occurred on November 17, 2009, but corrective actions at the time did not adequately address the issue, making it likely that the conditions leading to the trip were present for an extended period of

On several occasions between April 26 and September 2, 2010, the thirteen TDAFW pump at Salem Nuclear Generating Station, Unit 1, was found tripped. After consulting with the pump vendor, PSEG Nuclear, LLC (the licensee) ultimately determined that the root cause was a rounded head lever surface which resulted in an inadequate contact surface between the tappet nut and head lever. This caused inadequate engagement between the head lever and the tappet nut, making the overspeed trip mechanism overly sensitive. A contributing cause was that a positive rod stop prevented adequate engagement between the head lever and tappet nut. The rod stop mechanism had been installed on the TDAFW pump after initial installation of the pump but was not referenced in any procedure or drawing. PSEG Nuclear, LLC, determined that adjustments were made to the positive rod stop without using an approved procedure. An additional contributing cause identified by the licensee was that the valve's trip solenoid was worn. The licensee implemented corrective actions that included removing the positive rod stop mechanism from the TDAFW pump head lever and a weld build-up repair to the head lever to restore the original design configuration. Additional information is available in NRC Integrated Inspection Report 05000272/2010005 and 05000311/2010005, dated February 8, 2011, and can be found on the NRC's public website ADAMS under Accession Number [ML110390451](#).

Following a reactor trip on December 25, 2007, the Unit 2 TDAFWP at North Anna Power Station, Unit 2, automatically started but immediately tripped due to the actuation of the turbine mechanical overspeed trip mechanism. The cause of the inadvertent trip of the pump was determined to be inadequate engagement of the turbine trip mechanism head lever and tappet nut. Virginia Electric & Power Company, the licensee, reset the turbine trip mechanism and restarted the TDAFWP, which functioned properly for the remainder of the event. The cause of the trip mechanism being inadequately set was that the maintenance procedure did not identify some critical dimensional checks that should be performed when assembling the trip linkage. The licensee's corrective actions were to employ a more accurate method for obtaining critical dimension checks. Additional information is available in NRC Integrated Inspection Report 05000339/2008002 and 05000339/2008002, dated April 30, 2008, and North Anna Licensee Event Report 50-339/2007-004-01, dated May 29, 2008. These can be found on the NRC's public website in ADAMS under Accession Numbers [ML081220395](#) and [ML081620437](#), respectively.

time. As a result of the latest event, the licensee implemented corrective actions that included replacing the trip tappet nut, hand trip lever, and trip linkage spring. In addition, the licensee developed a more precise method of measuring adequate engagement of the head lever to the tappet nut. Additional information is available in NRC Augmented Inspection Team Follow-up Report 05000482/2012009, dated August 6, 2012, and can be found on the NRC's public website in the Agencywide Documents Access and Management System (ADAMS) under Accession Number [ML12227A919](#).
