UNITED STATES
NUCLEAR REGULATORY COMMISSION
OFFICE OF NUCLEAR REACTOR REGULATION
OFFICE OF NEW REACTORS
WASHINGTON, DC 20555-0001

NRC INFORMATION NOTICE 2014-03: TURBINE-DRIVEN AUXILIARY FEEDWATER
PUMP OVERSPEED TRIP MECHANISM ISSUES

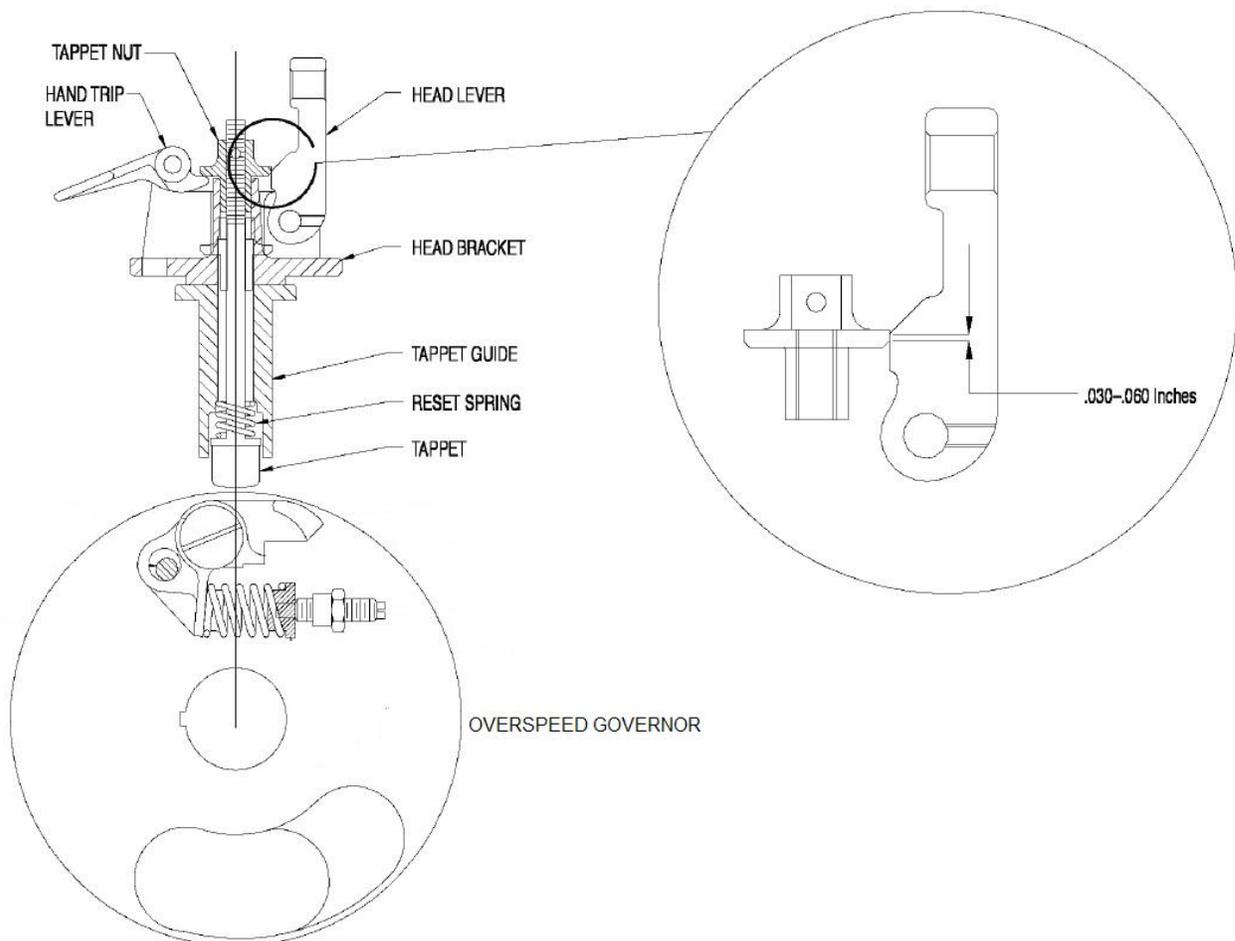
On January 13, 2012, during recovery from a loss of offsite power event at Wolf Creek Generating Station, Unit 1, the TDAFW pump overspeed trip mechanism unexpectedly actuated as operators were securing the pump. The licensee, Wolf Creek Nuclear Operating Corporation, determined that the cause of the unexpected actuation was inadequate engagement between the head lever and tappet nut on the overspeed trip mechanism (reference Figure 1 on the next page). The preventive maintenance procedure for adjusting the mechanism had been changed (specifically, removing steps that prescribed direct measurement of the tappet nut engagement), and instead relied on visual inspection. A similar event occurred on November 17, 2009, but corrective actions at the time did not adequately address the issue, making it likely that the conditions leading to the trip were present for an extended period of

time. As a result of the latest event, the licensee implemented corrective actions that included replacing the trip tappet nut, hand trip lever, and trip linkage spring. In addition, the licensee developed a more precise method of measuring adequate engagement of the head lever to the tappet nut. Additional information is available in NRC Augmented Inspection Team Follow-up Report 05000482/2012009, dated August 6, 2012, and can be found on the NRC's public website in the Agencywide Documents Access and Management System (ADAMS) under Accession Number [ML12227A919](#).

¹Figure 1 Generalized depiction of a turbine overspeed trip mechanism
