LTR-PAFM-10-50-NP
Revision 0

**Section XI Flaw Evaluation of Indication Recorded on
RC-32-MRCL-AIII-03 of the Point Beach Unit 1
Inlet Nozzle to Pipe Weld**

March 2010

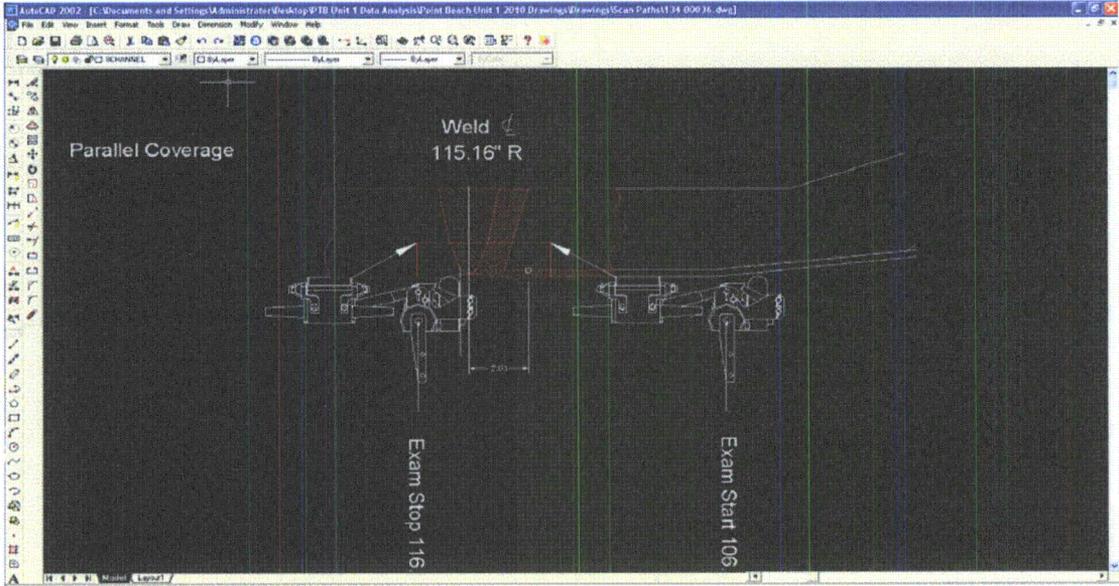
Figure 1: Inspection Volume of the Region of Interest, and Location of the Indication

Sizing scans were performed with the specified PA search unit, which assisted with the characterization of the indication. The sizing scans characterized the indication as being 0.71 inches long and 0.505 inches in through-wall dimension (18.10% a/t). The cladding thickness (not counted) is 0.25 inches, and the nominal pipe thickness (minus clad) is 3.27 inches. The surface "S" dimension was conservatively considered to be zero (0) to account for near-surface uncertainties.

With RMSE applied, the indication size is considered conservatively to be 0.592 inches through wall. The maximum allowable flaw depth, per the flaw acceptance standards of IWB-3500, would be 12.5% of the wall thickness (approximately 0.41 inches through-wall).

Based on current findings, it is considered that this indication or group of indications is most likely to be embedded fabrication flaws; however, it is being evaluated as a surface-connected flaw due to the proximity to the inside surface. The location is actually near to the buttering of the nozzle, and also near to the clad-to-base metal interface, as shown in the sketch of Figure 1.

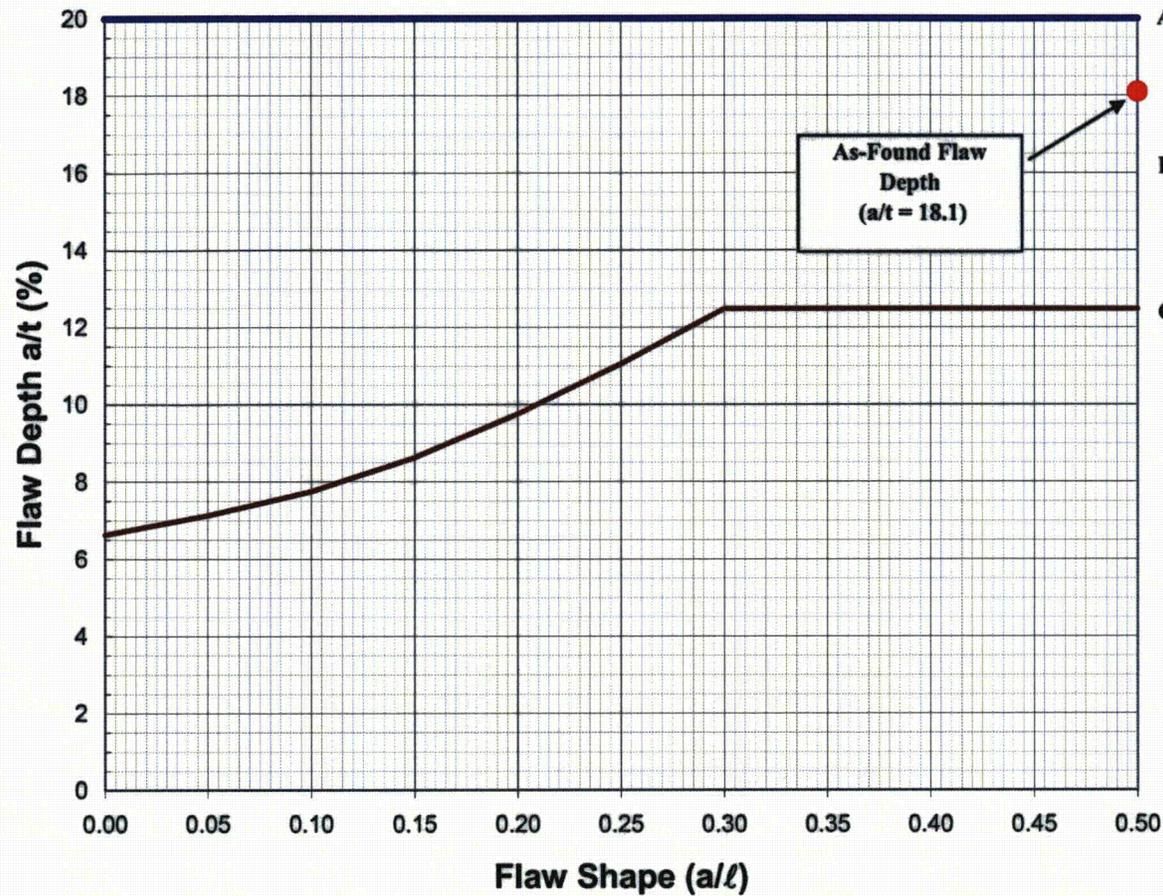
Figure 2 (Figure A-6.3) Evaluation Chart for Inlet Nozzle Safe-end to Nozzle Weld [1]

In preparation for the reactor vessel inspections, a set of flaw evaluation charts had been prepared for the reactor vessel weld regions [1,2], and the indication was compared with these flaw evaluation results, and found to be acceptable for further service without repair. The flaw evaluation chart of interest is Figure A-6.3 of reference 1, which is provided in an updated version as the last figure of this technical note, with the indication plotted.

It will be seen from Figure A-6.3 of WCAP 11477 [1] that the allowable depth for any indication, regardless of shape, is at least 20 percent of the wall thickness. The allowable depth line is across the very upper edge of the figure. This line is the result of a direct application of the Section XI acceptance criteria.

The allowable flaw depth for this location must also be compared with the allowable depth based on the primary stress limit criteria of Section III, NB-3200. The allowable depth from this calculation is 58% of the wall thickness, for a continuous circumferential flaw, so the fracture mechanics limits of IWB-3600 will be governing.

Therefore, we see that the allowable flaw depth is very large, regardless of the flaw shape for this location. For conservatism the allowable flaw depth in the chart of Figure 2 has been cut off at $a/t = 0.2$.

The evaluation chart for surface flaws is shown in Figure 2, for circumferential flaws. Note that there are three lines in the chart, representing the acceptable length of service, 10, 20, and 30 years.
