THREE MILE ISLAND NUCLEAR STATION, UNIT 1 (TMI-1)
RENEWED FACILITY OPERATING LICENSE NO. DPR-50
DOCKET NO. 50-289

SUBJECT: LICENSEE EVENT REPORT (LER) NO. 2013-001-00
"Reactor Coolant "B" Cold Leg Drain Line Flaw"

4. TITLE: Reactor Coolant "B" Cold Leg Drain Line Flaw

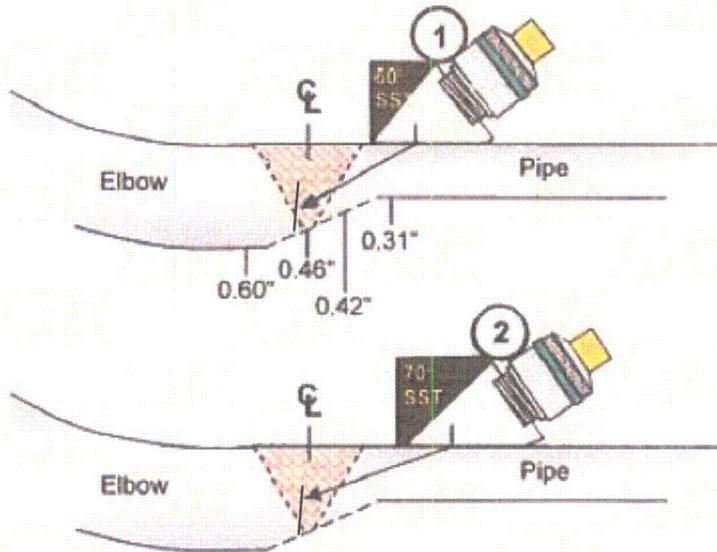
During T1R20 the “B” RCP cold leg suction drain elbow was examined using ultrasonic technology. At the weld designated as weld RC-289, an indication was found within the weld that initiated at the inside diameter (ID) and progressed approximately 66% through wall, toward the outside diameter (OD). The defect was verified using phased array technology and confirmed. The wall thickness at the defect was 0.460” and the defect was 0.280” in length leaving a remaining ligament of 0.180” (180 mils).

Weld RC-289 - NDE report diagram from 2013 discovery. The crack location, black line, is at the tip of the arrow.

ASME Section XI 2004, subsection IWB, paragraph IWB-3514-2 requires the acceptable flaw depth to be less than 12 ½% of measured wall thickness. The maximum wall loss that would have been allowable at this location was 57.5 mils. Based on 280 mils of wall loss measured, the crack was greater than the code allowable limit and the flaw was required to be removed. The fitting was shipped to B&W for destructive analysis to determine the failure mechanism. A new and similar fitting was welded in place. The weld that replaced RC-289 was performed under shop conditions and was radiographed. No indications were noted from the installation Non-Destructive Examination (NDE).

The apparent root cause that RCS weld RC-289 was found cracked in T1R20 was that a resultant stress, composed of multiple smaller stresses focused by weld geometry, initiated a crack in RC-289. This crack was driven through the weld by stresses from plant heatup, cooldown, and thermal fatigue.

Determine the source of the stress that is initiating the crack through the application of the following testing: Strain gauges, thermography, temperature measurement, and laser scanning.

If the crack source can be found and stopped, actions will be created to eliminate the source of the cracking.

If the crack source cannot be determined, actions will be created to determine if proactive replacement is warranted.
