L-PI-14-003

Prairie Island Nuclear Generating Plant, Unit 1  
Docket 50-282  
Renewed License No. DPR-42

Response to Request for Additional Information on 2012 Steam Generator Tube Inspections from 1R28

### REQUEST FOR ADDITIONAL INFORMATION 2012 STEAM GENERATOR TUBE INSPECTIONS PRAIRIE ISLAND NUCLEAR GENERATING PLANT, UNIT 1 DOCKET NUMBER 50-282

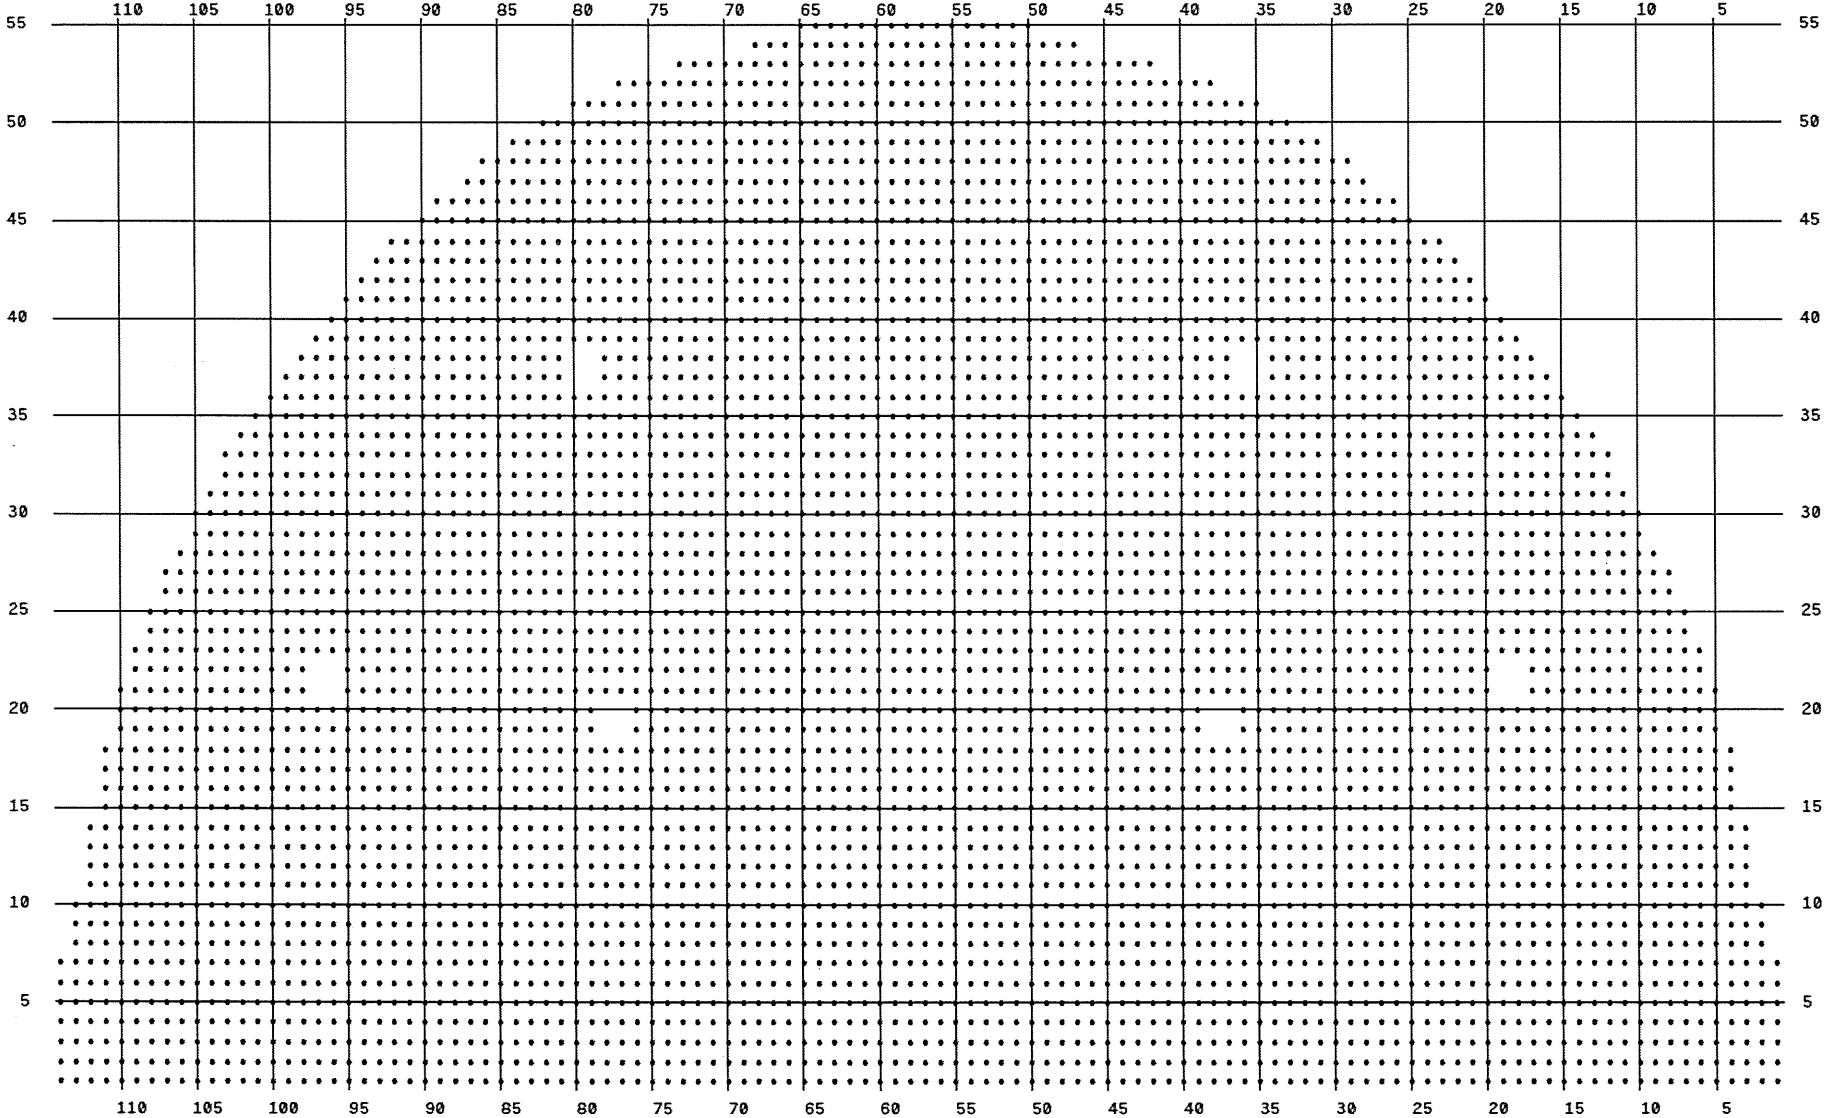
See the attached Figure 1 for a generic tubesheet map (tube array) of the installed Framatome Model 56/19 Replacement Steam Generators.
