RS-14-037

Braidwood Station, Units 1 and 2
Facility Operating License Nos. NPF-72 and NPF-77
NRC Docket Nos. STN 50-456 and STN 50-457

Subject: Response to Request for Additional Information Regarding Relief Request I3R-11 Associated with the Repair/Replacement of Control Rod Drive Mechanism (CRDM) Canopy Seal Welds

Response to Request for Additional Information Regarding Relief Request I3R-11 Associated with the Repair/Replacement of Control Rod Drive Mechanism (CRDM) Canopy Seal Welds

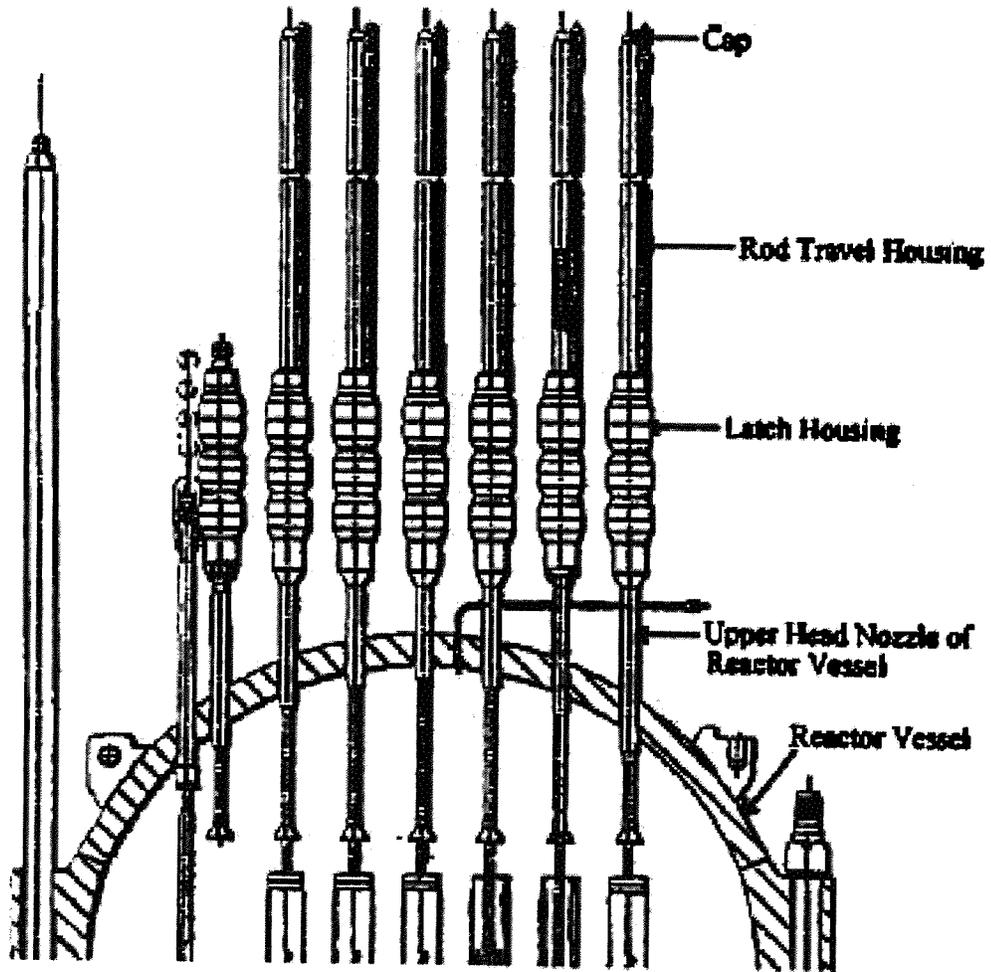
Fig. 1 Structure of CRDM Housing

Components associated with the canopy seal welds were assembled using threaded connections, were torqued and seal welded using consumable inserts. The general configuration of the canopy seal welds along with their general location on the control rod drive mechanism assembly are provided in Figures 1 and 2. The approximate diameter of the canopy seal welds ranges from 3.75" (for the upper canopy seal weld) to 6.45" (for the lower canopy seal weld).
