# LEAK IN CONTROL ROD DRIVE MECHANISM HOUSING, PALISADES NUCLEAR PLANT

David Alley<sup>(1)</sup>, Paul Deniston<sup>(2)</sup>, James Hyres<sup>(3)</sup>

This paper is the first of a series of 3 papers which address a leak in a control rod drive mechanism housing which occurred at Palisades Nuclear Power Plant in the August 2012. This paper will: provide some background concerning control rod drive mechanisms; describe the event and associated inspections; provide some background regarding other, related events; describe plans for future activities; and provide some regulatory context. This paper will also begin a discussion of the failure mechanism and the laboratory analysis performed in response to this failure. These last two topics are the subjects of the companion papers.

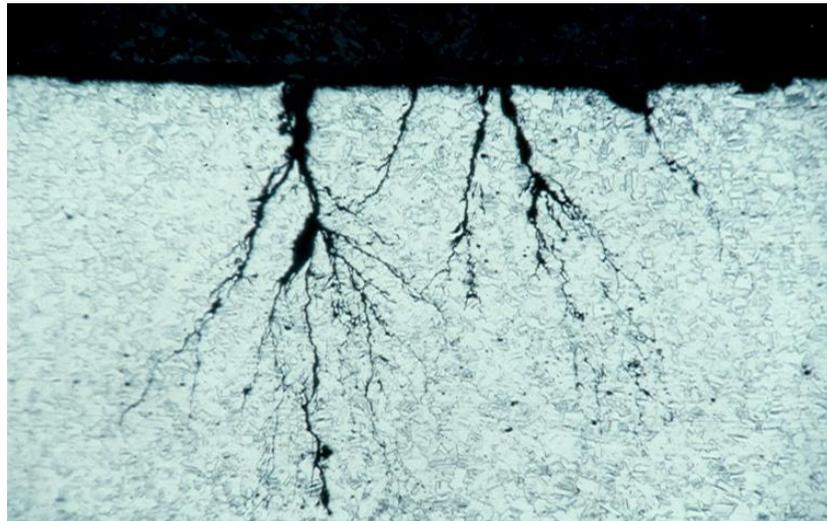
oxygen. This phenomenon generally occurs at temperatures above 60°C (140°F) although some instances of cracking have been observed at lower temperatures. As shown in Figure 3, chloride stress corrosion cracking is generally transgranular and highly branched. Transgranular chloride stress corrosion cracking may occur in weld metal, weld heat affected zones and base metal [3]. Sensitization is not required for transgranular chloride stress corrosion cracking, however, in some instances especially where sensitization is present, chloride stress corrosion cracking may be intergranular in nature [2]. Although chloride stress corrosion cracking normally occurs in the presence of chlorides, identical cracking may occur in the presence of other halogens such as fluorides. This may be significant near welds as fluxes for some stainless steel welds contain fluorides [4].

Figure 3: Typical chloride stress corrosion crack in 300 series stainless steel (micrograph courtesy of Mark Mucek, UOP LLC)

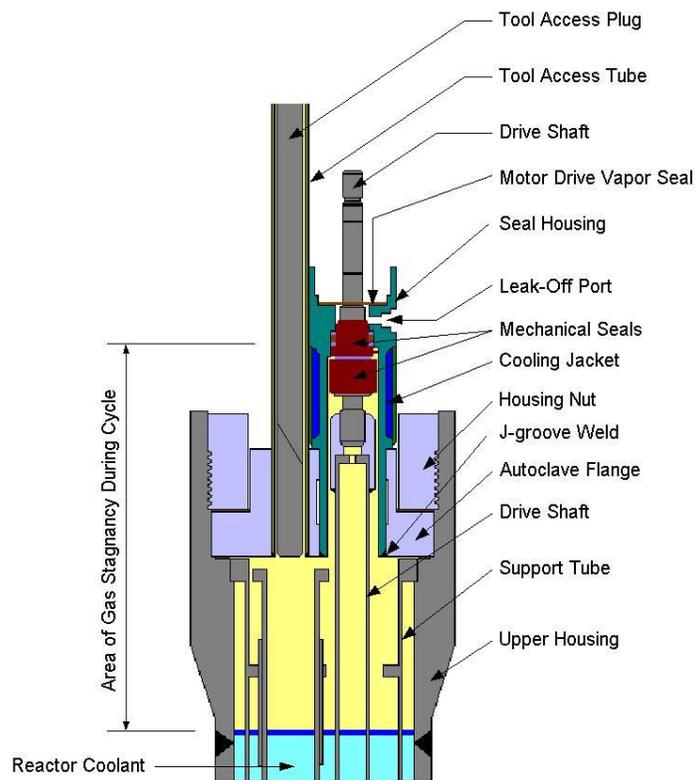
Beginning in 1986 Palisades began to experience reactor coolant system leakage from the J-Groove weld in the CRDM seal housing (which is located above the CRDM Housing). These seal housings were constructed from type 304 stainless steel. A cross section of the seal housing portion of the CRDM housing is shown in Figure 5. Additional events occurred in 1988, 1991-1993, 1999 and 2001.

In each case, failure analyses determined that the observed leakage was caused by transgranular stress corrosion cracking. Failure analyses postulated the presence of chlorides and oxygen at levels greater than typically found in PWR primary water. Destructive analyses also identified a shallow layer of cold worked material which was present on the inside surface of the pipe at the location where the observed cracks initiated.

Figure 5: Cross section of the seal housing area of the CRDM housing. [1]

Cracking became sufficiently prevalent that, between 1991 and 1993, all the seal housings were replaced with seal housings which were constructed from type 347 stainless steel and redesigned to reduce residual and operating stresses. It appears that this material change was made based on the inherent resistance of type 347 stainless steel to sensitization and the mistaken belief that the absence of sensitization would reduce the potential for transgranular chloride stress corrosion cracking.

The changes in design, material, and operating conditions did not prove to be fully effective; cracking continued to occur in the seal housings. In 2001 Palisades replaced all the seal housings with housings constructed from Alloy 600 and redesigned using a one piece forging to minimize residual and operating stresses. Alloy 600 is considered to be more resistant than austenitic stainless steels to stress corrosion cracking under the environmental conditions which exist in the seal housings.

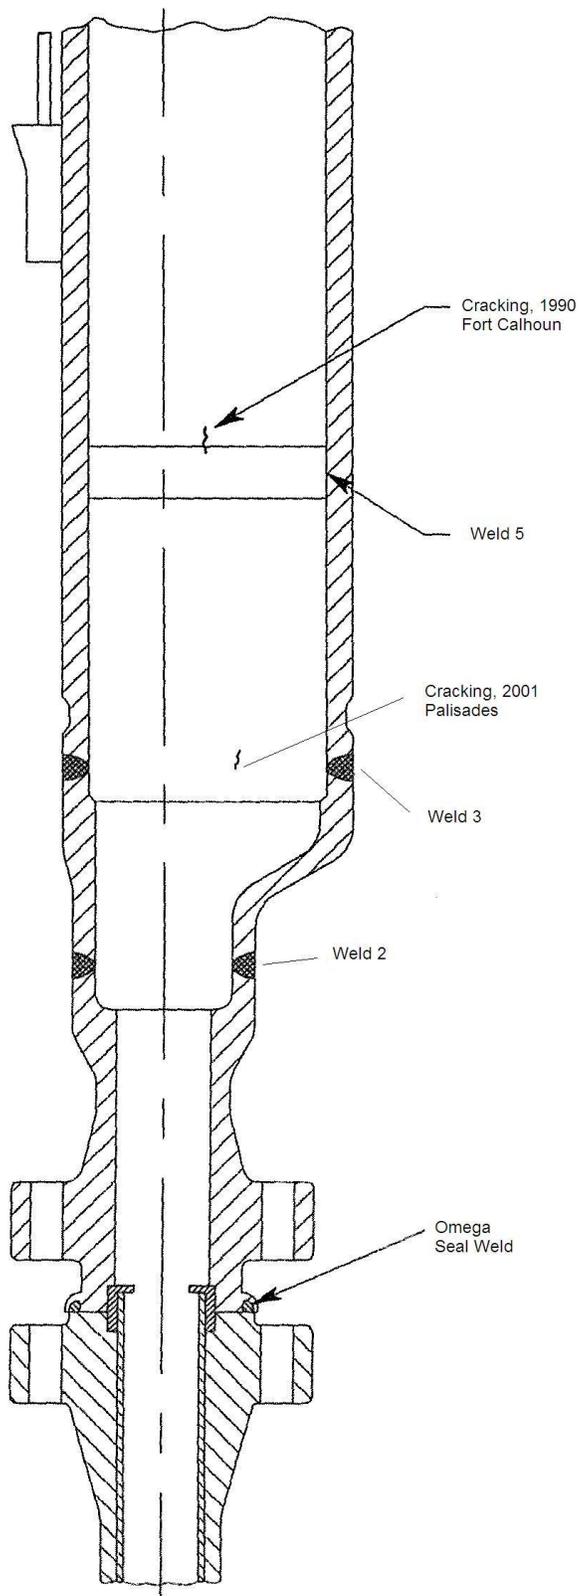
In 1990, following 17 years of operation, Fort Calhoun detected leakage from one of two spare CRDM housings. Spare housings are installed on the reactor head in a manner identical to active housings but do not contain a control rod drive mechanism. As shown in Figure 6 [7], the leak was associated with weld

number 5. Weld 5 is a non-pressure boundary weld overlay provided to ensure accurate alignment of the CRDM as it is inserted into the housing. Both weld 5 and the CRDM housing tube were constructed from type 348 stainless steel.

The failure analysis performed in response to this event identified the source of the leak as a transgranular chloride stress corrosion crack. The failure analysis also identified a second, non-through-wall crack at weld 5 in this housing. Extent of condition inspections revealed additional, non-through-wall cracks at weld 5 in the other spare CRDM housing. Based on measurements made during the failure analysis, circumferential tensile stresses (which support axial cracking) of approximately 70% of the yield strength of the material existed at the inside diameter of weld 5.

Figure 6: Detail showing location of significant welds and two leakage events. [7]

- a. Elimination of weld number 2 (see Figure 6)
- b. Relocation of weld number 3 to a higher location thereby minimizing the deposition of crud in the gap between the weld and the bottom plate of the rack and pinion assembly
- c. Reduction in residual stresses and cold work on welds by requiring better surface finishes
- d. Use of heat sink welding to reduce ID residual tensile stresses

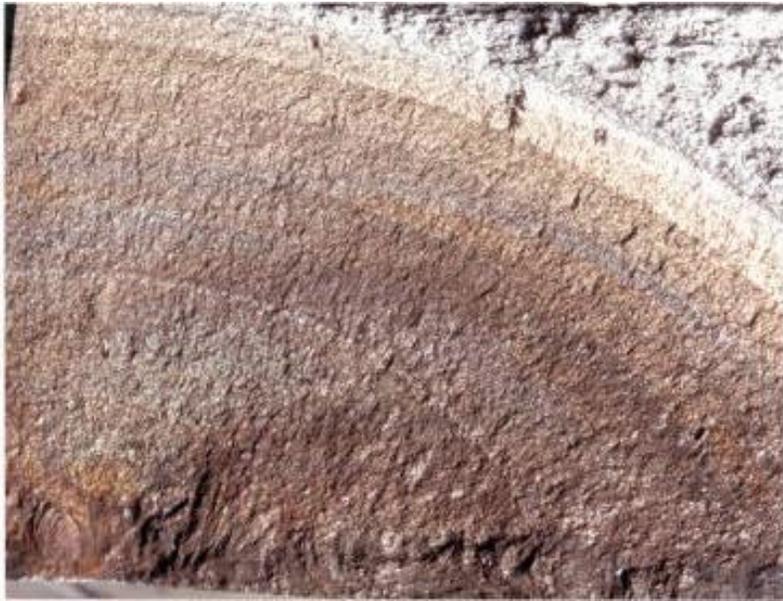
An interesting aspect of this failure analysis, as shown in Figure 7 [1], is the presence of beach marks on the crack fracture surfaces examined. While beach marks are normally associated with fatigue fractures, Lisowj reported ample evidence of transgranular stress corrosion cracking and no evidence to support a fatigue failure. Based on the apparent cyclical nature of the crack growth Lisowj proposed that each beach mark was related to a refueling cycle as this was the only common plant operational cycle which would affect the CRDM housings [7].

The rate of crack growth for this failure was estimated based on the number of beach marks present and crack growth rates contained in the literature. While the beach marks were correlated with refueling outages, the lack of variability in oxygen content over time indicates that temperature/pressure cycles rather than oxygen variability may be responsible for the cyclic nature of crack growth.

Figure 7: Fractograph showing transgranular SCC and accompanying beach marks [1]

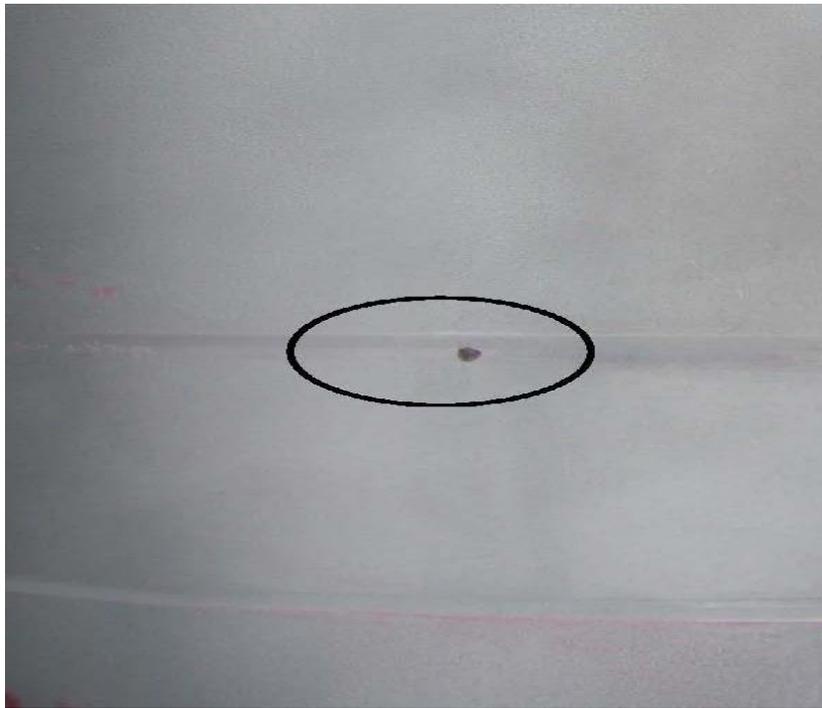
Once the plant reached a cold shutdown condition, plant personnel performed a dye penetrant exam in the area of the steam leak. As shown in Figures 9 and 10, the leak was a 1/8<sup>th</sup> inch by 1/16<sup>th</sup> inch L shaped crack located at the upper end of the witness mark. The witness mark is a groove machined in the OD of the CRDM housing during manufacturing which is used as a reference point for determining critical dimensions.

Figure 9: Dye Penetrant Exam Results, through wall leak in CRDM housing 24, Palisades 2012 (After [9])

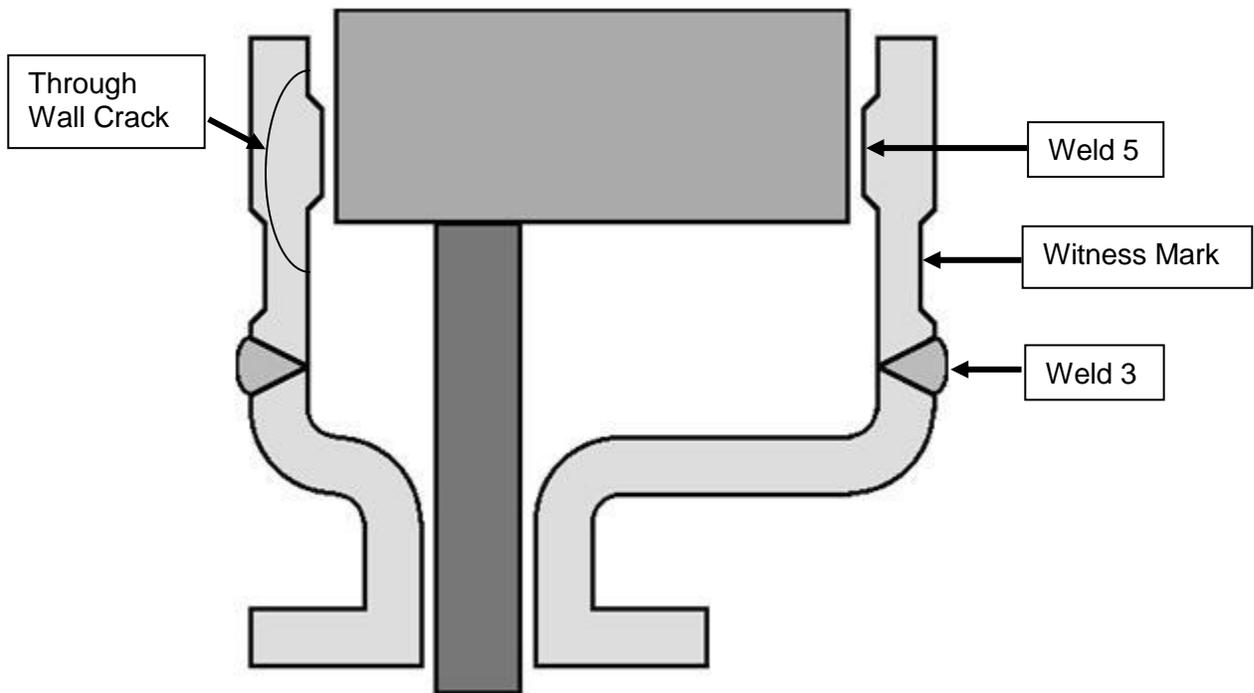
The witness mark, as shown in Figure 10, is machined into the outside diameter of the housing during the manufacturing process as an aid to locate and size critical dimensions such as weld 5. The witness mark and weld 5 should be concentric to both the ID and OD of the CRDM housing. On CRDM housing 24, neither the witness mark nor the ID surface of weld 5 were concentric to either the ID or the OD of the housing or each other. Additional investigation revealed that two of the bolt holes in the lower CRDM housing flange were enlarged in the field to permit installation onto the head penetration. These observations, in conjunction with the rub mark support the possibility that the CRDM internals were misaligned in the CRDM housing and created non-uniform circumferential stressing in the CRDM housing which contributed to the observed cracking.

Figure 10: Simplified cross section of CRDM housing showing welds 3, 5, witness mark, and OD location of steam leak

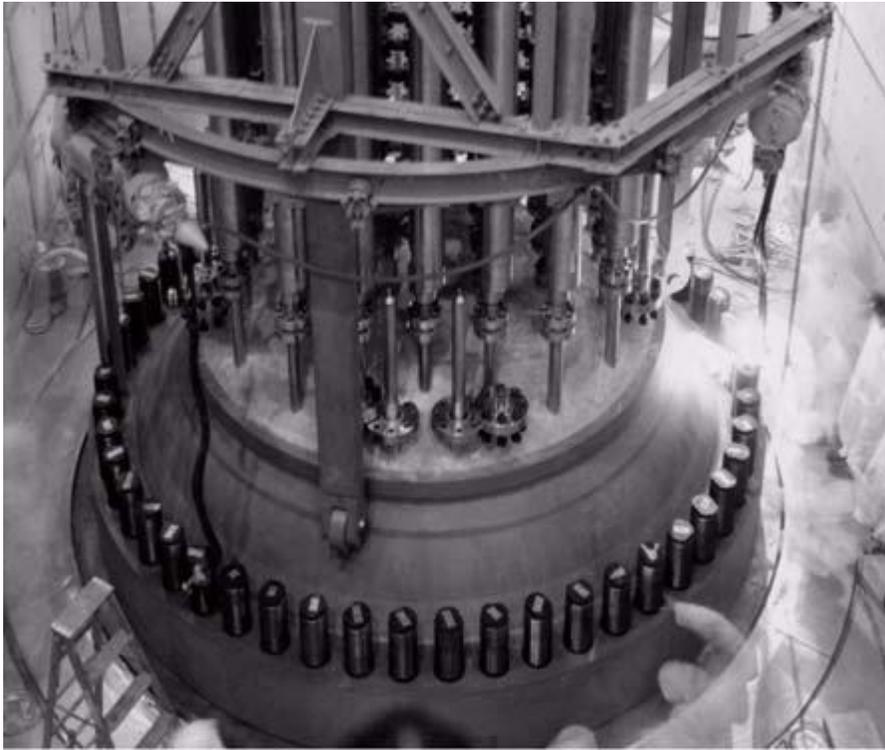
To determine whether cracking was limited to CRDM housing 24, UT examinations identical to those described above were performed on 8 additional CRDM housings which were located on the periphery of the head. As shown in Figure 11, which is a photo of the Palisades reactor head and CRDM housings, CRDM housings not on the periphery of the head could not be examined with the available equipment due to access considerations. The NDE vendor stated that no reportable indications were observed.

Figure 11: Photo of reactor vessel head and CRDM housings. Note limited access for inspection of interior housings [9]

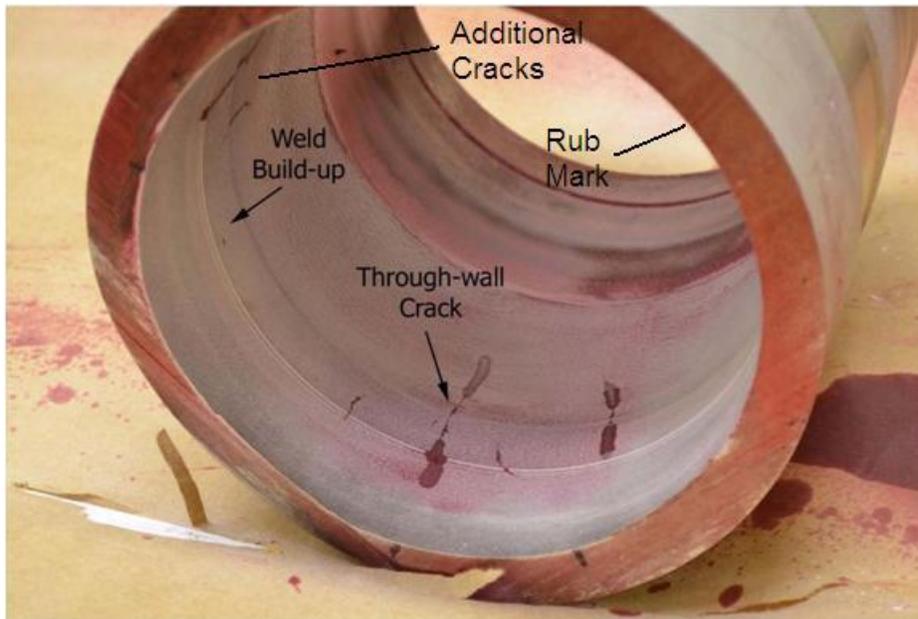
Upon receipt, by the Babcock and Wilcox<sup>6</sup> (B&W) laboratory the CRDM was sectioned circumferentially and subjected to dye penetrant examination. As shown in Figure 12 [8], the dye penetrant examination revealed 9 axial cracks and 1 rub mark. The rub mark is believed to indicate impingement of the CRDM on the housing during operation. The 9 cracks were located in two groups. Each crack group and the rub mark were located approximately 120° from each other. The spacing of the crack groups and rub mark is believed to be significant in that it indicates non-uniformity in the circumferential stresses in the CRDM housing with circumferential position around the housing. No cracks were found in any other CRDM housing sections.

Figure 12: Dye penetrant exam of outside diameter of CRDM housing 24 showing leak two areas of cracking and location of rub mark [8]

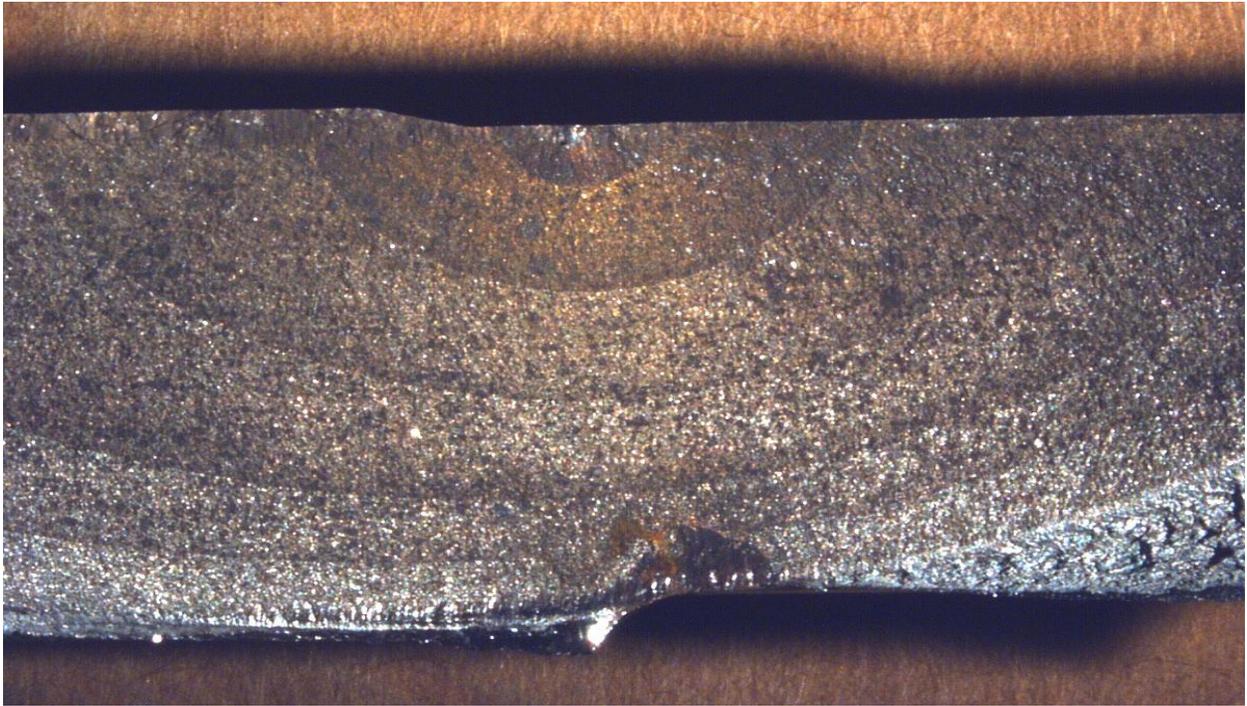
As shown in Figure 13 [8], examination of the fracture surfaces revealed beach marks as seen in previous failures. The crack which resulted in the through wall leak had 6 beach marks. Other cracks had between 4 and 6 beach marks. As in previous failures, the fracture surface supported transgranular stress corrosion cracking as the cracking morphology. No evidence of fatigue was observed. Although chlorides were not identified, the presence of chlorides and elevated levels of oxygen were inferred based on past findings of elevated levels of chlorides and oxygen in CRDM housings. Cracking was, therefore, attributed to transgranular chloride stress corrosion cracking.

Oxygen ingress occurs during reactor outages. The surface oxide color differences noted in each of the beach marks clearly shows the initiation region to be older than the subsequent beach marks; however, it could not be conclusively determined if the beach marks corresponded to refueling outages (i.e., 18 month cycle) or shorter periods as occurred during outages over the past 24 months

Figure 13: Macrograph showing beach marks, Palisades 2012 [8]
