**Area Walk-By Checklist (AWC)**

Location (Bldg, Elev, Room/Area): **Area 40 - AB2, 633, 9**

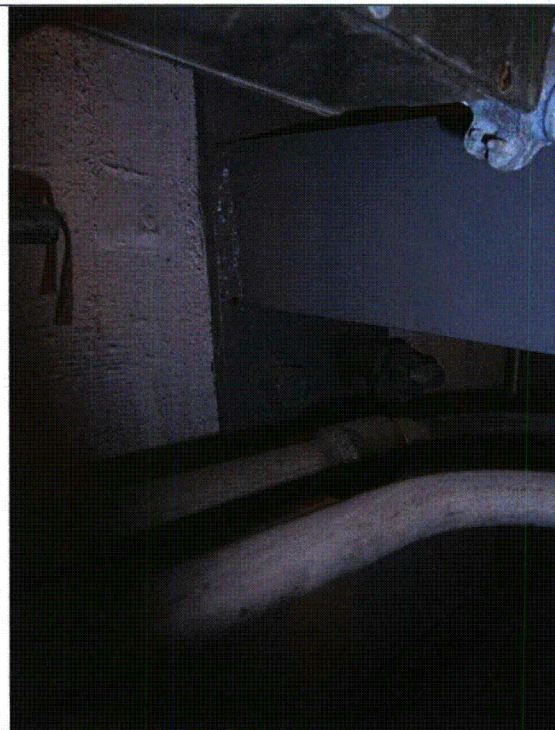
Note: Lower left bolt on brace with less than required thread engagement (P3280100)

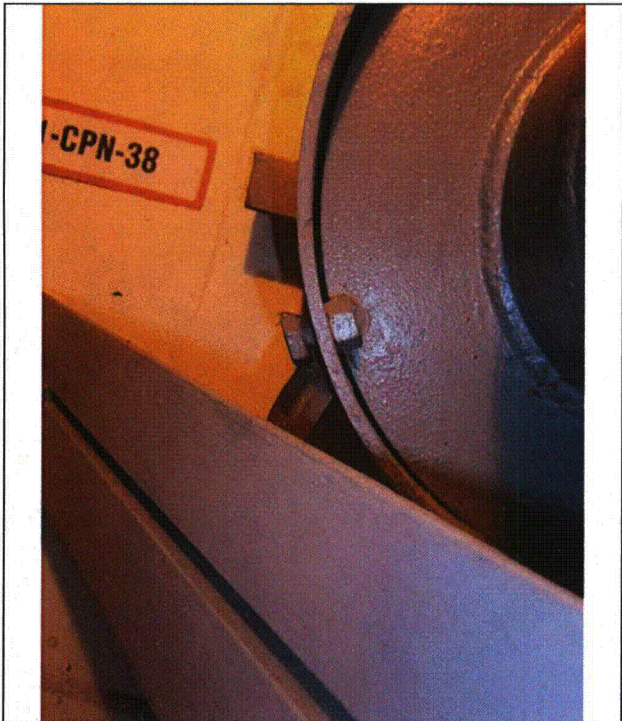
**Note:** Backed out bolt on 1-CPN-38  
(P3280102)

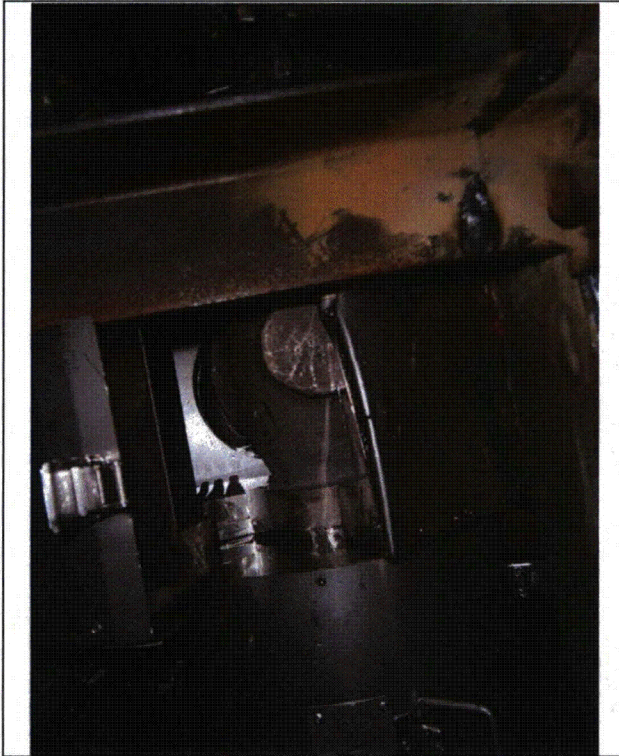
**Note:** *Insulation was found unclipped. Not a seismic concern; insignificant weight and no soft targets below (P3280049)*

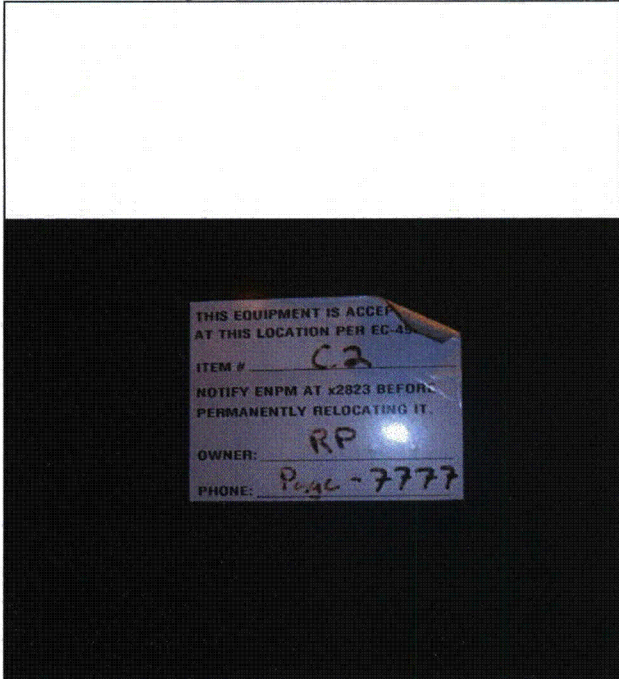
Note: Note accepting the location of the RP storage cabinet per Engineering (P4050279)

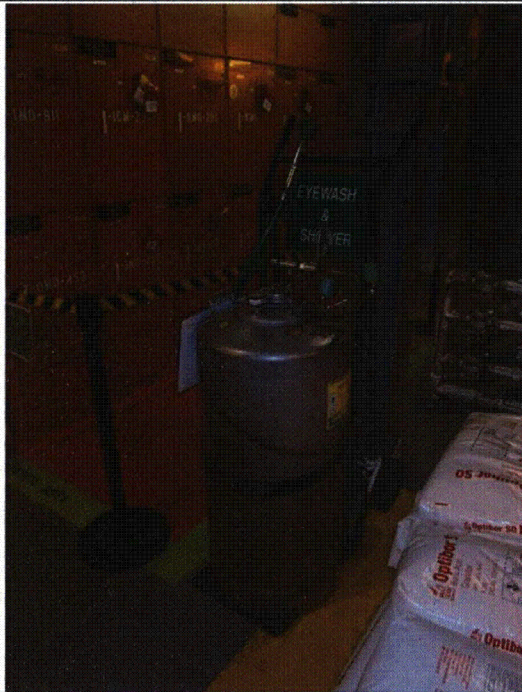
*Note: Eyewash and shower station properly tied off and restrained (P4050294)*

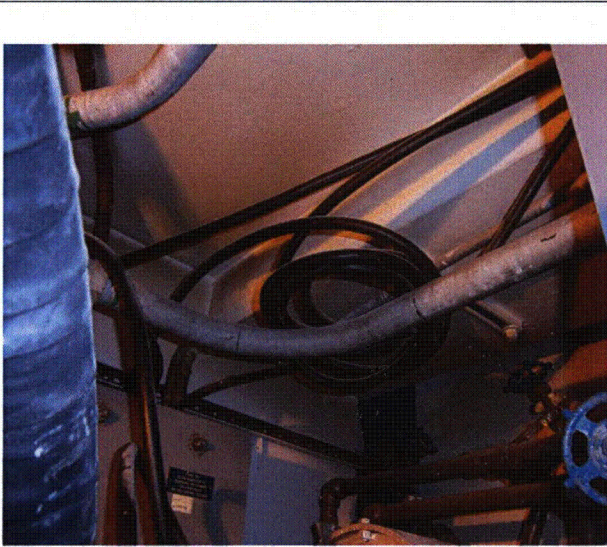
3. Based on a visual inspection from the floor, do the cable/conduit raceways and HVAC ducting appear to be free of potentially adverse seismic conditions (e.g., condition of supports is adequate and fill conditions of cable trays appear to be inside acceptable limits)? Y  N  U  N/A   
*Conduit runs well supported on unistrut.*  
*Air hoses to valve actuators hanging in front of protection cabinet. Not a seismic concern.*

**Note:** (PA-040549) Air Hoses for Air Operated Valve actuators. (See Comments Above)

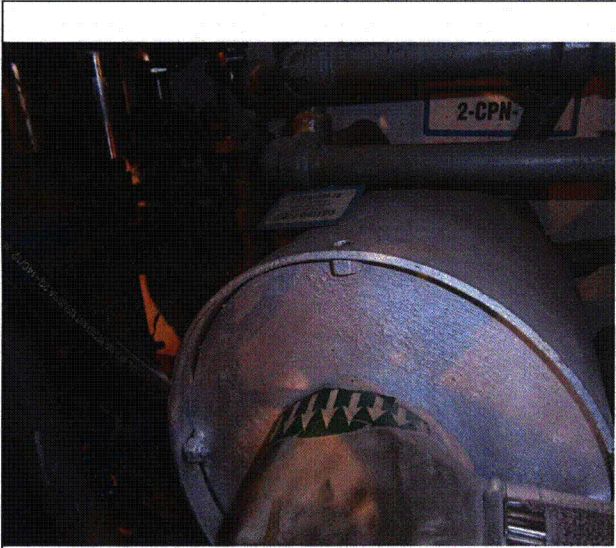
*2-CPN-79 is missing 2 bolts. The top bolt hole has a nut welded in place, however the bottom bolt hole has no bolt or nut. This is not a seismic concern. AR 2013-14875 was written to replace the missing bolts.*

**Note:** (PA-040555) 2-CPN-79 missing bolts. (See Comments Above)

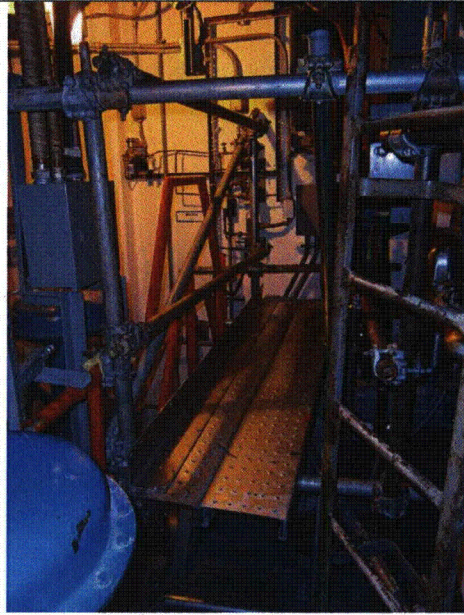
**Note:** (PA-040558) Scaffold built near Solenoid Protection Cabinet containing 2-XSO-321. (See comments above)

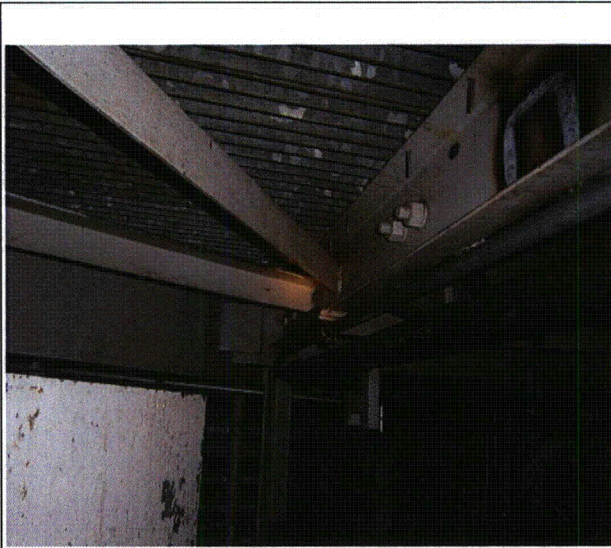
**Note:** (PA-040475) Bolts securing grating are self tapping, no nuts required

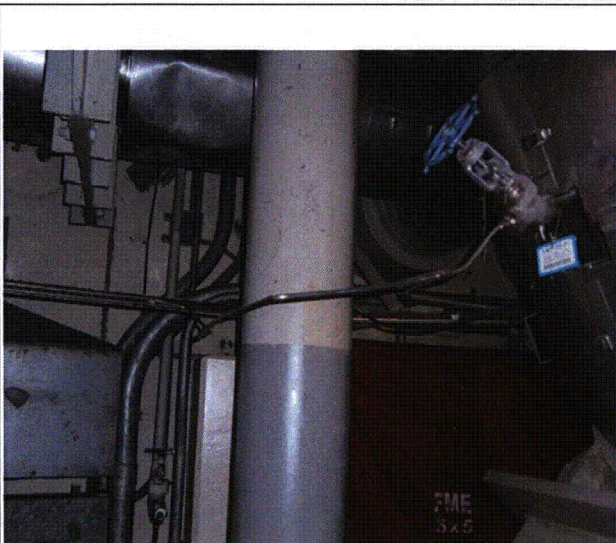
**Note:** (PA-040500) Tubing spanning from valve 2-NFP-220-V1. (See Comments Above)

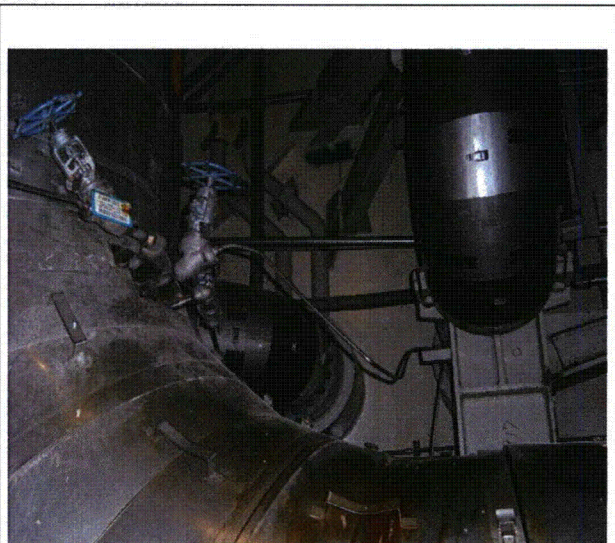
**Note:** (PA-040502) Tubing spanning from valve 2-NFP-220-V2. (See Comments Above)

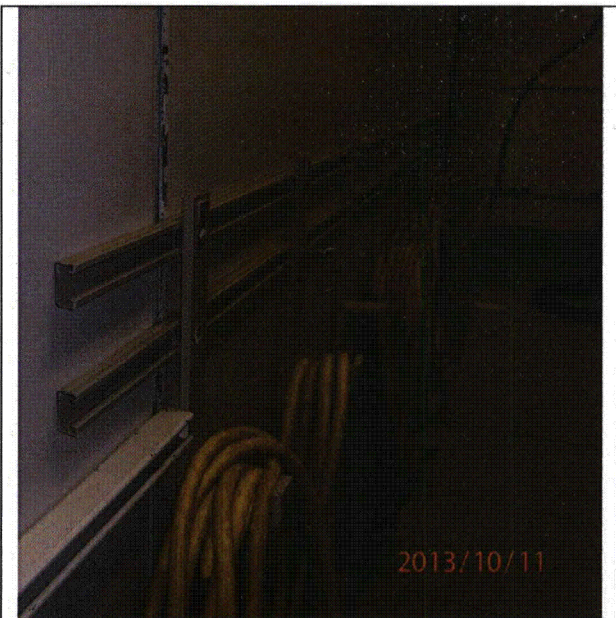
**Note:** (PA110628) Missing eyebolt in one hook, not a seismic concern.

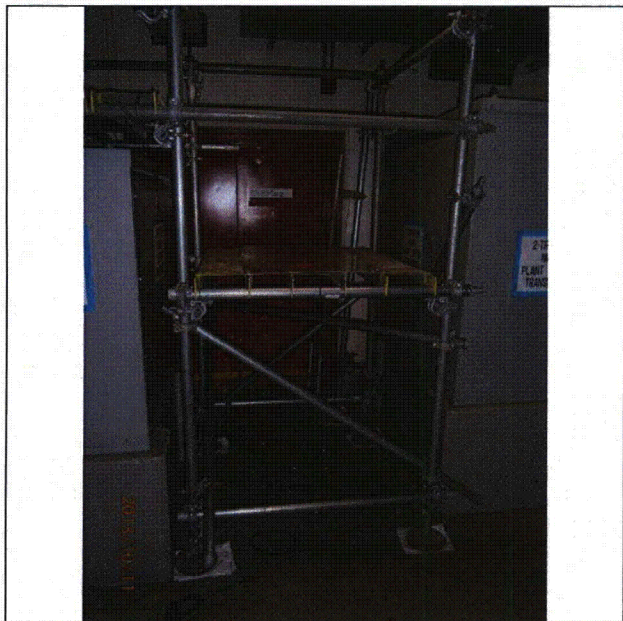
**Note:** (PA110666) Seismic scaffold anchored to the floor and braced against the wall per plant procedure.

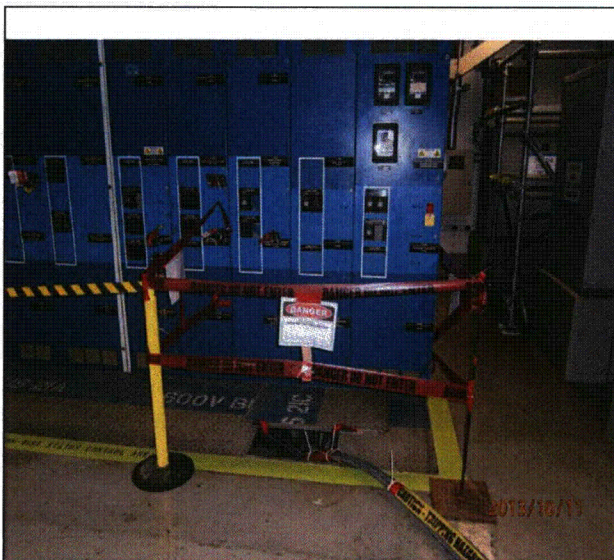
**Note:** (PA110673) Stanchions warning of open floor grating for Unit 2 Cycle 21 refueling outage work. Not a seismic concern.
