Part 21 (PAR)

Event # 49809

PART 21 INTERIM REPORTING REGARDING TRICENTRIC TRIPLE OFFSET BUTTERFLY VALVES

RE: 10CFR Part 21 Interim Reporting of TRICENTRIC Triple Offset Butterfly Valves

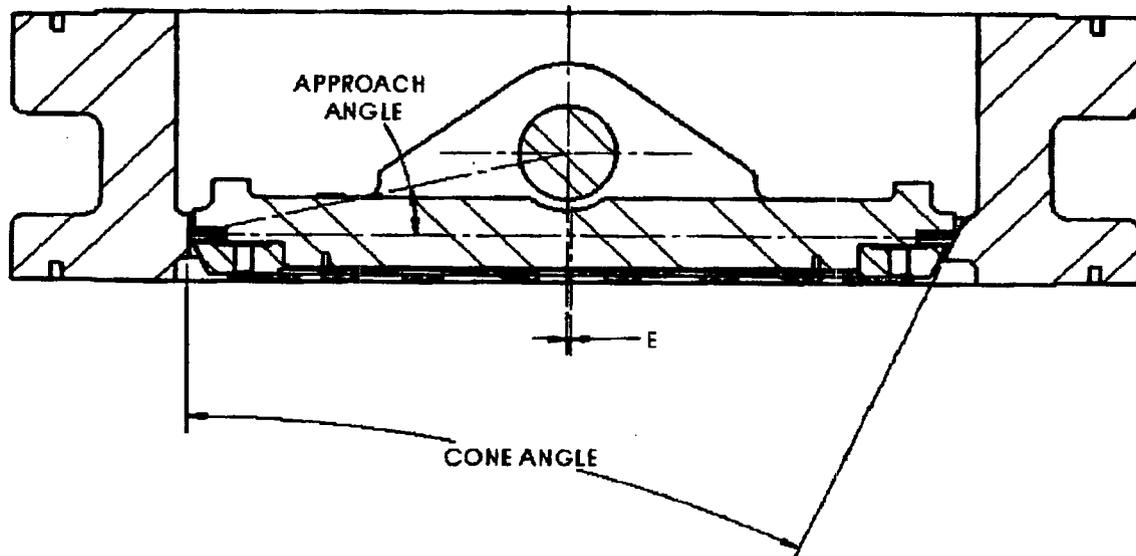
Figure: Critical Dimensional Characteristics Related to Unseating

Weir has completed a regression analysis of the loads to seat then unseat the valve. The load to unseat the valve with packing and bearing loads removed is proportional to the input torque. Weir reviewed the variables that could contribute to the load. The TRICENTRIC surfaces employ a series of angles to create the seal, it was determined the seal stack on the shaft offset side was the point of drag on the unit. Additionally, Weir established that the torque could be conservatively described by:

$$T_{ULS} = [T_{s@0 \text{ degrees}} * \mu_{fs} * \text{SIN Approach Angle}] / 2$$

Independently T_{Ulp} could not exceed $T_{s@0 \text{ degrees}}$ as the approach angle and friction plus the additional normal load to create the seal exist and the sealing load must work on the entire seal perimeter. Therefore, this load will need to be captured and reported in Weir's actuator sizing calculations but does not have an impact on safety.
