**RE: Uranium One, Willow Creek ISR Operations, Header House 5-5 Spill Inspection Report, Permit No. 478**

**SPILL INSPECTION REPORT**

**COMPANY/MINE:** Uranium One, Willow Creek ISR Uranium Mine, PT478

**SUBJECT:** Inspection of Christensen Ranch Mine Unit 5, Module 5-5 Header House Spill

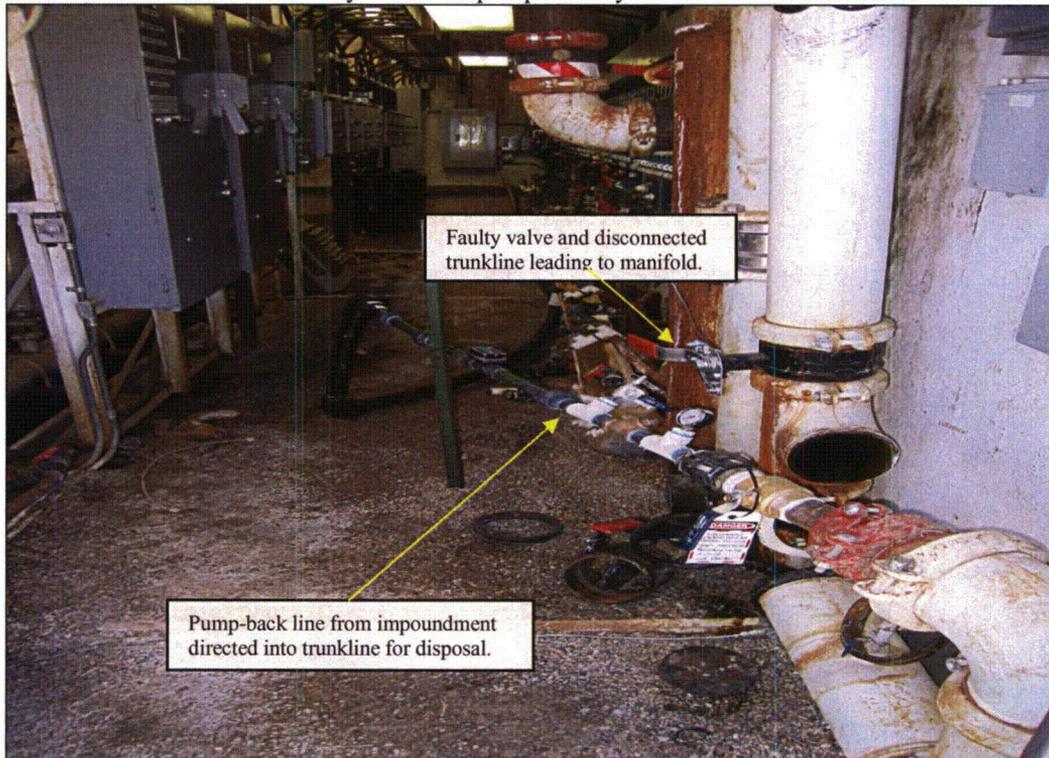
inactive. The trunkline from the Module 5-5 header house ties into the trunkline that carries production fluid from an actively producing portion of Mine Unit 5, Module 5-2. The Module 5-5 trunkline was not isolated from the Module 5-2 trunkline which resulted in production fluid being backed-up in the line connected to the Module 5-5 header house. A 6-inch butterfly valve is located in the Module 5-5 header house and serves as the isolation valve between the trunkline and header house production manifold (**Photo 1**).

Mr. Winter and Mr. McCullough advised the inspectors that the valve was determined to be faulty as the indicator was in the closed position but allowing fluid to leak by and fill the production manifold located in the header house. U1's investigation into the root cause of the spill identified recent weather data showing ambient temperatures had been below zero (minus 24°F) on January 5 and 6, 2014. U1 therefore concluded that the break in the above-ground, PVC constructed manifold was from expansion of freezing production fluid which had seeped into the manifold line (**Photos 2 & 3**). Due to the building being inactive, the release was unnoticed for an estimated nine days until routine quarterly sampling activities occurred in the area.

**Photo #1** – View of faulty valve and pump-back system in Module 5-5 header house.

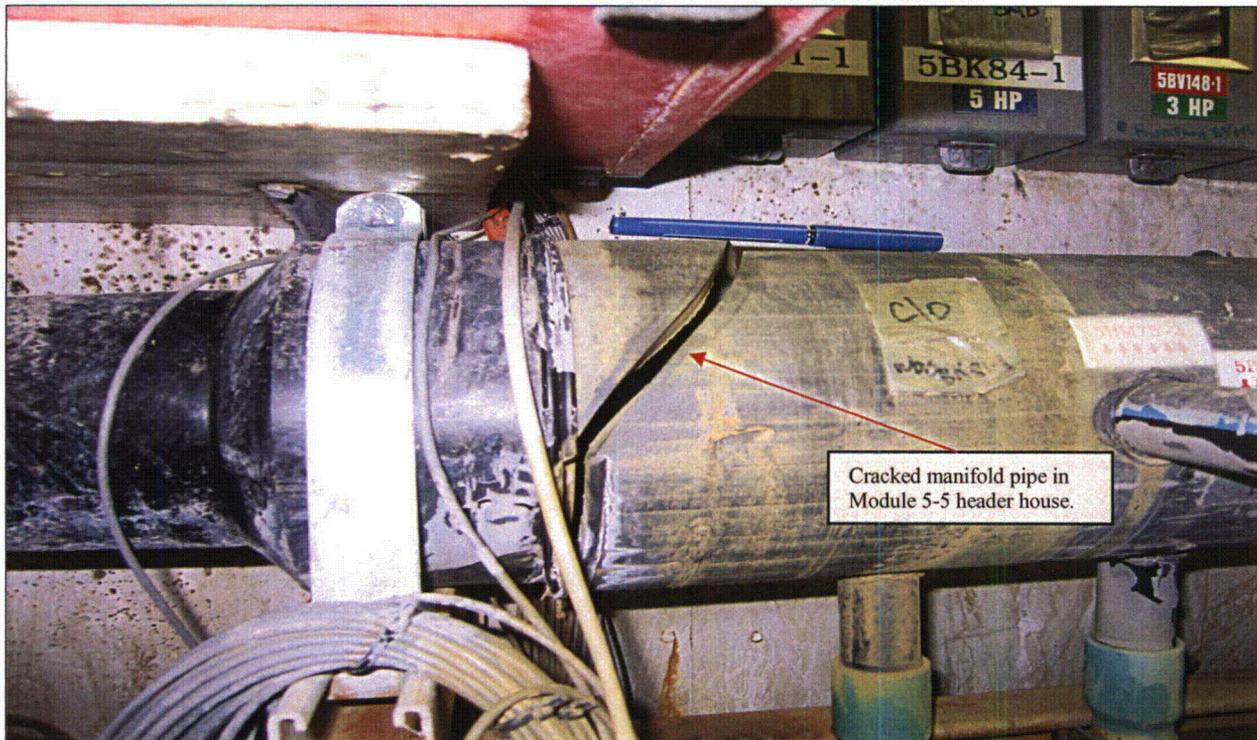
**Photo #2** – View of break in Module 5-5 header house manifold.

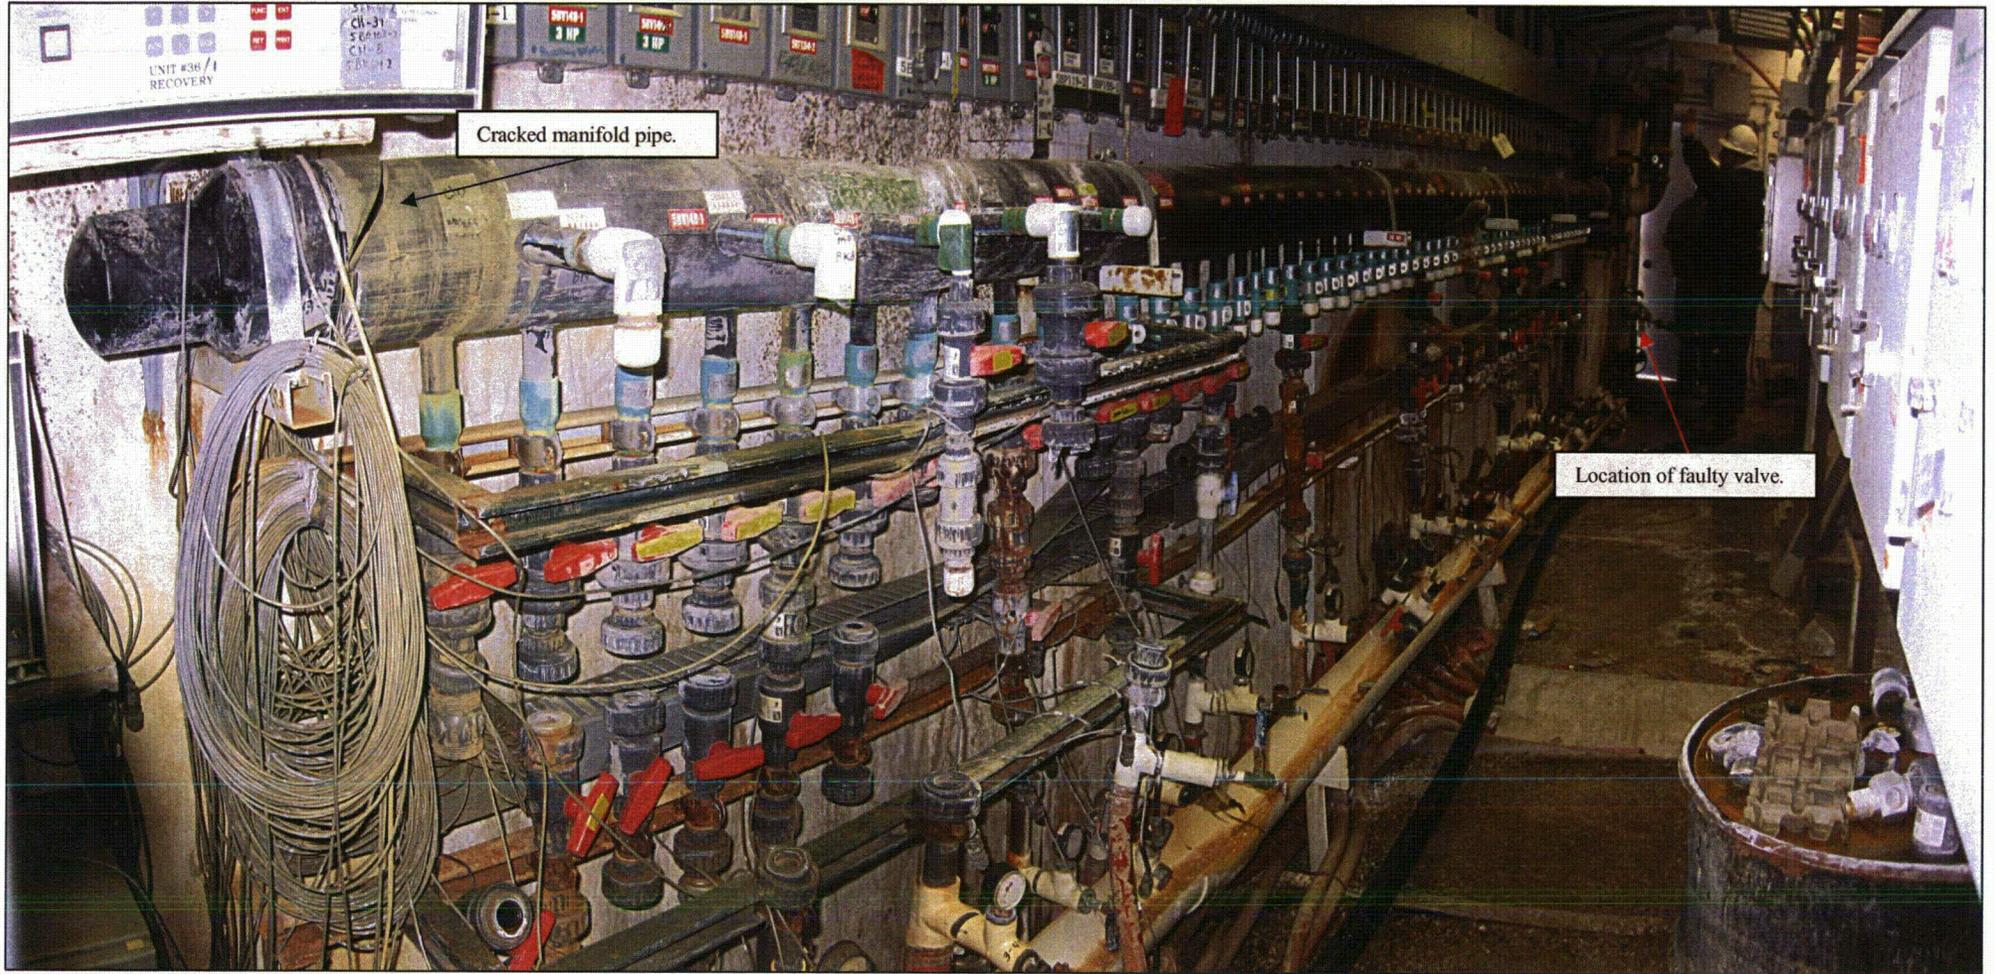
**Photo #3** – Interior view of Module 5-5 header house manifold.

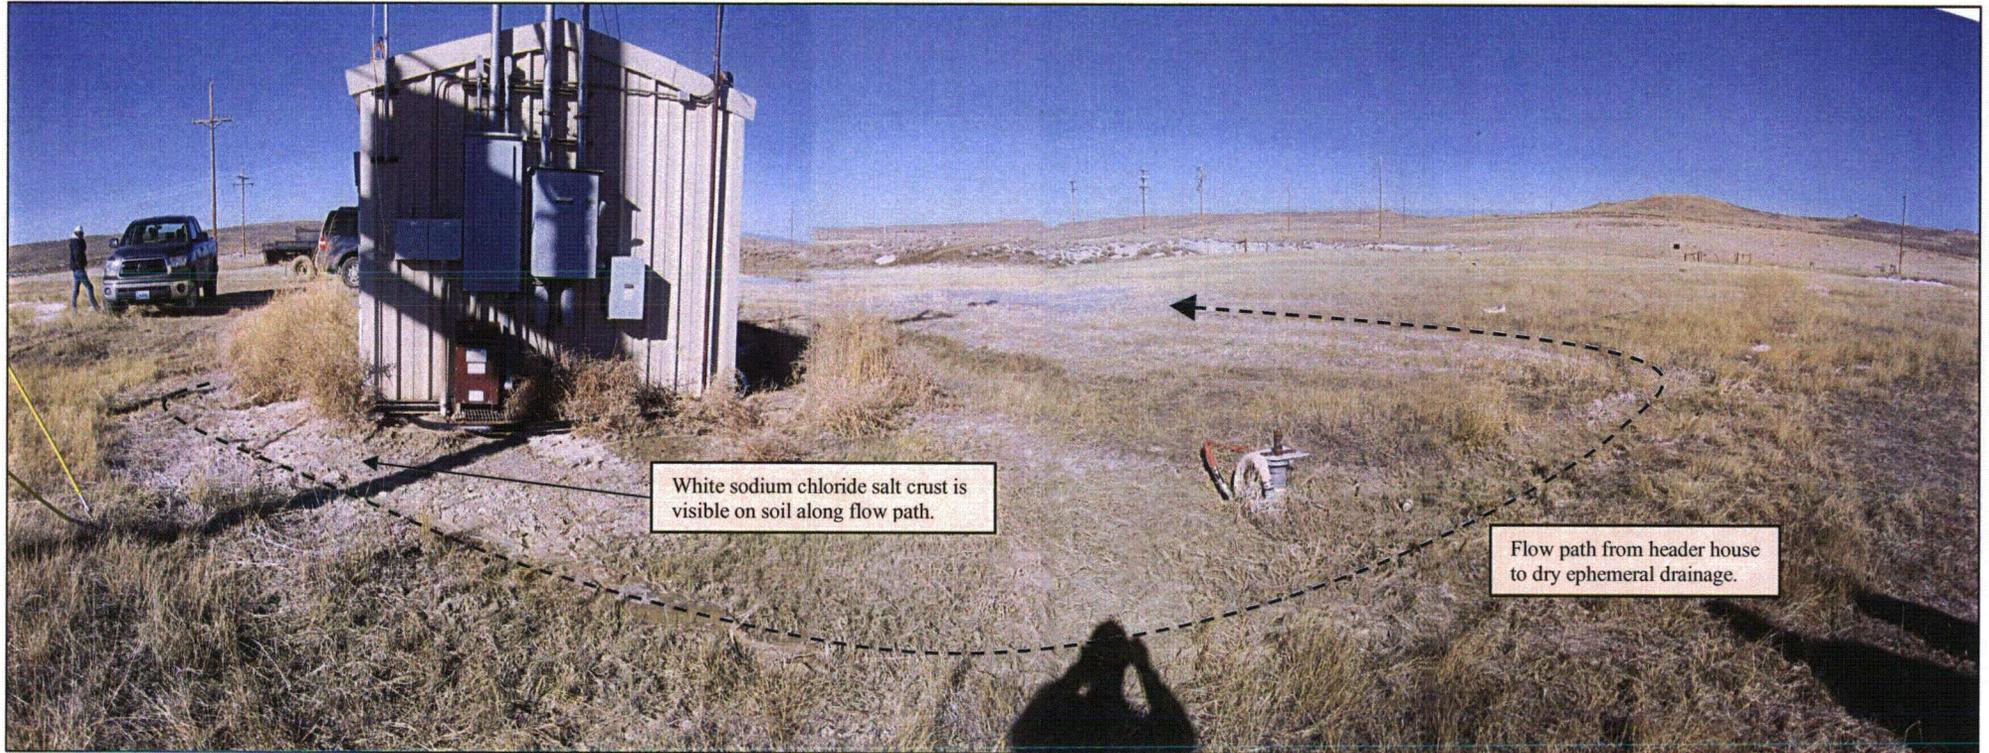
The release was observed to have flowed out of the header house and to the North West down a dry ephemeral drainage which leads to Willow Creek which is also ephemeral. Because of the very cold temperatures at the time of the spill, the fluid appeared to have moved slowly, freezing as it flowed down the drainage causing no significant erosion (**Photos 4, 5, 6, 7, & 8**). Visual observation of the frozen flow, along with surface water sampling data U1 collected downstream from the spill indicated that the spill did not reach any active waters including Willow Creek (**Photos 9 & 10**). The distance along the drainage from the header house to Willow Creek is approximately 6,000 feet. According to the U1's written Spill Report, the release flowed approximately 5,440 feet down the dry ephemeral drainage. U1 estimated that approximately 24,000 square feet (0.56 acre) of soil was impacted.

**Photo #4:** View of spill flow path from header house.

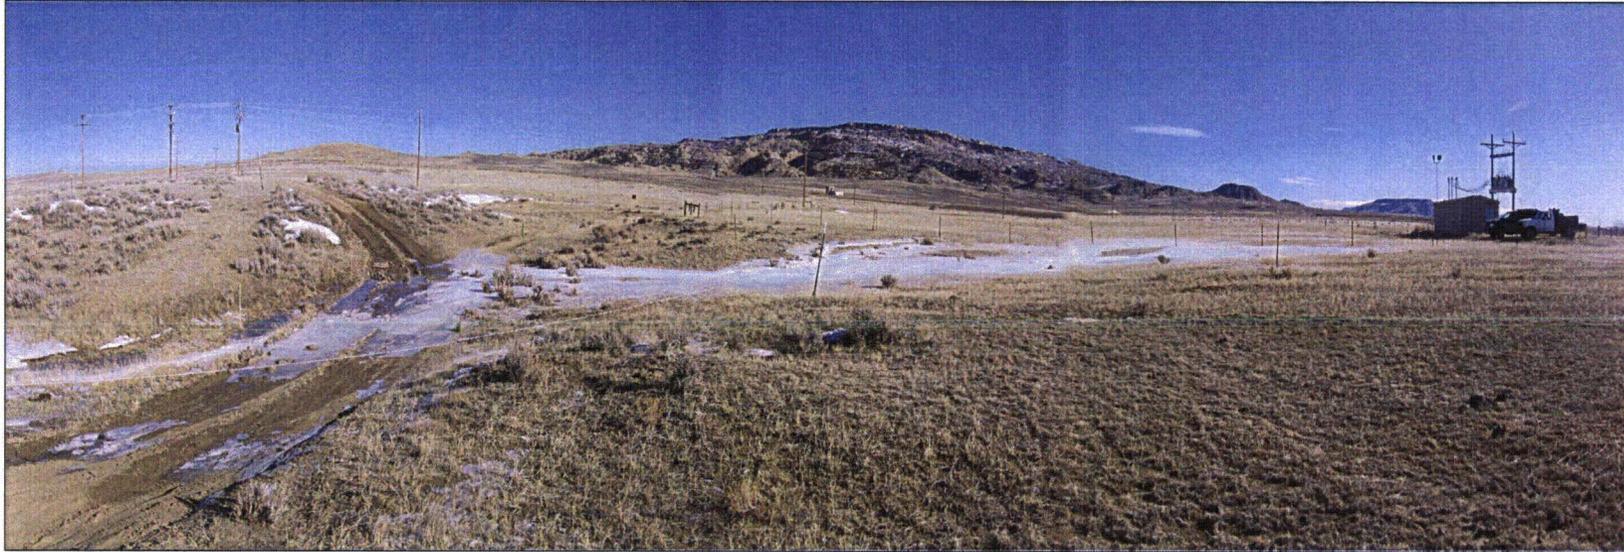
**Photo #5:** View of frozen spill flow path in drainage directly down-stream from header house.

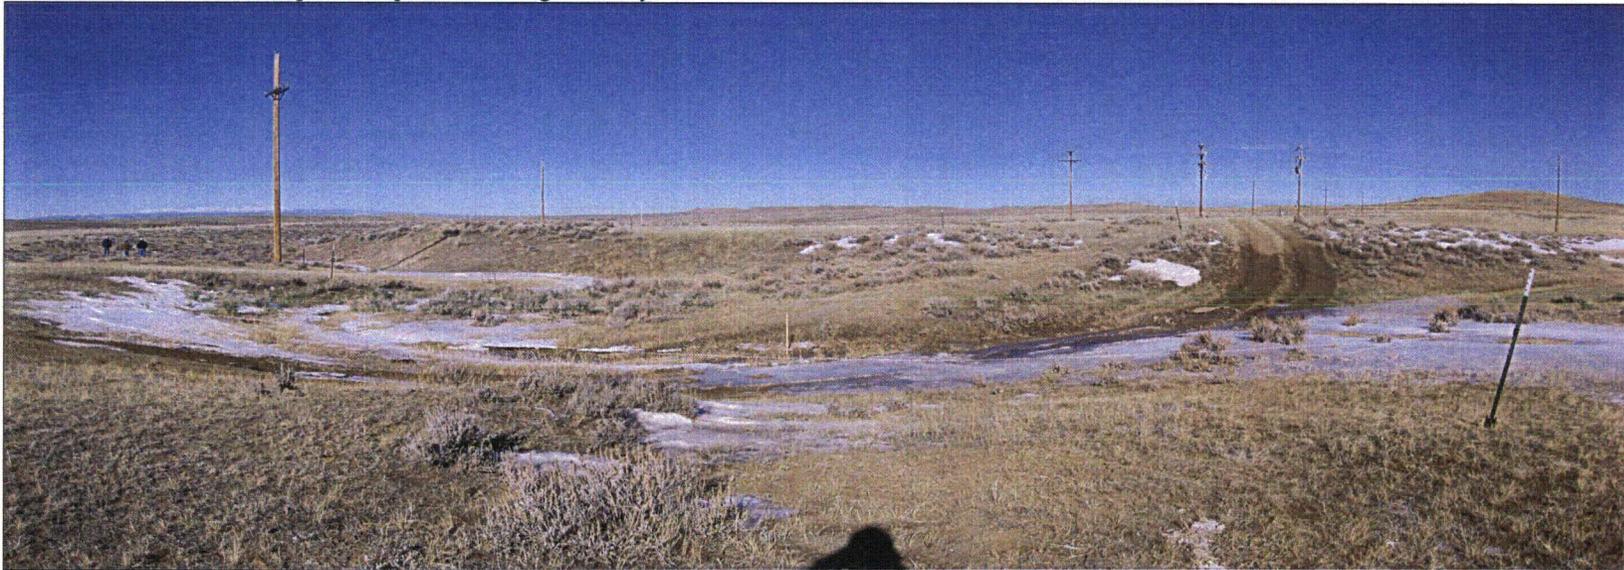
**Photo #6:** View of frozen spill flow path in drainage directly down-stream from header house.

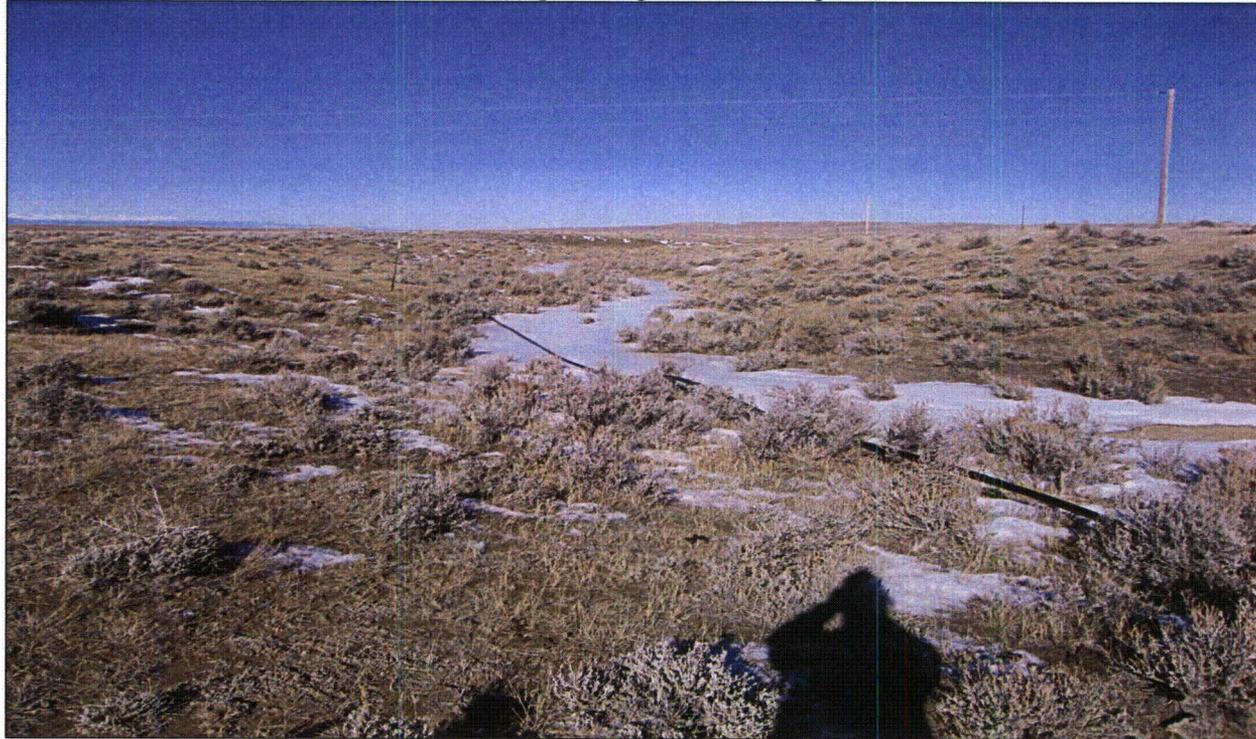
**Photo #7:** View looking down-stream of frozen spill flow path between impoundment and header house.

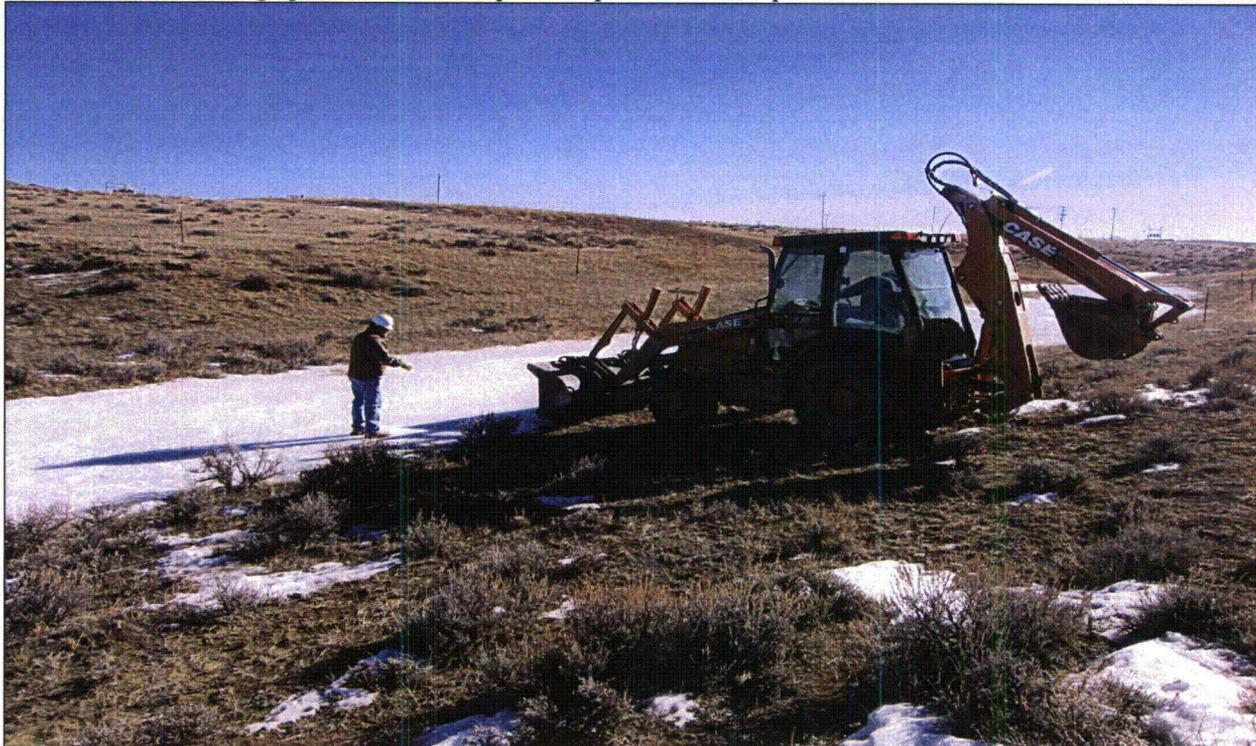
**Photo #8:** View looking upstream of frozen spill flow path between impoundment and header house.

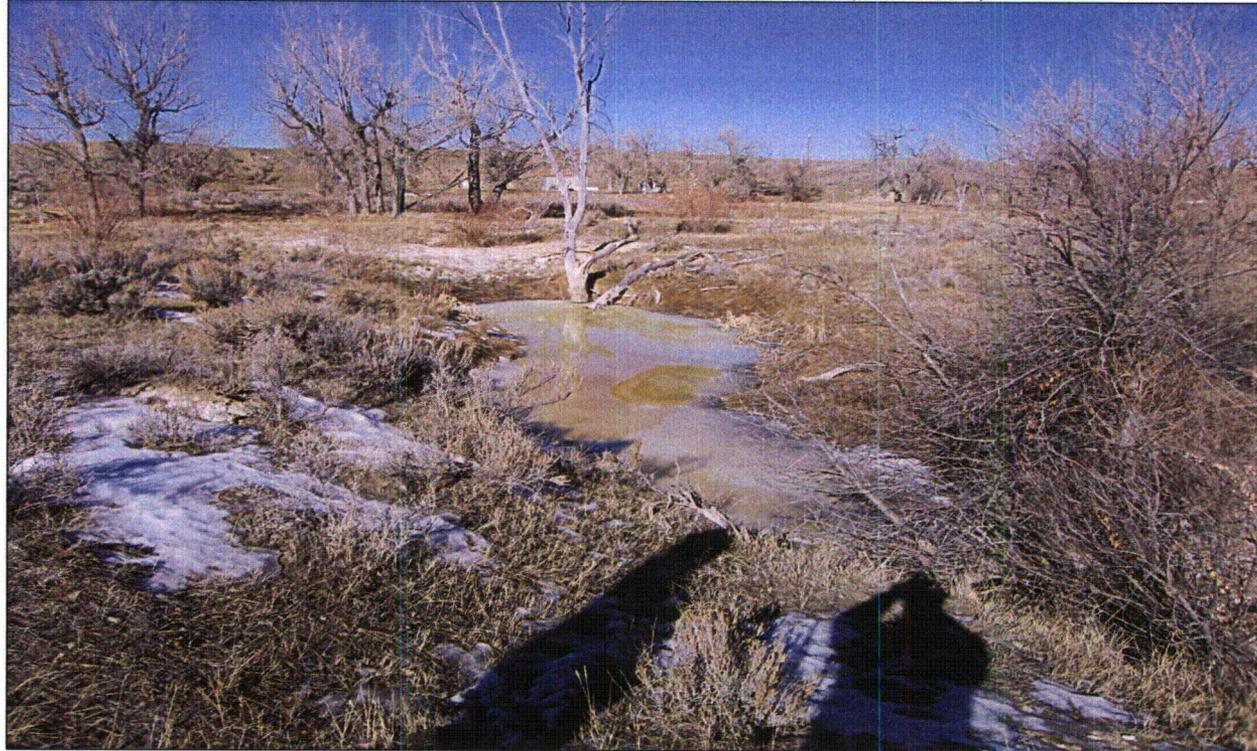
**Photo #9:** View of pond located at confluence of drainage and Willow Creek (DV-1 Pond).

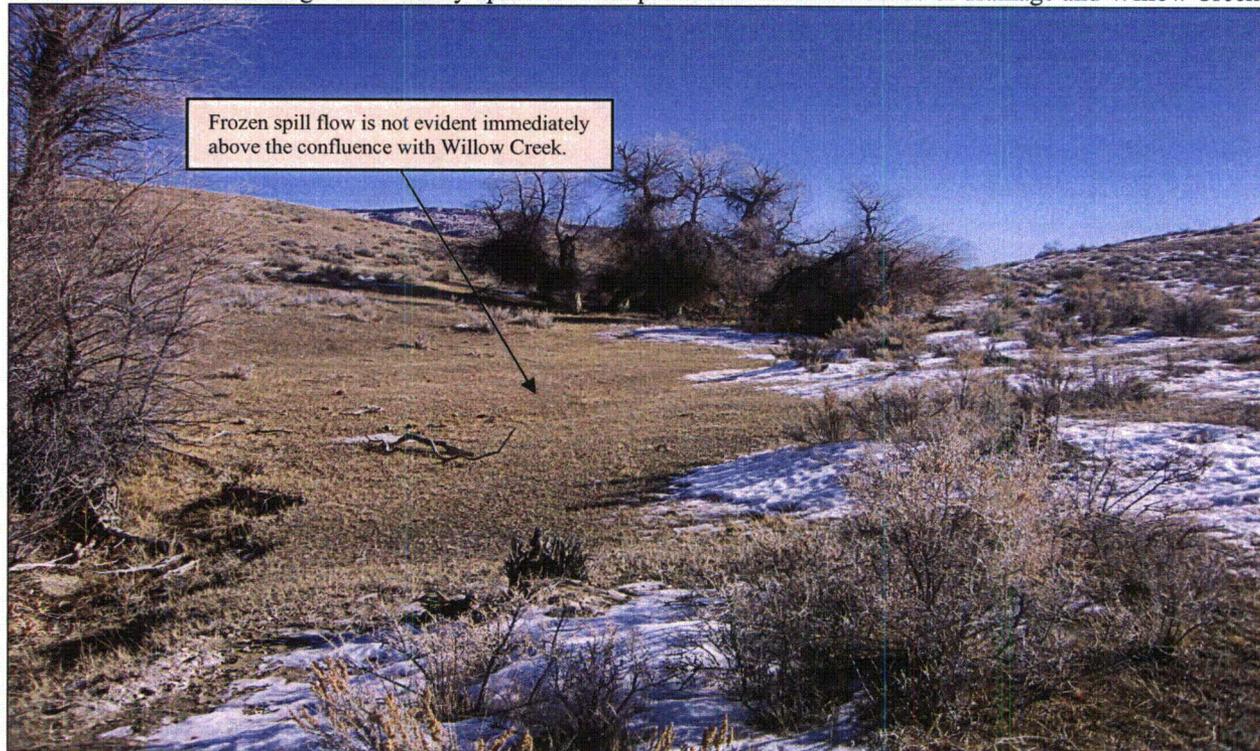
**Photo #10:** View of drainage immediately upstream from pond located at confluence of drainage and Willow Creek.

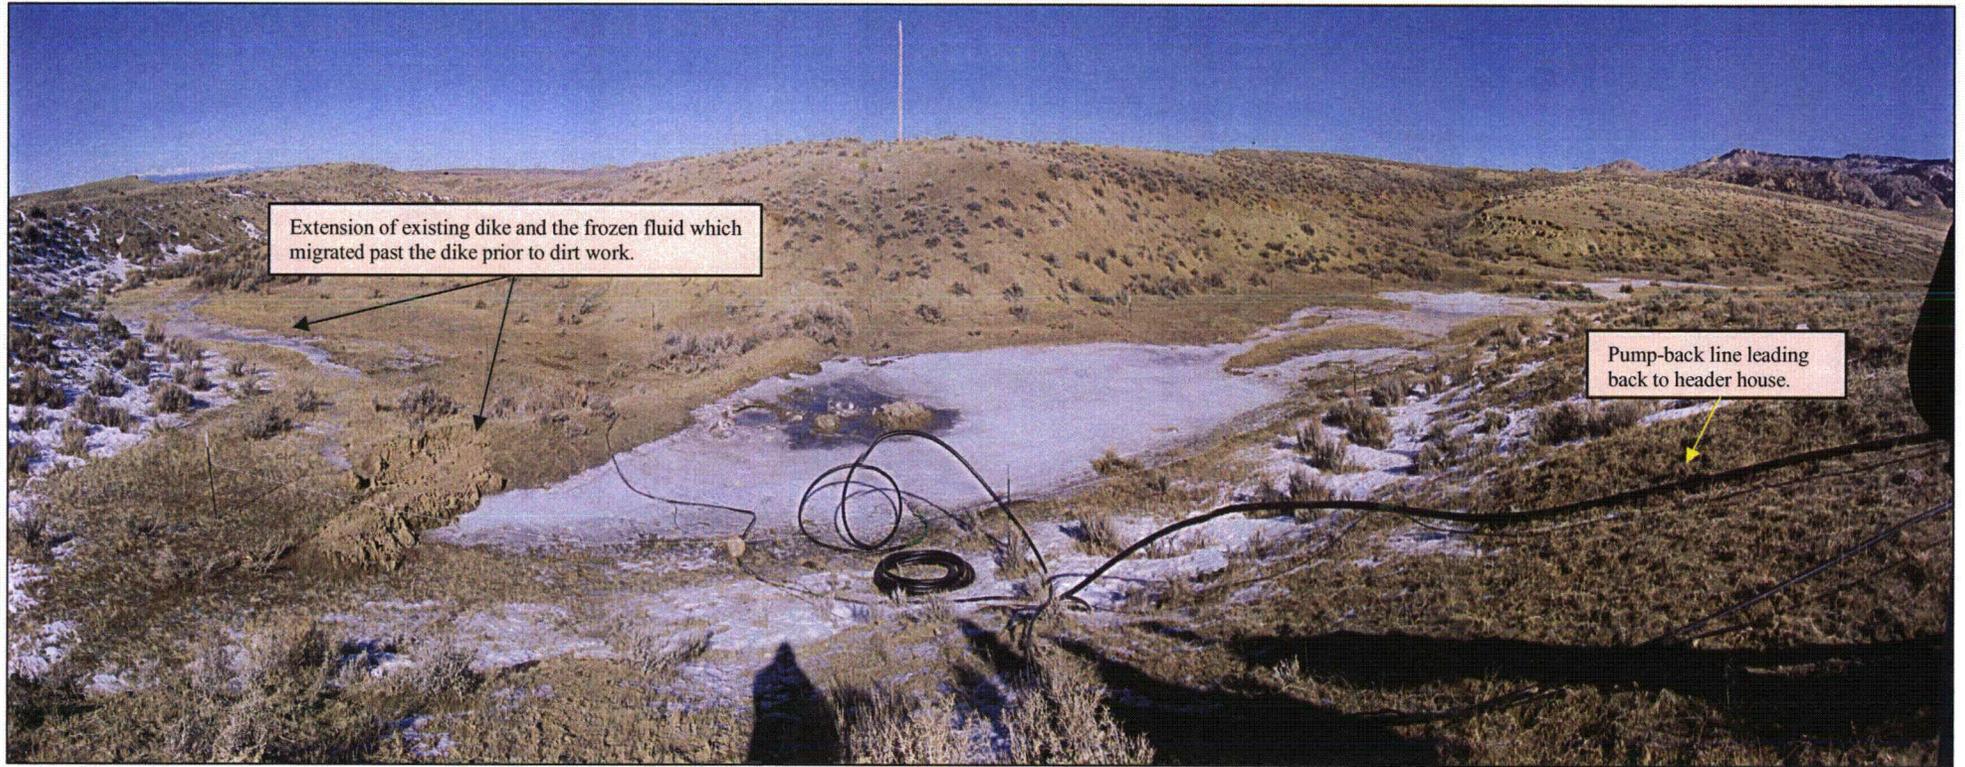
The majority of the spill volume appeared to be concentrated between the header house and an existing earthen dike (impoundment) located within the drainage approximately 3,300 feet downstream (channel distance) from the header house. As indicated by the total length of the spill's flow path discussed above, some of the fluid had flowed around the dike when the capacity of the diked area had been exceeded. After discovering the spill, U1 bermed up the west end of the dike to prevent any additional fluids from flowing further down the drainage. A submersible pump and associated piping had been installed in the impoundment to pump fluid back to the Modular 5-5 header house for disposal. Per U1's Spill Report, approximately 9,000 gallons of the released fluid was able to be recovered before the remaining fluid in the impoundment froze solid (**Photo 11**). The frozen fluid in the drainage is interpreted to be comprised of spill fluid and frozen surface run-off from recent snow melt occurring prior to the spill.

**Photo #11:** View of impoundment with pooled spill fluids located approximately 3,300 feet down the drainage from Module 5-5 header house.

LQD encourages U1 to continue its efforts to pump and collect fluid from the impoundment and two catchment basins through the spring of 2014, focusing on pumping efforts during and following melting and/or precipitation events that may carry affected soils down the drainage to Willow Creek.

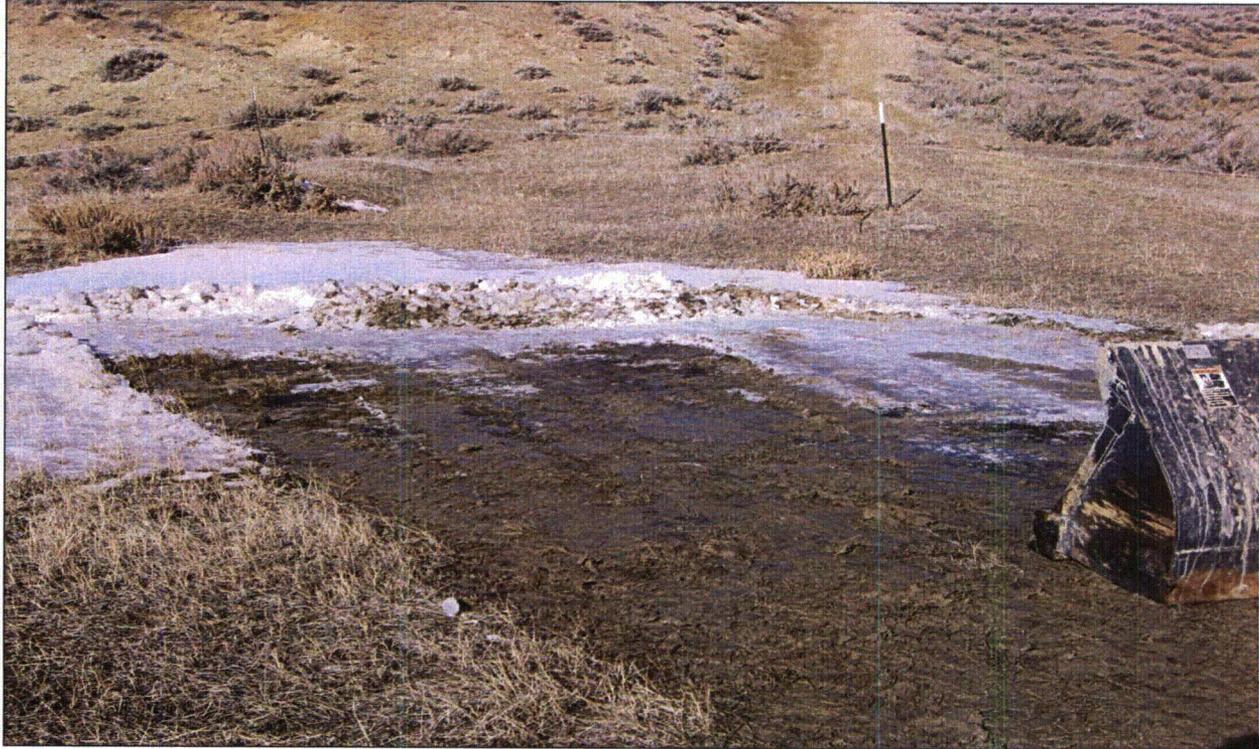
assessed with an on-site backhoe and was found not to be viable due to the fluid being frozen into the topsoil (**Photos 12 & 13**). Further assessment of this clean-up option concluded that picking up large amounts of the frozen spill fluid would result in extensive damage to the ground surface which could expose the underlying soil in the channel bottom to erosion. Additionally, it was considered that handling and transporting the frozen production fluid could potentially pose an unnecessary human health and environmental safety risk. As a result, LQD recommended excavating two catchment basins in the drainage between the header house and the impoundment. As reported in U1's written Spill Report, such basins were installed following the inspection to catch and recover fluid as it melts.

**Photo #12:** Attempt to peel up frozen spill with loader.

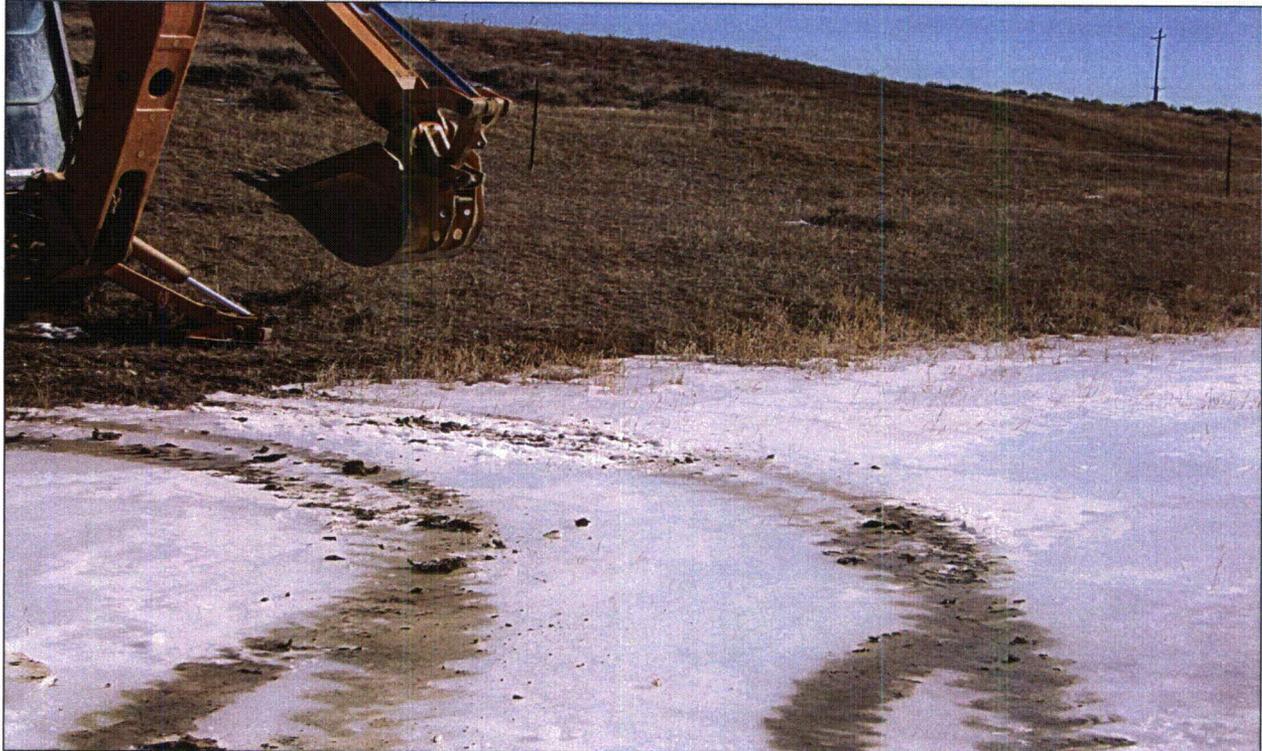
**Photo #13:** Attempt to peel up frozen spill with back-hoe.
