Subject: 10CFR21 Reporting of Defects and Non-Compliance -
Engine Systems, Inc. Report No. 10CFR21-0111, Rev. 0

Starting Air Pressure Regulator, Nordberg P/N 1776 506

Report No. 10CFR21-0111

**10CFR21 REPORTING OF DEFECTS
AND NON-COMPLIANCE**

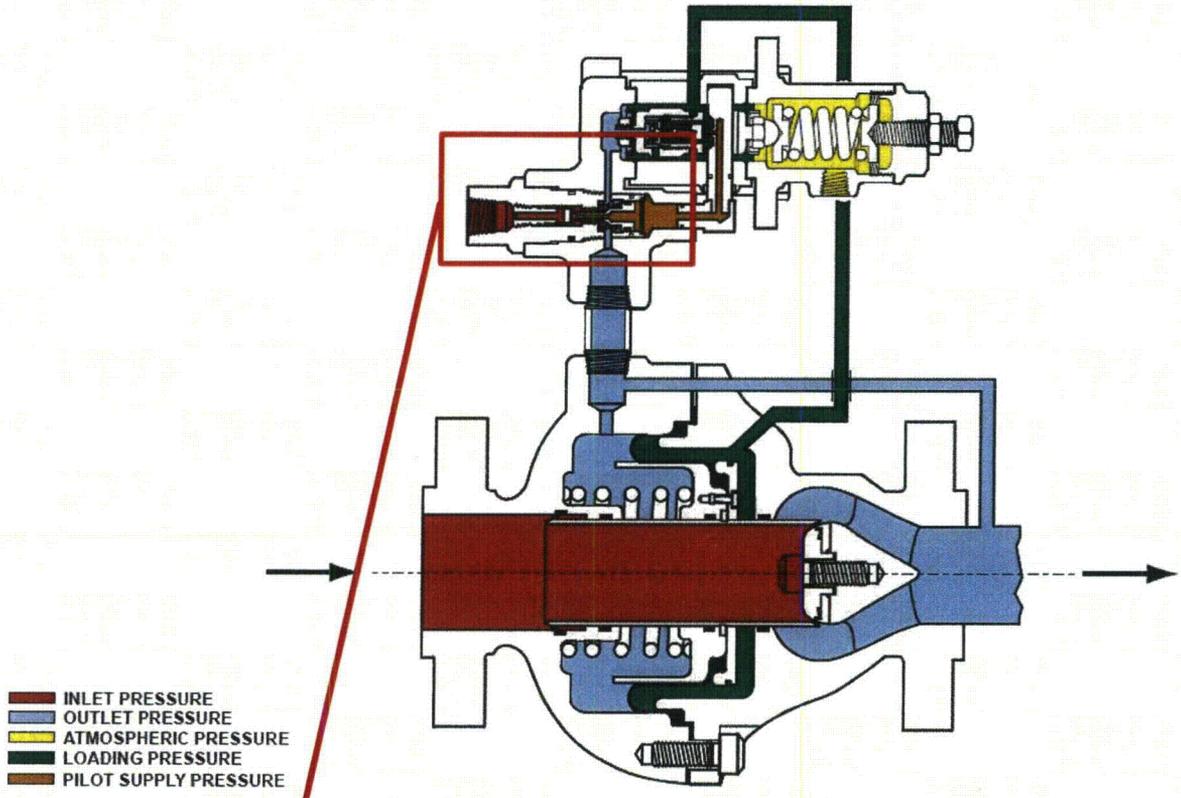
The conclusion of ESI's failure analysis was that an o-ring within the piston guide assembly of the pressure regulating valve had been improperly installed at the factory. The o-ring was squeezed to the point that when the mating piston was inserted through the o-ring, material was shaved from the inside diameter of the o-ring, compromising its sealing capability. This debris ultimately migrated through the piston; however it was the damaged sealing surface of the o-ring that led to the regulator failure. See Figures 1 through 6 on the following pages for a visual depiction.

Figure 1: Pressure Regulator Cut-Away

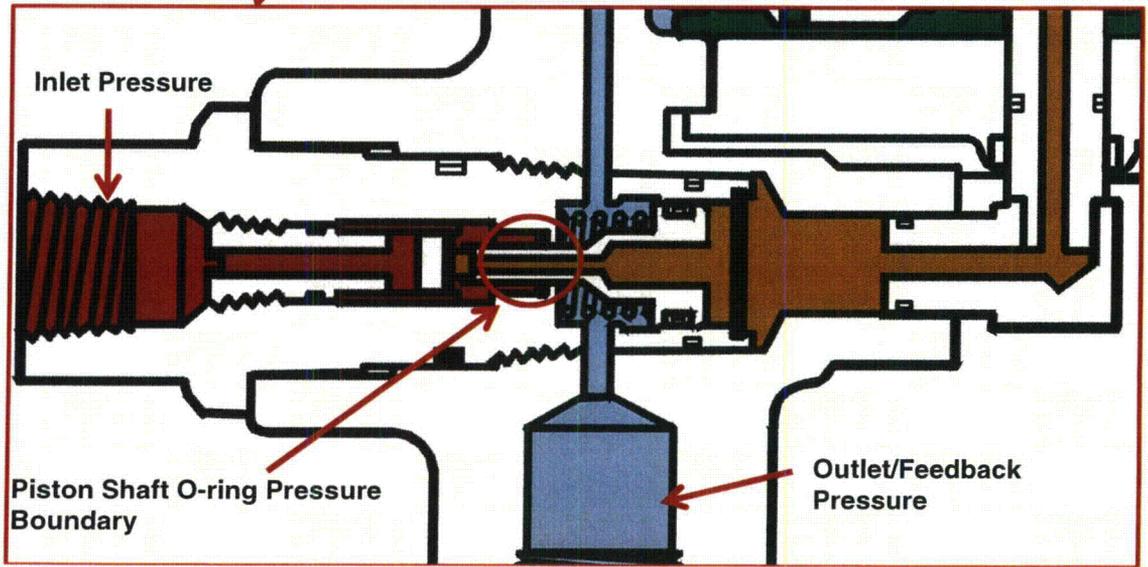
Figure 2: Close-up View of O-ring Location

It has been determined that the piston shaft o-ring within the piston guide assembly of the pressure regulating valve had been improperly installed at the factory. During installation, the o-ring fits into a bore of the piston guide and rests against a shoulder within the bore. To form the o-ring groove, a bushing is then pressed into the bore. One end of the bushing is chamfered to aid in this installation process. It is ESI's determination that when this bushing was pressed into place, it was installed backwards such that the chamfered side was facing away from the o-ring meaning that the installation process required more force than typically utilized. This additional force resulted in the o-ring being squeezed (o-ring groove too narrow) which caused the inside diameter of the o-ring to decrease. During subsequent piston installation, the leading edge of the metal piston shaved material from the inside diameter of the o-ring. It is the seal between the o-ring and piston shaft that was compromised and ultimately resulted in failure of the regulator.

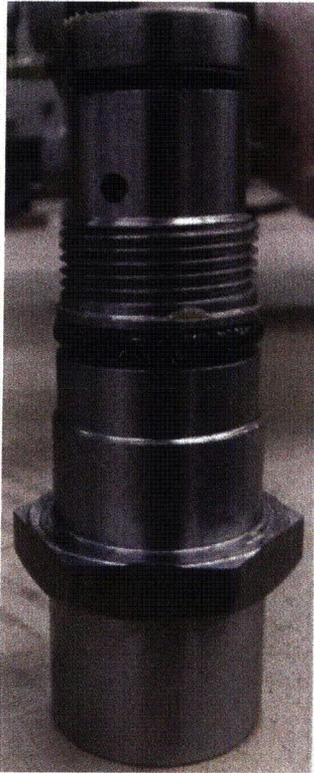
Figure 3: Piston Guide Assembly

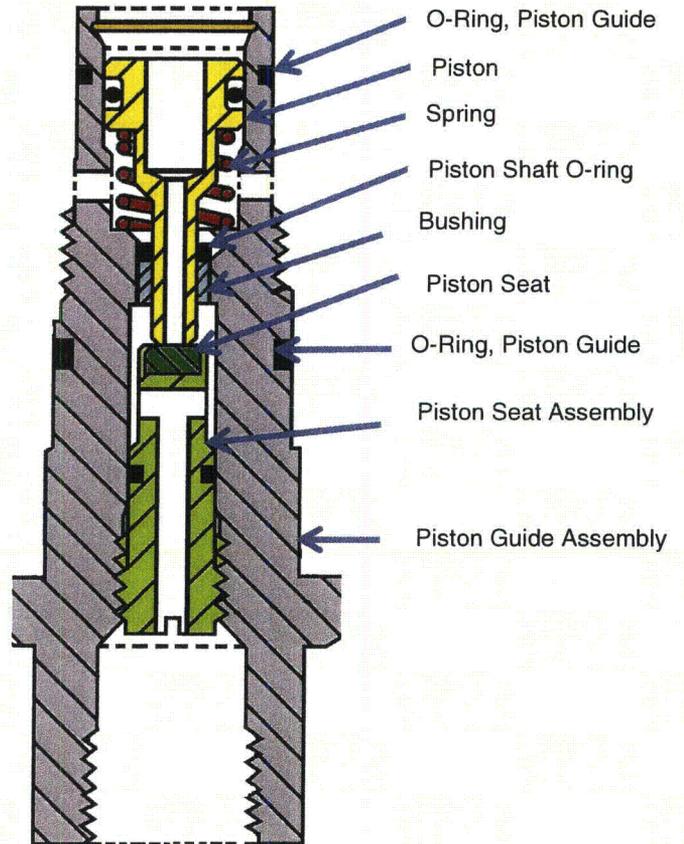
Figure 4: Piston Guide Assembly Section View

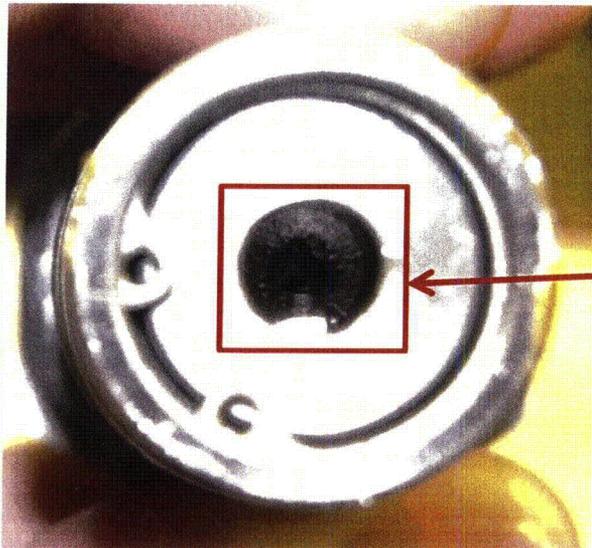
Figure 5: End View of Piston Guide Assembly

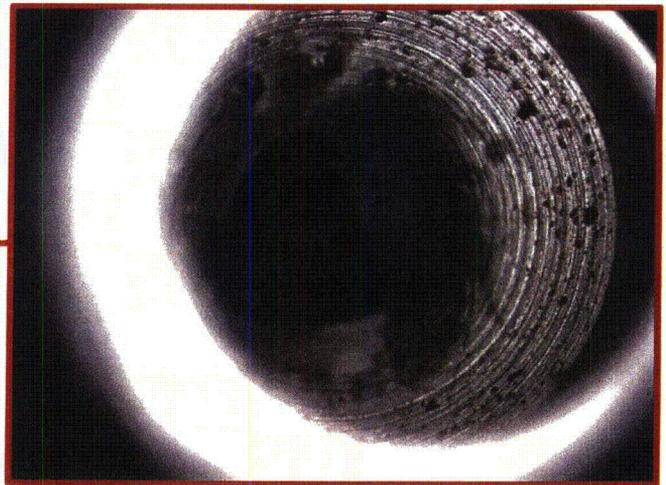
Figure 6: Close-up Showing O-ring Fragments

Otherwise, the regulator should have an inspection performed to visually inspect for the o-ring damage. This requires disconnecting the pilot supply connection from the piston guide assembly and then removing (unscrewing) the piston guide assembly from the pilot valve. Then the piston seat should be removed (unscrewed) using a flat head screwdriver. A visual inspection of the interior of the piston guide assembly would then be performed to confirm no o-ring fragments. Additionally, manually actuate the piston to check for sluggishness, excessive binding, or slow re-coil (the piston is spring retract). If these inspections warrant further investigation, remove the snap ring that retains the piston and remove the piston to access the o-ring. If inspections confirm the o-ring is in acceptable condition, re-assemble in reverse order and continue with use. If the o-ring is damaged, return to ESI for refurbishment.
