Monticello Nuclear Generating Plant
2807 W County Road 75
Monticello, MN 55362

Subject: 10 CFR 50.55a Request RR-008 Associated with the Fifth Ten-Year Inservice Inspection (ISI) Interval

**PROPOSED ALTERNATIVE IN ACCORDANCE WITH 10 CFR 50.55a(a)(3)(ii)
10 CFR 50.55a REQUEST RR-008**

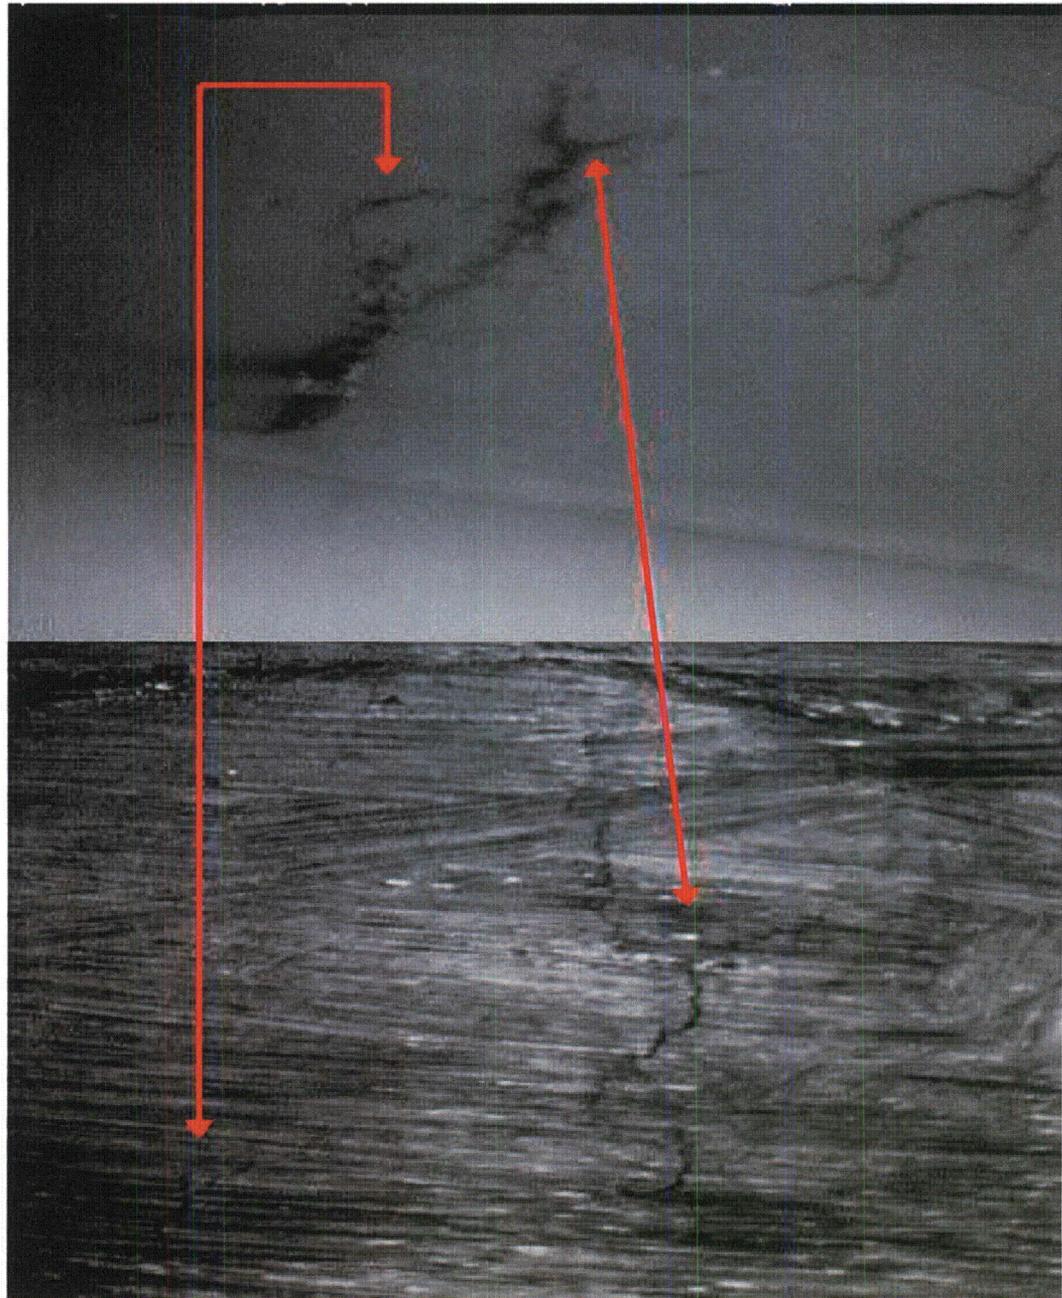
The flaws reinspected in 2013 were initially inspected in their as-found condition with indications being easily visible on a layer of surface deposits on the welds. Following a specialized cleaning process that cleaned the surface to bare metal, the same locations were reexamined. The underlying cracks that produced the

linear indications on the surface deposit were readily apparent and were essentially identical to the as-found indications seen prior to cleaning.

It was described that the indications in the surface deposit were very similar to the conditions produced during a liquid dye penetrant examination, where the bleed out from the underlying flaw is highly visible on the background provided by the developer. Although the cleaning provided validation that the indications were relevant and were emanating from cracks in the weld metal, examination with the surface deposit in place was equally effective for identifying the flaws and the extent of cracking. (see Attachments F and G)

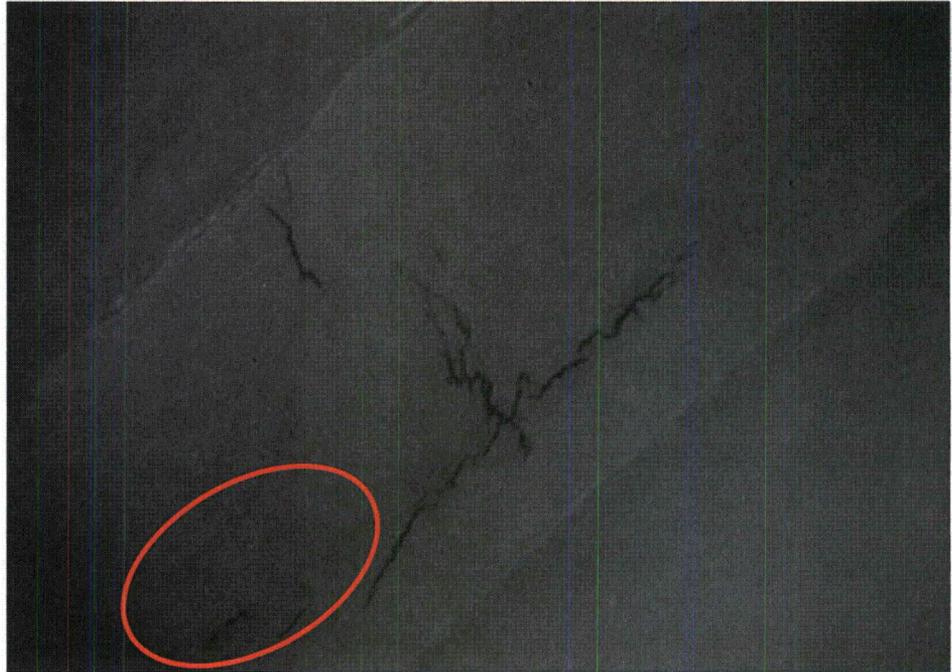
The flaws on the H8 and H9 welds were identified on all of the accessible regions inspected on the underside of the welds using access provided through the jet pump inlet and openings into the lower plenum of the vessel. During the inspection in 2011, it was noted that the flaws appeared to continue beyond the regions accessible for inspection on the underside of the welds, as shown in Attachment H. Therefore, for evaluation purposes, it has been assumed that there are similar flaws in all the uninspected regions of both the H8 and H9 welds.

H8 Weld
Indication at 70°
- Note Indication
appears to
continue past
field of view of
the camera

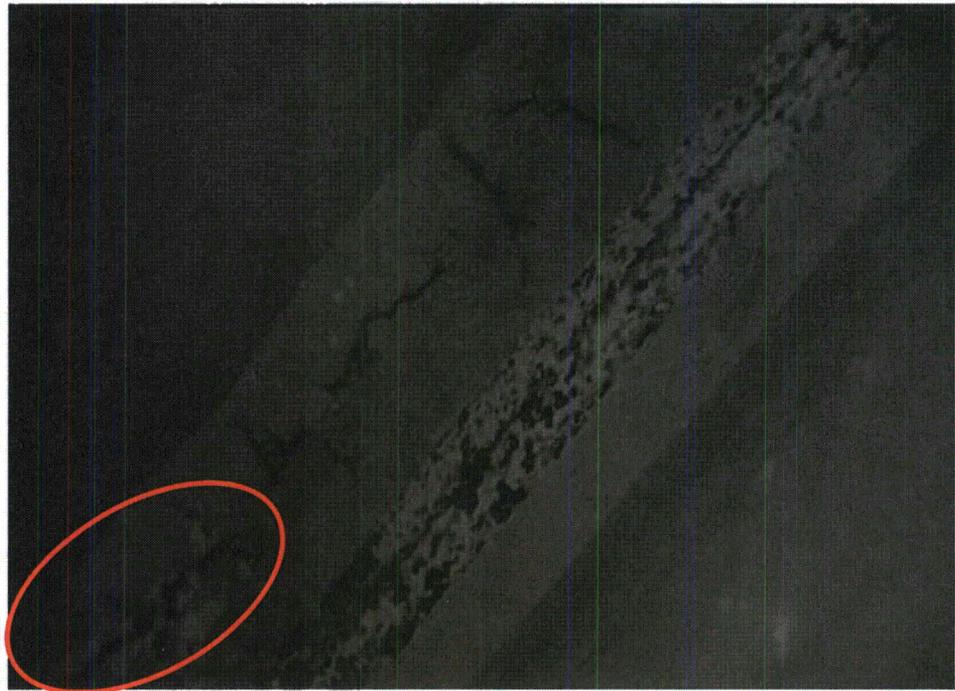
H9 Weld
Indication at 300°
- Note Indication
appears to
continue past
field of view of
the camera
