Re: Turkey Point Unit 4  
Docket No. 50-251  
Response to Request for Additional Information Regarding  
Steam Generator Tube Inspection Report

**ATTACHMENT TO  
L-2014-034**

**Response to Request for Additional Information Regarding  
Unit 4 Steam Generator Tube Inspection Report**

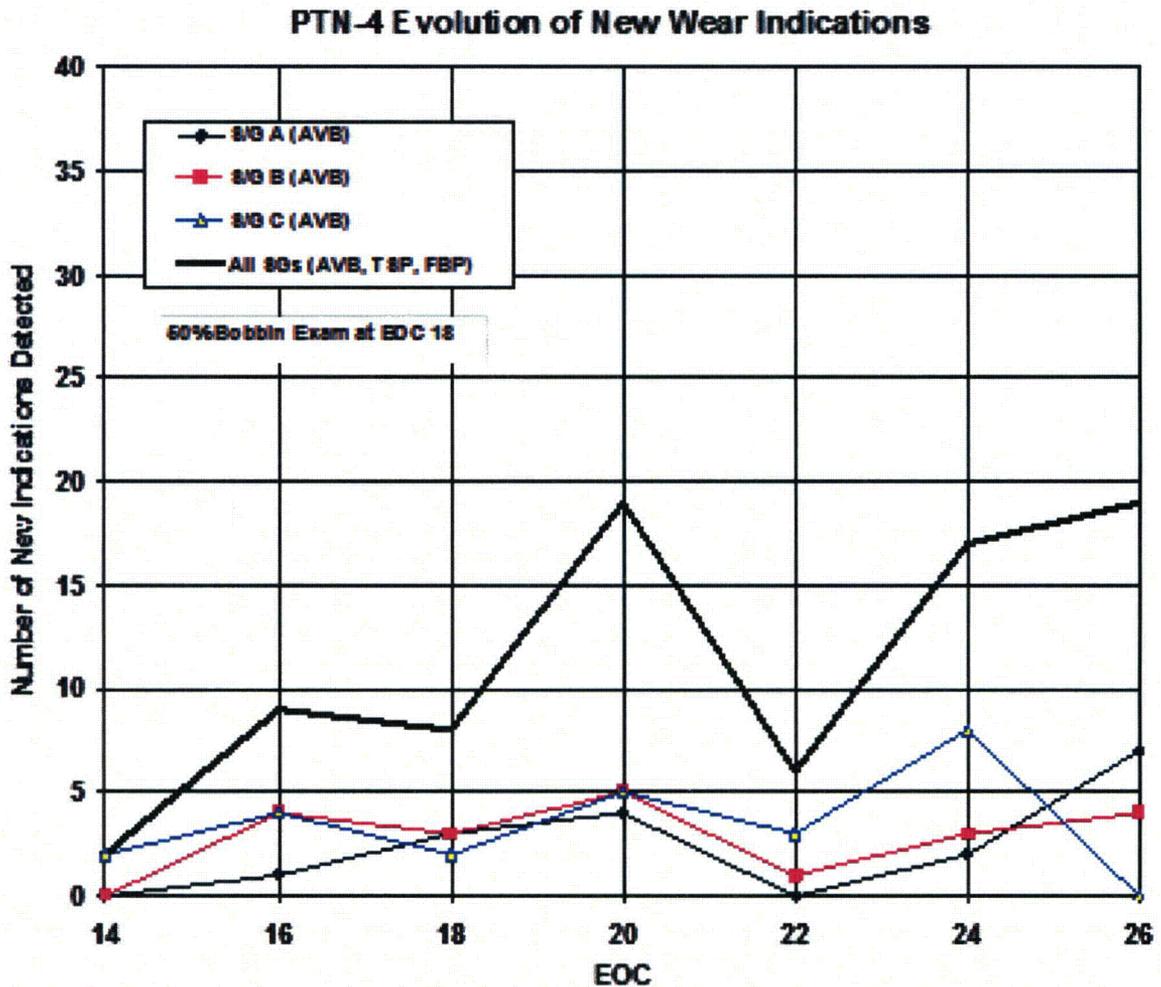
It appears that the number of new wear indications is increasing. Please discuss any insights on this trend.

The figure below shows the trend in new wear indications at Turkey Point Unit 4. The trend for all wear mechanisms has not been significantly increasing. For AVB wear only, the number of new wear indications is a weak function of operating time. The variability in the uniform trend is most likely due to the sensitivity of the NDE results to the probability of detection, which reflects both technique and analyst uncertainties.
