Part 21 (PAR)

PART 21 REPORT - FAILED PRESSURE REGULATOR DURING POST-INSTALLATION EDG PRESSURE TESTING

Report No. 10CFR21-0111

COMPONENT: Starting Air Pressure Regulator
Nordberg P/N 1776 506

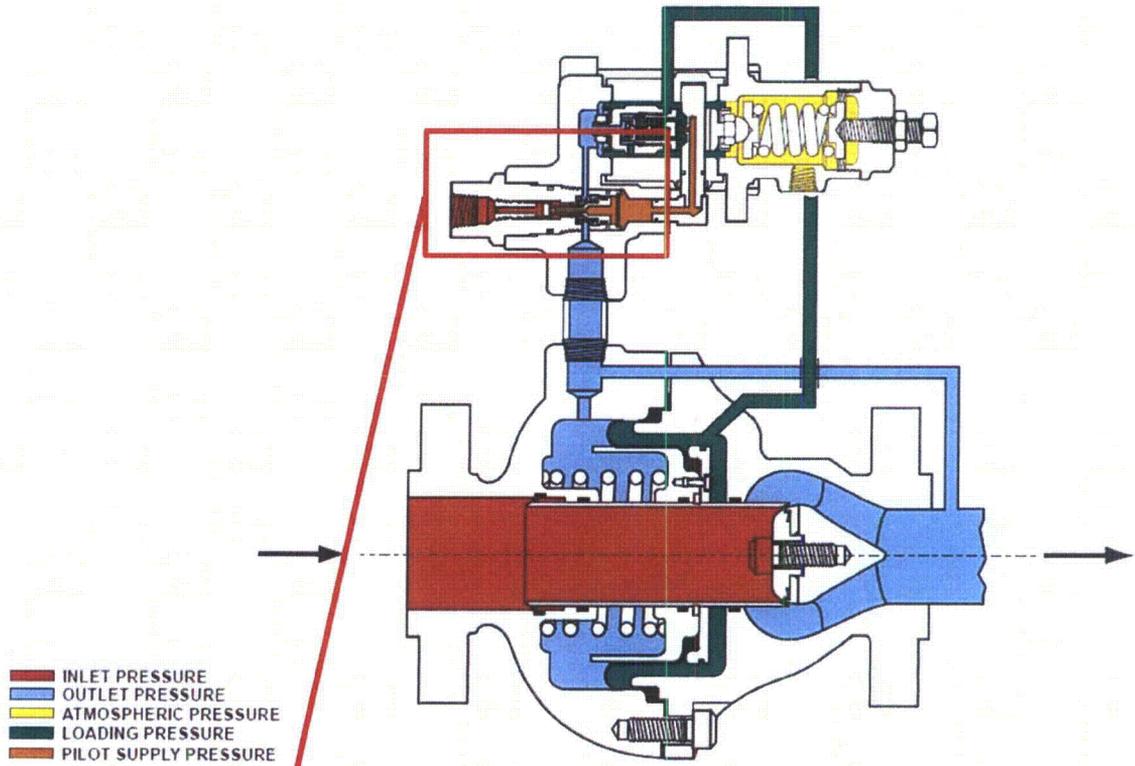
Figure 1: Pressure Regulator Cut-Away

The conclusion of ESI's failure analysis was that an o-ring within the piston guide assembly of the pressure regulating valve had been improperly installed at the factory. The o-ring was squeezed to the point that when the mating piston was inserted through the o-ring, material was shaved from the inside diameter of the o-ring, compromising its sealing capability. This debris ultimately migrated through the piston; however it was the damaged sealing surface of the o-ring that led to the regulator failure. See Figures 1 through 6 on the following pages for a visual depiction.

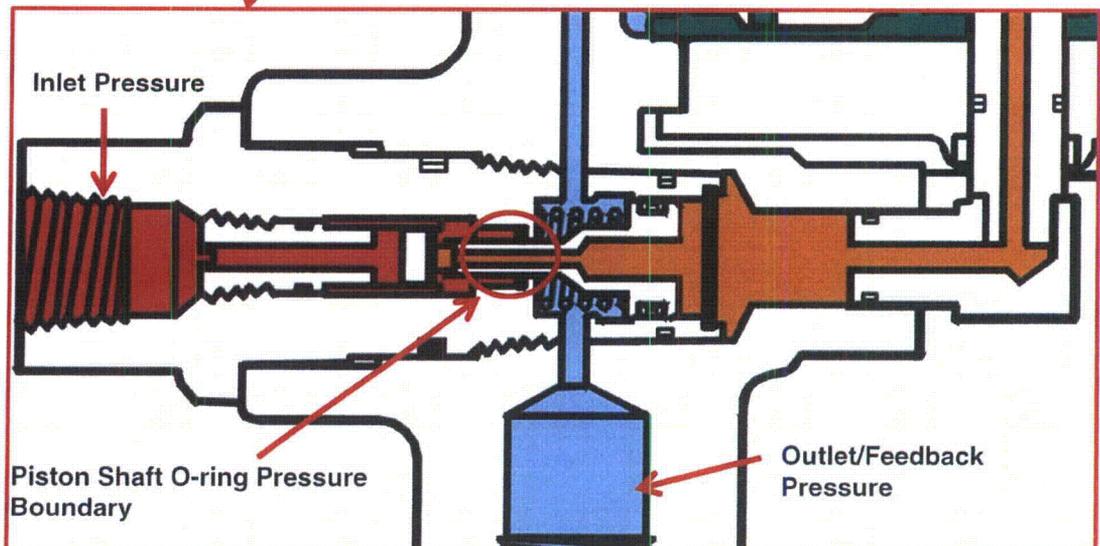
Figure 2: Close-up View of O-ring Location

It has been determined that the piston shaft o-ring within the piston guide assembly of the pressure regulating valve had been improperly installed at the factory. During installation, the o-ring fits into a bore of the piston guide and rests against a shoulder within the bore. To form the o-ring groove, a bushing is then pressed into the bore. One end of the bushing is chamfered to aid in this installation process. It is ESI's determination that when this bushing was pressed into place, it was installed backwards such that the chamfered side was facing away from the o-ring meaning that the installation process required more force than typically utilized. This additional force resulted in the o-ring being squeezed (o-ring groove too narrow) which caused the inside diameter of the o-ring to decrease. During subsequent piston installation, the leading edge of the metal piston shaved material from the inside diameter of the o-ring. It is the seal between the o-ring and piston shaft that was compromised and ultimately resulted in failure of the regulator.

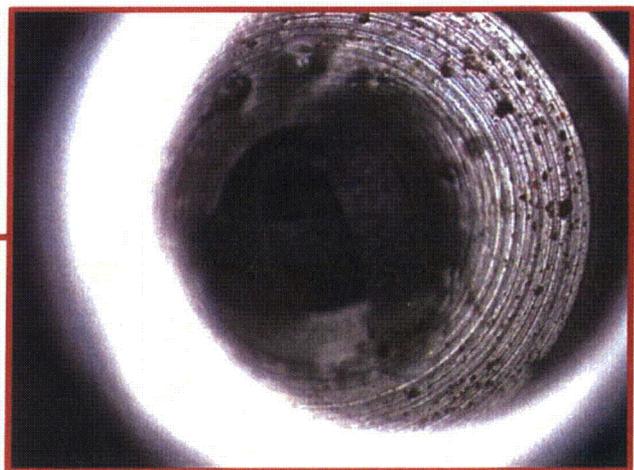
Figure 6: Close-up Showing O-ring Fragments

Otherwise, the regulator should have an inspection performed to visually inspect for the o-ring damage. This requires disconnecting the pilot supply connection from the piston guide assembly and then removing (unscrewing) the piston guide assembly from the pilot valve. Then the piston seat should be removed (unscrewed) using a flat head screwdriver. A visual inspection of the interior of the piston guide assembly would then be performed to confirm no o-ring fragments. Additionally, manually actuate the piston to check for sluggishness, excessive binding, or slow re-coil (the piston is spring retract). If these inspections warrant further investigation, remove the snap ring that retains the piston and remove the piston to access the o-ring. If inspections confirm the o-ring is in acceptable condition, re-assemble in reverse order and continue with use. If the o-ring is damaged, return to ESI for refurbishment.
