FISW2-1	Sheet 1 of 3 4 Status: Y N U
eismic Walkdown Checklist (SWC)	
quipment ID No. Q1G31H0001A Equip. Class ¹ 21	
quipment Description SPENT FUEL HEAT EXCHANGER 1A	
ocation: Bldg. AUXILIARY Floor El. 155 Room, Area445	
Ianufacturer, Model, Etc. (optional but recommended)	
nstructions for Completing Checklist his checklist may be used to document the results of the Seismic Walkdown of WEL. The space below each of the following questions may be used to record ndings. Additional space is provided at the end of this checklist for documentin	the results of judgments and
nchorage	/

NO. SNCF164-RPT-01, VERSION 2.0

UNIT 1 - IPEEE VULNERABILITIES INFORMATION

This attachment contains Appendix H from the report entitled, "Joseph M. Farley Nuclear Plant, Unit 1 and Unit 2, Individual Plant Examination of External Events – Seismic"

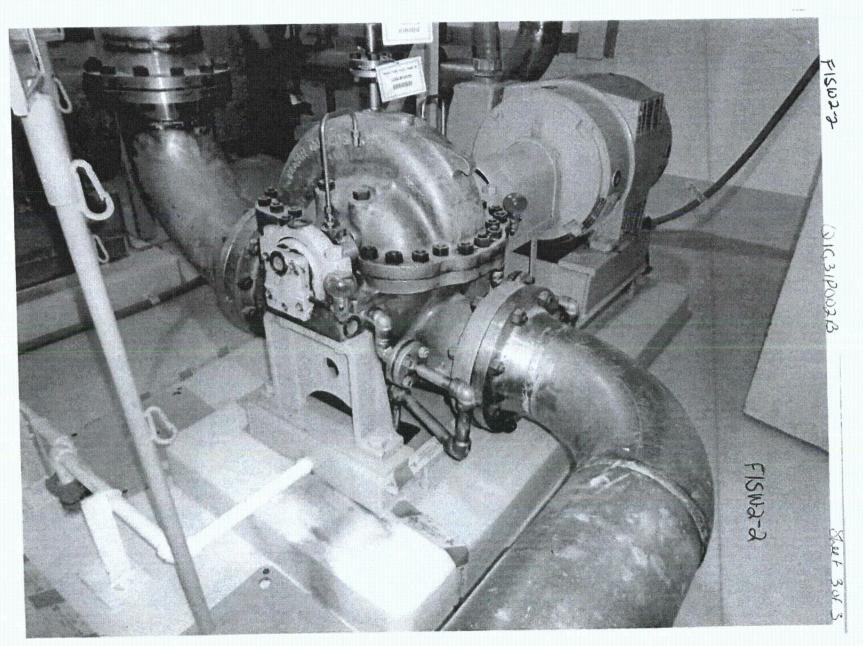
FISW2-2 Sheet 2 of 3 Status: YV NUU Seismic Walkdown Checklist (SWC) Equipment ID No. Q1G31P002B _ Equip. Class¹ 5 Equipment Description 1B SFP PUMP **Interaction Effects** YOND UD NAD 7. Are soft targets free from impact by nearby equipment or structures? 8. Are overhead equipment, distribution systems, ceiling tiles and lighting, YUN UNAN and masonry block walls not likely to collapse onto the equipment? 9. Do attached lines have adequate flexibility to avoid damage? 10. Based on the above seismic interaction evaluations, is equipment free YIN NO UO of potentially adverse seismic interaction effects? **Other Adverse Conditions** 11. Have you looked for and found no other seismic conditions that could ND UD YDY adversely affect the safety functions of the equipment? Comments (Additional pages may be added as necessary) NONE Evaluated by: Scott Walder Stall Lovelody Date: 8129.2012 8/29/2012

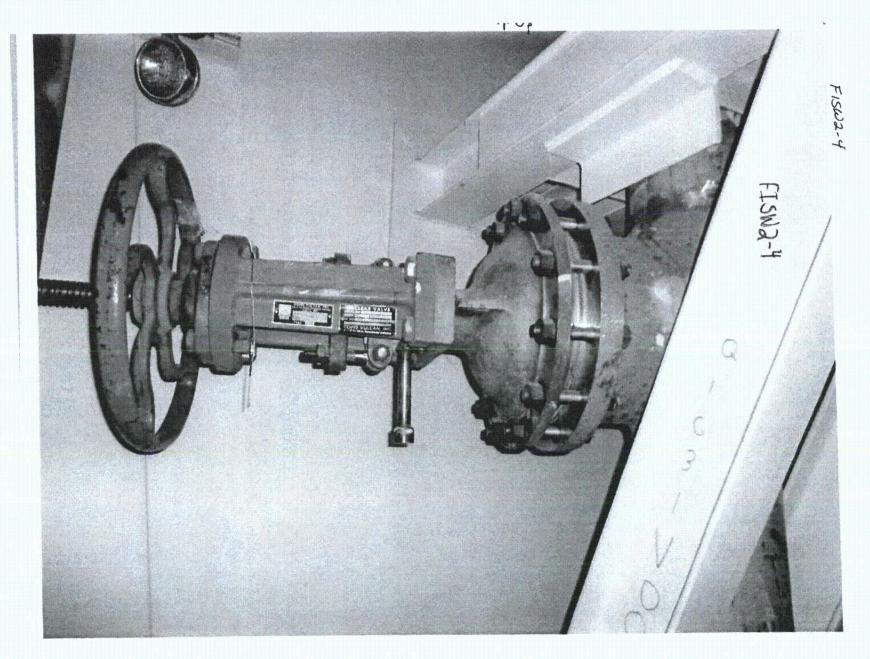
11. Have you looked for and found no other seismic conditions that could adversely affect the safety functions of the equipment?	WEND UD
<u>Comments</u> (Additional pages may be added as necessary)	
Evaluated by: Scott Warzen Stal Walks Crystal Love lady Ch	Date: <u>8-29-2012</u> <u>8/29/22</u>

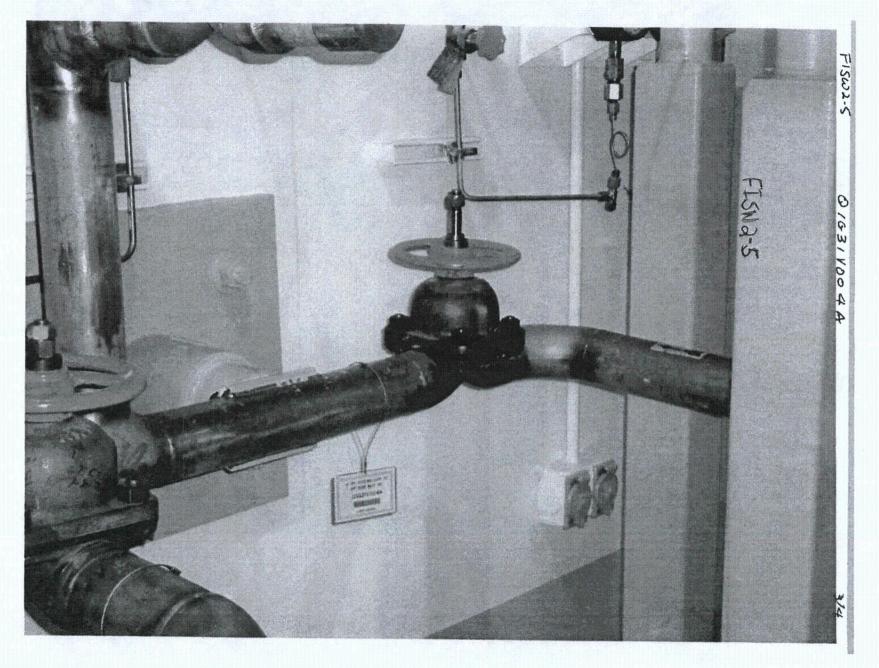
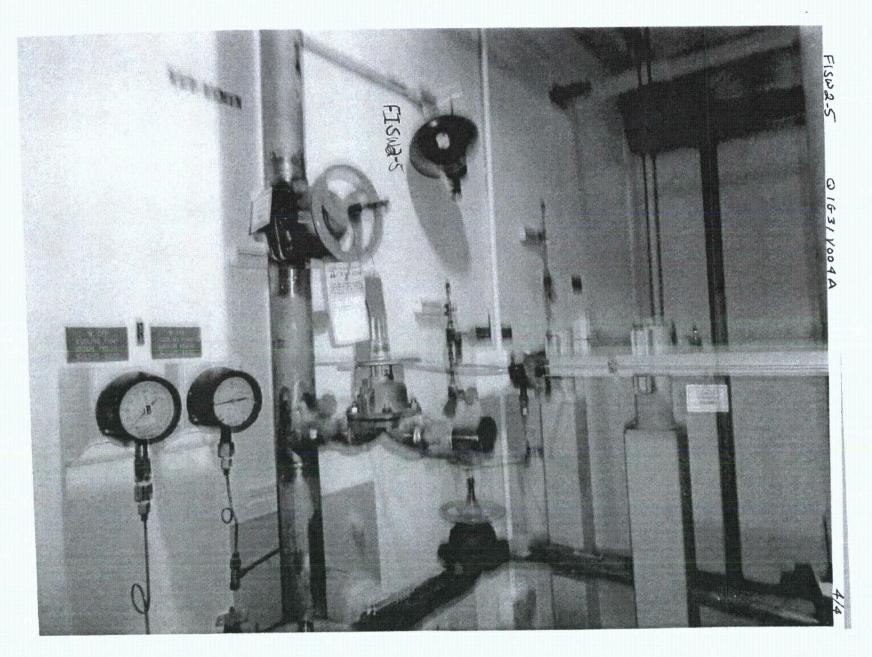
Sheet 2 of x 4 Al Status: YN NU Seismic Walkdown Checklist (SWC) Equipment ID No. Q1G31V004A _ Equip. Class¹ 0 Equipment Description 1A SFP COOLING LOOP TO SFP PURIF INLET ISO **Interaction Effects** YOND UD NAD 7. Are soft targets free from impact by nearby equipment or structures? Galtronics speaker is hanging by wire. the mass of speaker is judged TO NOT have an adverse seismic impact to the Value if It should come base. 8. Are overhead equipment, distribution systems, ceiling tiles and lighting, YE NO UD N/AD and masonry block walls not likely to collapse onto the equipment? Speaker is still held by wire judged to be more than a dequate to hold speaker, OKAY 9. Do attached lines have adequate flexibility to avoid damage? MINO UD : VEND UD NAD CR 515655 WAS WHITTEN TO Fix This. YE NO UD 10. Based on the above seismic interaction evaluations, is equipment free of potentially adverse seismic interaction effects? **Other Adverse Conditions** 11. Have you looked for and found no other seismic conditions that could YO NO UO adversely affect the safety functions of the equipment? Comments (Additional pages may be added as necessary) NONE Evaluated by: ScttWarpen SmtWelsen Date: 9.11.2012 Rypn Harles RAA 9/11/12

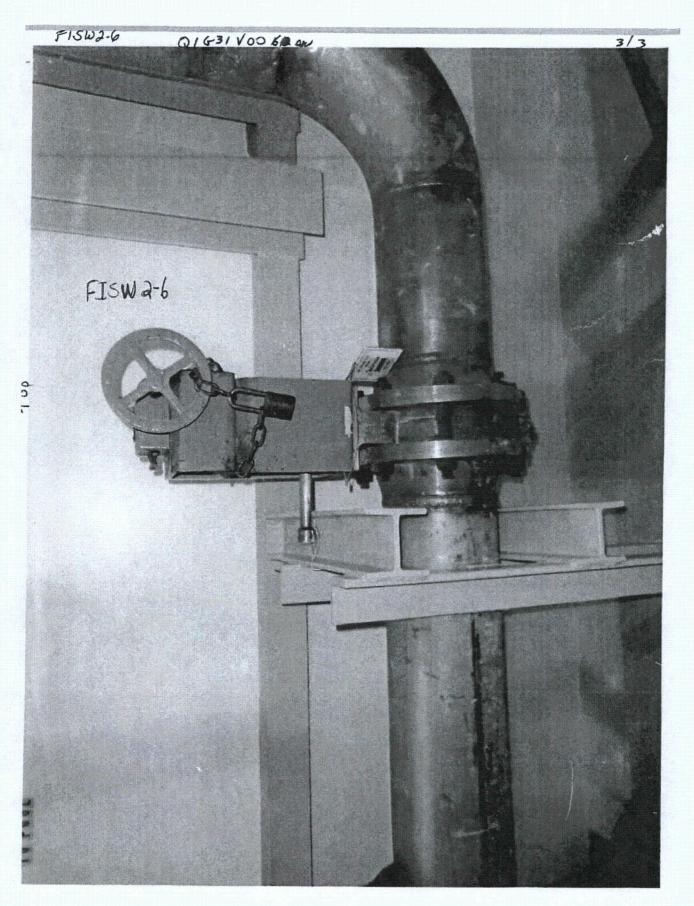
11. Have you looked for and found no other seismic conditions that could adversely affect the safety functions of the equipment? Support SPF-4-RIG is Ti away Vertice judged To Not be a seismic interaction c	My and 3' hore.
judged To not be a soismic interration (DACENA, OKAY
Comments (Additional pages may be added as necessary)	
Evaluated by: SCOTT WALDEN Soft Walde	Date: _9.11, 2012
Ryan Harlos Rolling	9/11/12
