Legacy
Management

2013 Annual Site Inspection and Monitoring Report for Uranium Mill Tailings Radiation Control Act Title I Disposal Sites

March 2014

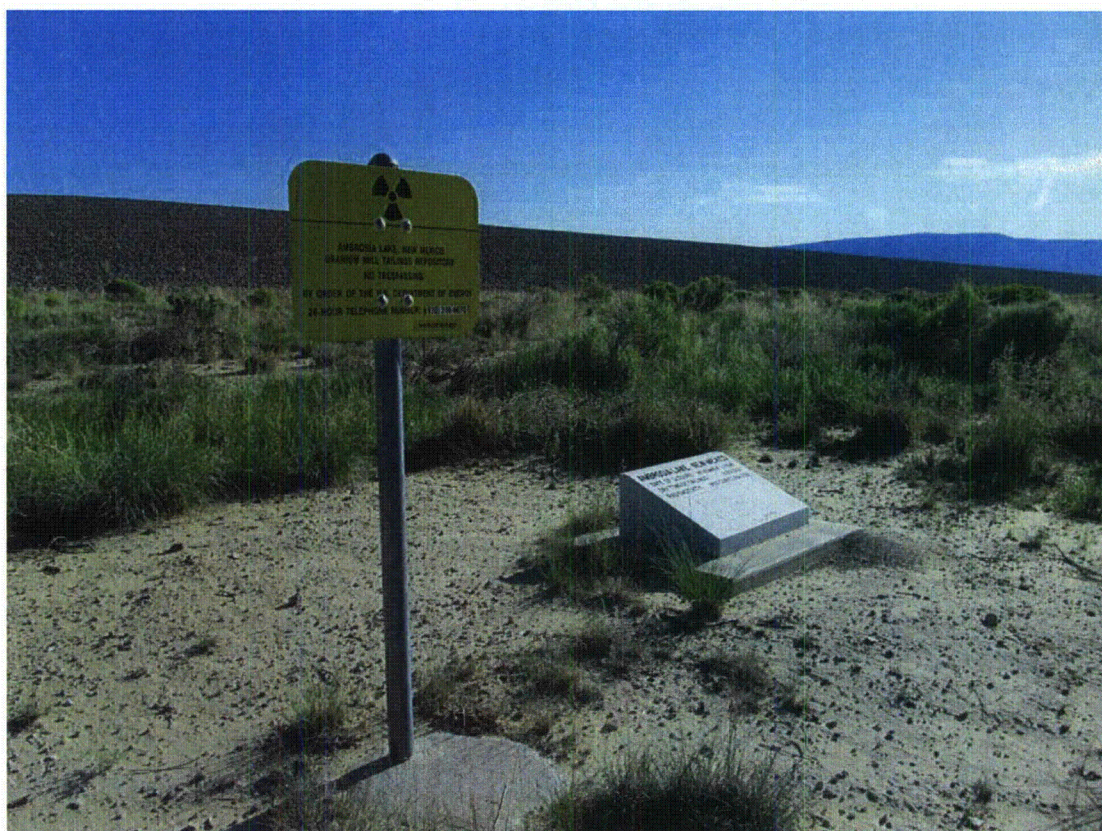
AMB 8/2013. PL-1. Entrance sign and site marker SMK-1.

The entrance sign was in good condition (PL-1).

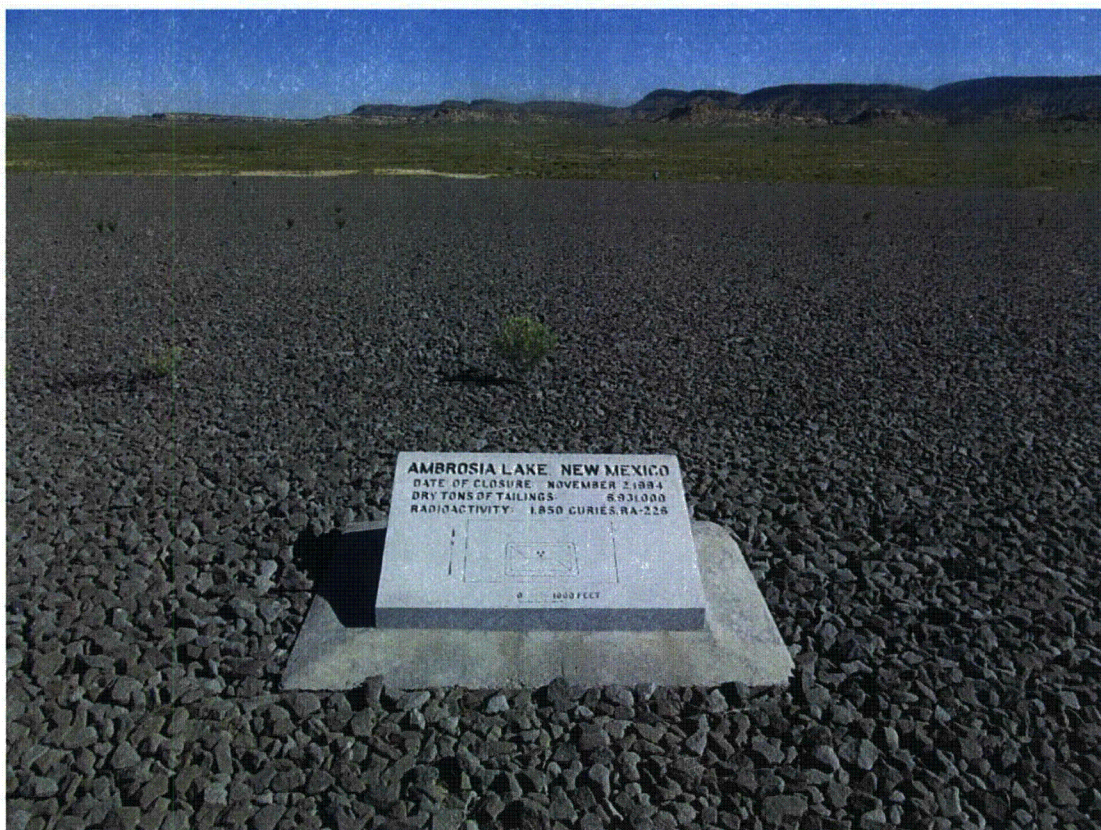
AMB 8/2013. PL-2. Site marker SMK-2 on disposal cell top.

Granite site markers are located near the site entrance and on top of the disposal cell (PL-2). Both site markers were in excellent condition.

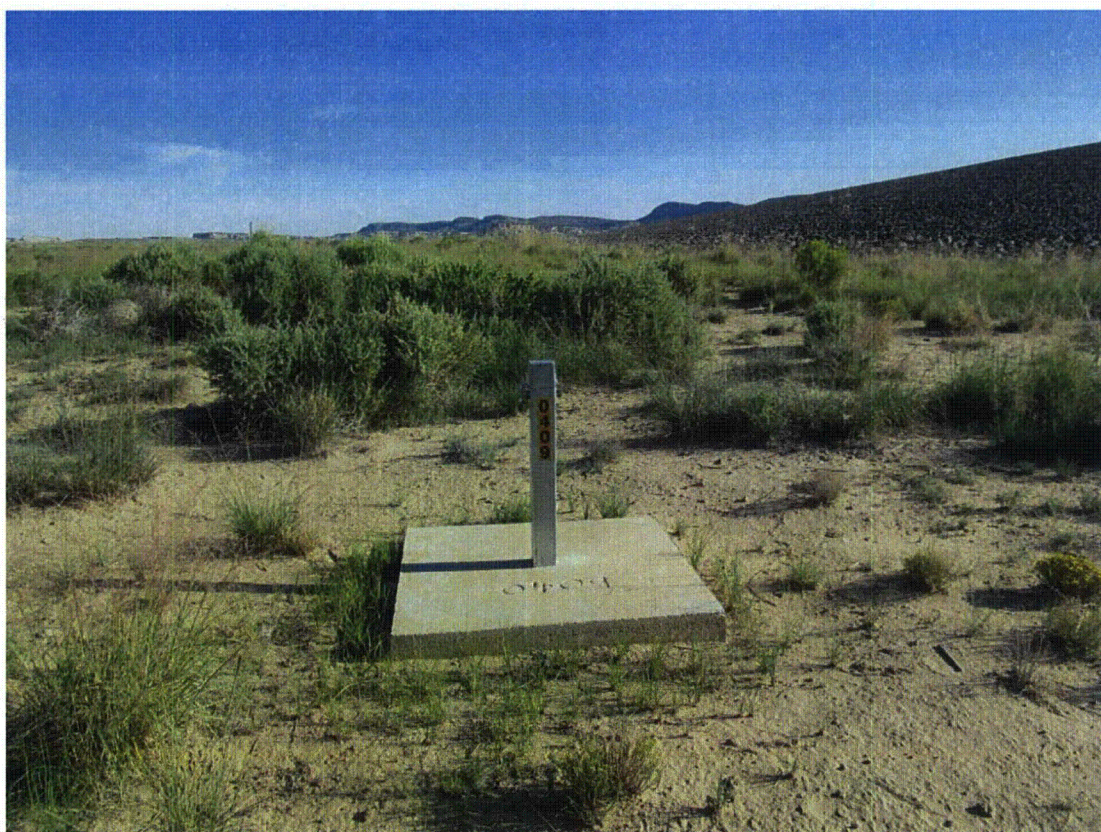
AMB 8/2013. PL-3. Monitoring well 0409.

Monitoring wells 0409, 0675, and 0678 were in good condition (PL-3). Gully formation adjacent to monitoring well 0678 appears to be stable, and the well is not impacted by the erosion.

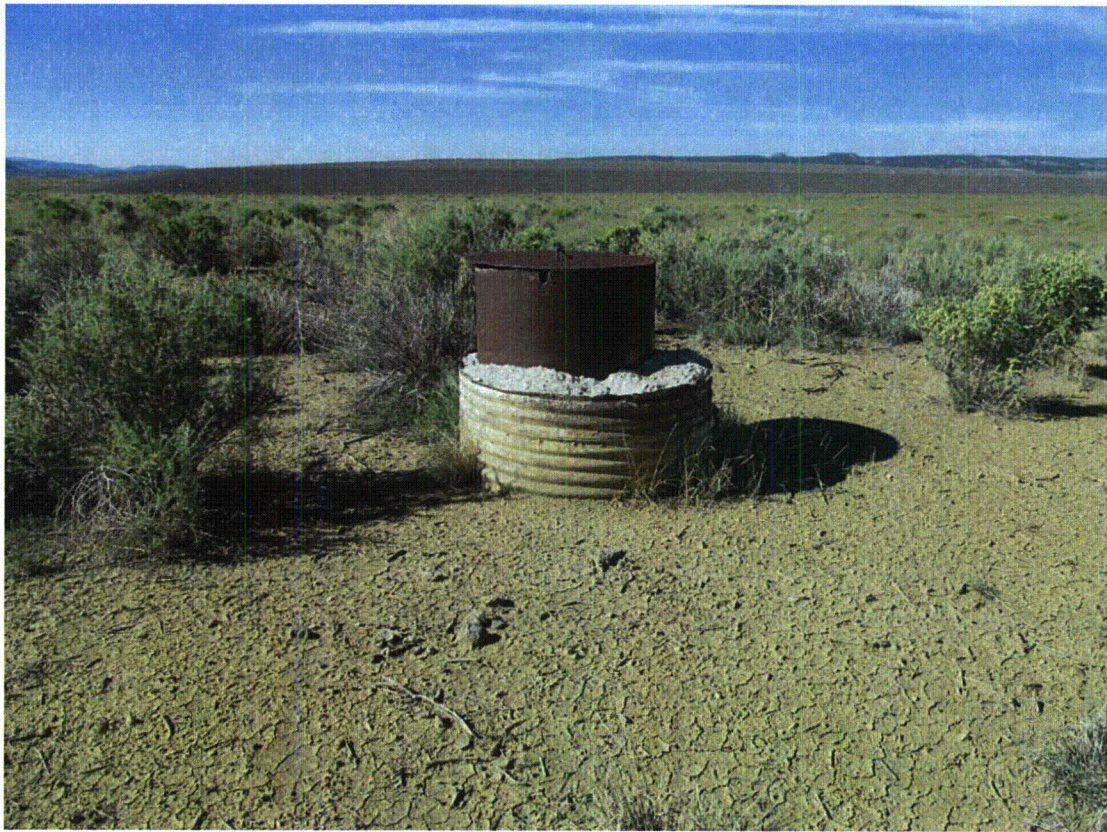
AMB 8/2013. PL-4. Secured mine vent shaft.

A mine vent shaft, associated with an abandoned underground mine, is within the site boundary in the northern portion of the site. The vent has a casing, which rises approximately 3 feet above the ground, and a spot-welded cover. The vent was secure at the time of the inspection (PL-4). Inspectors will continue to monitor the condition of the vent to ensure that the closure remains secure.

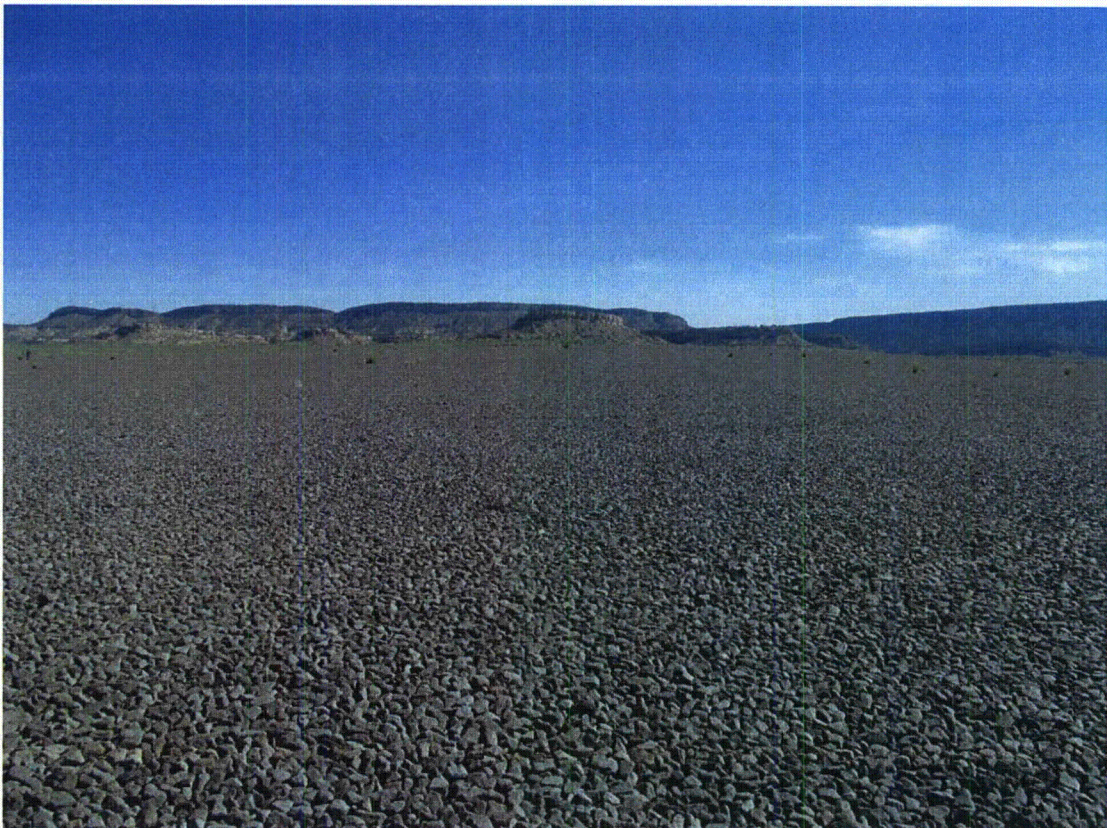
AMB 8/2013. PL-5. Disposal cell top slope.

The 91-acre disposal cell was completed in 1994. The basalt riprap-covered top slope of the disposal cell was in excellent condition (PL-5). There was no evidence of cracking, slumping, or erosion.

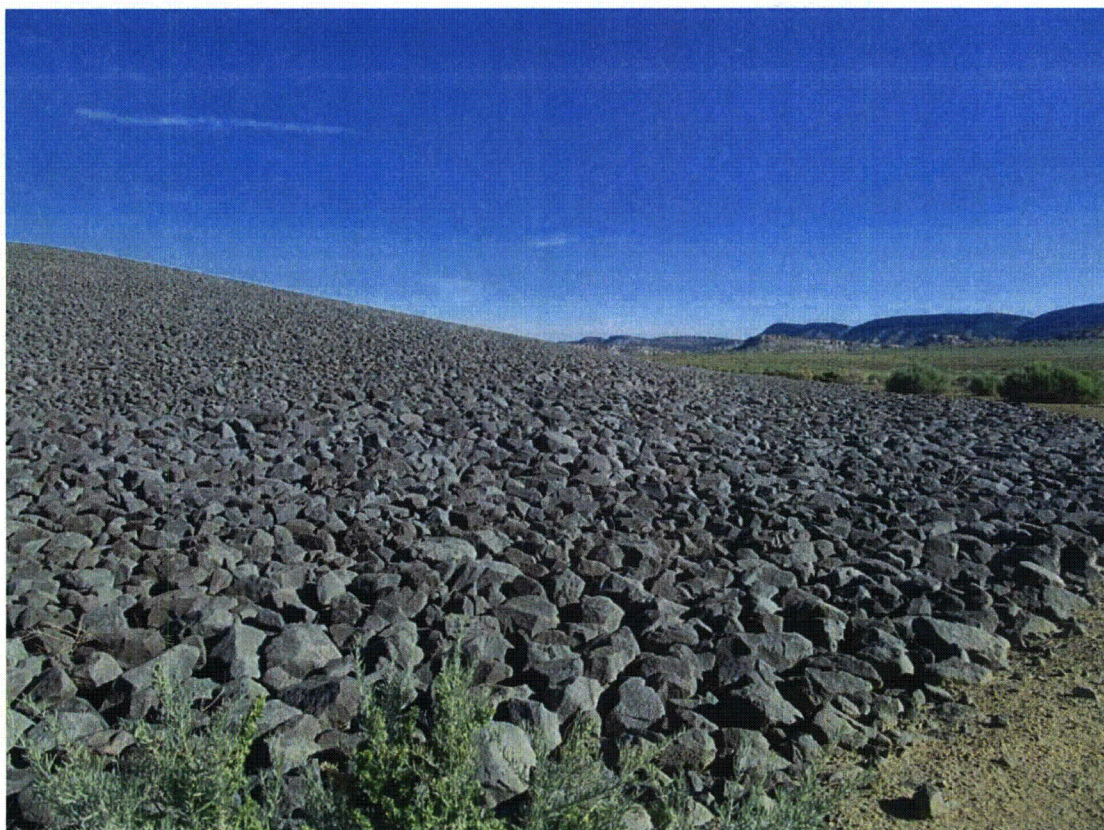
AMB 8/2013. PL-7. Southeast corner apron and east side slope of disposal cell.

The basalt riprap-covered side slopes and apron were in excellent condition and showed no evidence of cracking, settling, slumping, or erosion (PL-7).

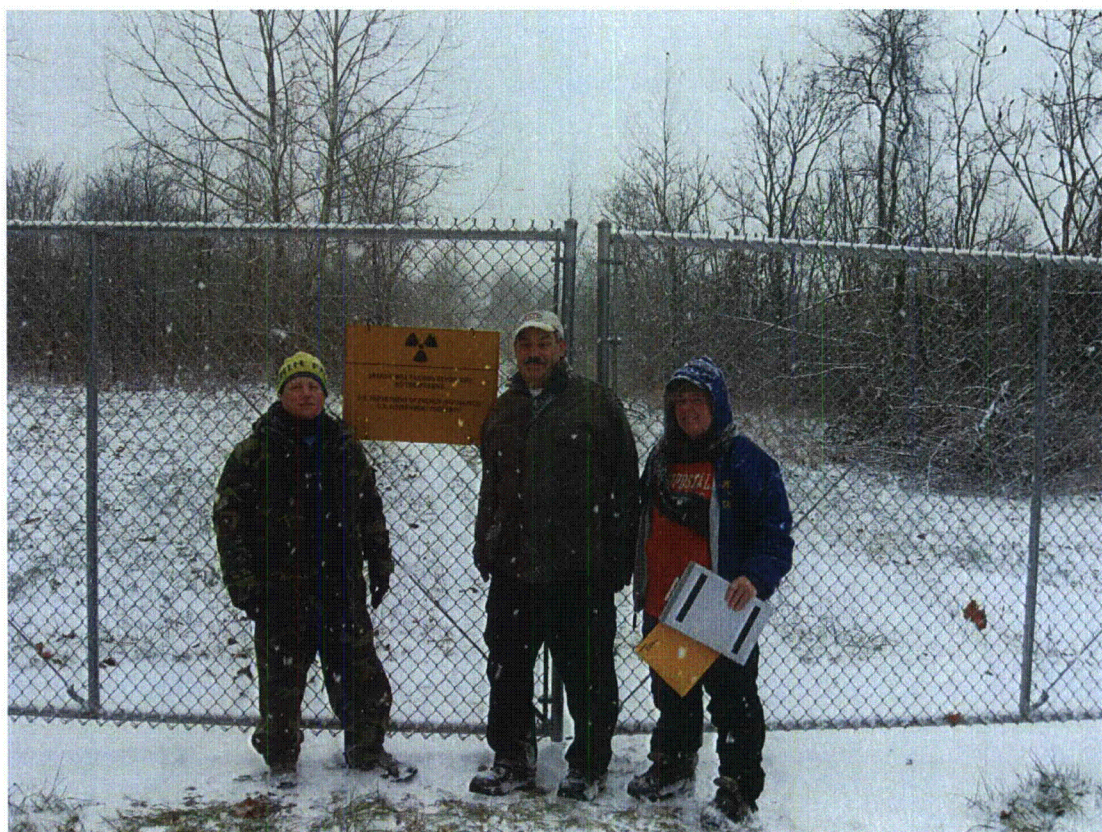
BUR 12/2013. PL-1. Inspectors in front of entrance gate.

Entrance gates were in good condition, and all gates were properly locked. The main gate lock was rusted and difficult to open, and inspectors replaced it with a new LM lock during the inspection. The entrance sign at the front gate was missing, and inspectors attached a new sign during the inspection (PL-1).

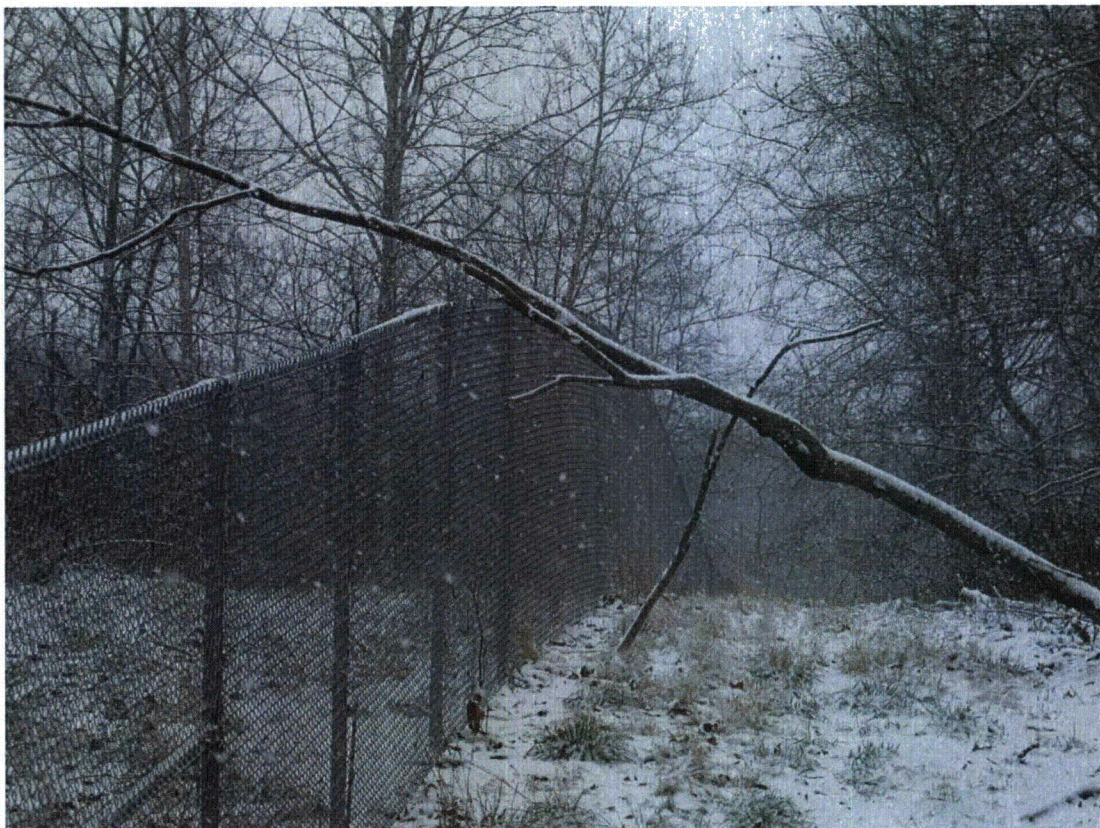
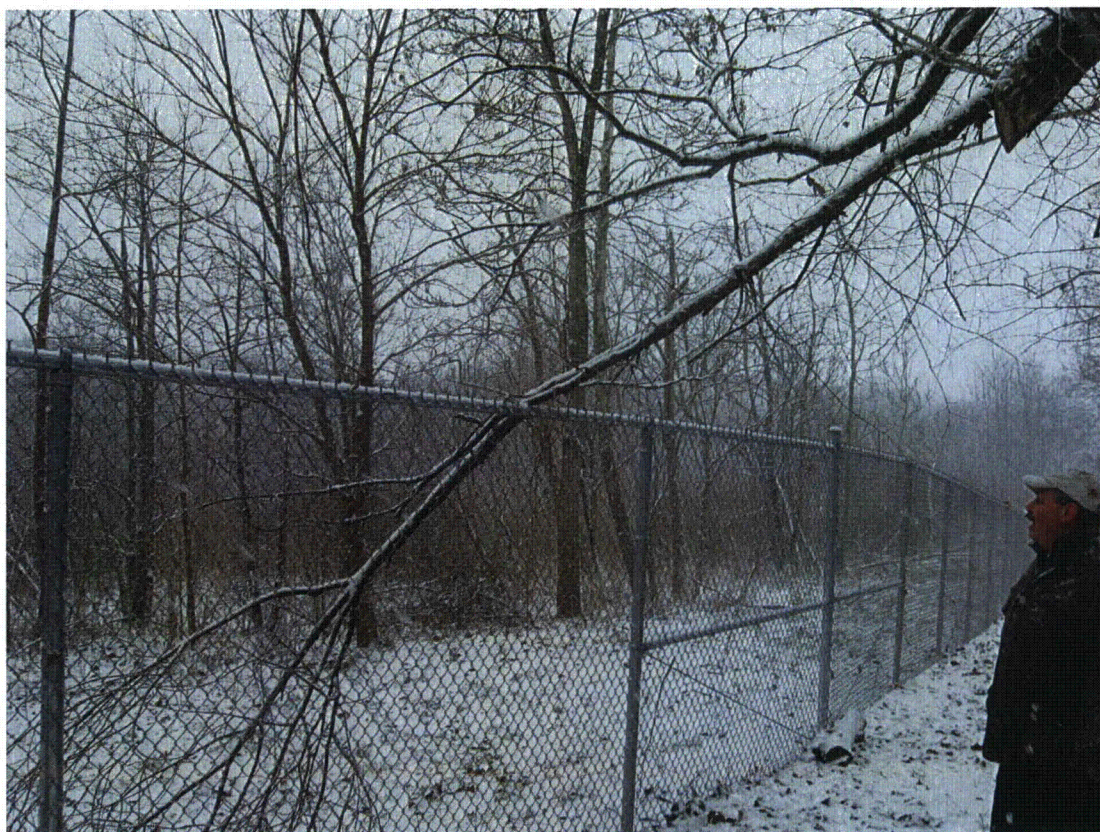
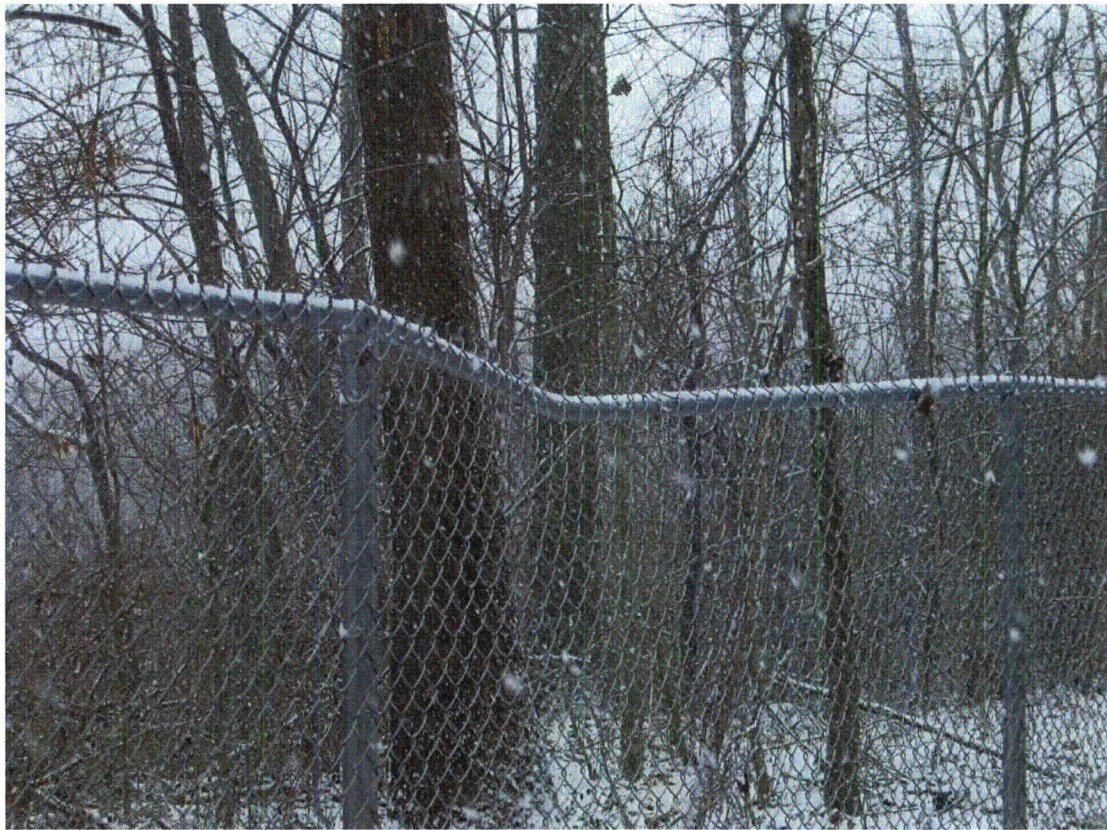
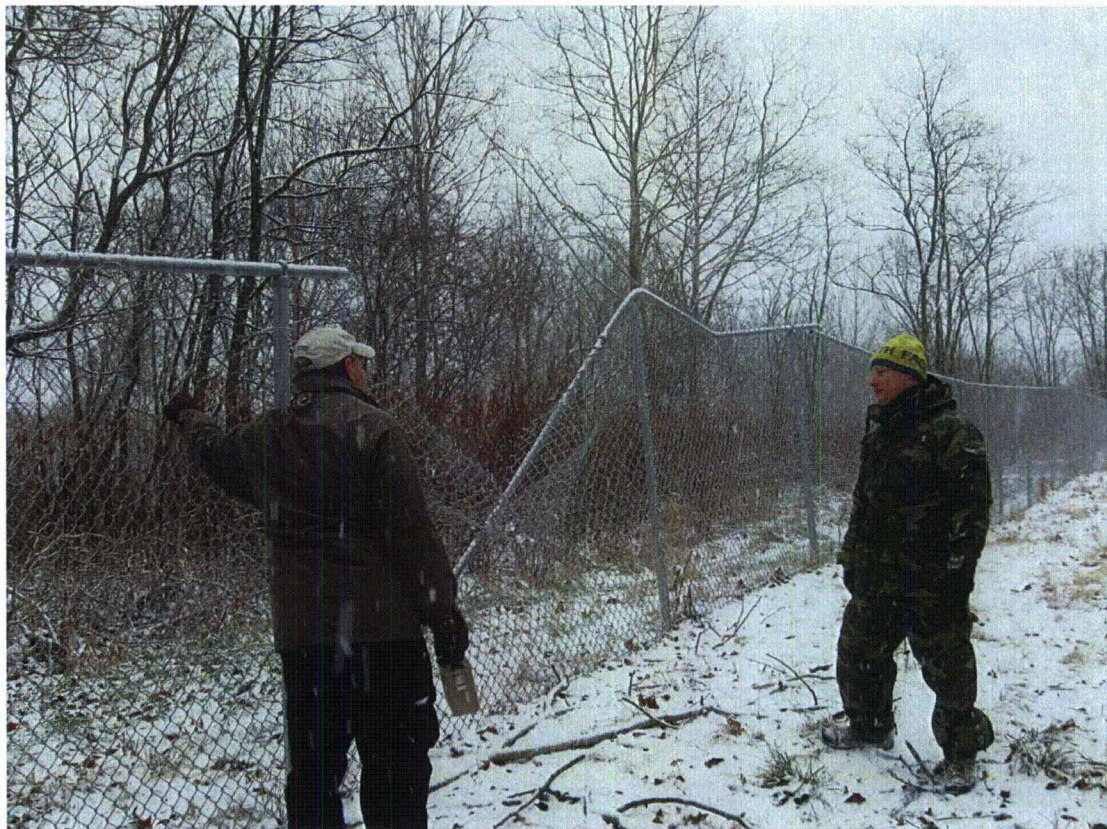
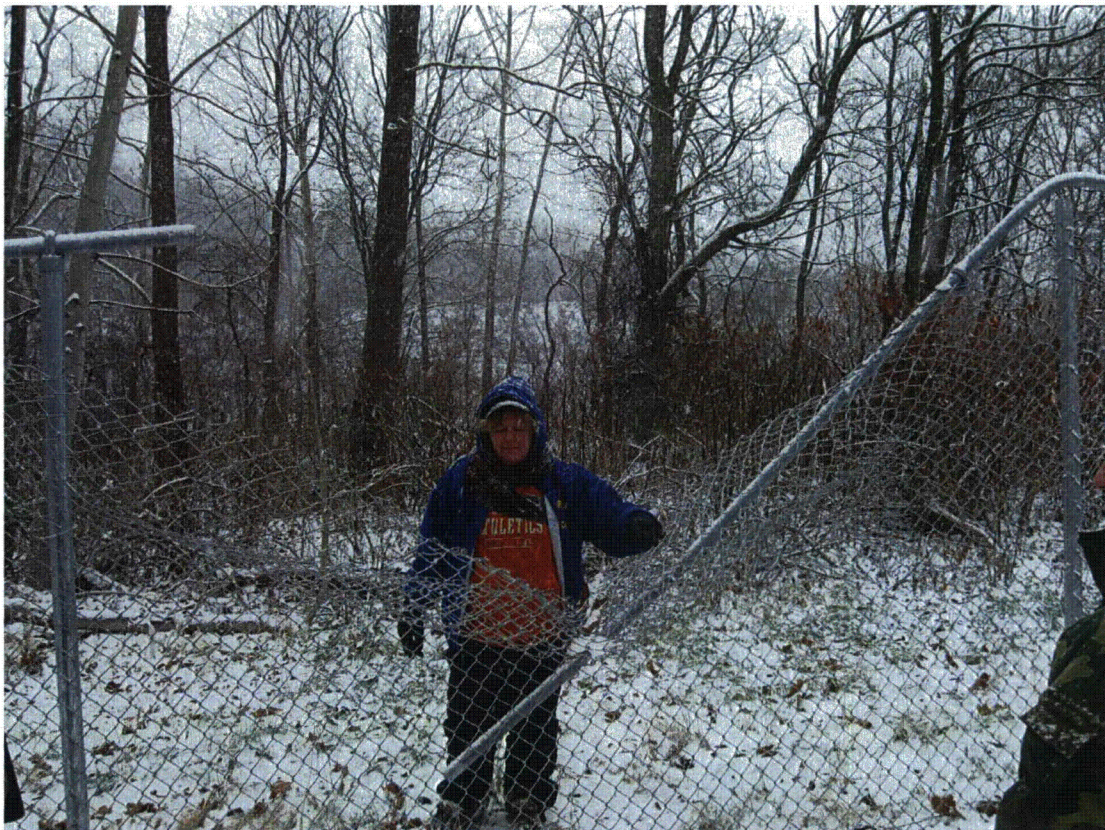
The chain link perimeter fence that encircles the site was replaced in 2007. The fence had minor damage at several locations along the south fence line due to fallen trees (PL-2 thru PL-6).

BUR 12/2013. PL-2. Tree down on south fence.

BUR 12/2013. PL-3. Tree across southern fence.

BUR 12/2013. PL-4. Damaged fence east of perimeter sign P12.

BUR 12/2013. PL-5. Damaged fence east of perimeter sign P11.

BUR 12/2013. PL-6. Damaged fence east of perimeter sign P11.

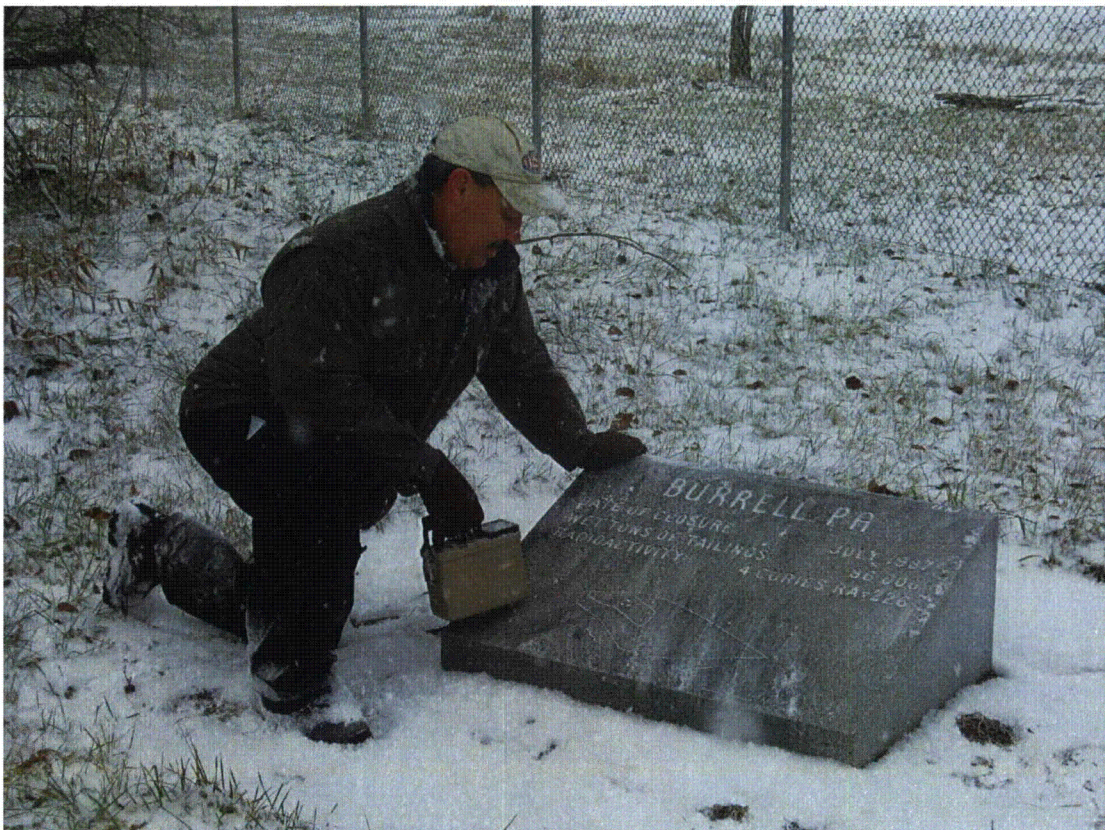
BUR 12/2013. PL-7. Inspector at site marker.

The Burrell site has one site marker. It is located just inside the main entrance gate and was in excellent condition (PL-7).

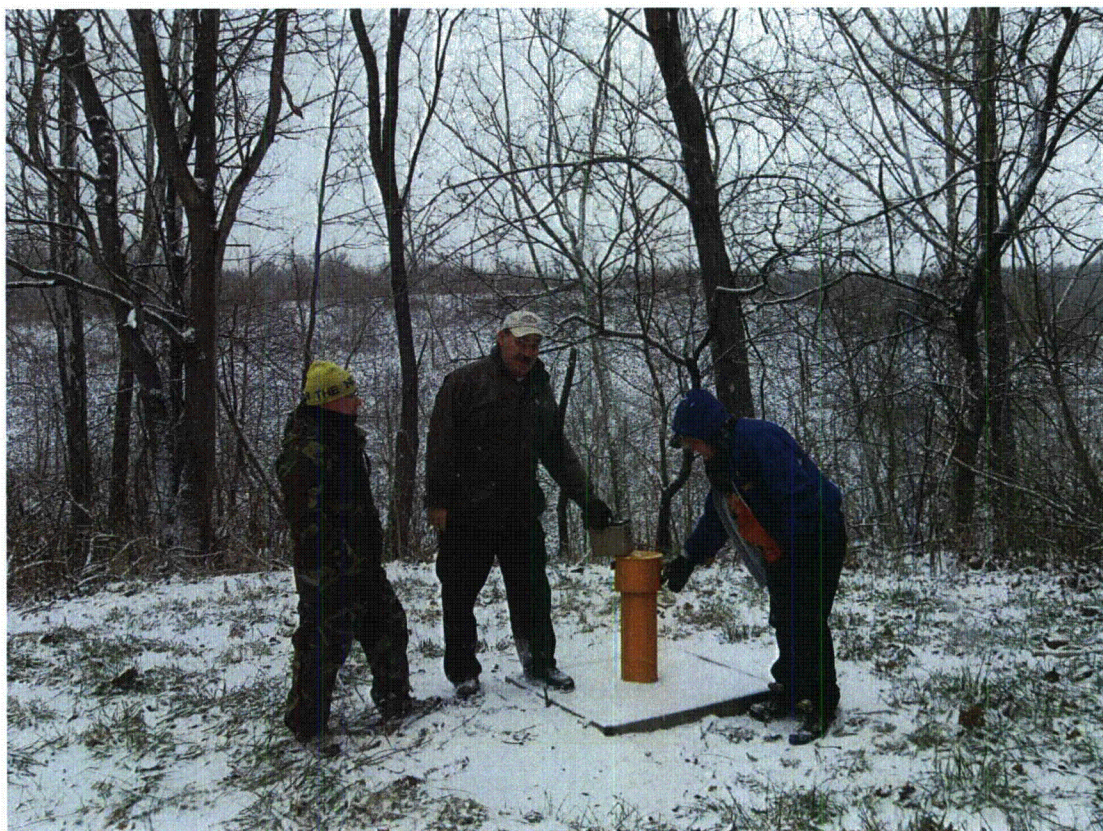
BUR 12/2013. PL-8. Inspectors at monitoring well 0423.

All wells found during the inspection were properly locked (PL-8). The interior of the monitoring wells were not inspected this year. The interiors were last inspected by the water sampling crew in November 2013 and found to be in good shape.

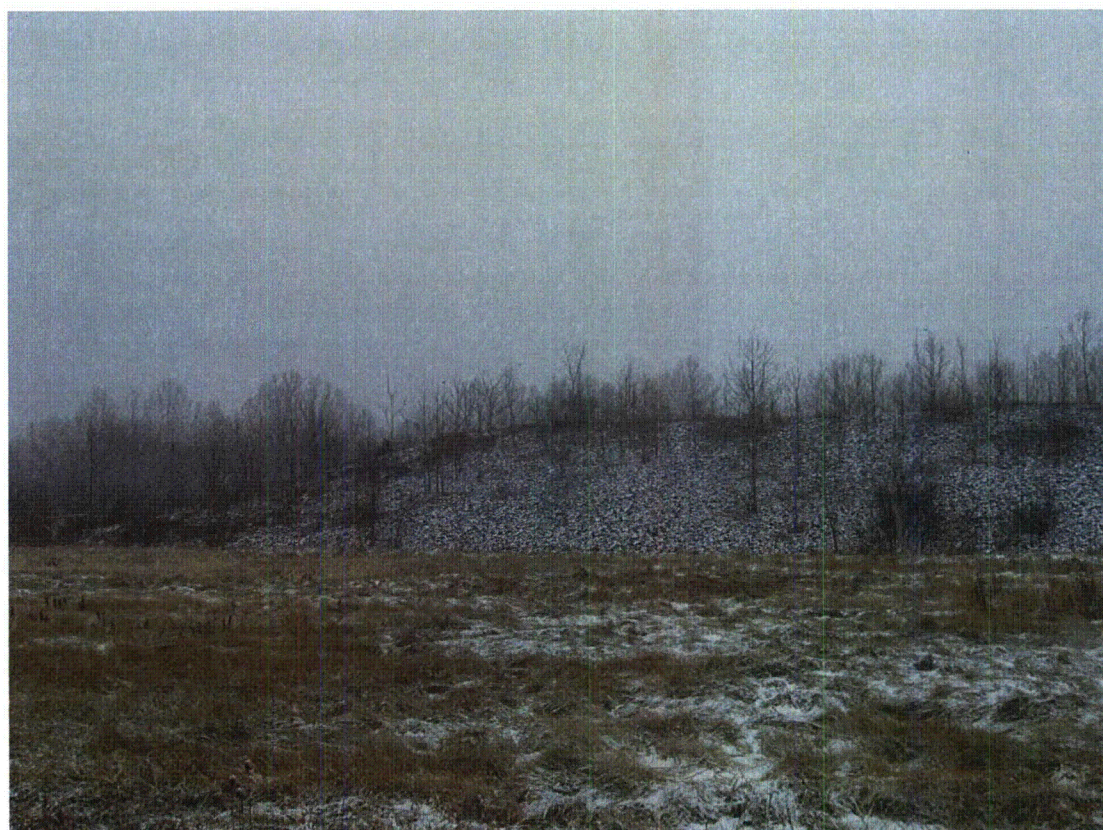
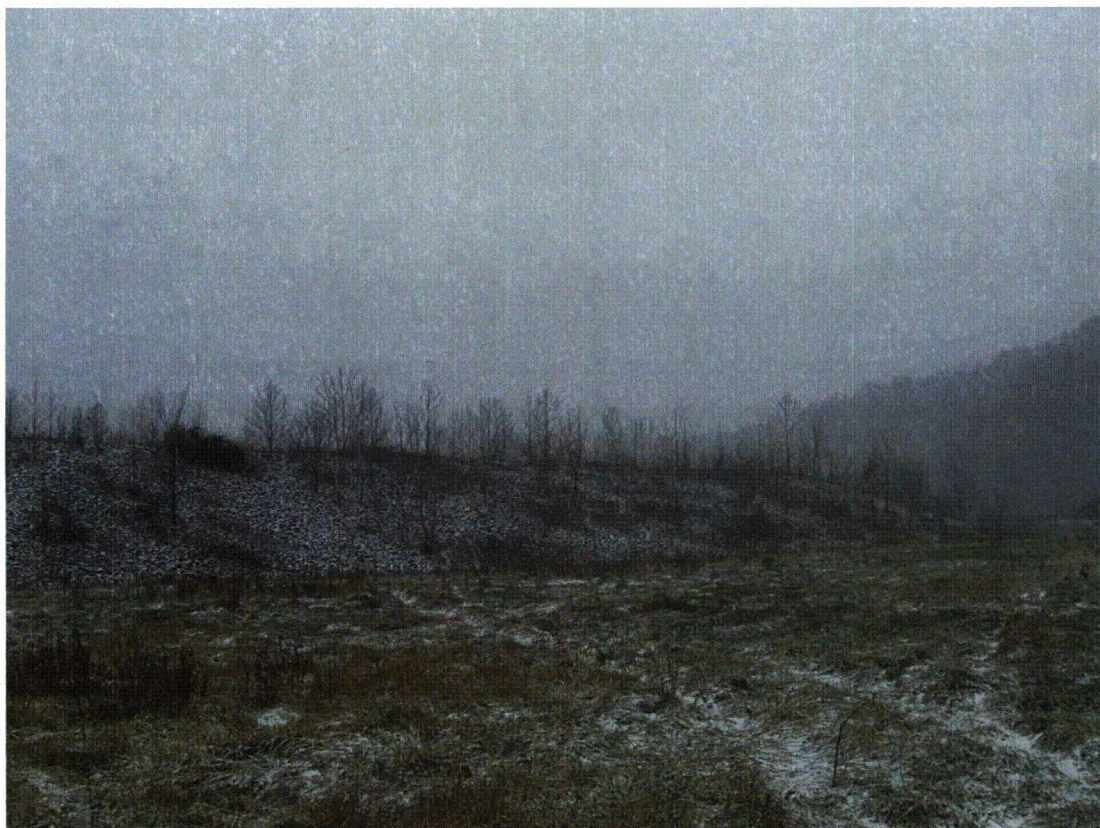
No indications of cell instability were noted by the inspectors (e.g., slumping, bulging, or differential settlement) (PL-9 and PL-10). Rock quality remains good; degradation of the riprap was not evident. No active seeps were found along the south slope of the disposal cell during the inspection.

BUR 12/2013. PL-9. Northeast face of disposal cell.

BUR 12/2013. PL-10. Northeast face of disposal cell.

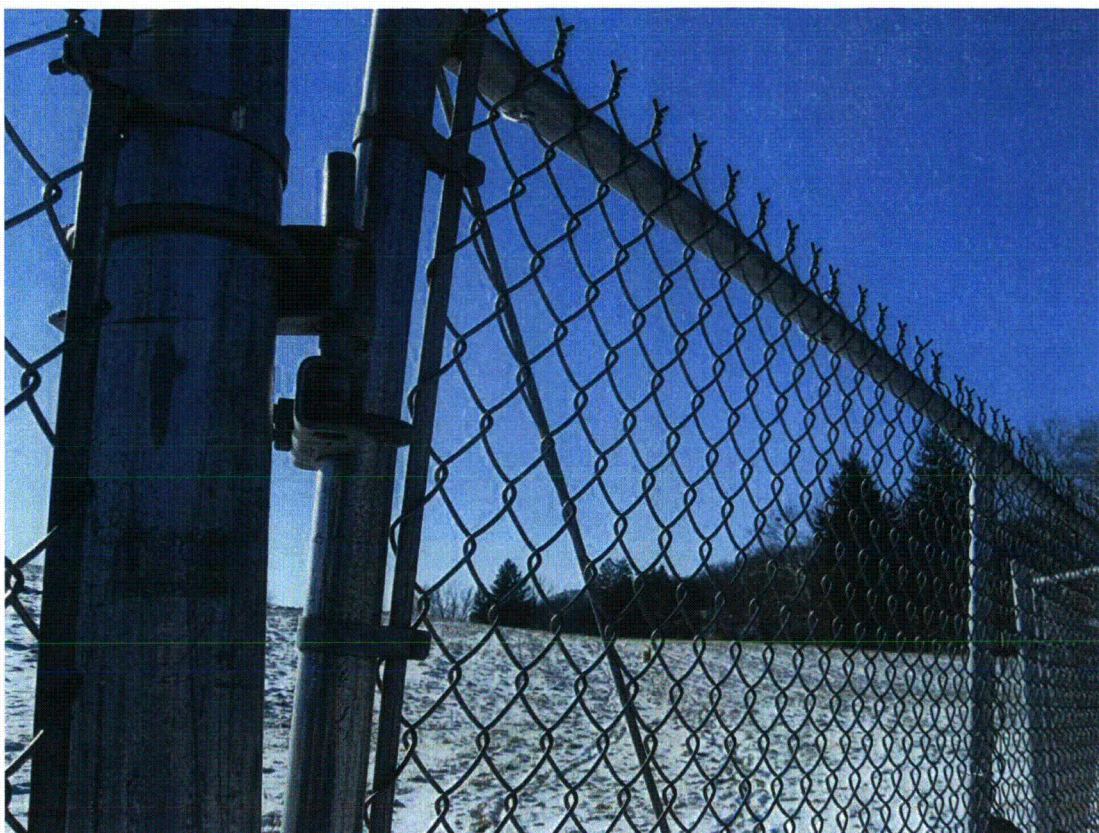
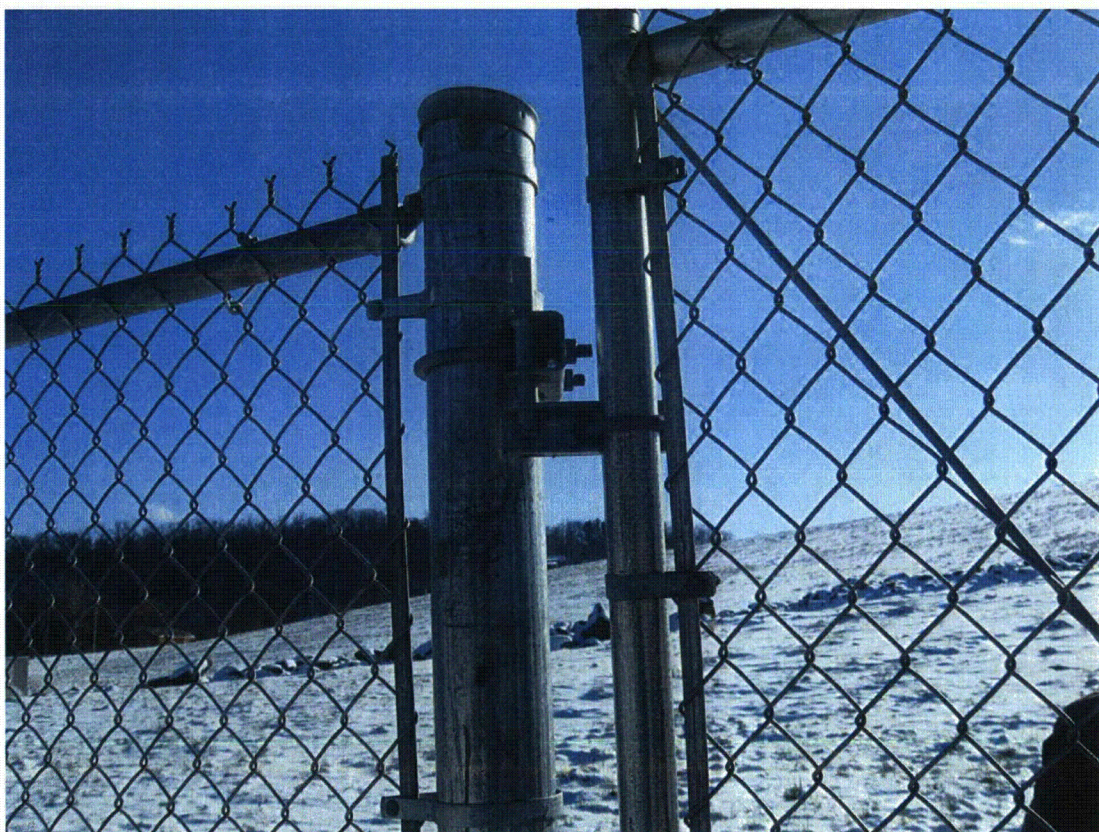
The security fence was replaced in 2007 and remains in excellent condition, with the exception of the north vehicle gate. The hinge on the north vehicle gate requires minor adjustment (PL-1 and PL-2). A vegetation-free buffer zone is being maintained around the entire site security fence.

CAN 10/2013. PL-1. Damage to vehicle gate near perimeter sign P8.

CAN 10/2013. PL-2. Damage to vehicle gate near perimeter sign P8.

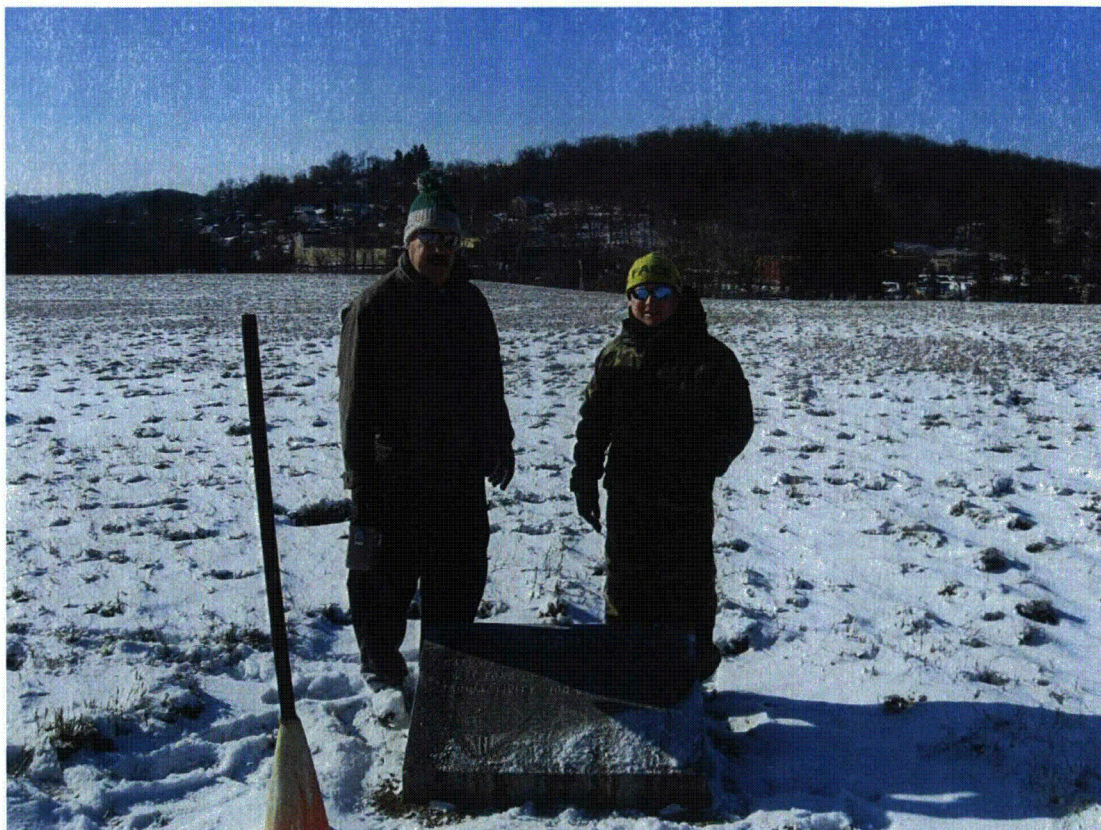
CAN 10/2013. PL-3. Inspectors at site marker on cell cap.

The site has two site markers. Both site markers were in good condition (PL-3).

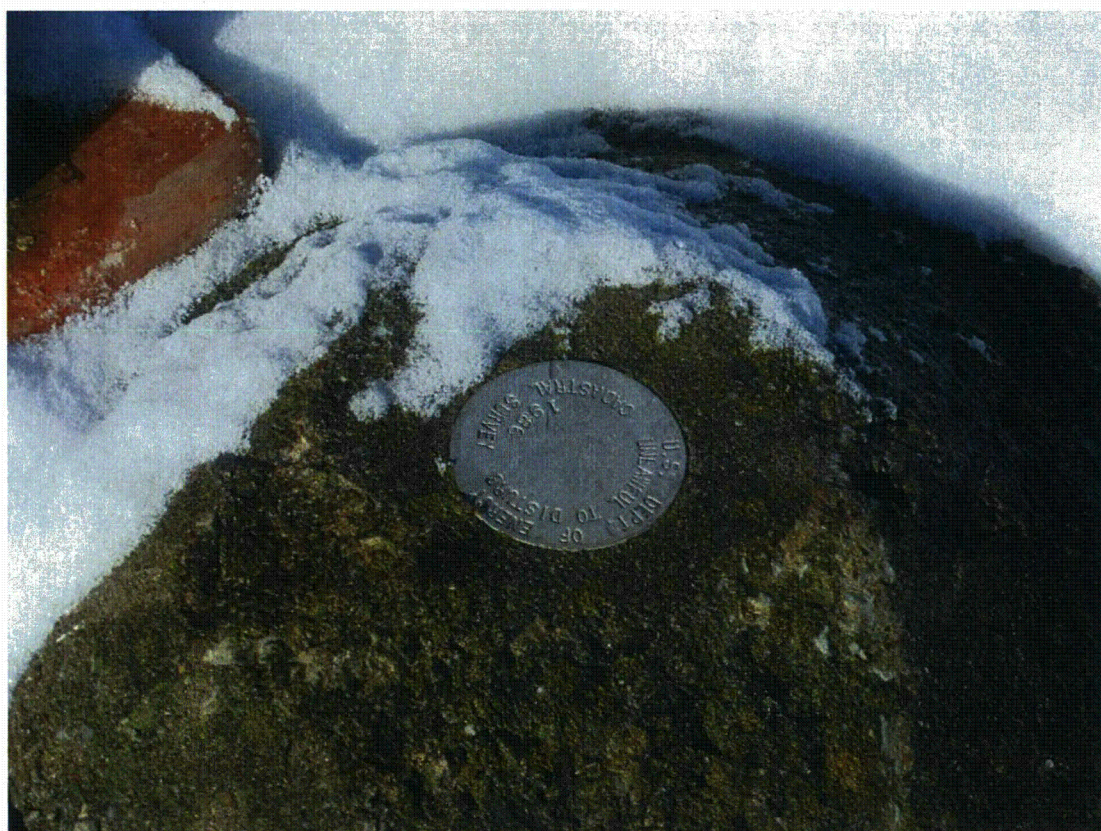
CAN 10/2013. PL-4. Survey monument SM-1.

The site has three survey monuments and four boundary monuments. Survey monument SM-1 was in good condition (PL-4). Snow cover limited verification of other survey and boundary monuments during this inspection. They were verified during the 2012 inspection and also during a recent Facilities Information Management System site visit.

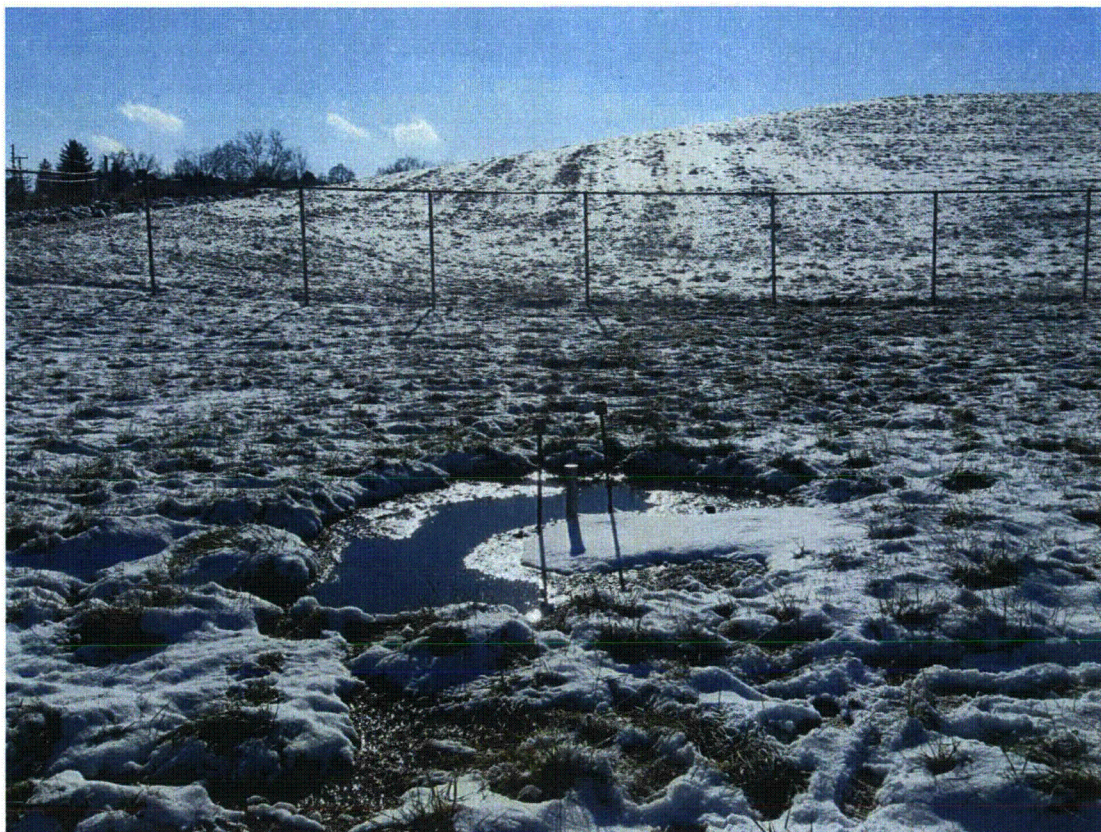
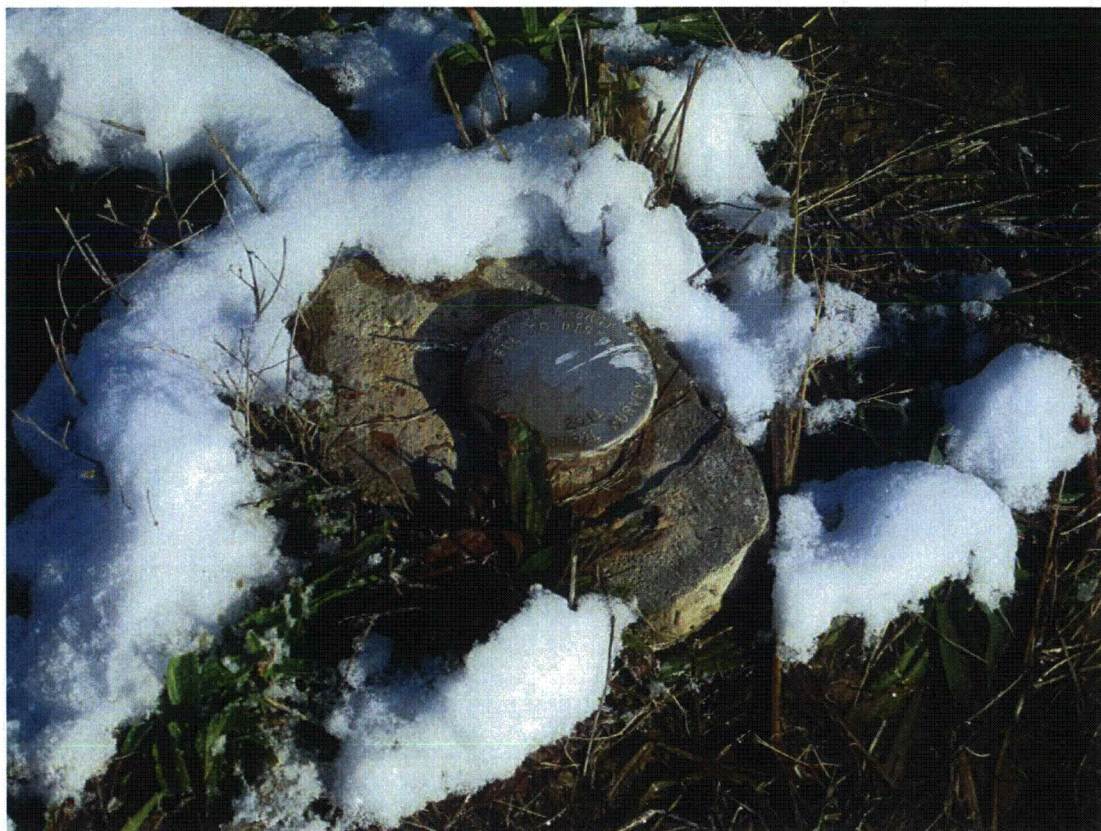
The site has four pairs of erosion control markers; all were in good condition (PL-5 and PL-6).

CAN 10/2013. PL-5. Erosion control marker 4B.

CAN 10/2013. PL-6. Erosion control marker 4A.

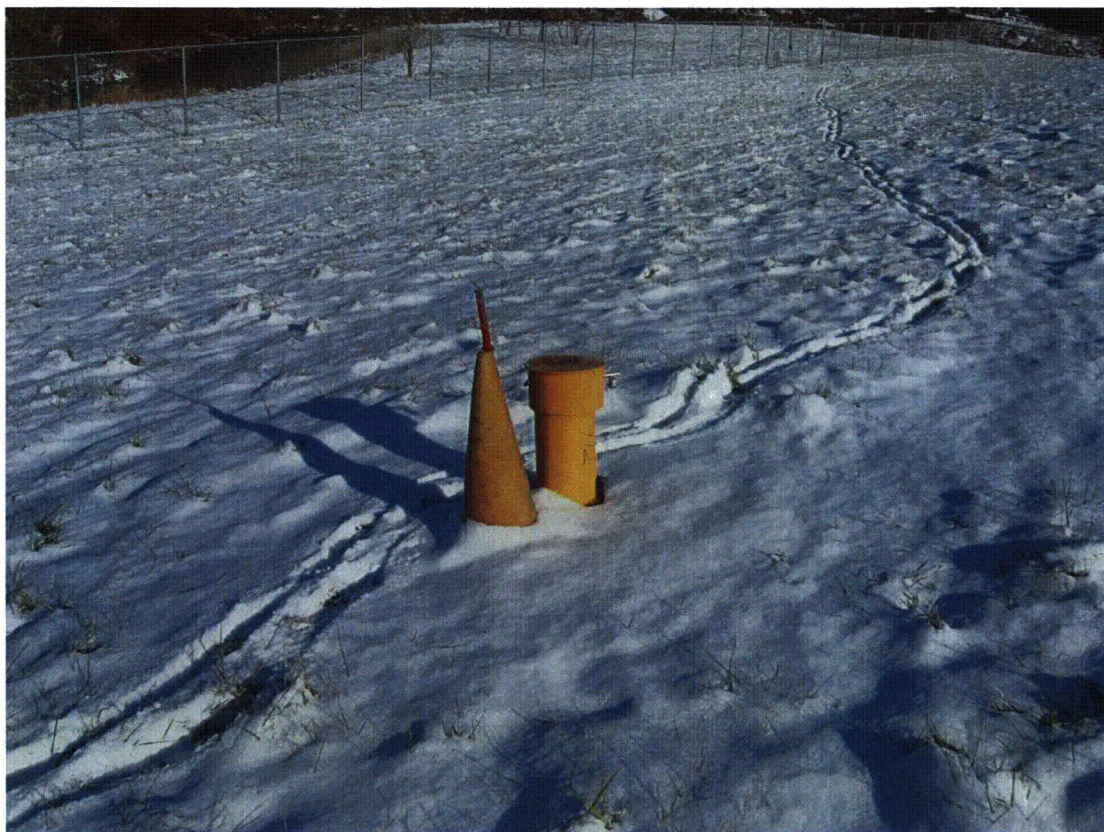
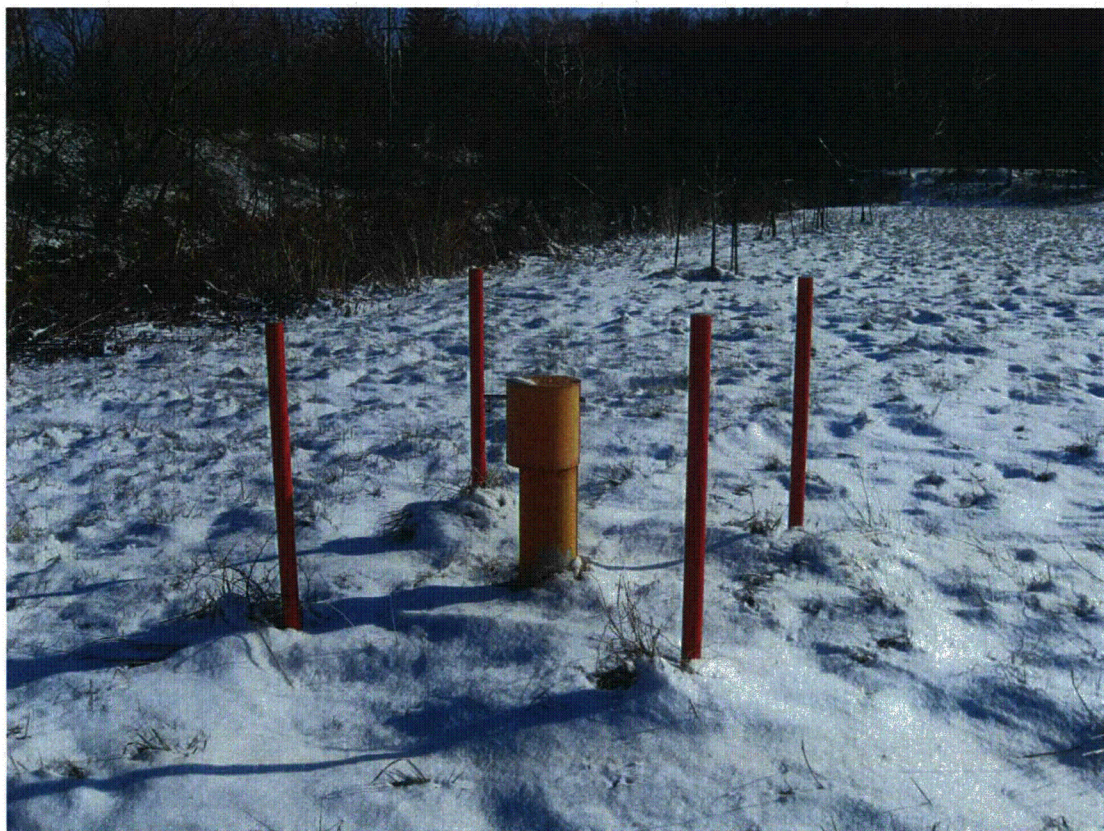
All monitoring wells were observed to be properly locked during the inspection (PL-7 and PL-8).

CAN 10/2013. PL-7. Monitoring well 0412.

CAN 10/2013. PL-8. Monitoring well 0412.
