Legacy
Management

2013 Annual Site Inspection and Monitoring Report for Uranium Mill Tailings Radiation Control Act Title I Disposal Sites

March 2014

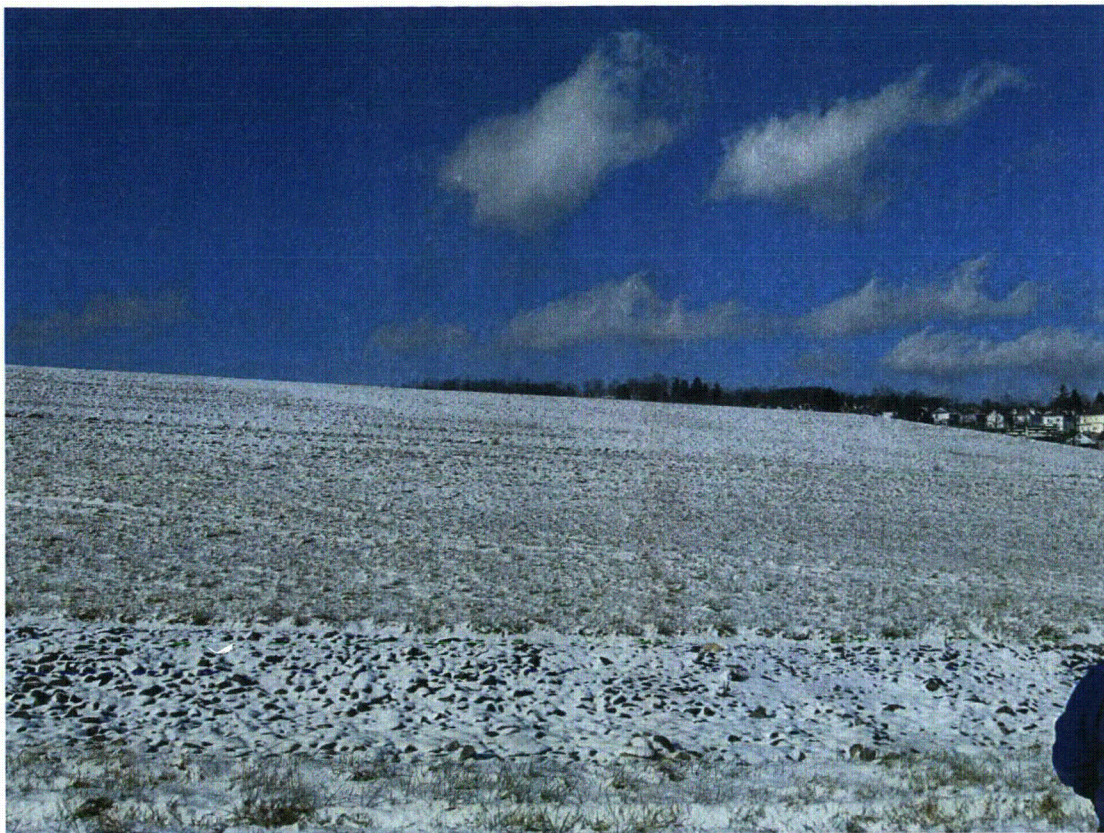
CAN 10/2013. PL-9. Southeast side of disposal cell.

The grass-covered disposal cell was in excellent condition (PL-9). No evidence of erosion or slope instability was observed during the inspection.

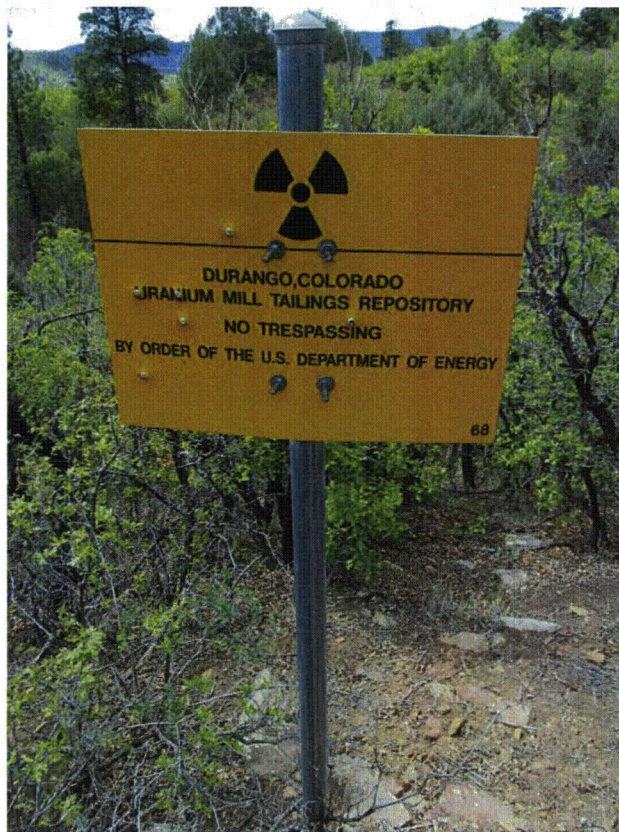
DUD 5/2013. PL-3. Perimeter sign P68, showing bullet hole damage.

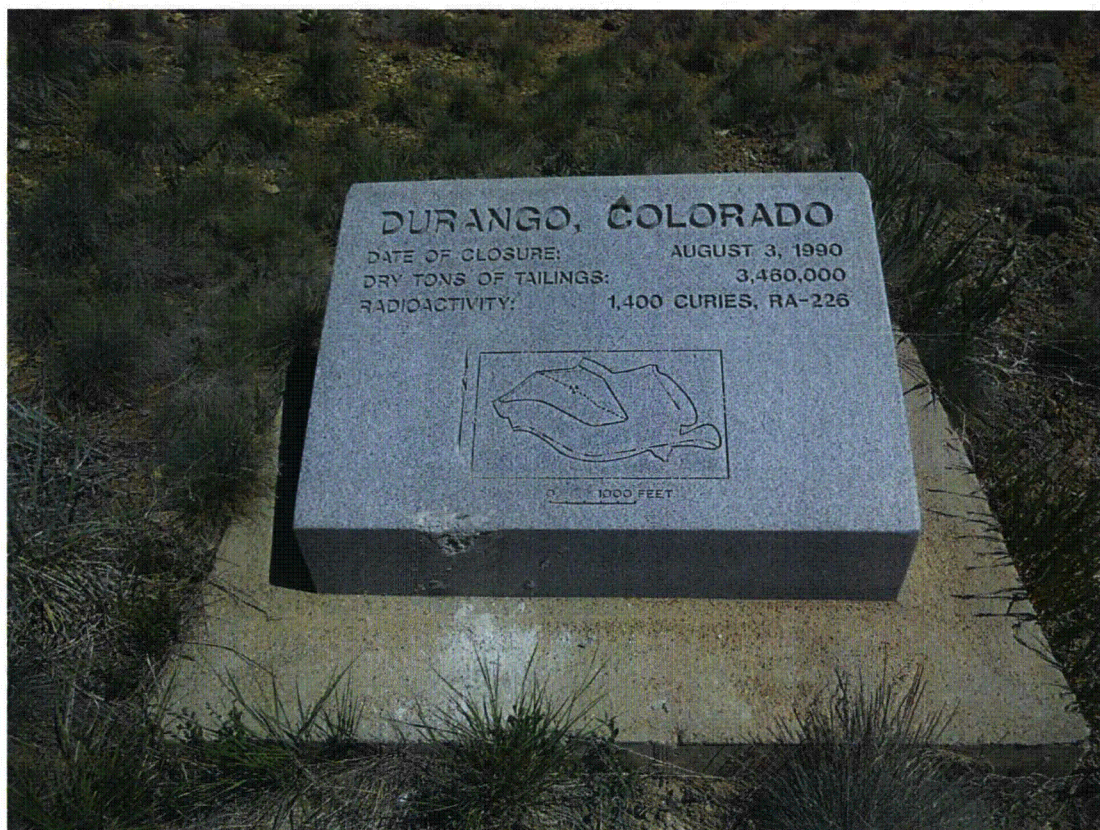
Site marker SMK-1 historically has been superficially pocked from gunfire but has remained legible. During the 2012 inspection inspectors discovered that an additional chip along the bottom edge of the marker had fallen off; however, the information on the face of the marker remains legible, and no new damage was observed (PL-4). SMK-2 remains in excellent condition.

DUD 5/2013. PL-4. Site marker SMK-1, showing damage.

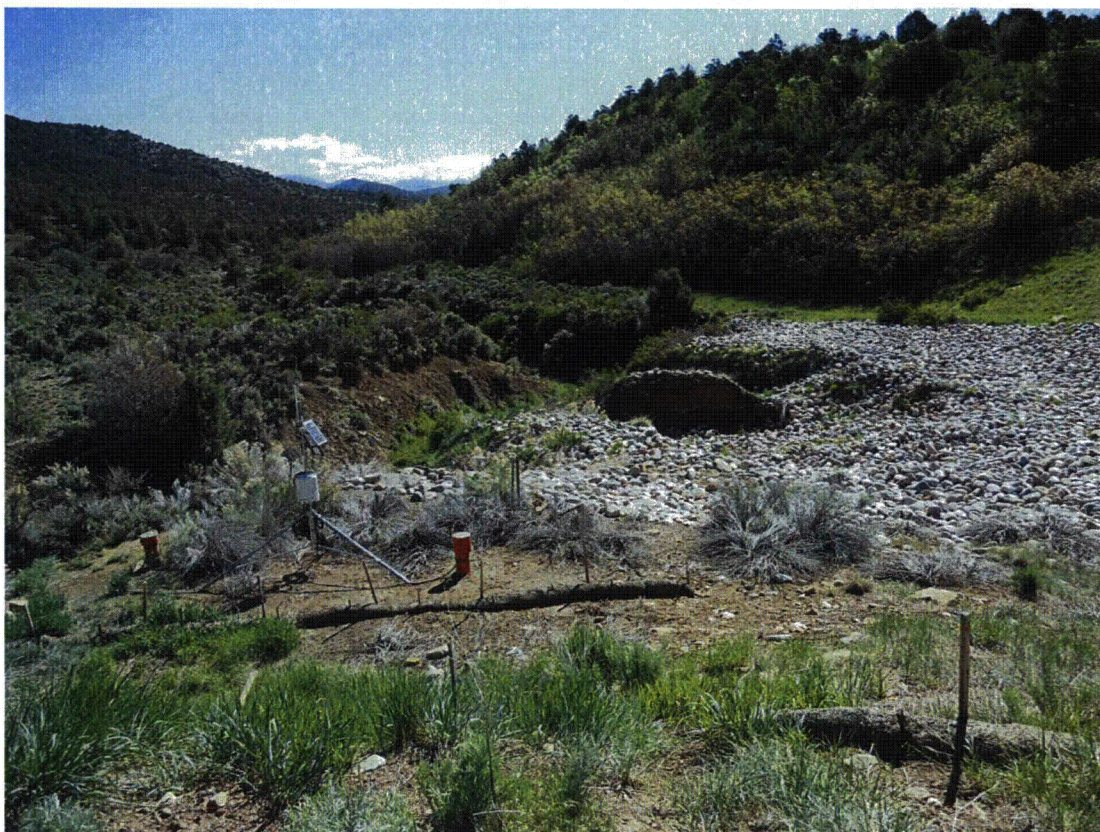
DUD 5/2013. PL-11. Northeast outflow, showing erosion areas.

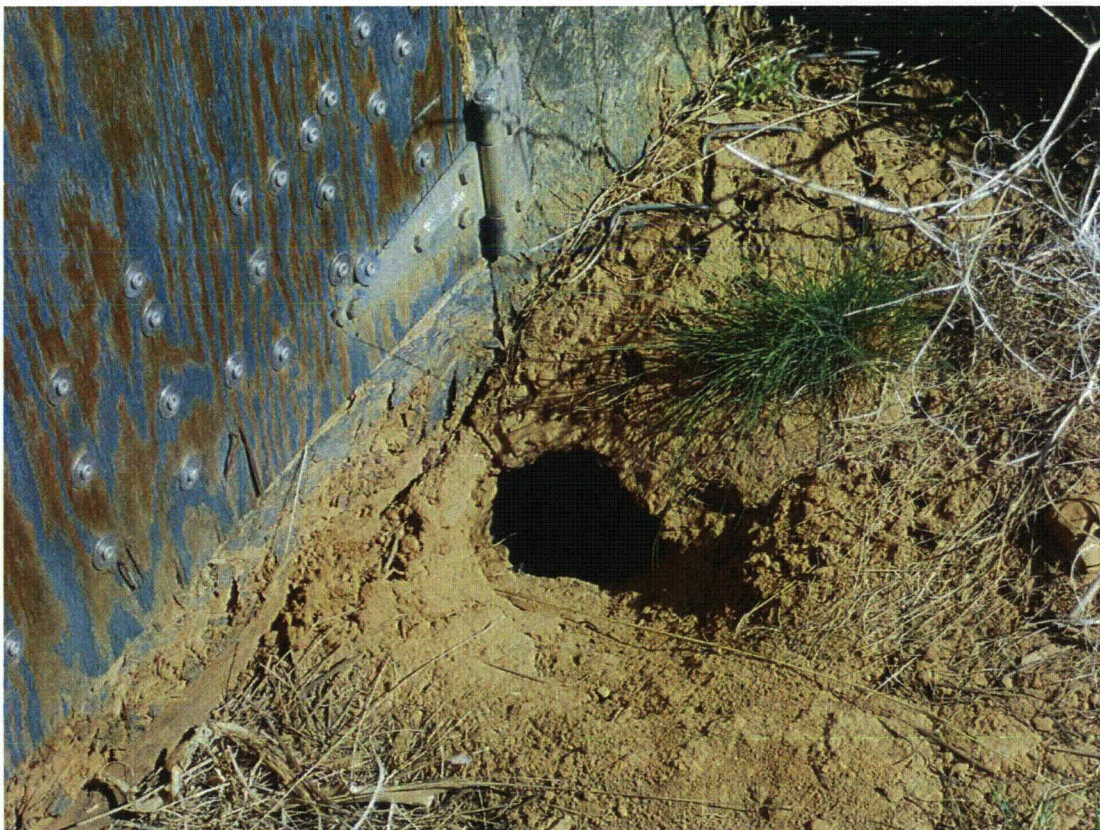
DUD 5/2013. PL-14. Animal burrow under east side (front) of shed. Edge of pond liner is at top of photo.

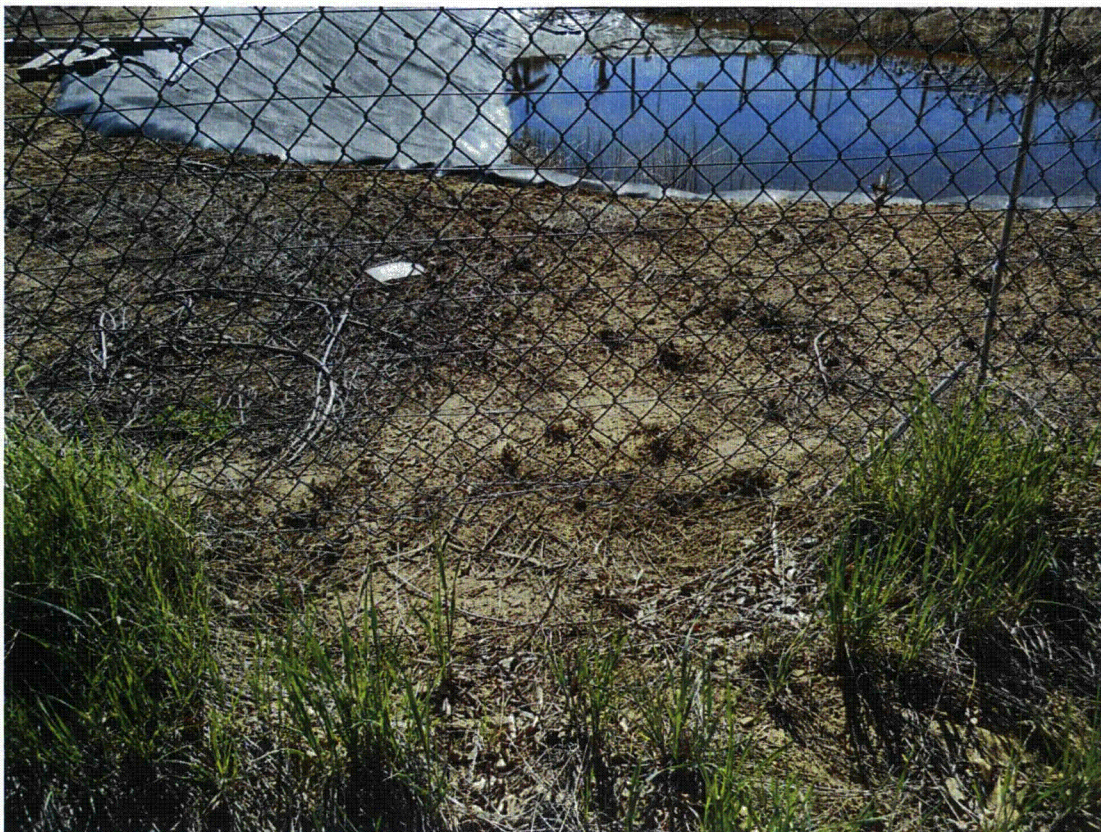
DUD 5/2013. PL-15. Gap under evaporation pond fence, west side.
