9.0 Lakeview, Oregon, Disposal Site

9.1 Compliance Summary

Figure 9-1. 2013 Annual Compliance Drawing for the Lakeview Disposal Site

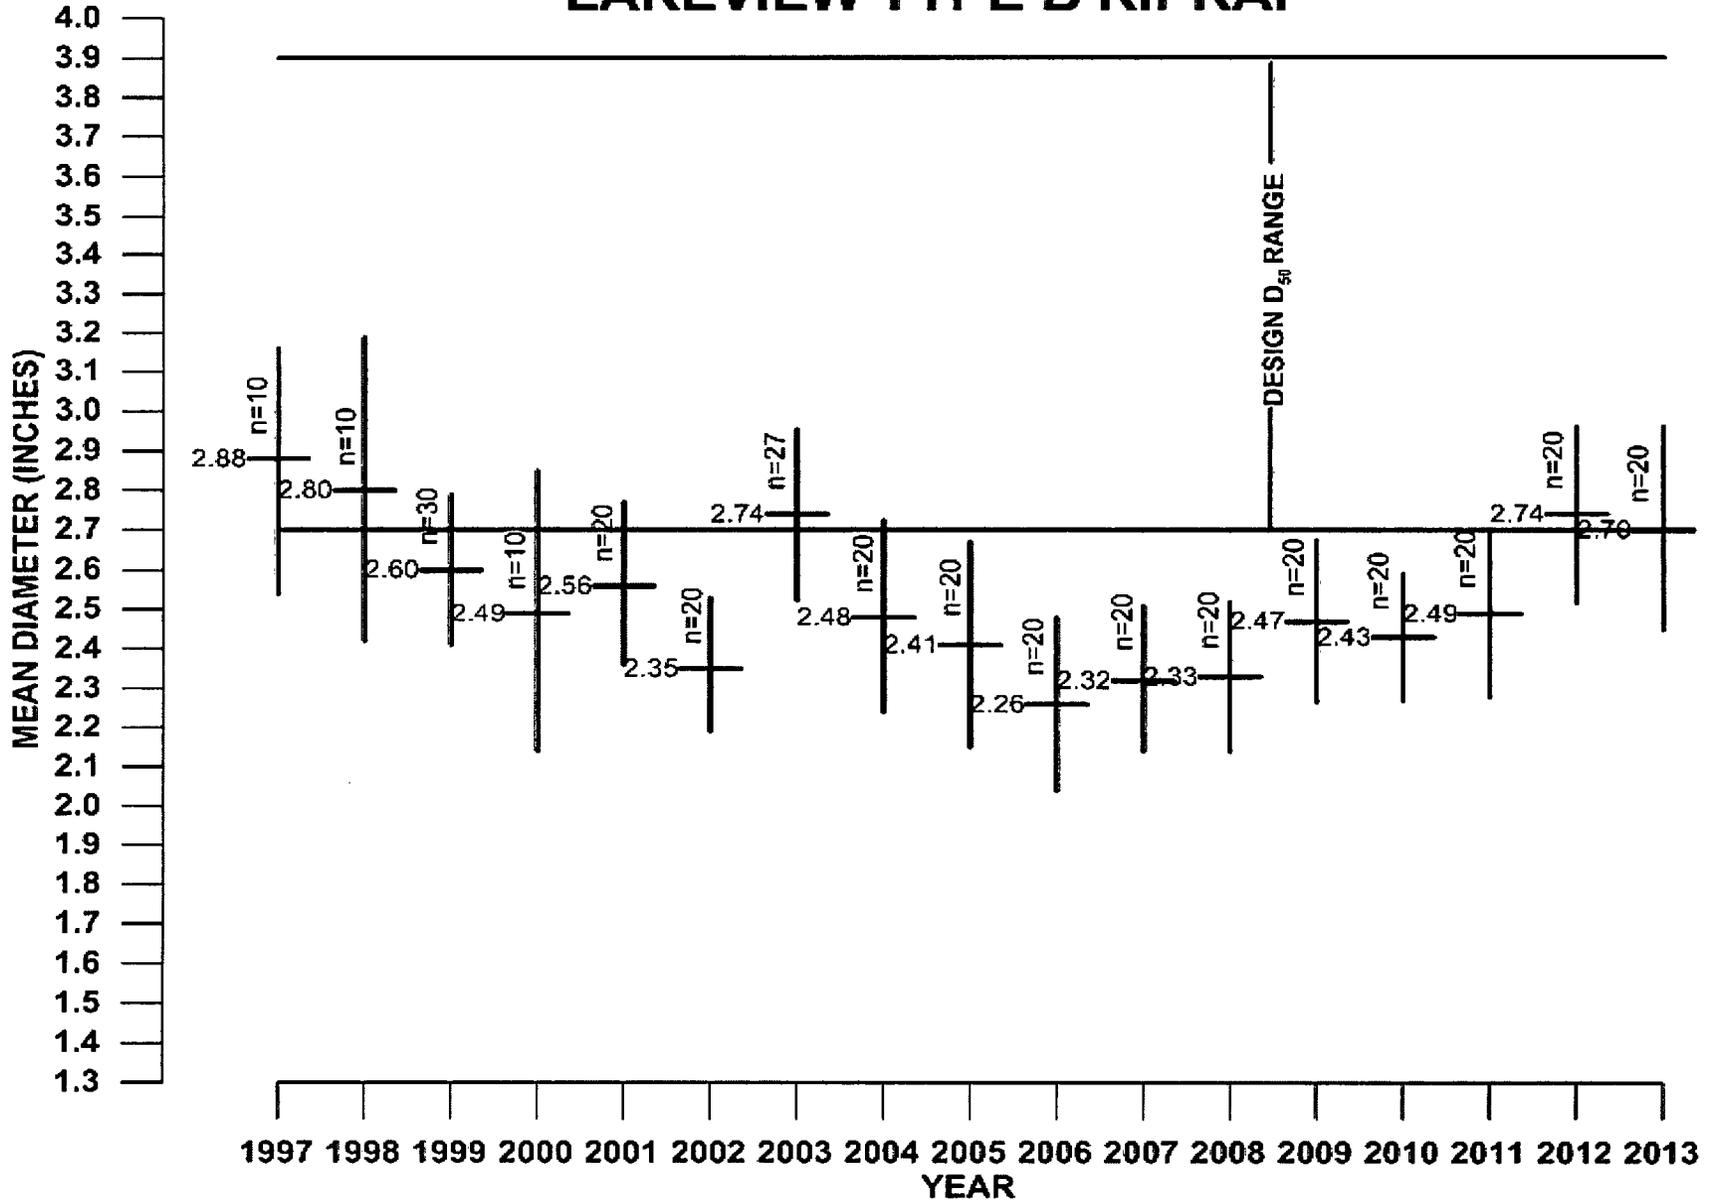
Figure 9-2. Riprap Gradation Monitoring

The U.S. Department of Energy (DOE) has been evaluating the condition of the riprap to ensure continued long-term protection of the cell from erosion during a severe precipitation event. The degradation of the rock riprap, observed at the site since the mid-1990s, has been monitored as part of the annual inspections to determine the mean diameter (D_{50}) value of the riprap on the west side slope. The D_{50} value obtained by the annual gradation monitoring measures the number of rocks retained per sieve size. The D_{50} value measured during the 2013 gradation monitoring is 2.70 inches, which falls within the original D_{50} design size range of 2.7 to 3.9 inches for the Type B side slope riprap, as specified in the *Long-Term Surveillance Plan for the Collins Ranch Disposal Site, Lakeview, Oregon* (LTSP) (DOE/AL/62350-19F, Rev. 3, DOE, August 1994). The 2013 D_{50} value is 0.04 inch smaller than the value of 2.74 inches measured during the gradation monitoring in 2012.

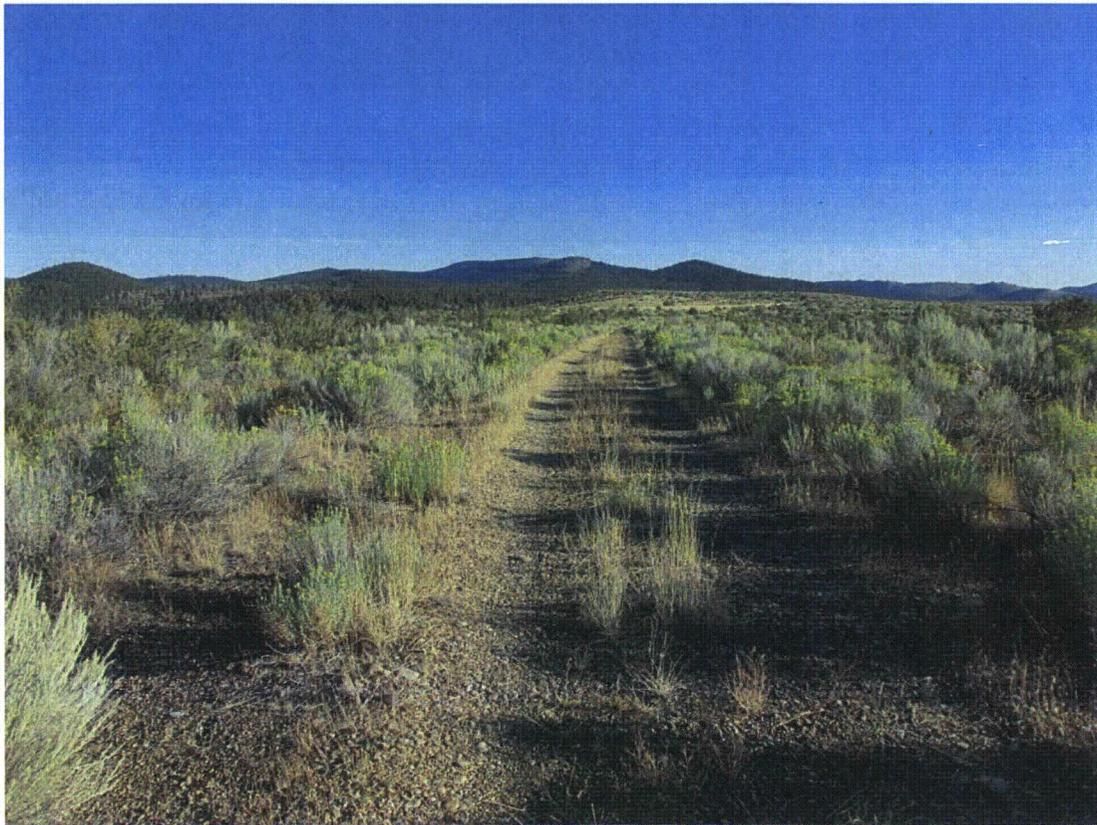
Access to the site is gained by traveling a gravel road that heads west off County Road 2-16B. DOE was granted a perpetual easement on the approximately 1.2 mile access road between the county road and the DOE property boundary. A locked gate across the access road on the adjacent privately owned land limits access to the site. The site access road is a gravel-surfaced road in good condition, as shown in PL-1.

LKV 8/2013. PL-1. Gravel site access road. View to north.

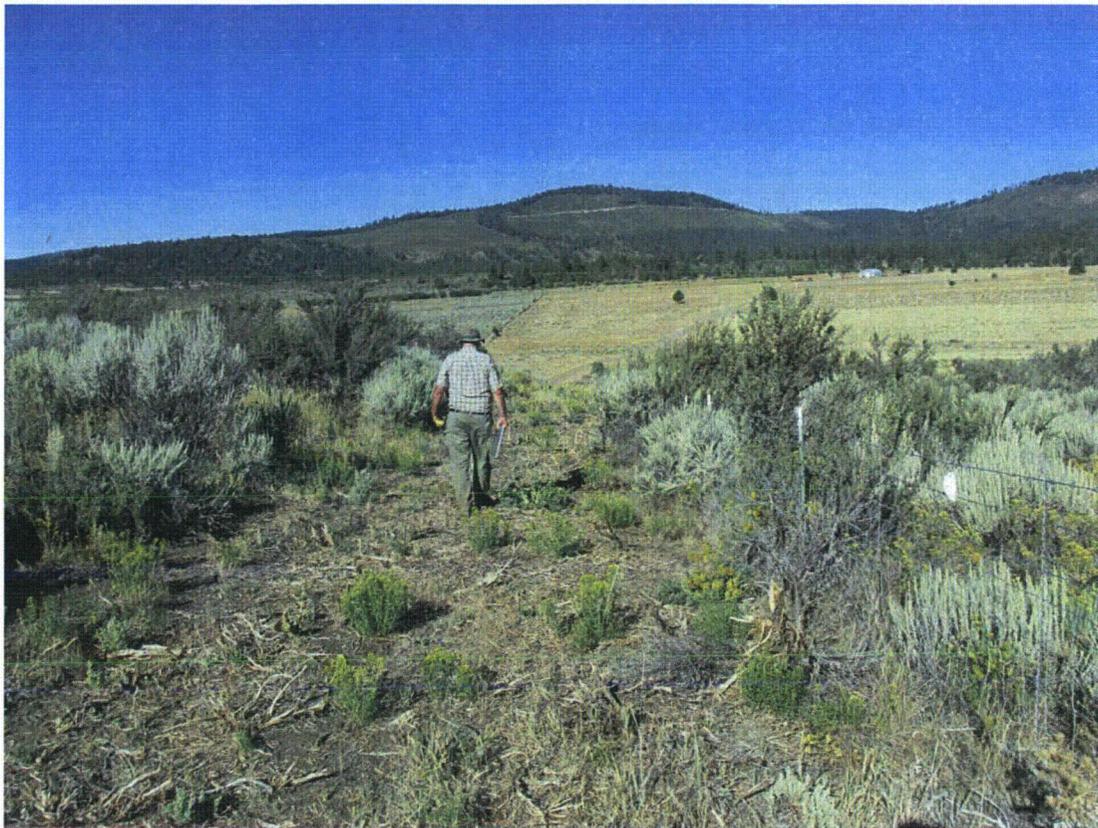
The site boundary fence is generally in good condition, but some loose and broken wire strands, and two loose t-posts were noted. Tightening and maintenance of the fence will likely be performed during 2014, as will some removal of vegetation near, and involved in, the fence line (PL-2).

LKV 8/2013. PL-2. View to west along south fence line. Shrub involvement with fence shown.

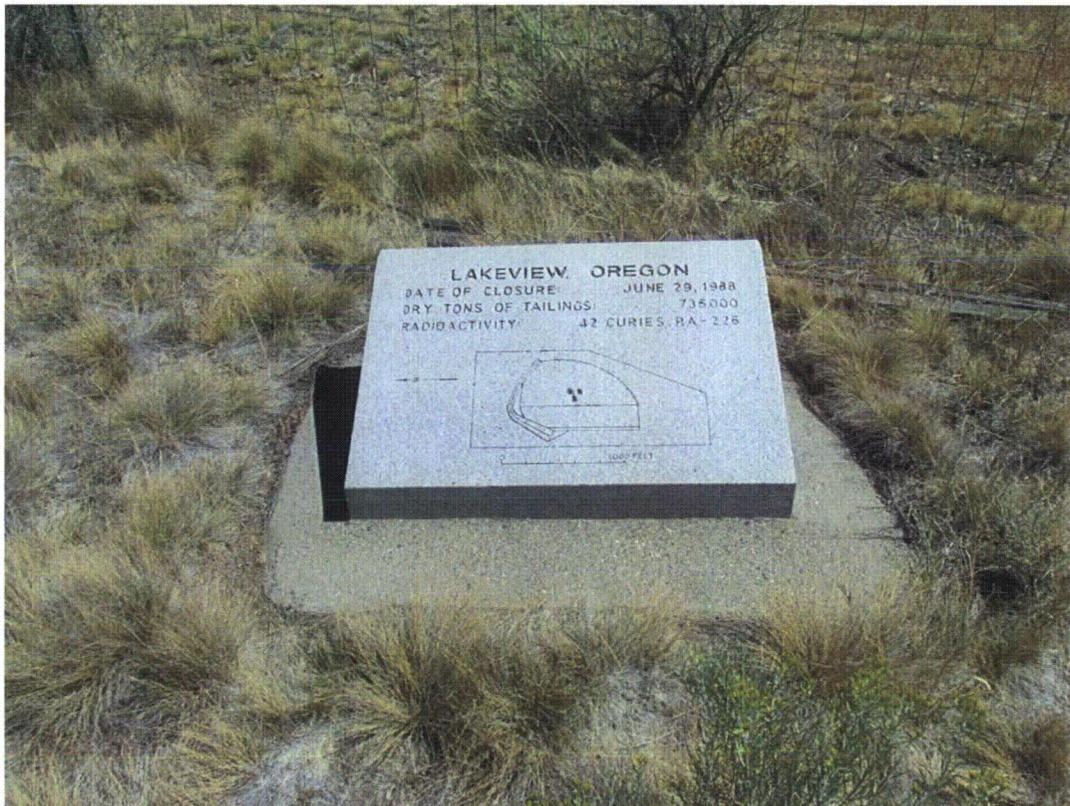
The two site markers—SMK-1, located near the site entrance, and SMK-2 on top of the disposal cell—are in good condition (PL-3).

LKV 8/2013. PL-3. Site marker SMK-1 near entrance gate.

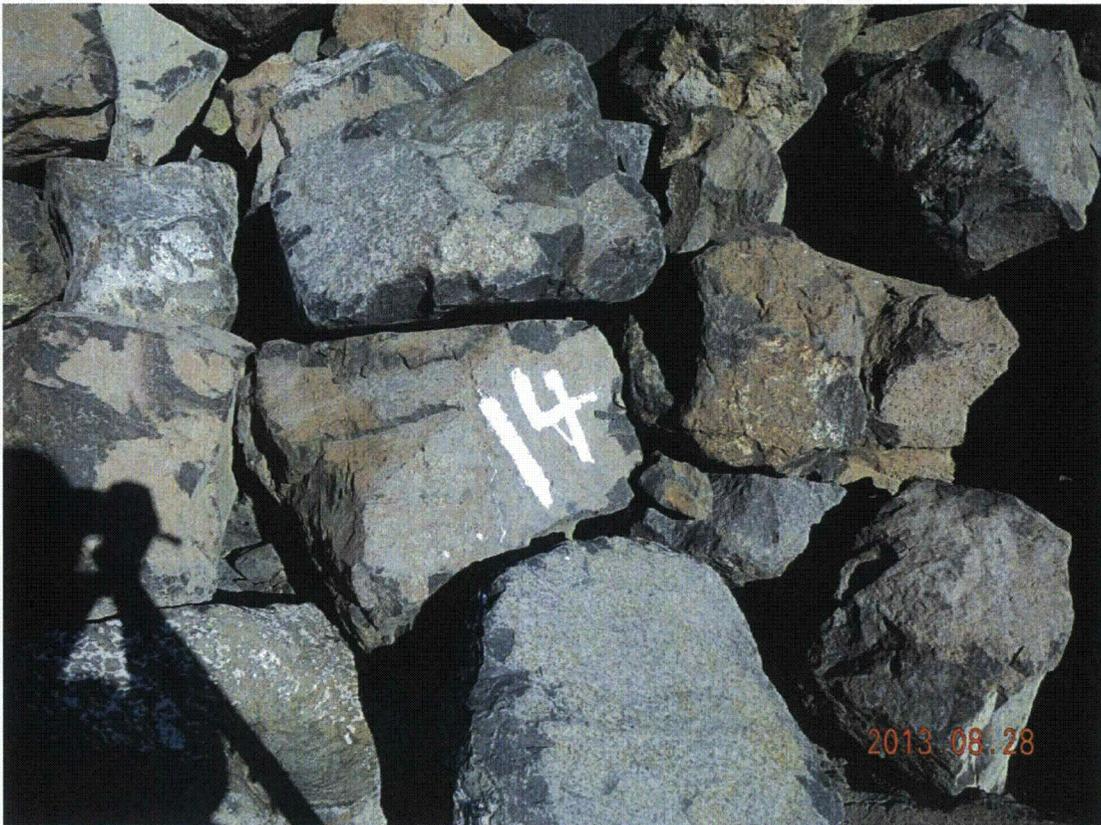
The annual photographic monitoring of the 18 photograph points for long-term rock monitoring was conducted in the energy dissipation area (EDA). PL-8 shows the rock at monitoring point location 14. Minor rock degradation has been observed since monitoring began at the original 10 photograph locations established in 1997 and at the eight additional locations established in

LKV 8/2013. PL-8. Riprap photo-monitoring location 14 in EDA.

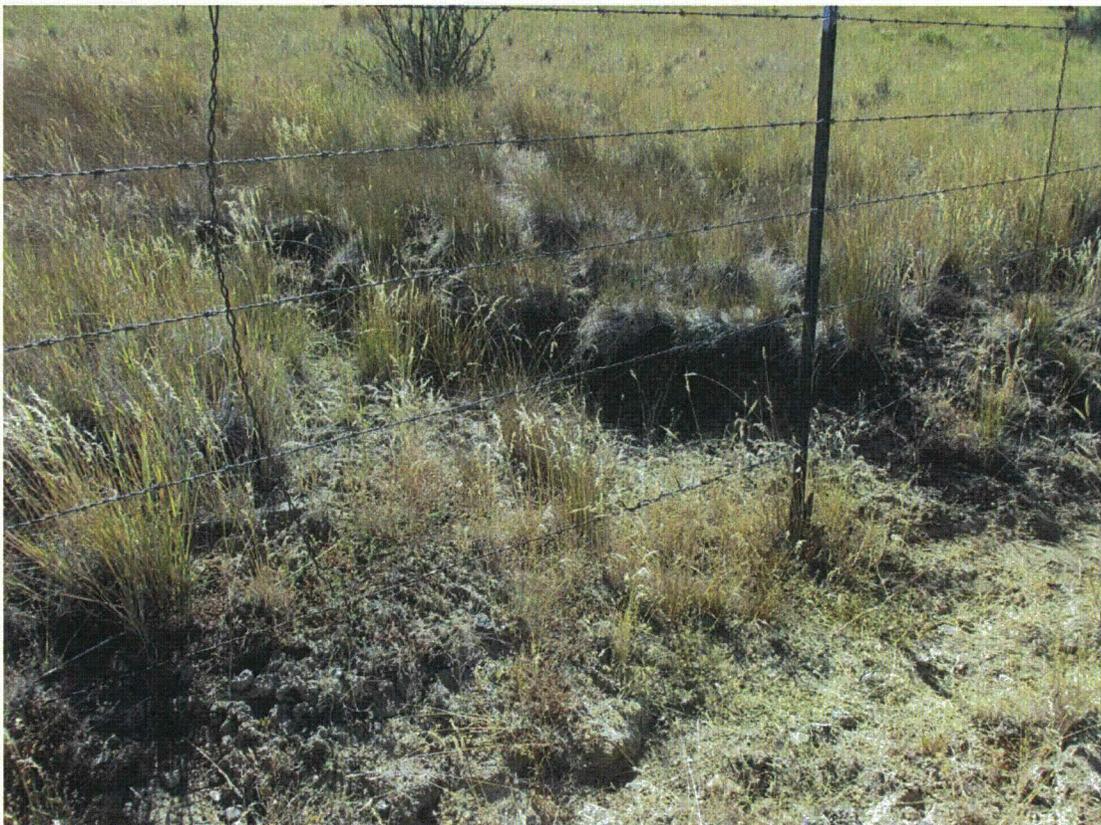
LKV 8/2013. PL-9. Gullying at west fence line showing erosion around fence stake.

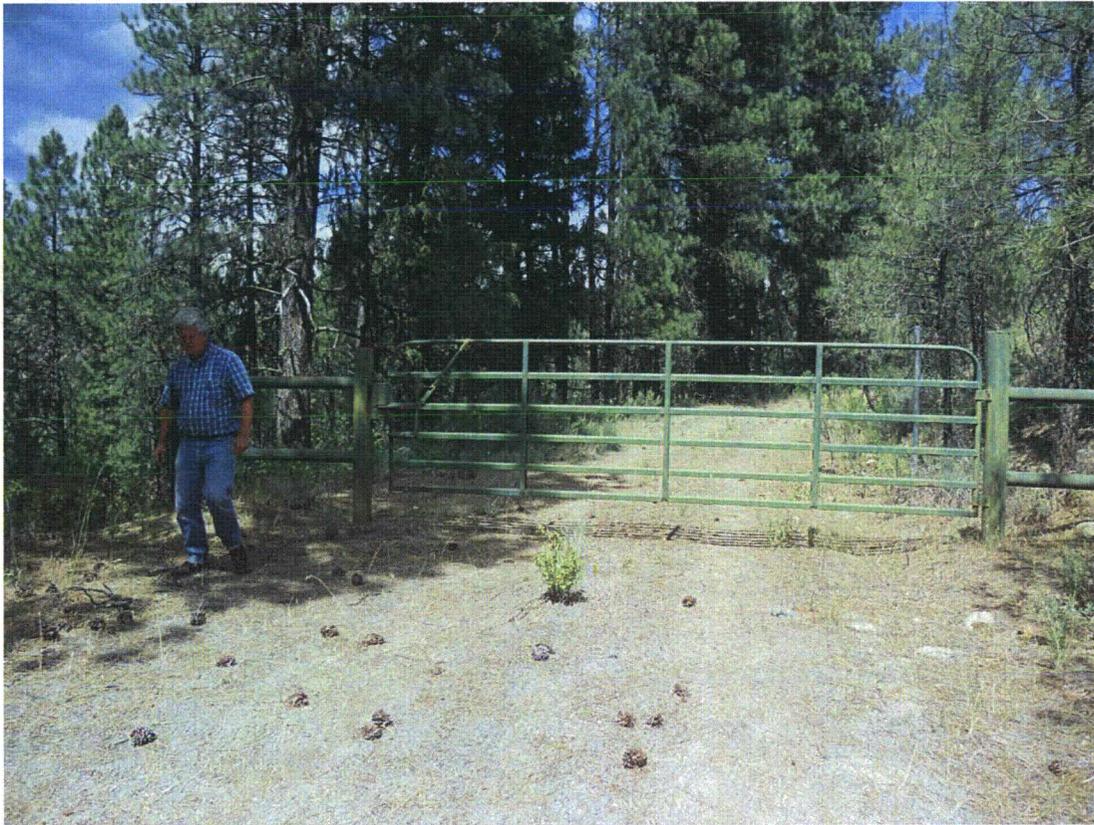
The site is at the end of a hard-packed gravel road about 650 feet north of Idaho State Highway 21. The road is in excellent condition. A locked gate spans the road about 150 feet from the state highway and is in excellent condition (PL-1).

LOW 7/2013. PL-1. Entrance gate.

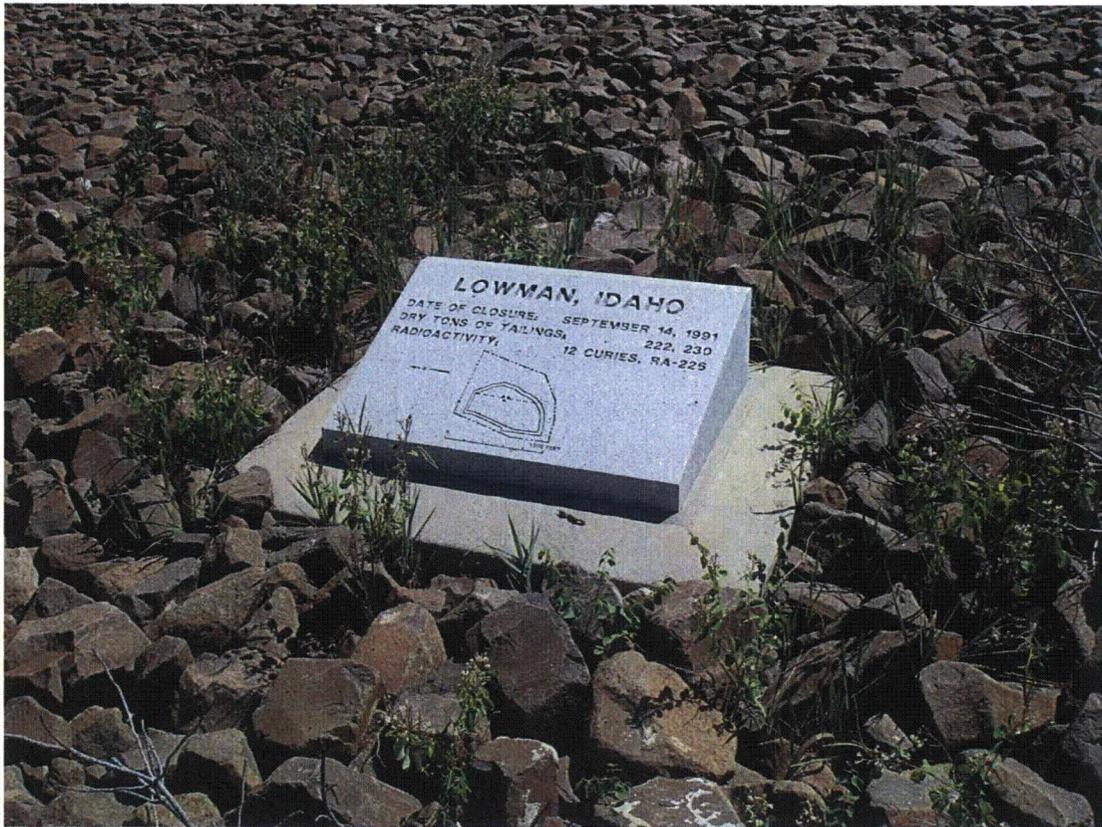
Two site markers are present at the site. The first, SMK-1, is just inside the site's southwest boundary. The second, SMK-2 (PL-2), is on top of the disposal cell. Both markers are in excellent condition.

LOW 7/2013. PL-2. Site marker 2 on cell top.

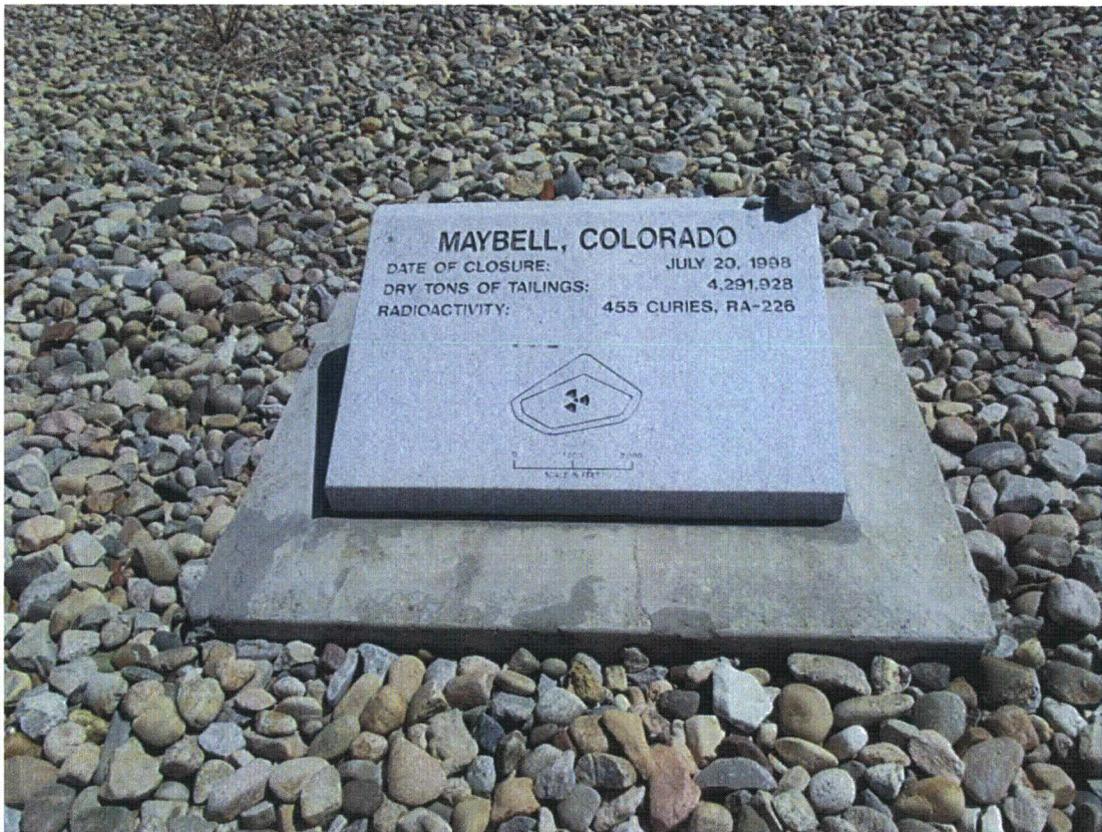
Two standard granite site markers are located onsite. Site marker SMK-1 is located near the entrance gate, and SMK-2 is located on top of the disposal cell (PL-2); both were in good condition.

MAY 8/2013. PL-2. Site Marker No. 2.

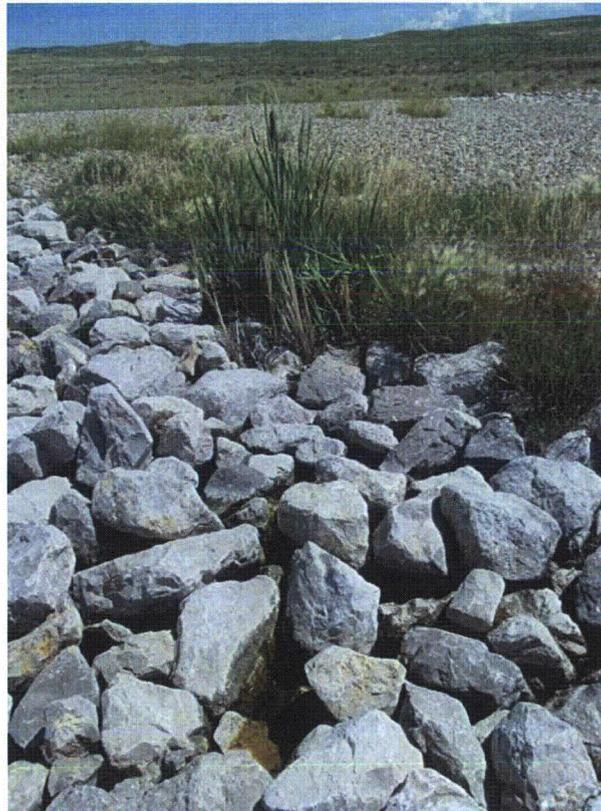
MAY 8/2013. PL-8. Cattails growing adjacent to the base of the east side slope of the disposal cell; standing water within apron in foreground.

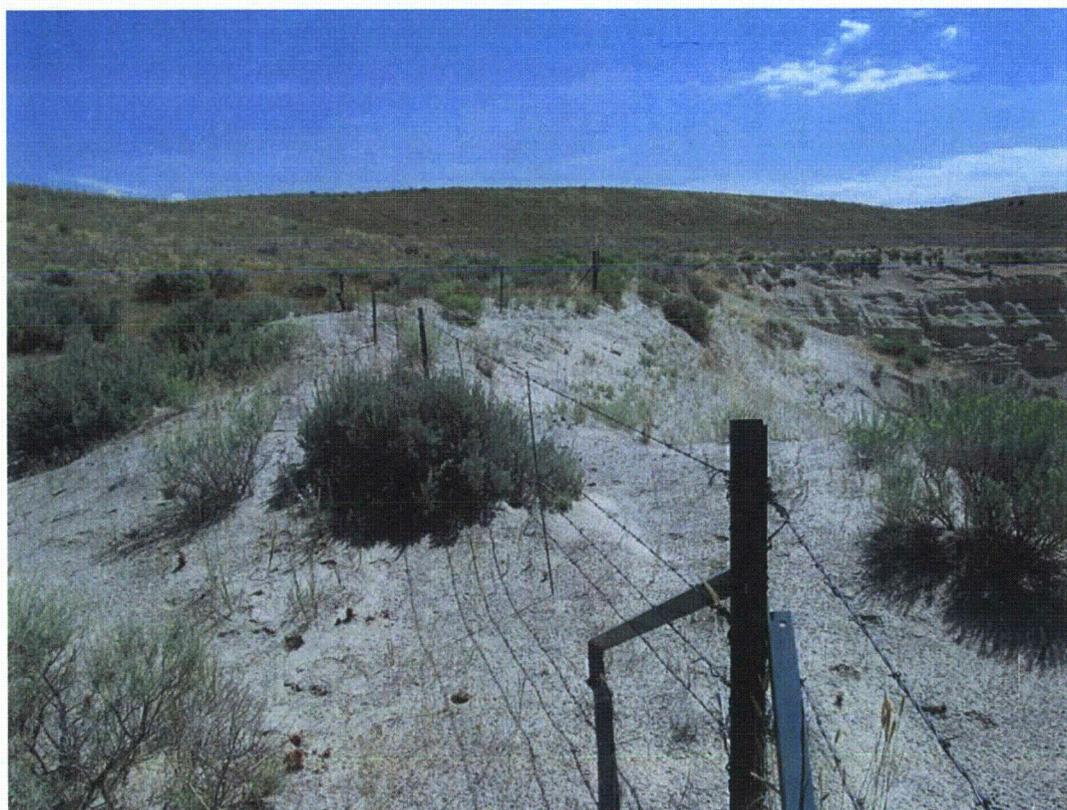
MAY 8/2013. PL-12. Windblown sand accumulation along the south perimeter fence at crest of the northern wall of the Johnson Pit; encroachment of pit in background.

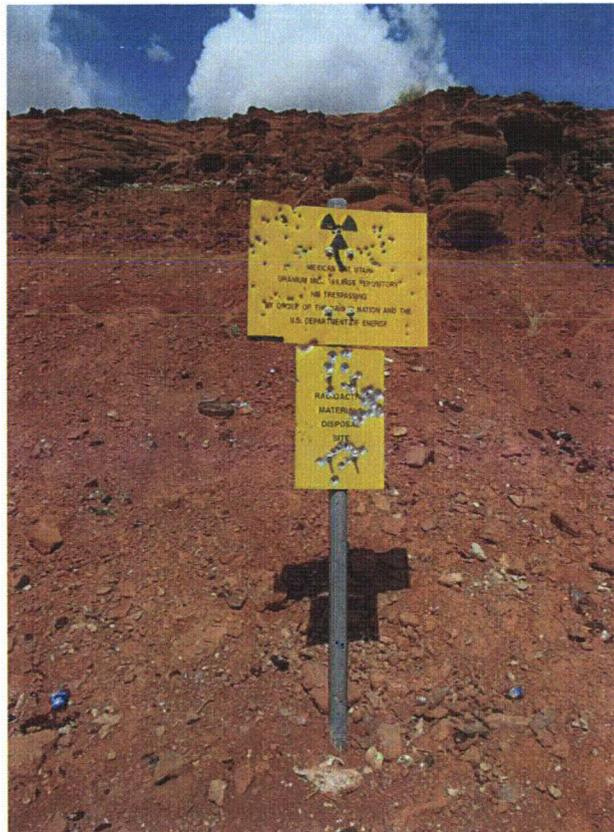
HAT 4/2013. PL-2. Perimeter sign P20 with bullet holes.

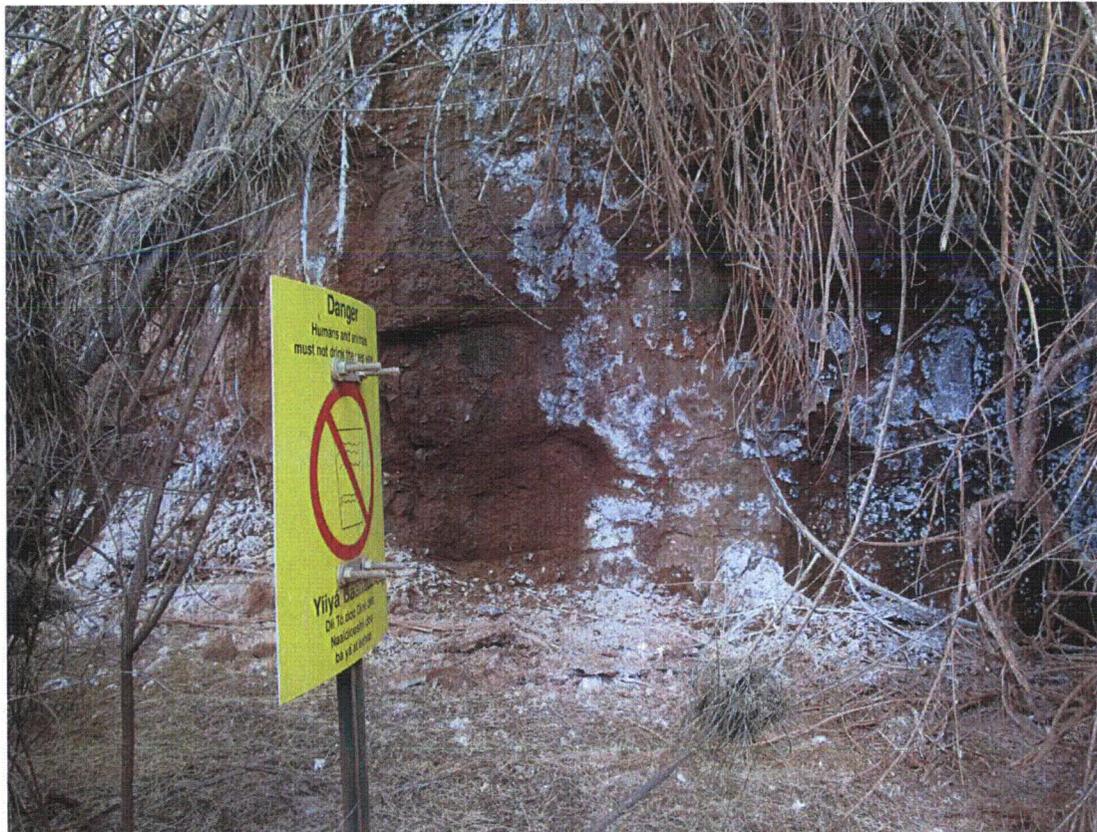
HAT 4/2013. PL-10. Seep 248 dripping conditions; no standing water.

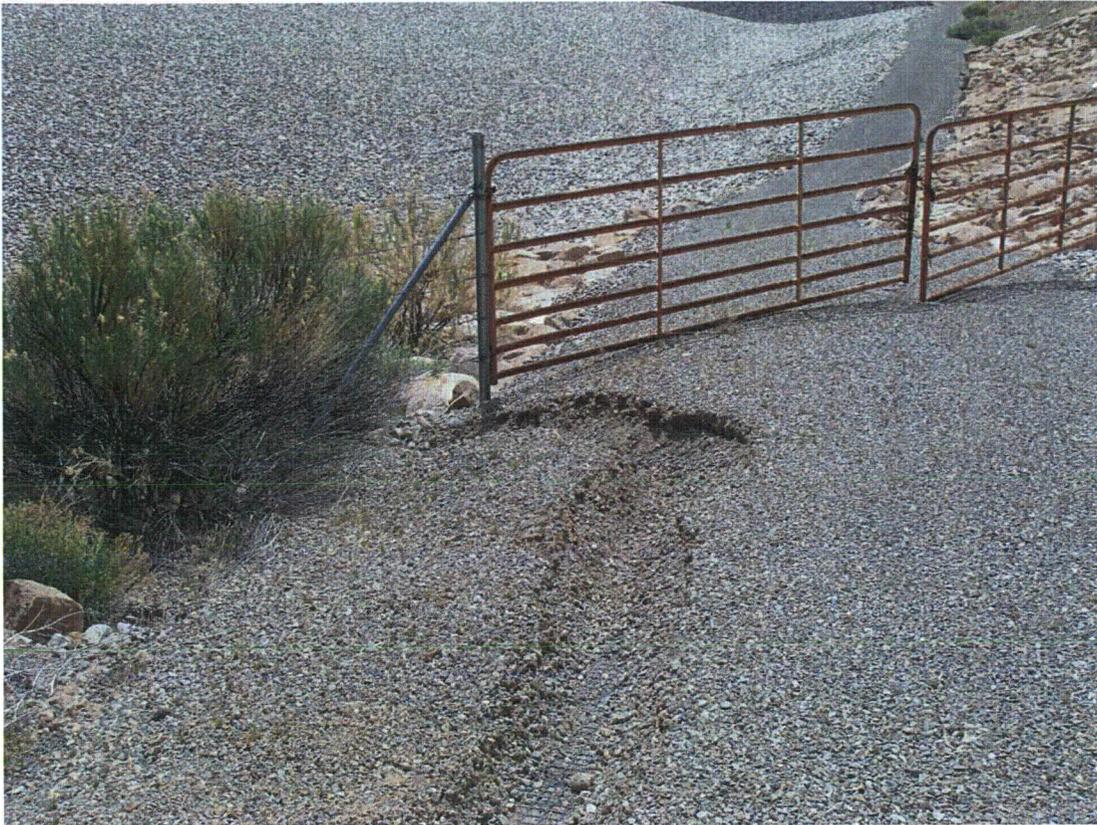
NAD 5/2013. PL-2. Erosion on access road near upper gate.
