**CALCULATION  
PACKAGE**

Calc. Pkg No. VSC-04.3101  
File No.: VSC-04.3101  
Revision: 3

VSC-04 / VSC-24 General Licensees

VSC-24 CoC Renewal Aging Management Review

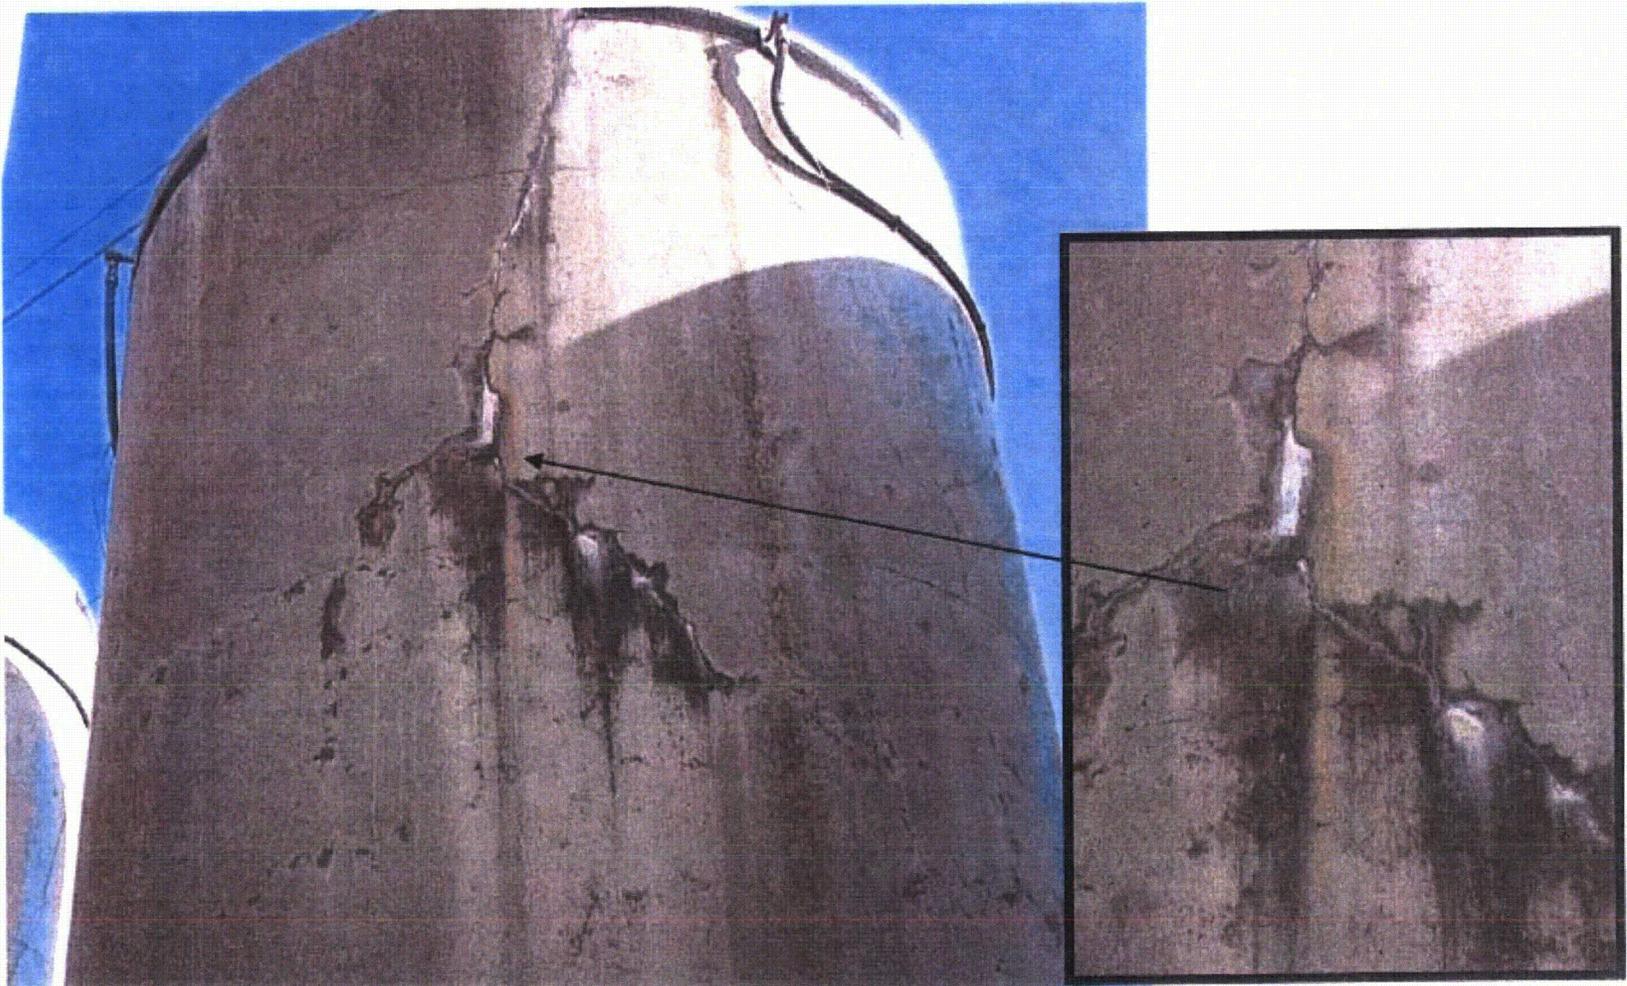
**Figure 1 - VCC Surface Cracks and Mineral Deposits**

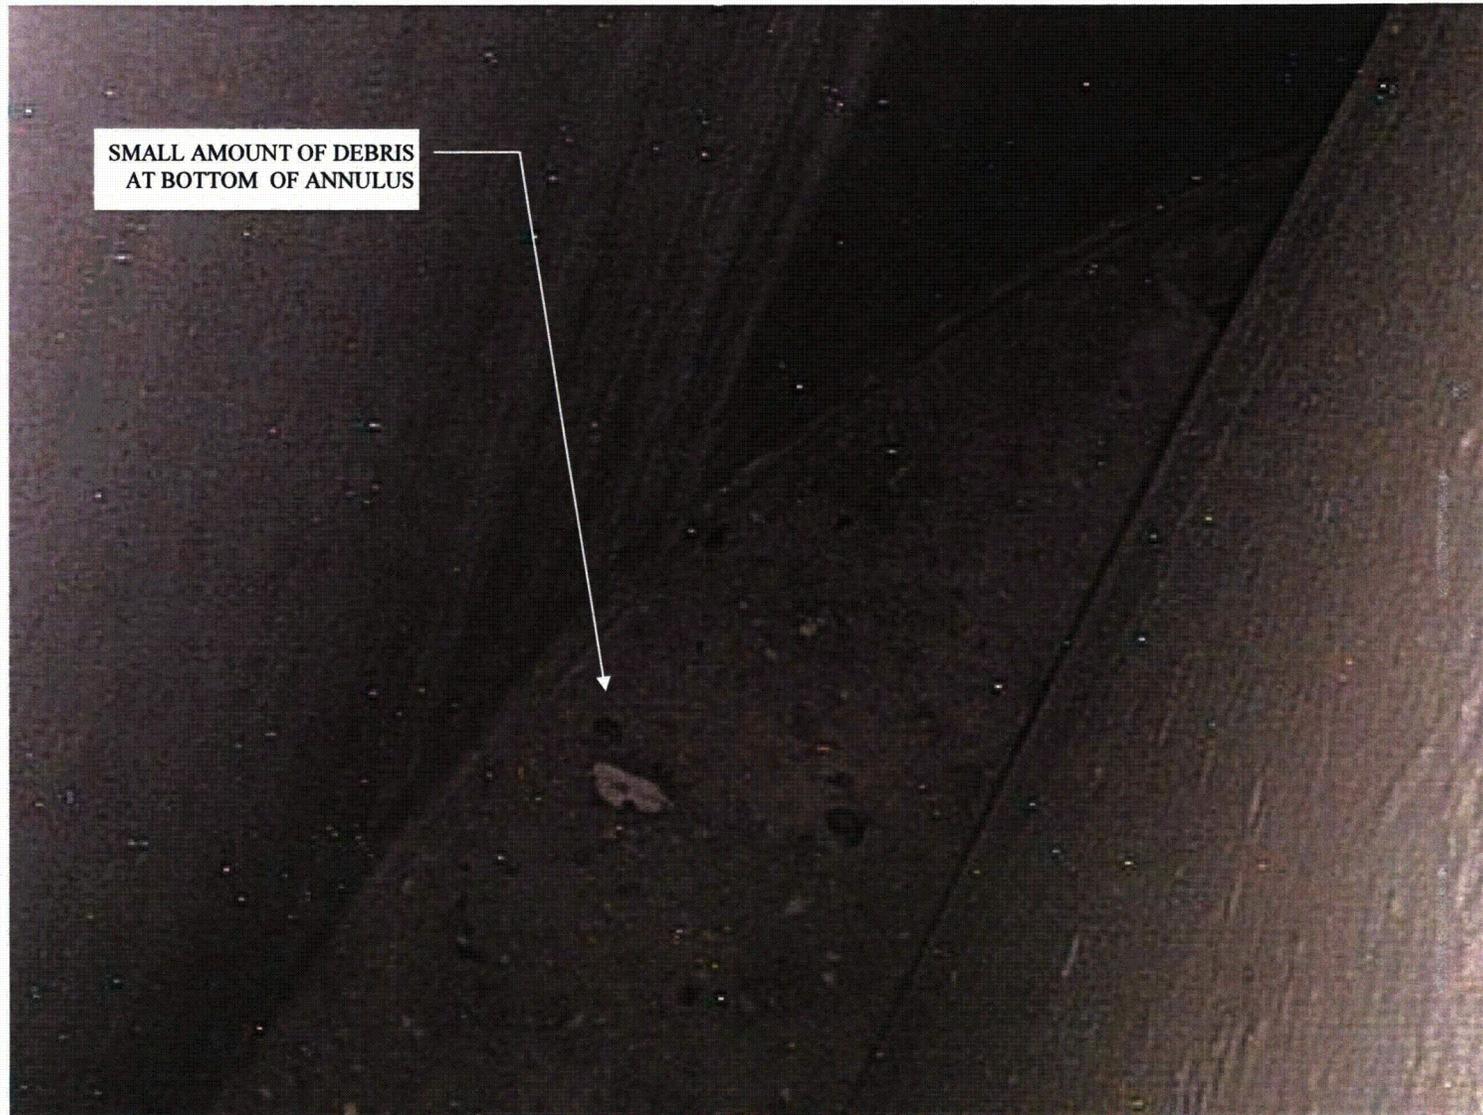
**Figure 2 - Debris at Bottom of VCC Annulus**

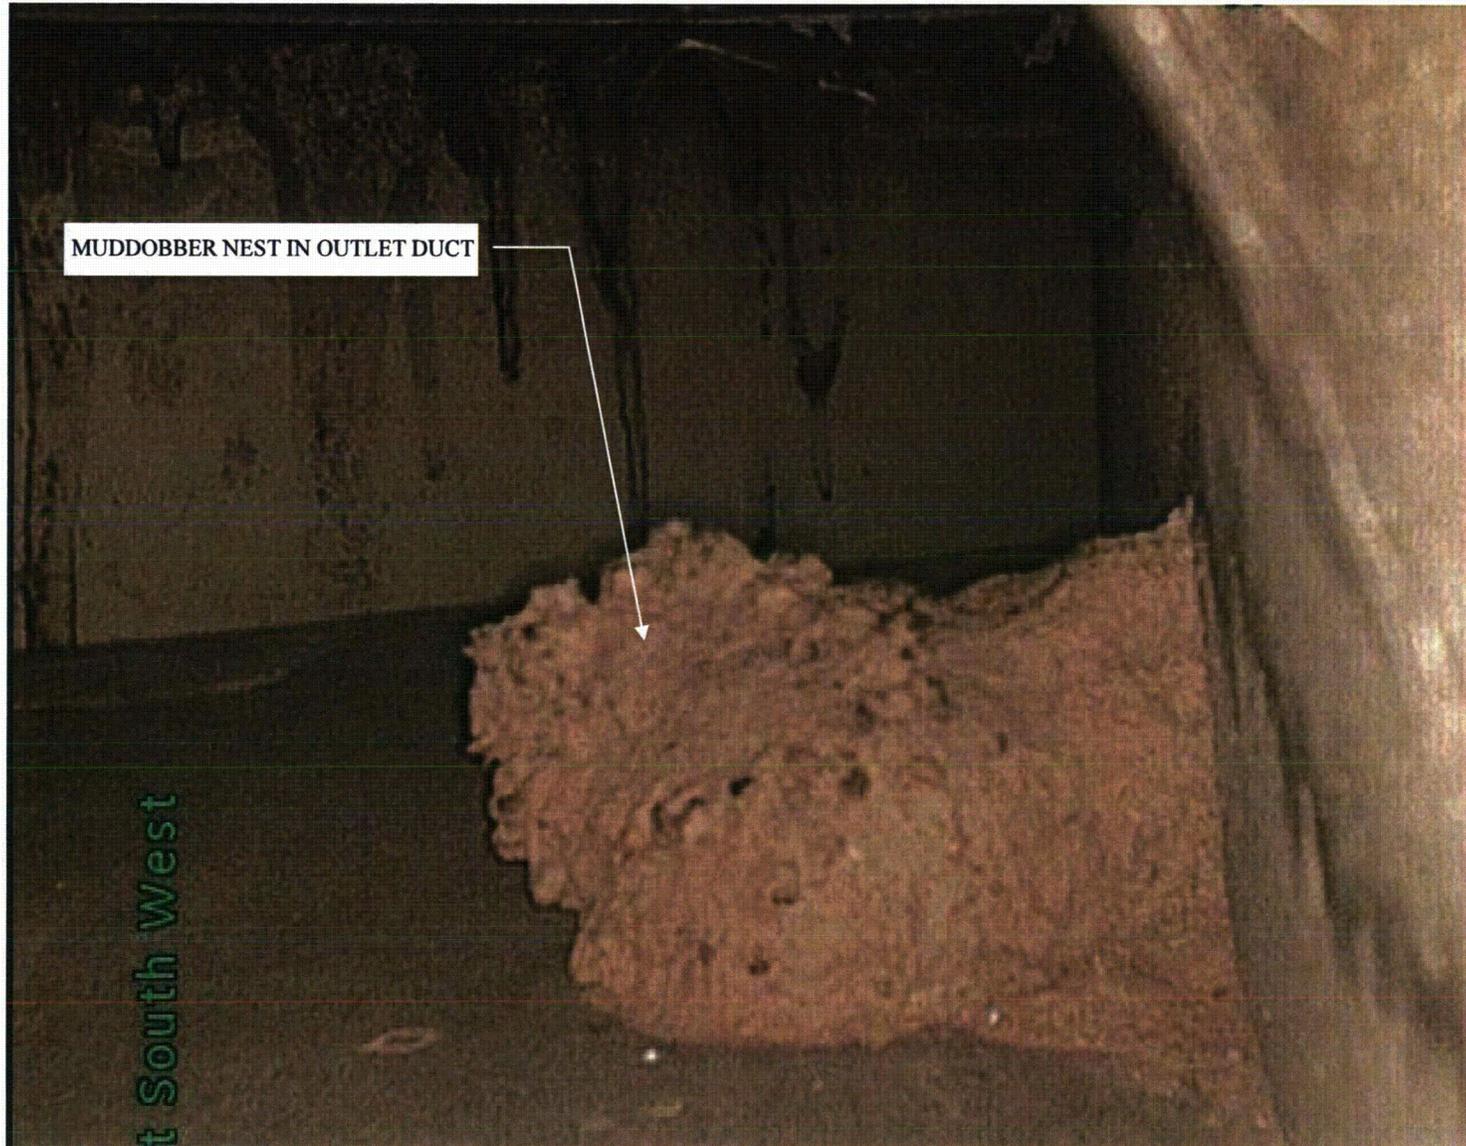
**Figure 3 - Muddobber Nest in VCC Outlet Duct**

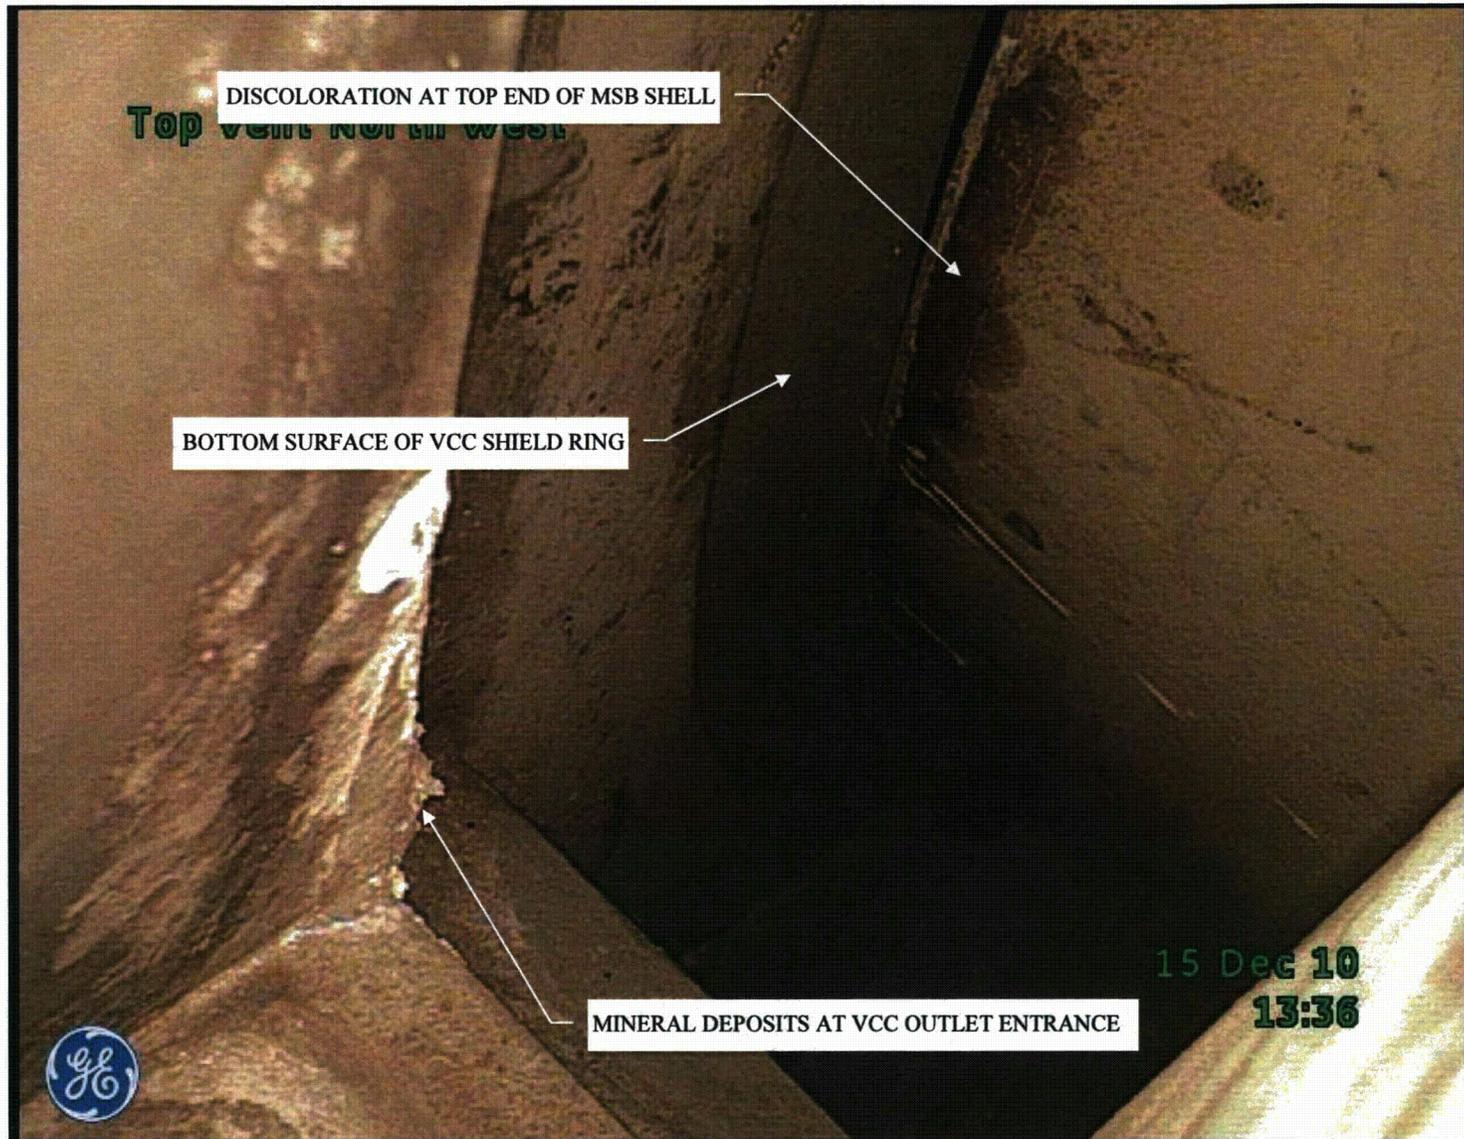
**Figure 4 - Top End of VCC Annulus and MSB Assembly**

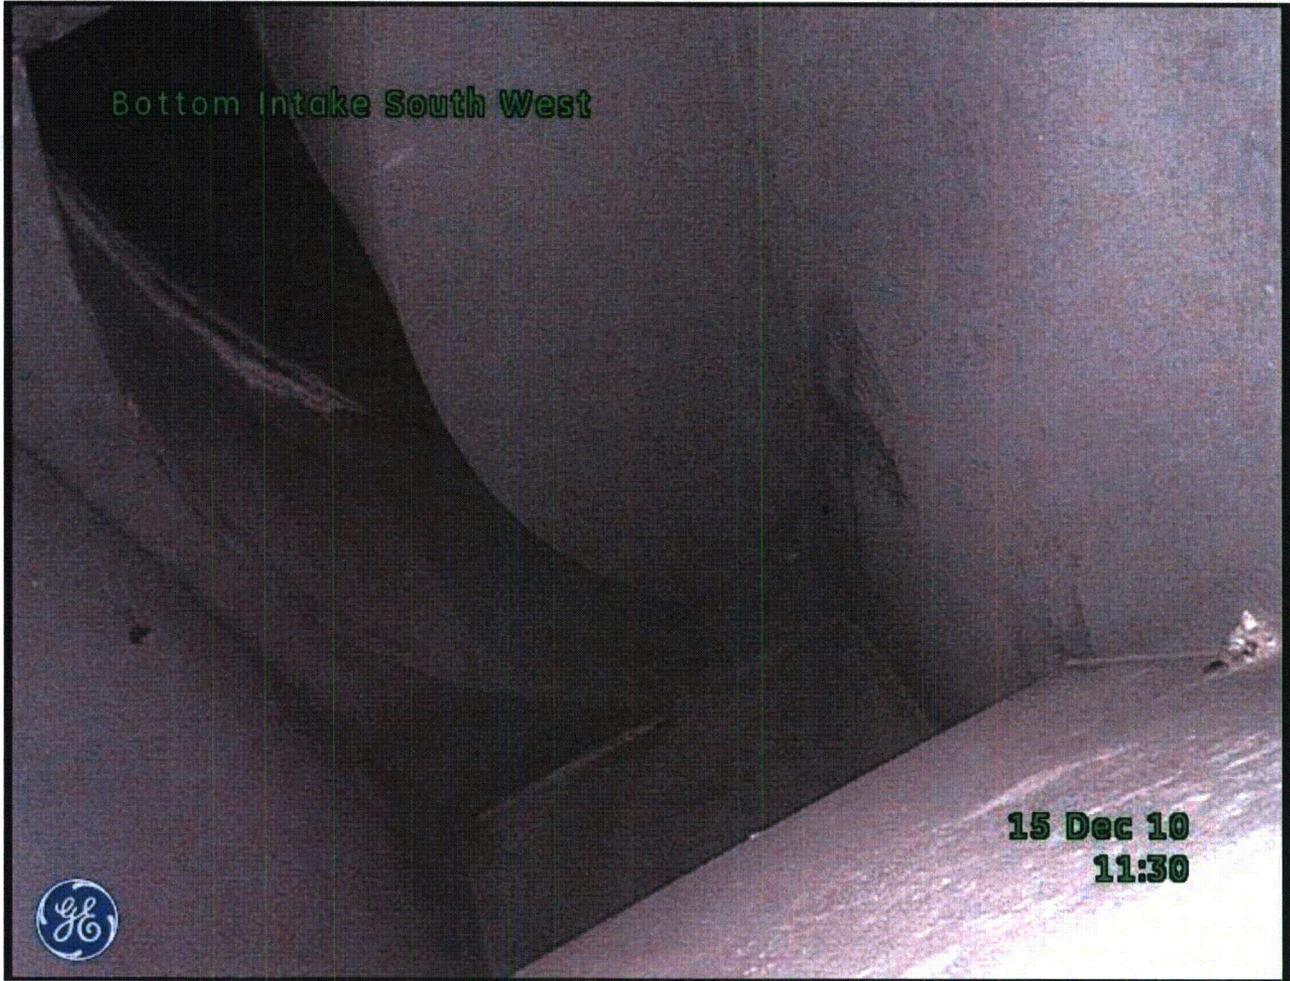
**Figure 5 - VCC Air Inlet Duct (looking up into VCC annulus)**

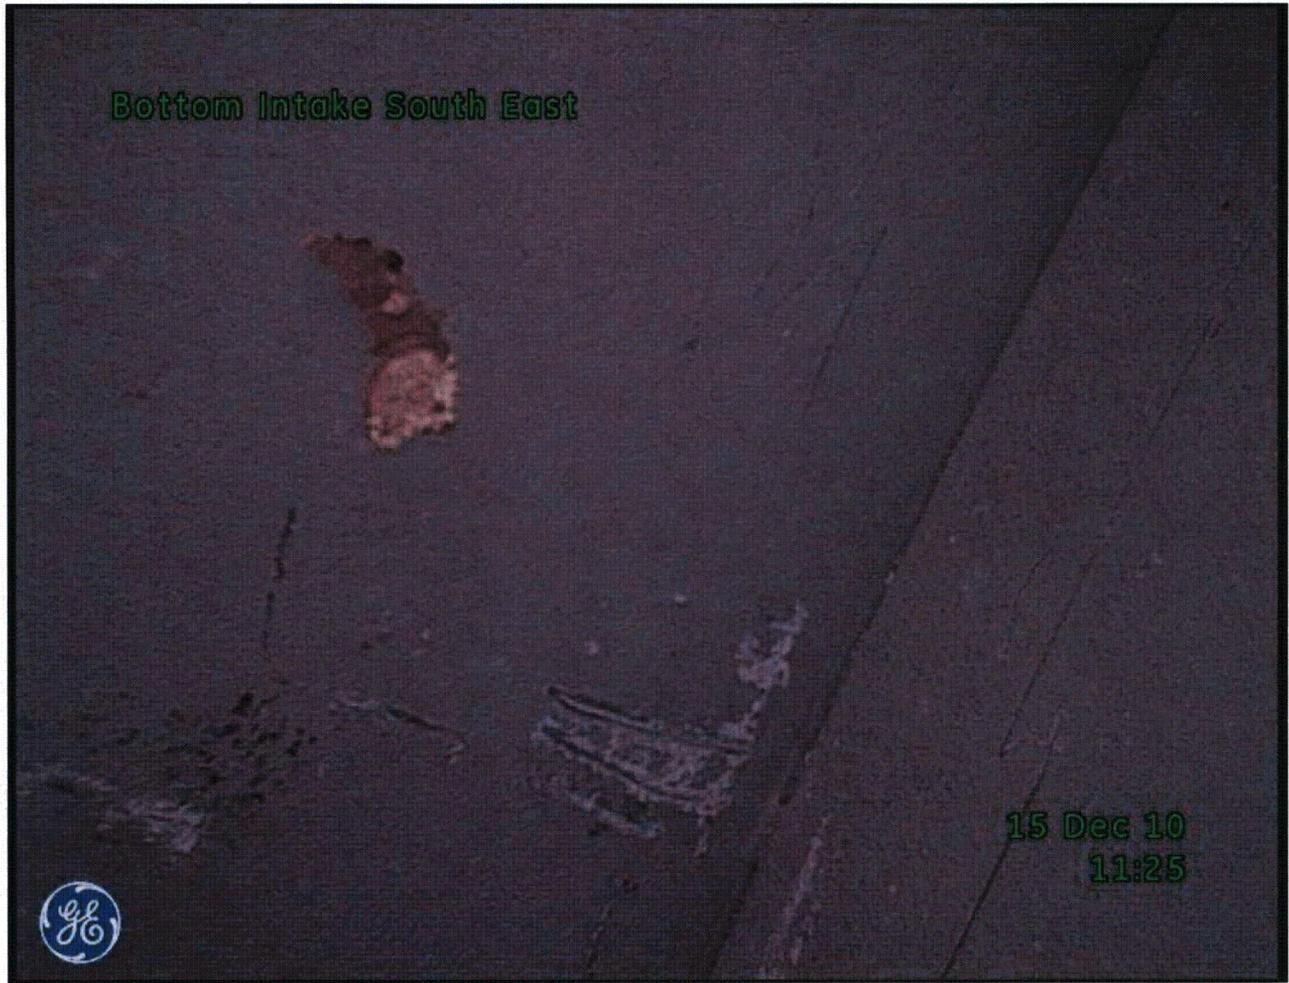
**Figure 6 - Local Coating Failure and Metal Corrosion**

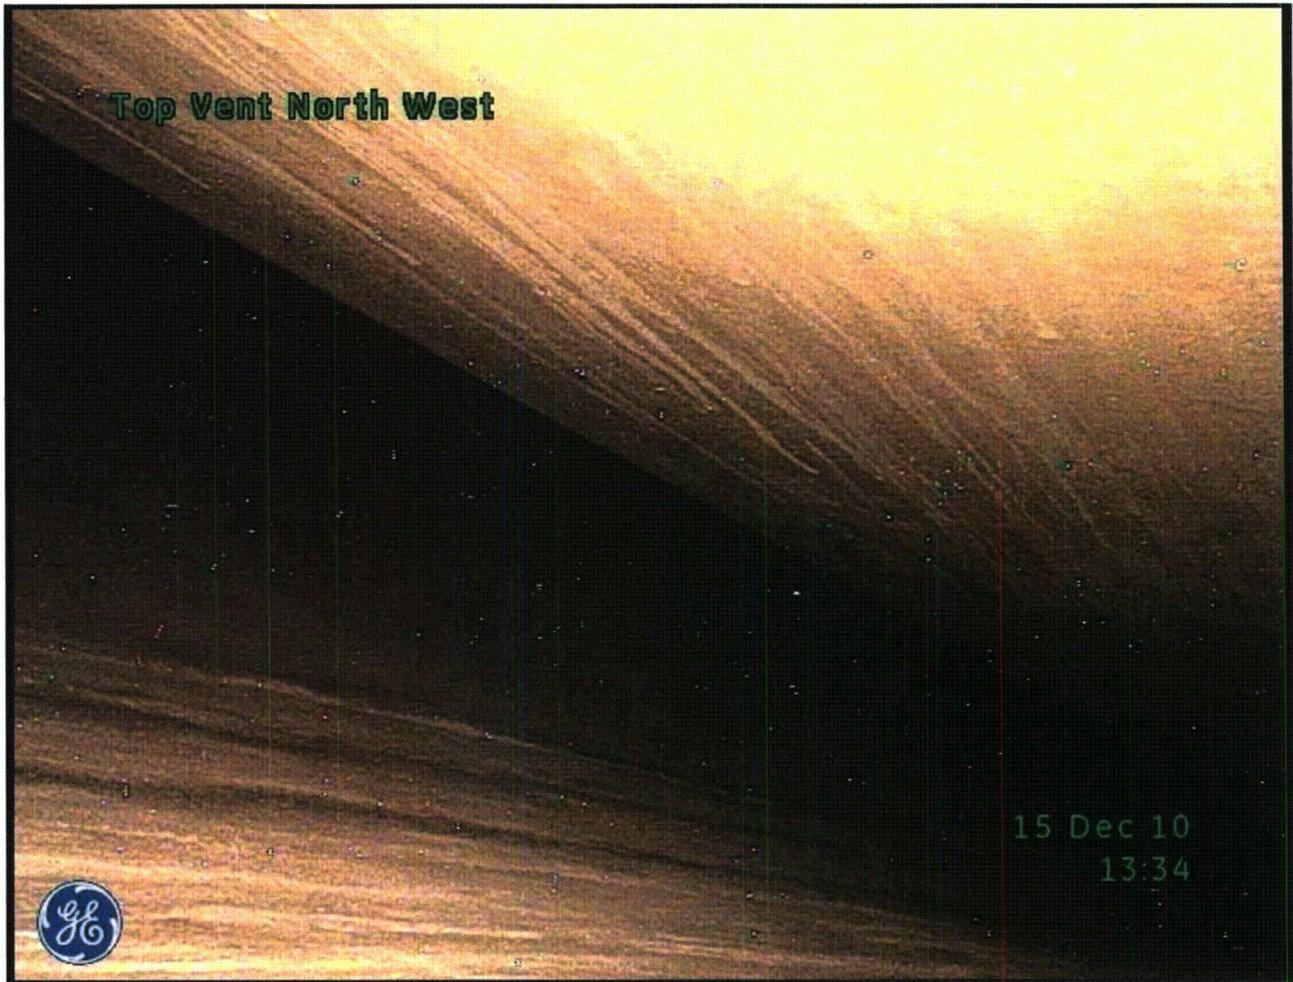
**Figure 7 - Deposits on MSB Radial Surface**
