April 4, 2014  
ES/NRC 14-006  
Docket No. 72-1007

**Subject: Response to Request for Additional Information for the VSC-24 CoC  
Renewal Application (TAC No. L24694)**

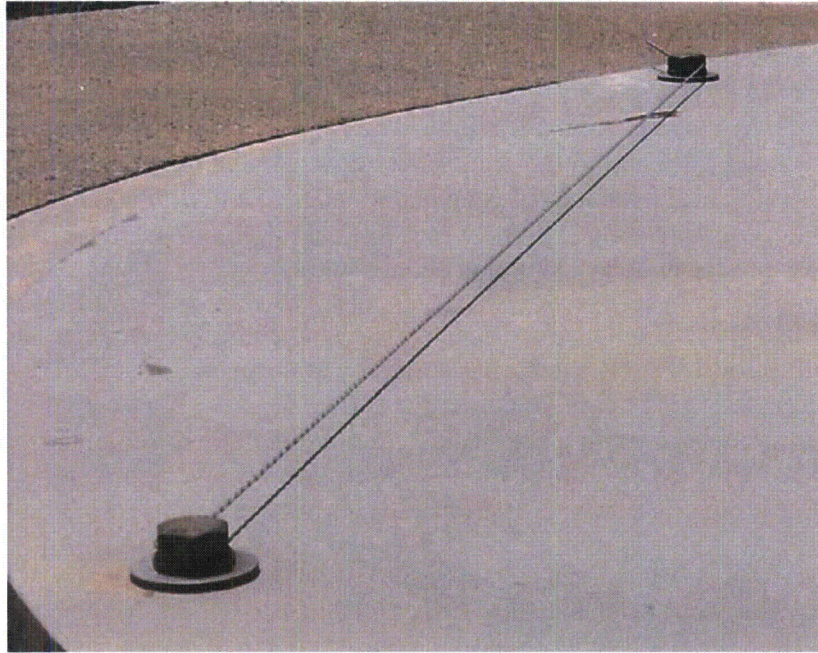
### Condition of Palisades Lead Cask VCC Lid Bolts

The VCC lid bolts are made from A307 carbon steel with a zinc coating or other protective finish. The protective finish on the VCC lid bolts is intended to inhibit corrosion. However, the VCC lid bolts may experience some corrosion during the extended storage period, as operating experience shows. As noted in the Palisades Lead Cask Inspection Report, when the VCC lid bolts were removed, some corrosion was identified on the bolts. However, as shown in the picture below, the amount of corrosion on the VCC lid bolts of the Palisades lead cask was limited to local discoloration of the surface finish, and as such, they were determined to be acceptable for continued use.

- Sections 3.2.2.4: Revised to clarify that the corrosion on the VCC lid bolts was limited to discoloration of the surface finish (i.e., rust bloom) and that the bolts were determined to be acceptable for continued use.

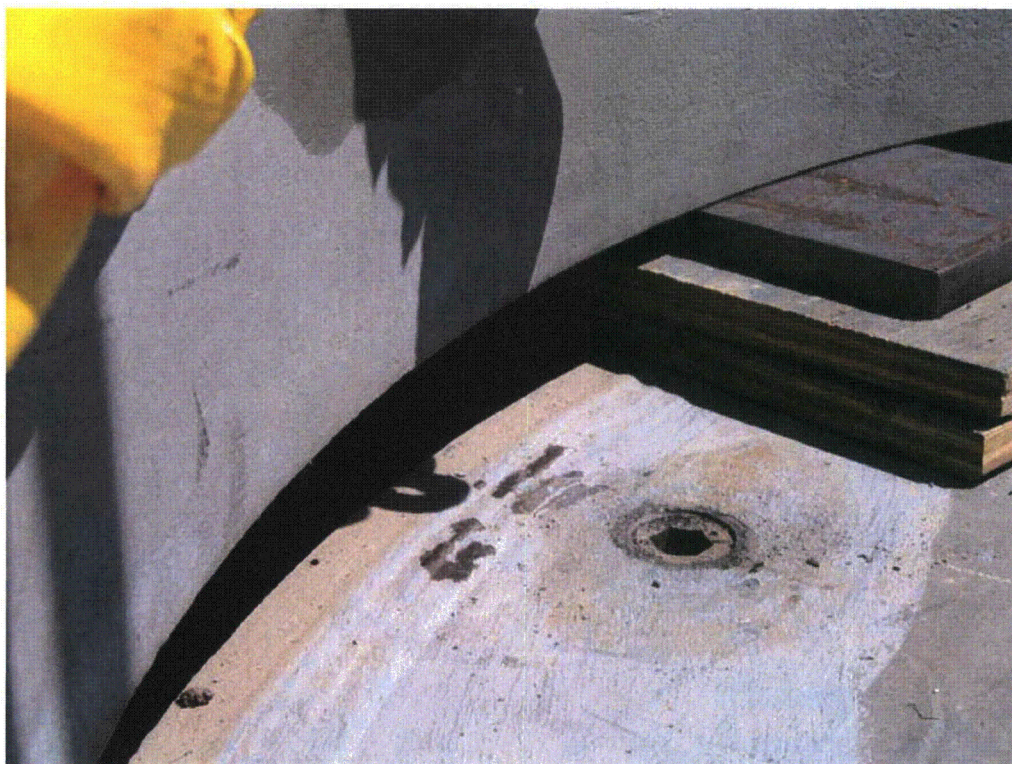
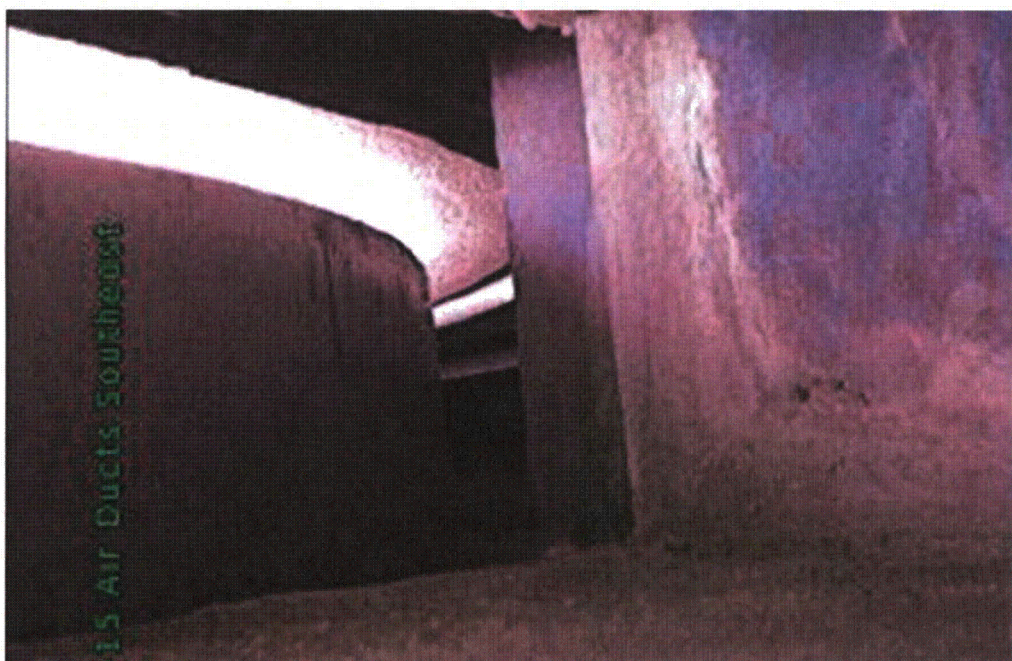
**Photographic Evidence of No Crevice Corrosion at MSB Top Corner**

As discussed in Section 3.2.2.4, the VCC shield ring was lifted by a small amount (approximately 3-inches) to allow visual inspection of the MSB top corner region (i.e., the MSB closure weld), as shown in the first figure below. The visual examination did not identify any evidence of crevice corrosion occurring between the top end of the MSB assembly and the VCC shield ring. Further evidence of the lack of crevice corrosion at the top end of the MSB assembly is shown in the photographs provided below, which are included in the Palisades Lead Cask Inspection Report. The first photograph shows the top edge of the MSB shell exposed after lifting the shield ring. There are no visible signs of corrosion on the top corner of the MSB shell, although some coating was inadvertently scraped off, as discussed in Section 3.4.4 of the renewal application. The second photograph, which is taken from inside one of the VCC air outlet assemblies looking at the top corner of the MSB assembly, shows some discoloration of the coating at the top end of the MSB shell due to high temperatures experienced during the closure welding process, but no signs of corrosion.
