**Subject: October 2013 Inspection Report
Cameco Resources Permit 603**

OCTOBER 2013 INSPECTION REPORT

PERMIT 603

COMPANY: Cameco Resources (CR)
LOCATION: North of Glenrock, Converse County (Highland)
DATE OF INSPECTION: October 23, 2013
DATE OF REPORT : February 6, 2014
INSPECTOR: Pam Rothwell, Permit Coordinator
CO. STAFF PRESENT: Ken Garoutte, CR SHEQ Manager

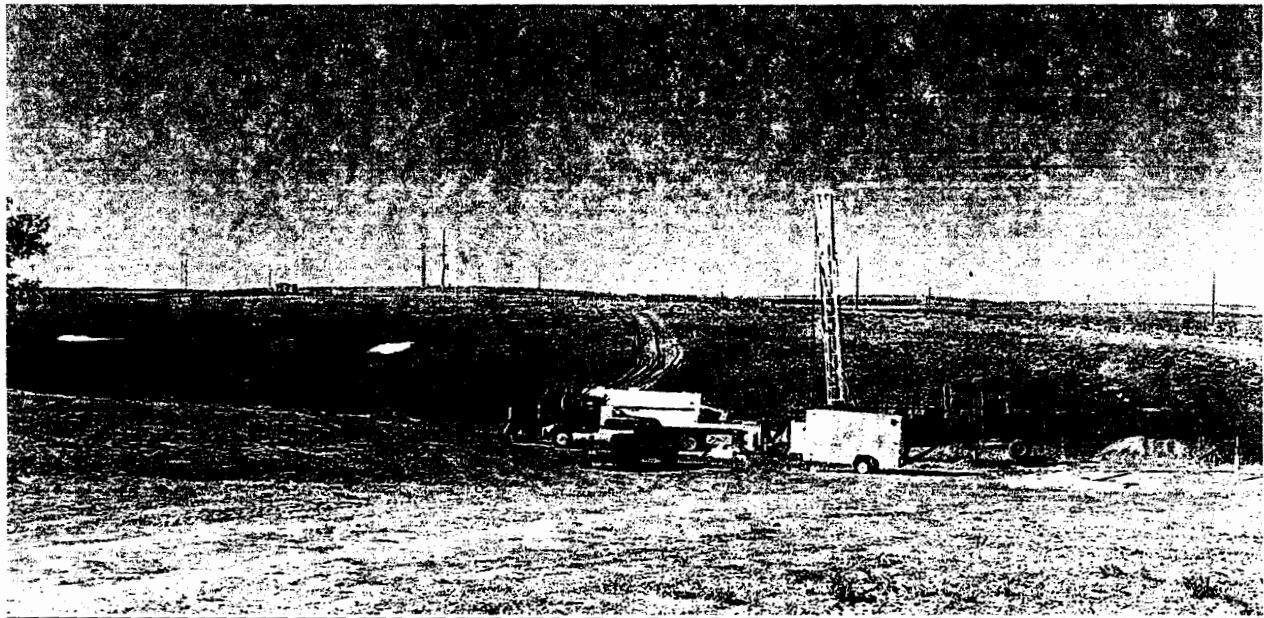
- New shallow investigation well (i.e., NOV Docket No. 5131-13) were being drilled at the time of the inspection (**Figure 1**)
- MU-E (South)
 - Inspected HH 13, Five wells turned on for RO injection

Figure 1 drill rig installing new shallow aquifer investigation wells

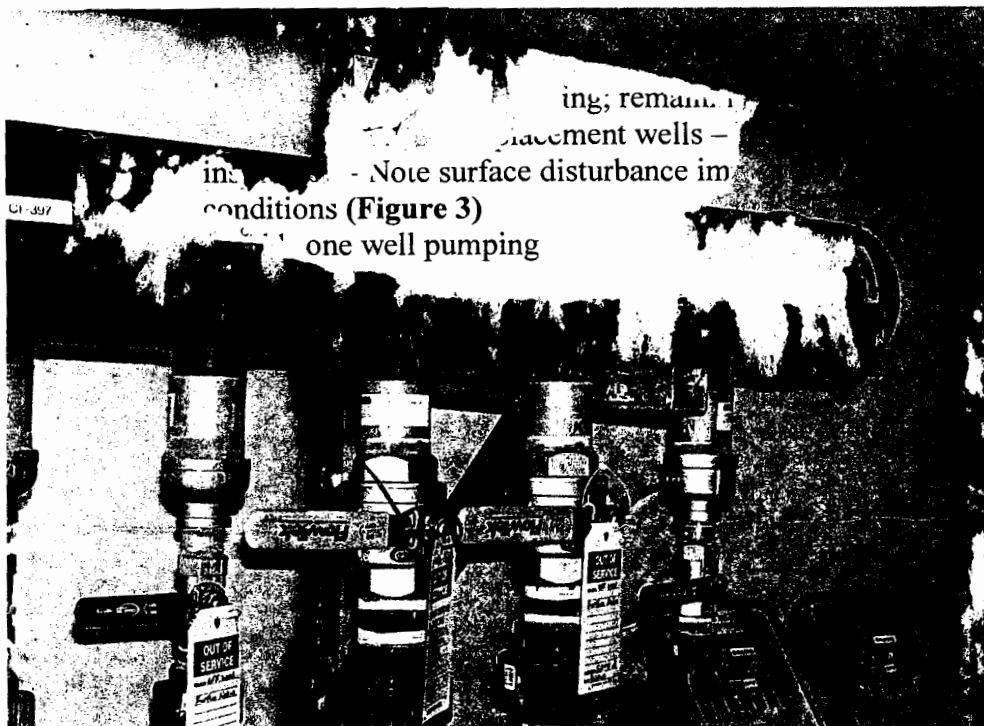
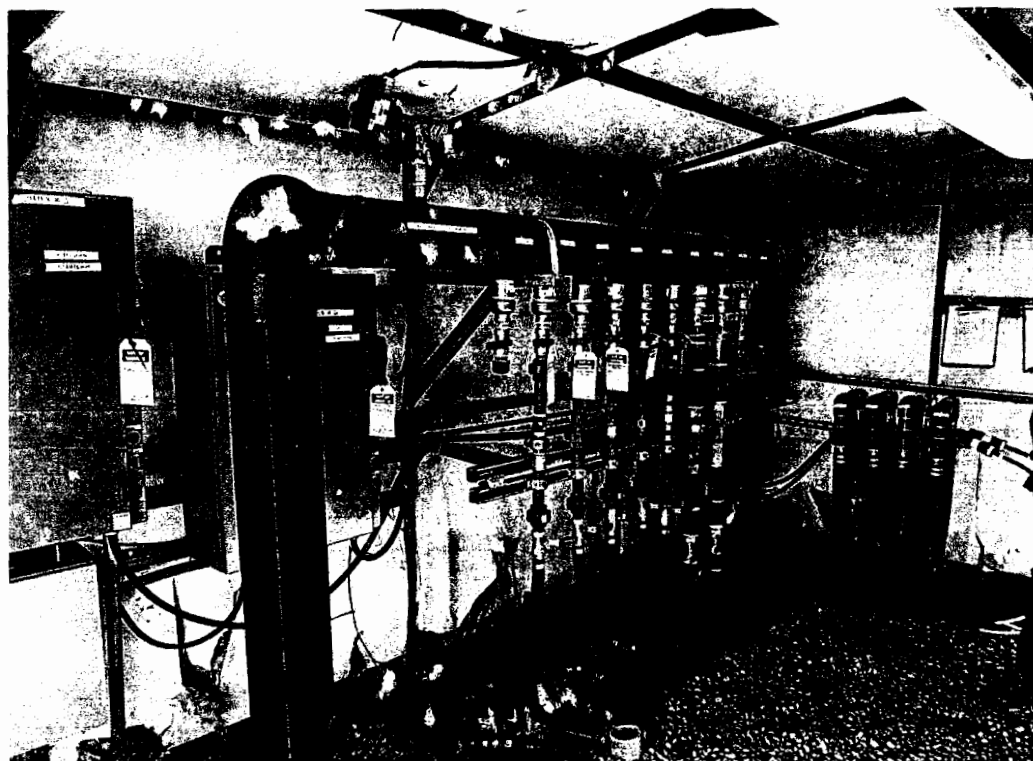
- Inspected HH 12, GWS
 - Inspected HH E12 also used for HHD2-3, DP-22 operating
- MU-C
 - Six wells along the haulageway @ approx. 600' piped to HH C-19 (**Figures 2, 3 & 4**) Request to turn on the wells but need approval for converting the wells (will discuss at meeting with LQD Supervisor on 10-25-14)

Figure 2 New piping for underground haulageway restoration wells CIMW-1 and CRMW-3

Figure 3 New piping for underground haulageway restoration wells CIMW-1 and CRMW-3

1. The wells used for the underground haulageway restoration (CIMW-1, CRMW-2, CRMW-3 and CRMW-4) were noted to be piped into HH -C19 during the inspection. To date, Cameco does not have an approved restoration plan for the haulageway. LQD sent review comments addressing the proposed plan on January 3, 2013. No response has been received. LQD agreed to allow Cameco to pursue restoration of some mine units while restoration plans and reviews are in progress. However, delays in the reviews to approve the restoration plans are not acceptable. Please submit the responses to comments within 30 days.

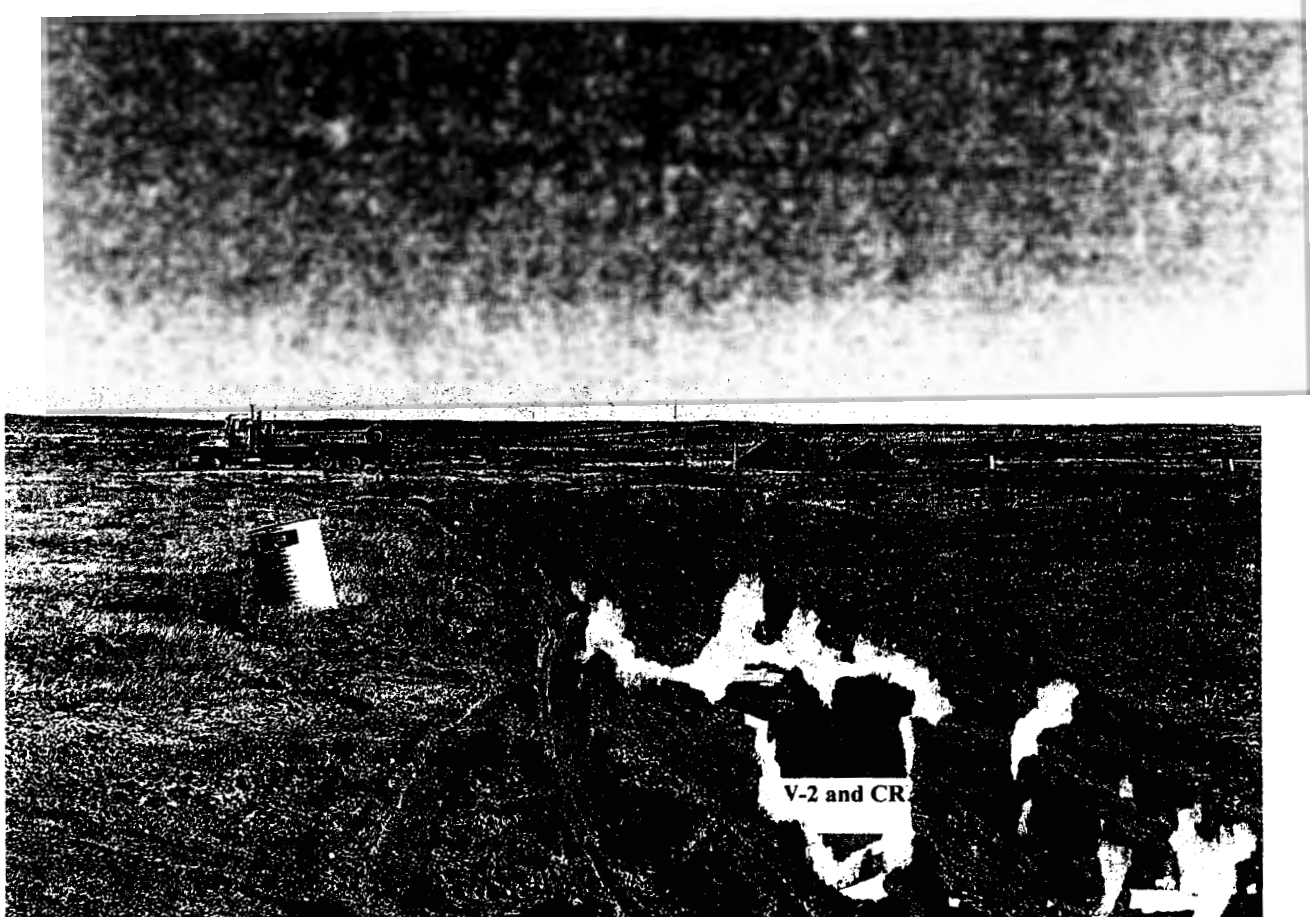
- MU-H
 - Inspected HH 1, Four wells in operation to remove residual uranium
 - HH 4 and HH 14 not operating; remaining HHs are operating
 - Proposal for sixteen replacement wells – Mud pit construction ongoing during inspection – Note surface disturbance impacts due to heavy equipment on wet conditions (**Figure 3**)
 - HH 11, one well pumping

Figure 6 Road disturbances to topsoil for construction of mud pits in MU-H (replacement wells)

2. The surface disturbance in MU-H due to mud pit construction was noted. Cameco is reminded as stated in the permit, *Areas where topsoil has not been removed, such as temporary non-routine access to individual well drilling sites, is not intended for routine vehicular access. Regular access across such areas is restricted to foot traffic or low bearing pressure vehicles to prevent topsoil compaction.* Please continue to encourage the field operators to use designated pathways as much as possible to access the construction sites. Please ensure the appropriate reclamation work including chisel plowing or ripping of the soil is completed followed by reseeding the soil.
