Re: Turkey Point Unit 3  
Docket No. 50-250  
Inservice Inspection Plan - Fifth Inspection Interval  
Unit 3 Relief Request No. 1 – Response to Request for Additional Information

Turkey Point Unit 3  
Fifth Inspection Interval  
Relief Request No. 1  
Response to Request for Additional Information

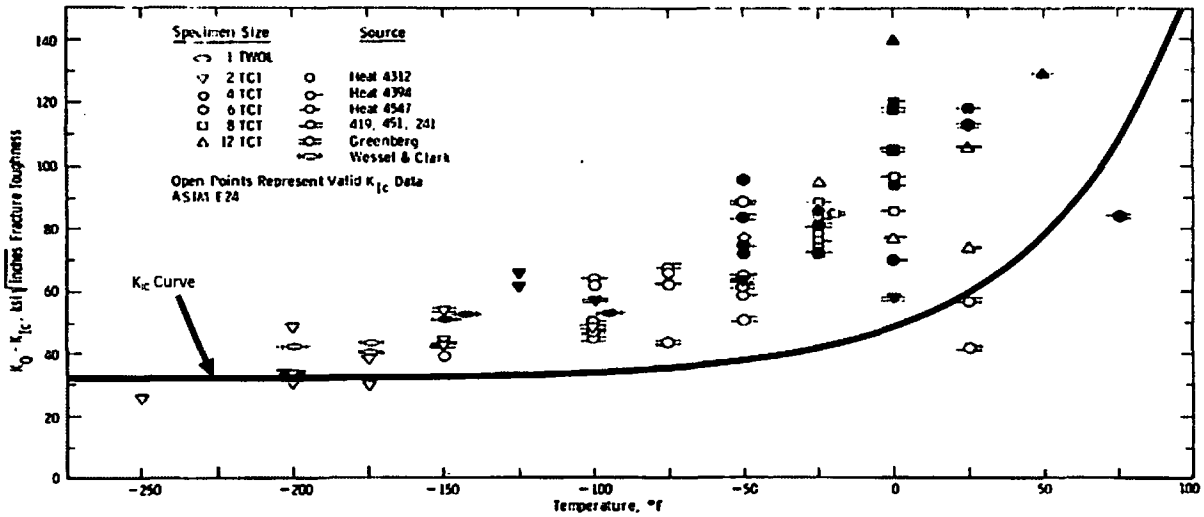
Figure 1: A216 Gr. WCC Fracture Toughness, K<sub>IC</sub> [4]

The pressurizer head is fabricated from SA-216 Gr. WCC cast steel, and the ASME Code KIC curve is directly applicable to this material. Over the years, a great deal of fracture toughness information has been obtained regarding this material, and a figure has been prepared to summarize the data as compared to the ASME Code reference KIC curve; see Figure 1. The fracture toughness was determined for nine heats of material, whose results are plotted [Reference 4]. Sufficient Charpy information was also obtained on these heats of material, and the NUREG-0800 method was used to estimate RTNDT, which was found to be 10°F for each heat. Figure 1 shows that the KIC curve is clearly appropriate for this steel.

Per [1], the KIC allowable for the pressurizer lower head (heater sleeves) at end of cooldown is 25.0 ksi- $\sqrt{\text{in}}$ , with RTNDT = 30°F. The end of cooldown is 70°F, conservatively using the RTNDT of 30°F,  $T - \text{RTNDT} = 40^\circ\text{F}$ . The KIC at 40°F from Figure 1 is approximately 70 ksi- $\sqrt{\text{in}}$ , which is much higher than the KIC = 25.0 ksi- $\sqrt{\text{in}}$  used in [1]. Therefore, it is conservative to compare the CE stability evaluation in [1] to the Turkey Point plant.

Fig. 19—Curve showing both valid and invalid toughness data for 9 heats of A216 (WCC Grade) cast steel
