Seabrook Station

Response to Request for Additional Information Regarding
Bulletin 2012-01, "Design Vulnerability in Electric Power System" (TAC NO. ME9385)

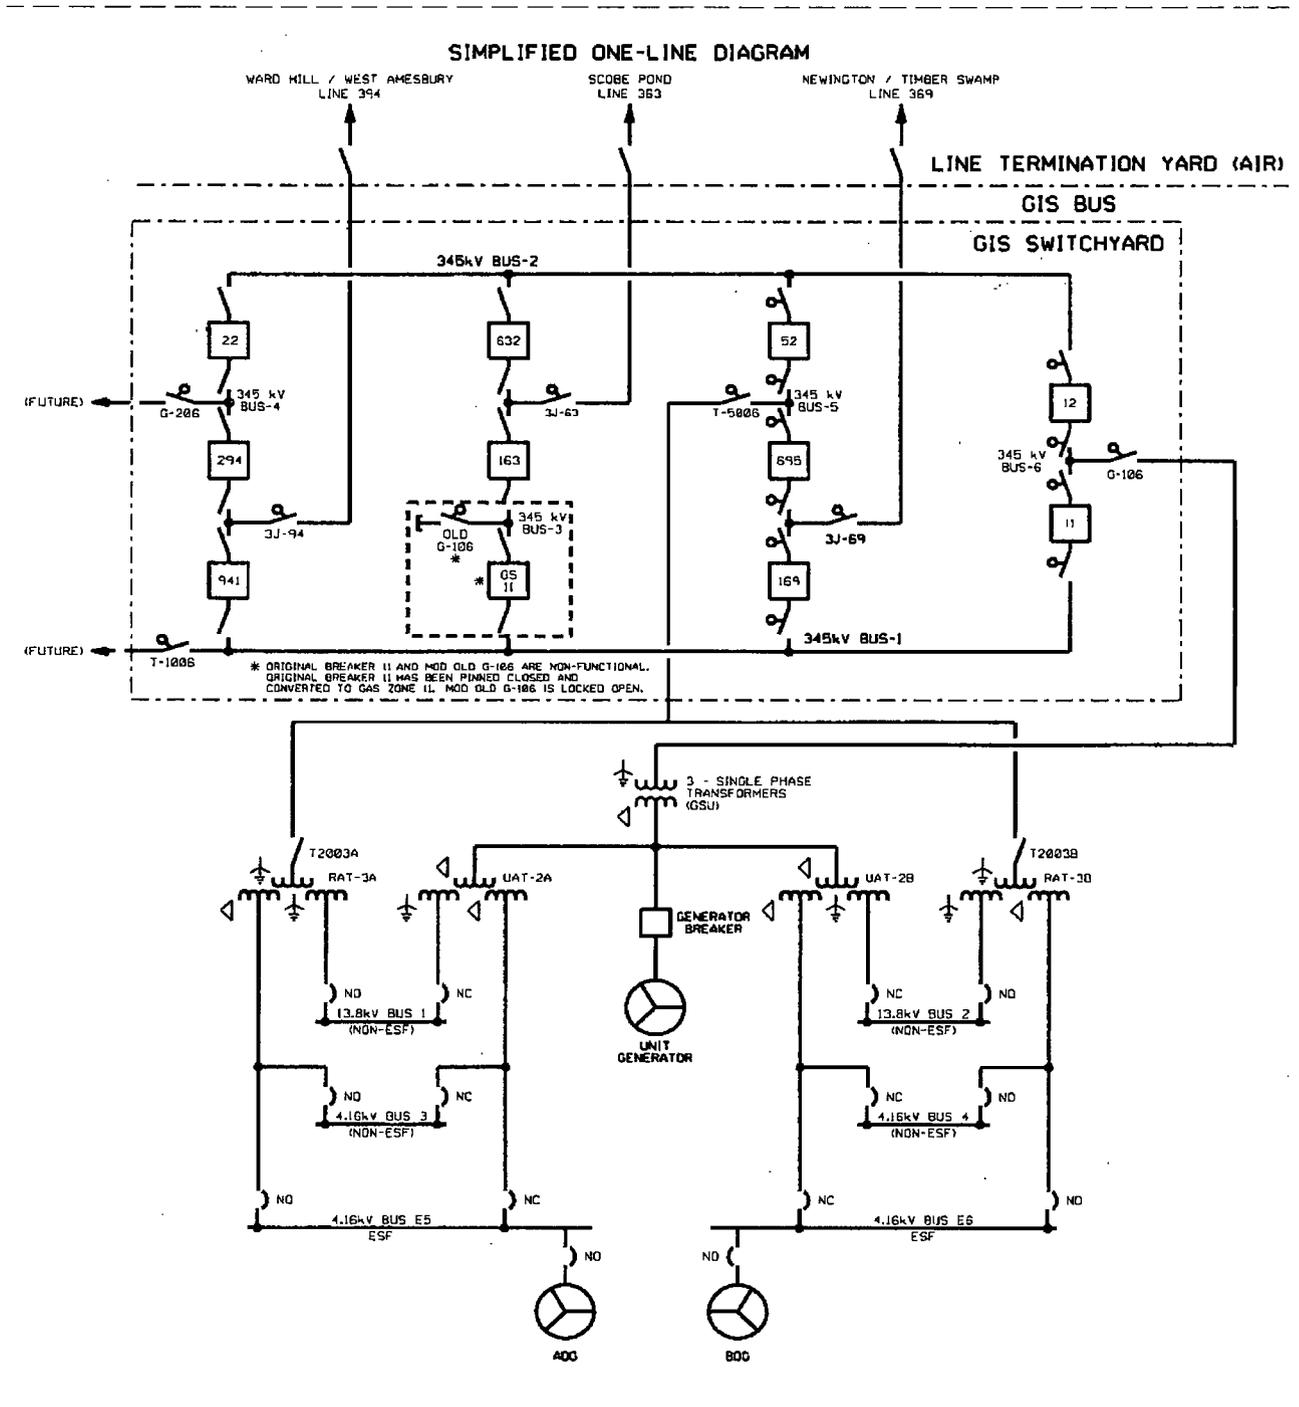
Seabrook Station Simplified One Line Diagram

The transmission grid connections that provide offsite power to Seabrook Station consist of three 345kV transmission lines, as shown in the Simplified One-Line Diagram (see Page 4). Each transmission line, associated 345kV buses and circuit breakers have the capacity to supply the power requirements of station auxiliaries under all plant conditions. These lines are designed and built to provide the electrical and structural independence necessary to insure continuity of offsite electrical power to the station. At Seabrook Station, the three lines terminate at separate terminating structures. From the terminating structures each circuit is routed in a metal-enclosed, Sulphur Hexafluoride (SF₆) gas-insulated bus to a common switching station as shown in the Simplified One-Line Diagram. Two separate and independent safety-related 4.16kV emergency buses and associated diesel generators are the source of power for the plant auxiliaries, protection system and Engineered Safety Features (ESF) loads during normal, abnormal and accident conditions. The normal supply to Train A (Bus E5) and Train B (Bus E6) 4.16kV emergency buses is from separate Unit Auxiliary Transformers (UATs). When the unit is operating the turbine generator output is supplied through the generator circuit breaker and the UATs to the emergency buses. When the unit is shutdown, the generator breaker is opened and the current flow is reversed through the Generator Step-Up Transformer (GSU) and supplied to the UATs. The Reserve Auxiliary Transformers (RATs) provide an alternate source of power to the emergency buses. On loss of normal supply (UAT) to a bus, the alternate supply (RAT) is automatically connected. In addition to a normal and alternate supply, each emergency bus has an emergency power supply in the form of an emergency diesel generator.

The Seabrook Station Generator Step-Up Transformers (GSUs) and the Unit Auxiliary Transformers (UATs) are connected to the ring bus through two circuit breakers (11 & 12). The Seabrook Station Reserve Auxiliary Transformers (RATs) are also connected to the ring bus through two circuit breakers (52 & 695). As such, it is not credible that a single failure in one breaker would result in a loss of one or two phases in the switchyard supply circuit to either the GSU/UAT circuit or the RAT circuit.
