**UNITED STATES
NUCLEAR REGULATORY COMMISSION**
REGION III
2443 WARRENVILLE RD. SUITE 210
LISLE, IL 60532-4352

SUBJECT: DONALD C. COOK NUCLEAR POWER PLANT, UNITS 1 AND 2
NRC INTEGRATED INSPECTION REPORT 05000315/2014002;
05000316/2014002

Inspection Report (IR) 05000315/2014002, 05000316/2014002; 01/01/2014 – 03/31/2014; Donald C. Cook Nuclear Power Plant, Units 1 and 2; Fire Protection; Other Activities; Licensee Identified Violations.

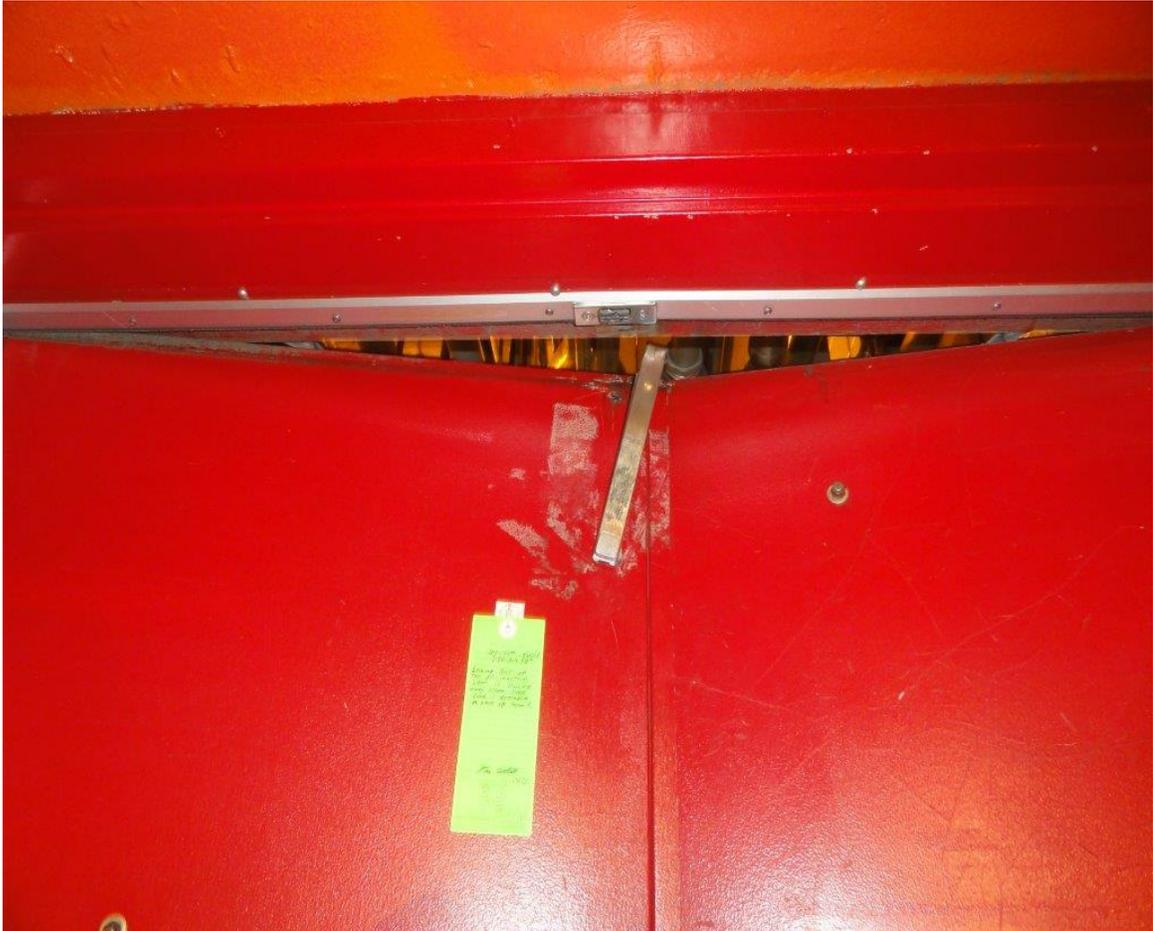
Introduction: The inspectors identified a finding of very low safety significance (Green) and associated NCV of License Condition 2.C.4 for Unit 1, for the licensee's failure to ensure that a fire door would be closed at the time of a fire. Specifically, fire door 1-DR-AUX387 was found with a degraded latch that prevented the door from closing.

Description: On January 17, during a walkdown of the auxiliary building, the inspectors identified that door 387 would not close because part of the latching mechanism interfered with door closure. Figure 1 shows the door in the as found condition. After identifying the issue, the inspector located an auxiliary operator. The operator attempted to correct the condition but could not reposition the latch. The auxiliary operator informed the shift manager and fire protection. Upon notification, fire protection impaired the door and commenced an hourly fire watch as required by the fire protection program. Shortly thereafter, fire protection succeeded in rotating the latch, allowing the door to

close and restoring it to a functional status. A few days later, the licensee completed a permanent repair of the door.

Door 387 provides separation between fire area 44N, which contains safety-related and safe shutdown equipment, and fire zone 38, which contains safety-related equipment and safety-related cabling. The Fire Hazards Analysis describes the door as a 3 hour fire door. In addition, the door is a High Energy Line Break (HELB) door intended to mitigate the effects of a HELB in fire zone 38 from impacting equipment in zone 44N. In response to the inspectors inquiries regarding the impact of the impairment on HELB, the licensee performed an analysis and concluded that the in the event of a HELB, equipment in zone 44N would remain operable.

The licensee conducts a daily fire door inspection. Because of the inspection, the licensee was able to provide the inspectors with a timeline bounding the period when the door could not perform its function. Fire protection had inspected the door at about 2000 on 16 January and verified the door closed. The inspectors identified the failure at approximately 0900 the following day.

During review of the condition, the inspectors noted that the licensee had identified latch degradation on September 25, 2013. When first discovered, the door remained capable of performing its intended function. The licensee processed the deficiency through the work control process. As part of the prioritization process, the licensee obtains the criticality code. Per PMP-2291-WMP-001, if no criticality code is assigned, the equipment is considered run to failure. Since the licensee considered the door as run to failure, by procedure, the door was assigned a priority of 3C, or routine maintenance. As a result, the maintenance was not performed until after the door could no longer perform its function.

Analysis: The inspectors determined the licensee's failure to ensure a fire door would close during a fire was a performance deficiency that warranted a significance determination. Using IMC 0612, Appendix "Issue Screening", issued September 7, 2012, the inspectors concluded that traditional enforcement did not apply. The inspectors determined the finding was more than minor because it was associated with the Mitigating Systems cornerstone attribute of Protection Against External Events (Fire) and adversely affected the cornerstone objective of ensuring the capability of systems that respond to initiating events to prevent undesirable consequences (i.e., core damage). Specifically, the licensee failed to maintain door 387 such that it could perform its required function as a 3 hour fire barrier.
