SUBJECT: SEP TOPIC III-3C "Inservice Inspection of Water Control Structures"

Systematic Evaluation Program Topic Assessment

Location: San Onofre 1

Topic: III-3.C - Inservice Inspection of Water-Control Structures

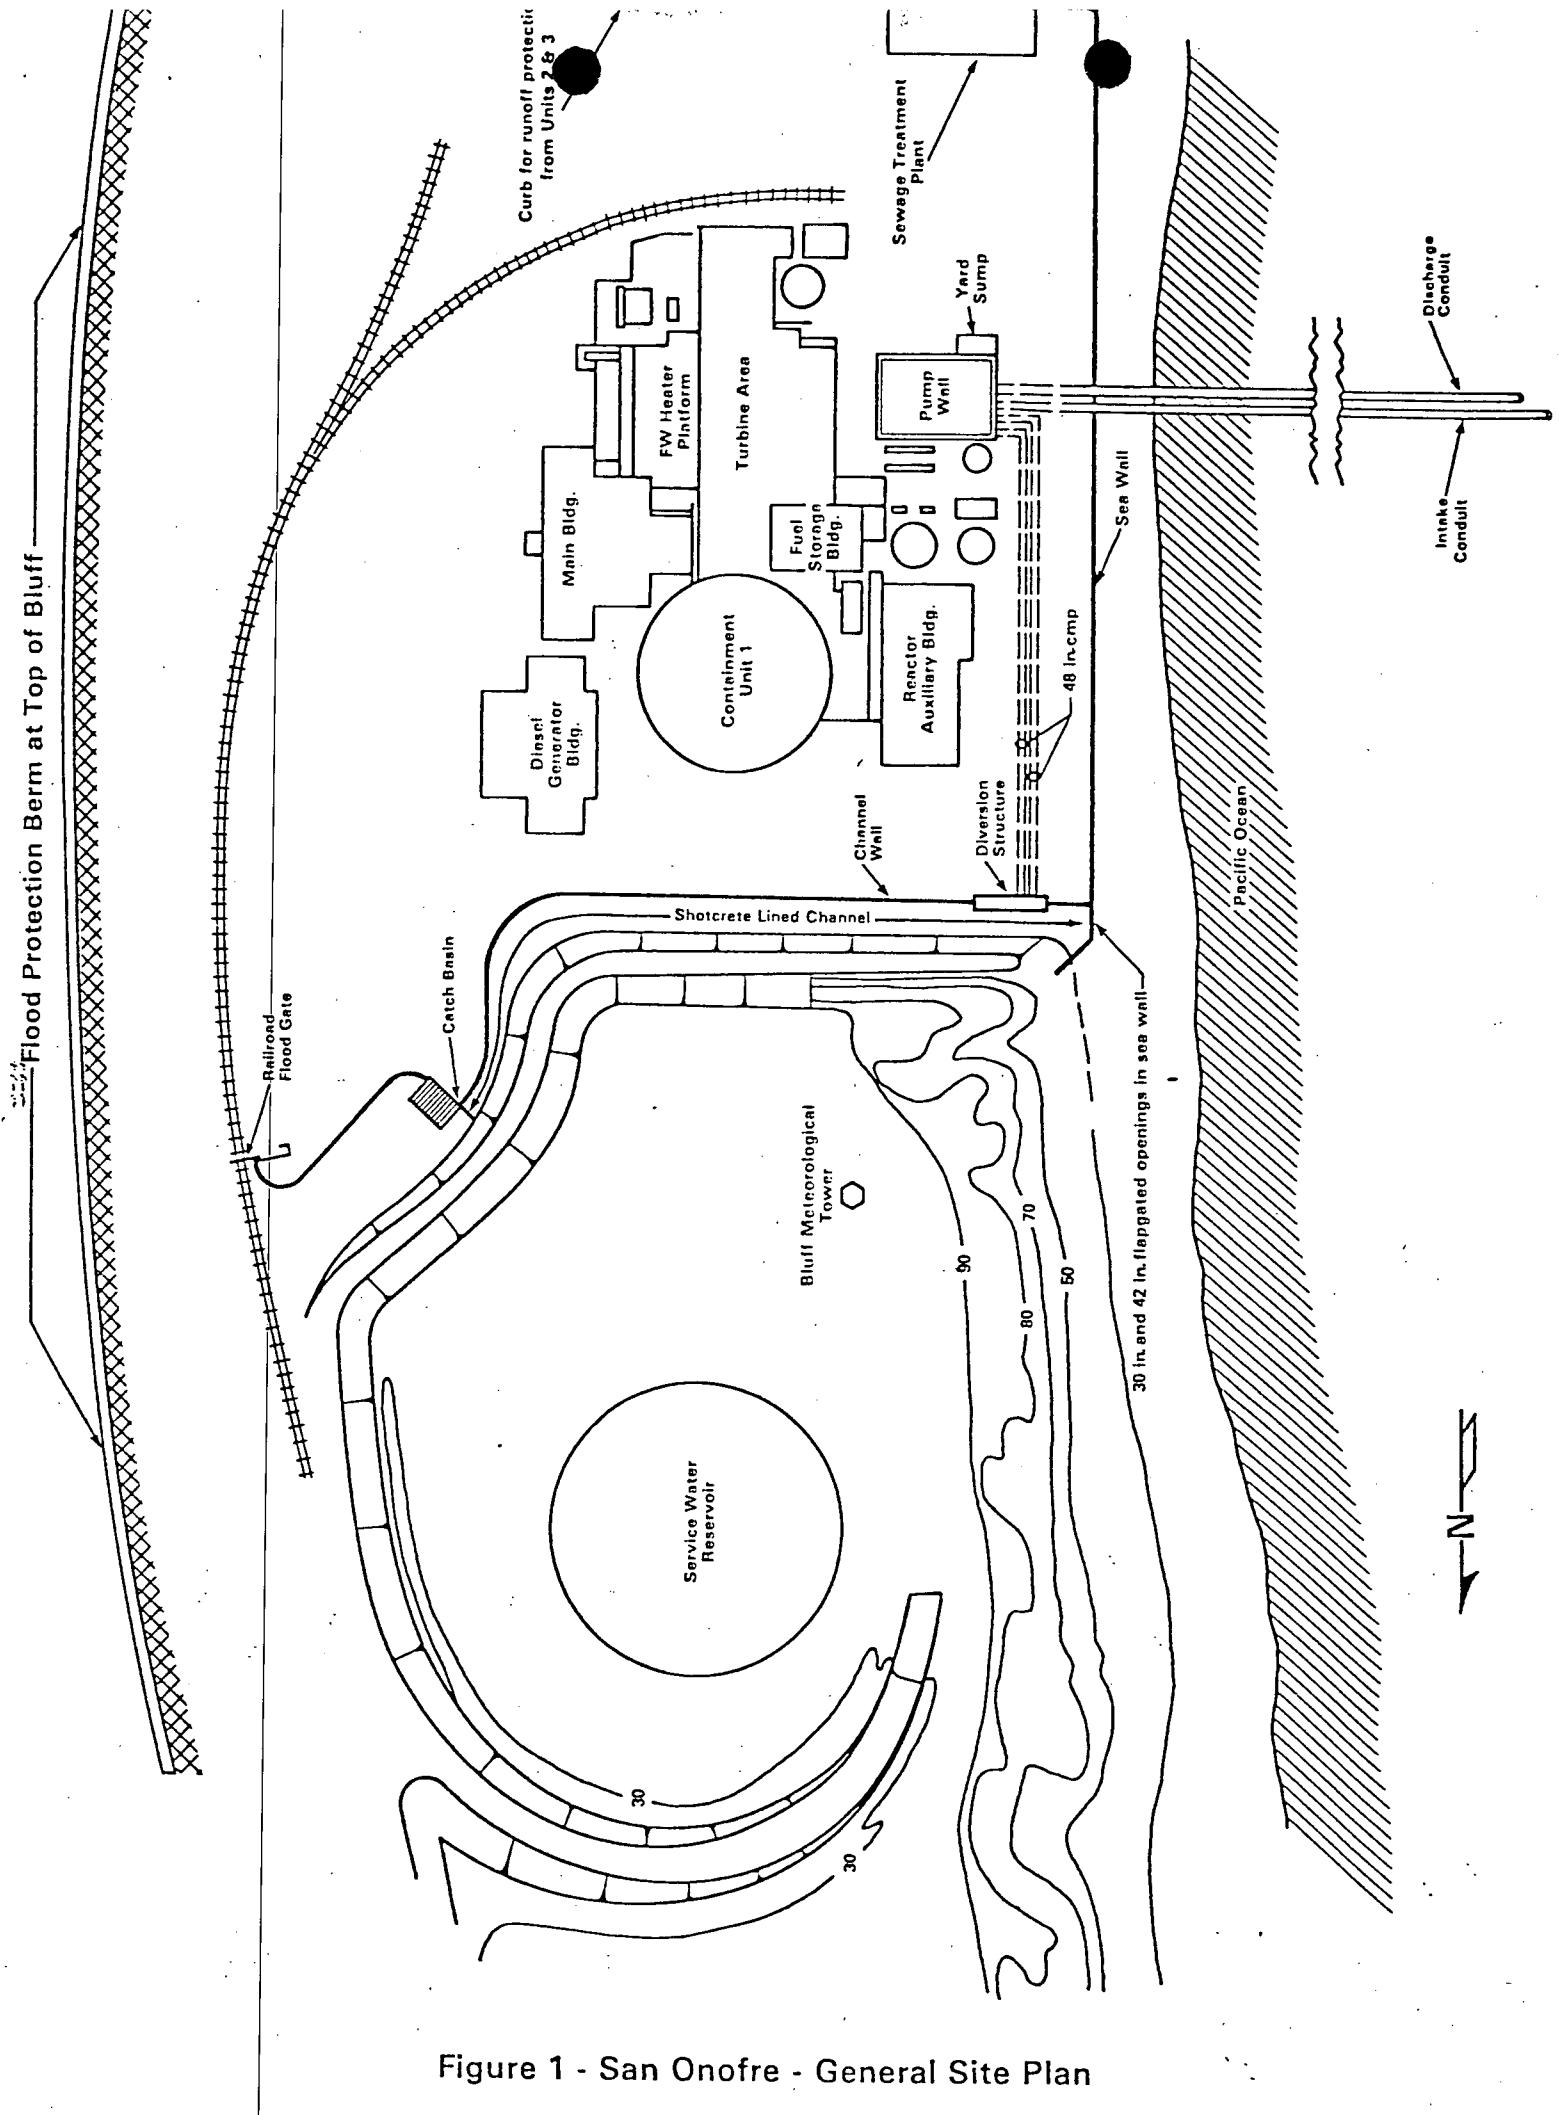
Figure 1 - San Onofre - General Site Plan

The following structures and components associated with the San Onofre Unit 1 site have been identified as requiring surveillance in accordance with applicable Commission rules and the regulatory guidance in Regulatory Guide 1.127. (See Figure 1)
